RollerCheck360

Roll Inspection from 08.12.2025

Rolls: 178

We have analyzed for you 178 rolls.

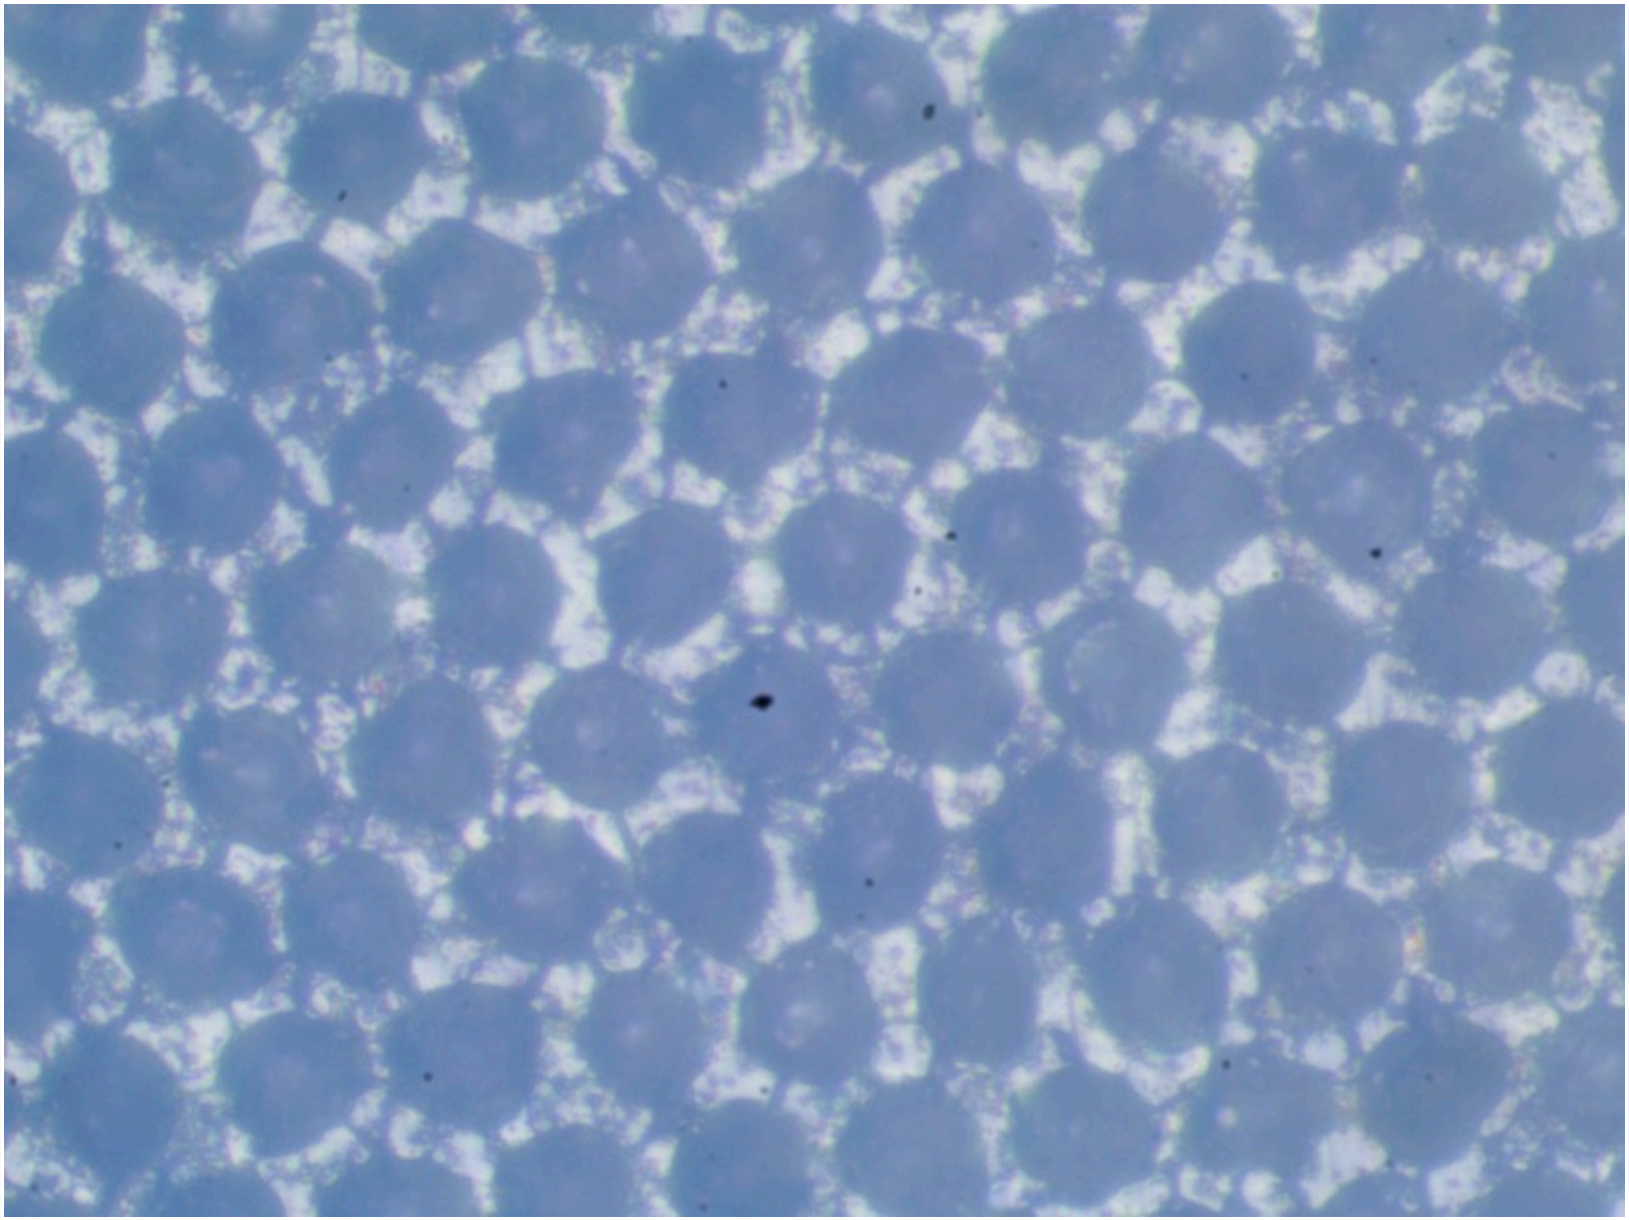
Roll "h100479-7".	Photo of the anilox roll surface

Ink transfer volume decrease from the passport value: 15%

Bridge / Cell: 1 / 5
Depth before / after: 13 / 13 мкм
Depth decreased by: 0%

Comment
radial doctor-blade streaks.
Roll ground off.

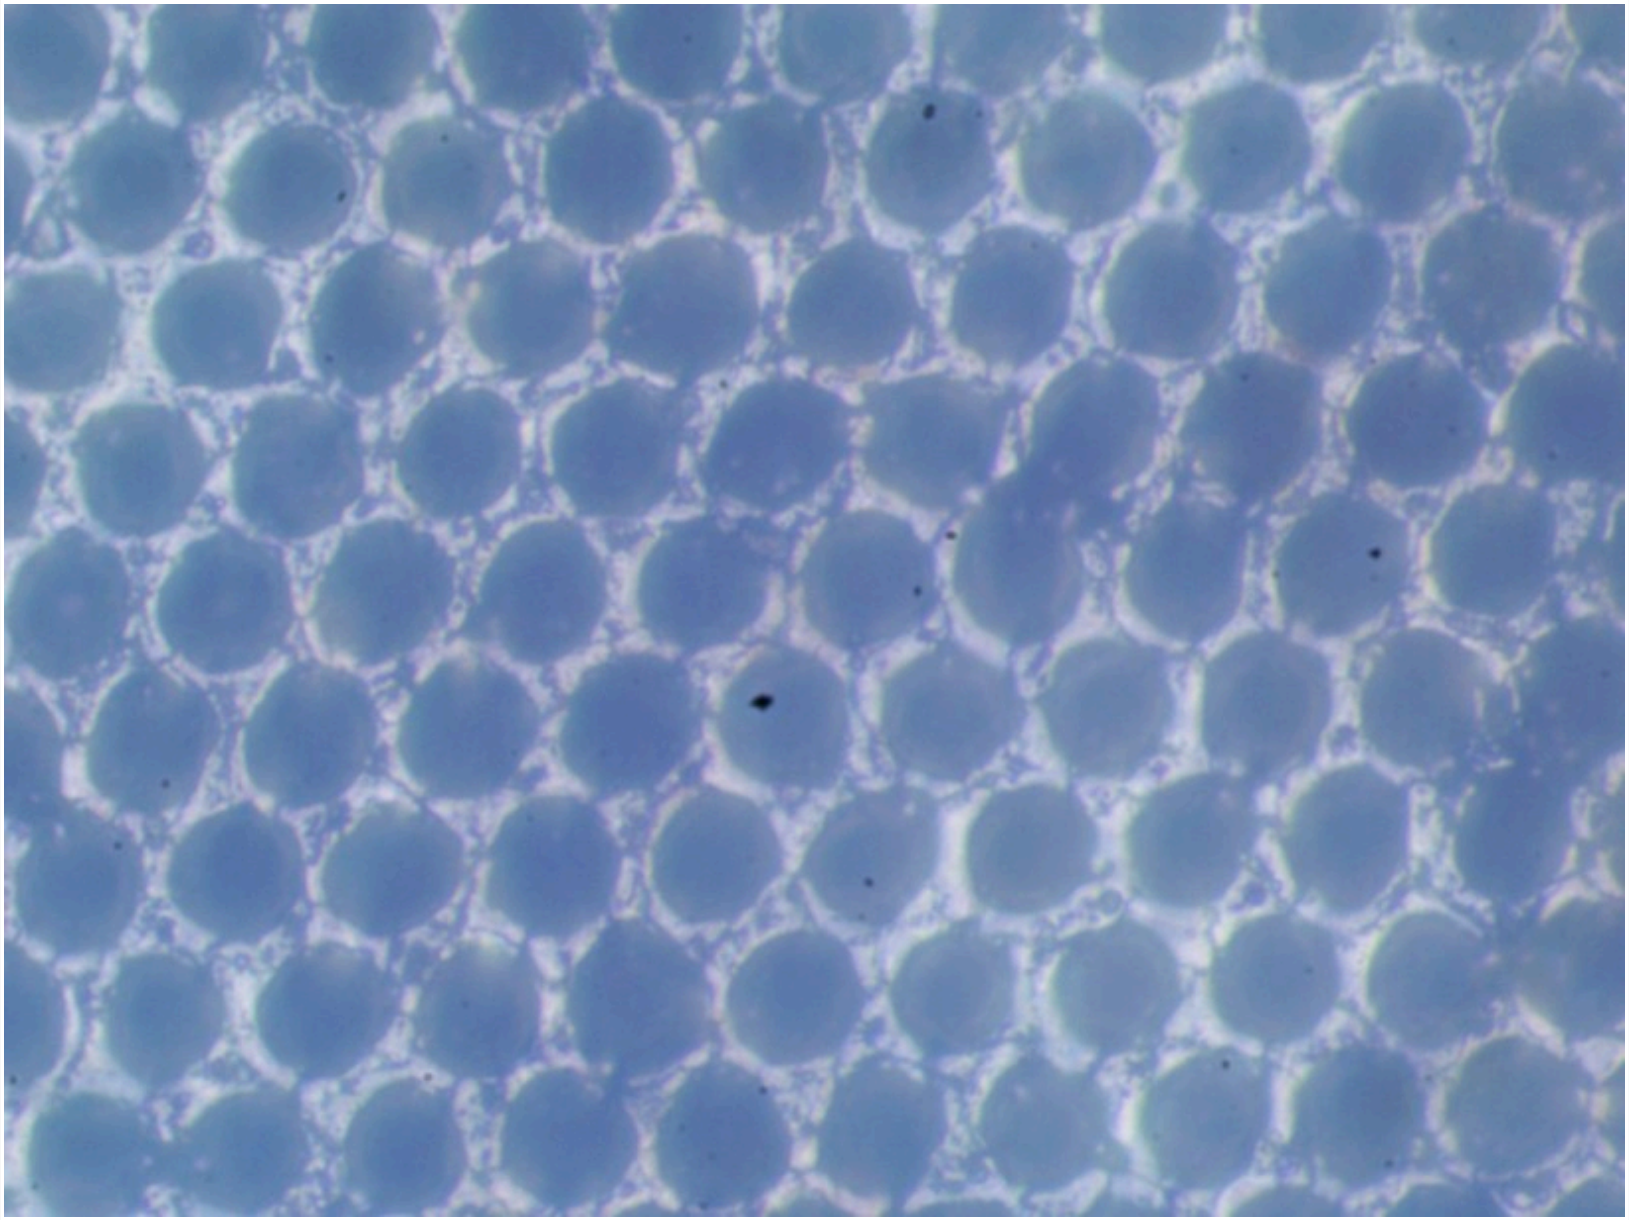
Roll "sa0007096".	Photo of the anilox roll surface

Comment
radial doctor-blade streaks.
Roll ground off.

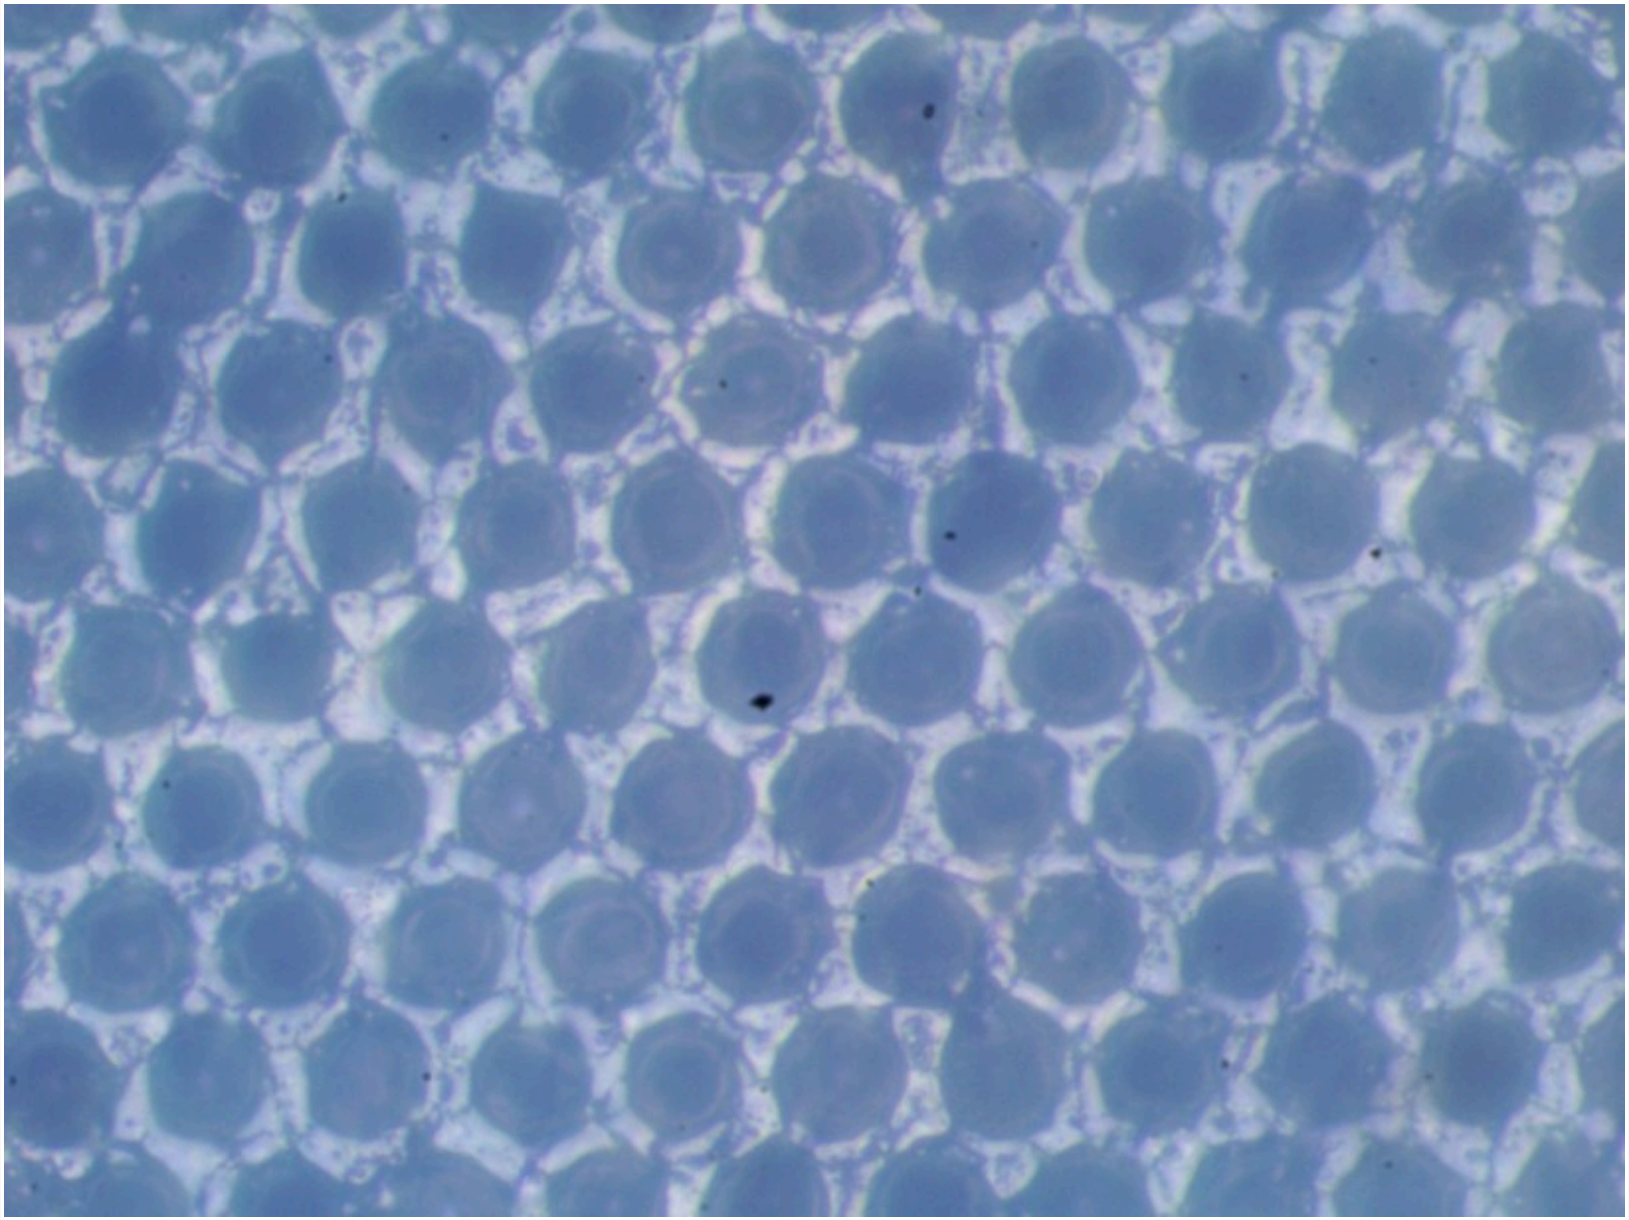
Roll "sd007094".	Photo of the anilox roll surface

Comment
radial doctor-blade streaks.
Roll ground off.

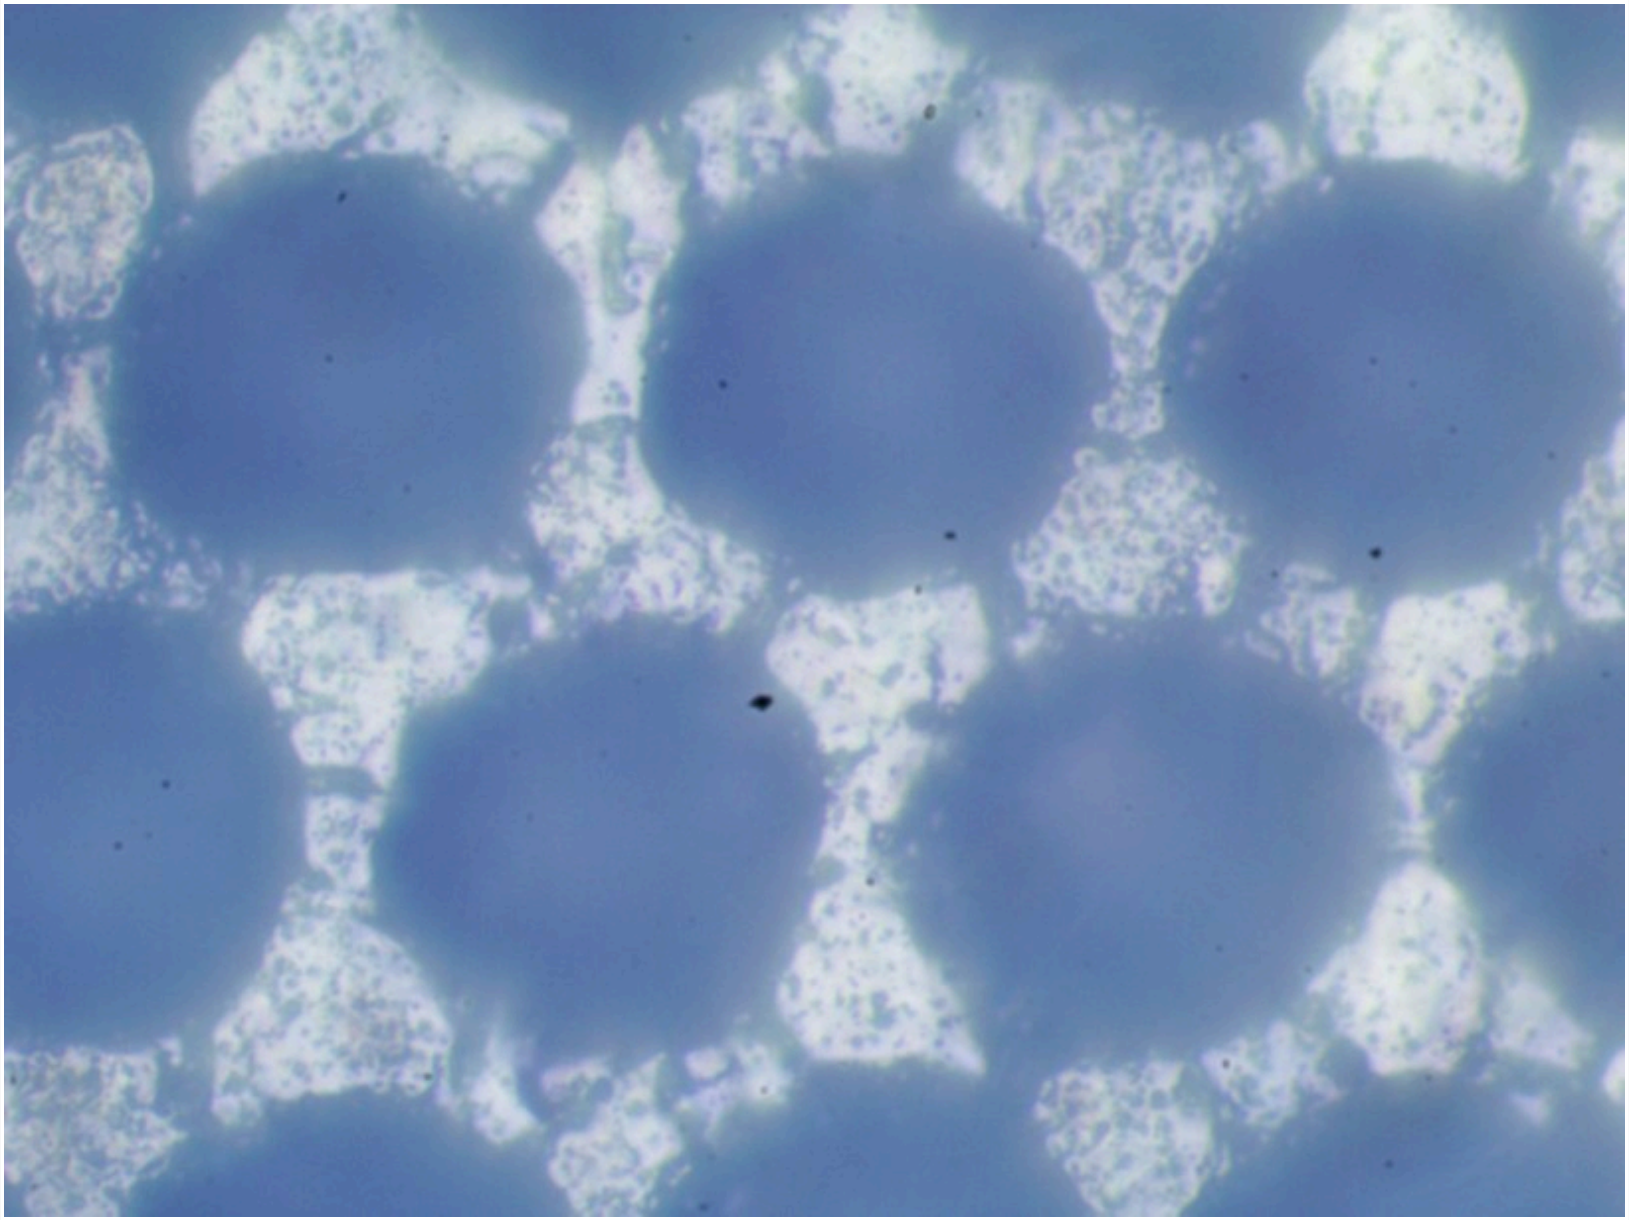
Roll "h100749-1".	Photo of the anilox roll surface

Comment
streak 225 scratches 425 1250 spot 510 400.

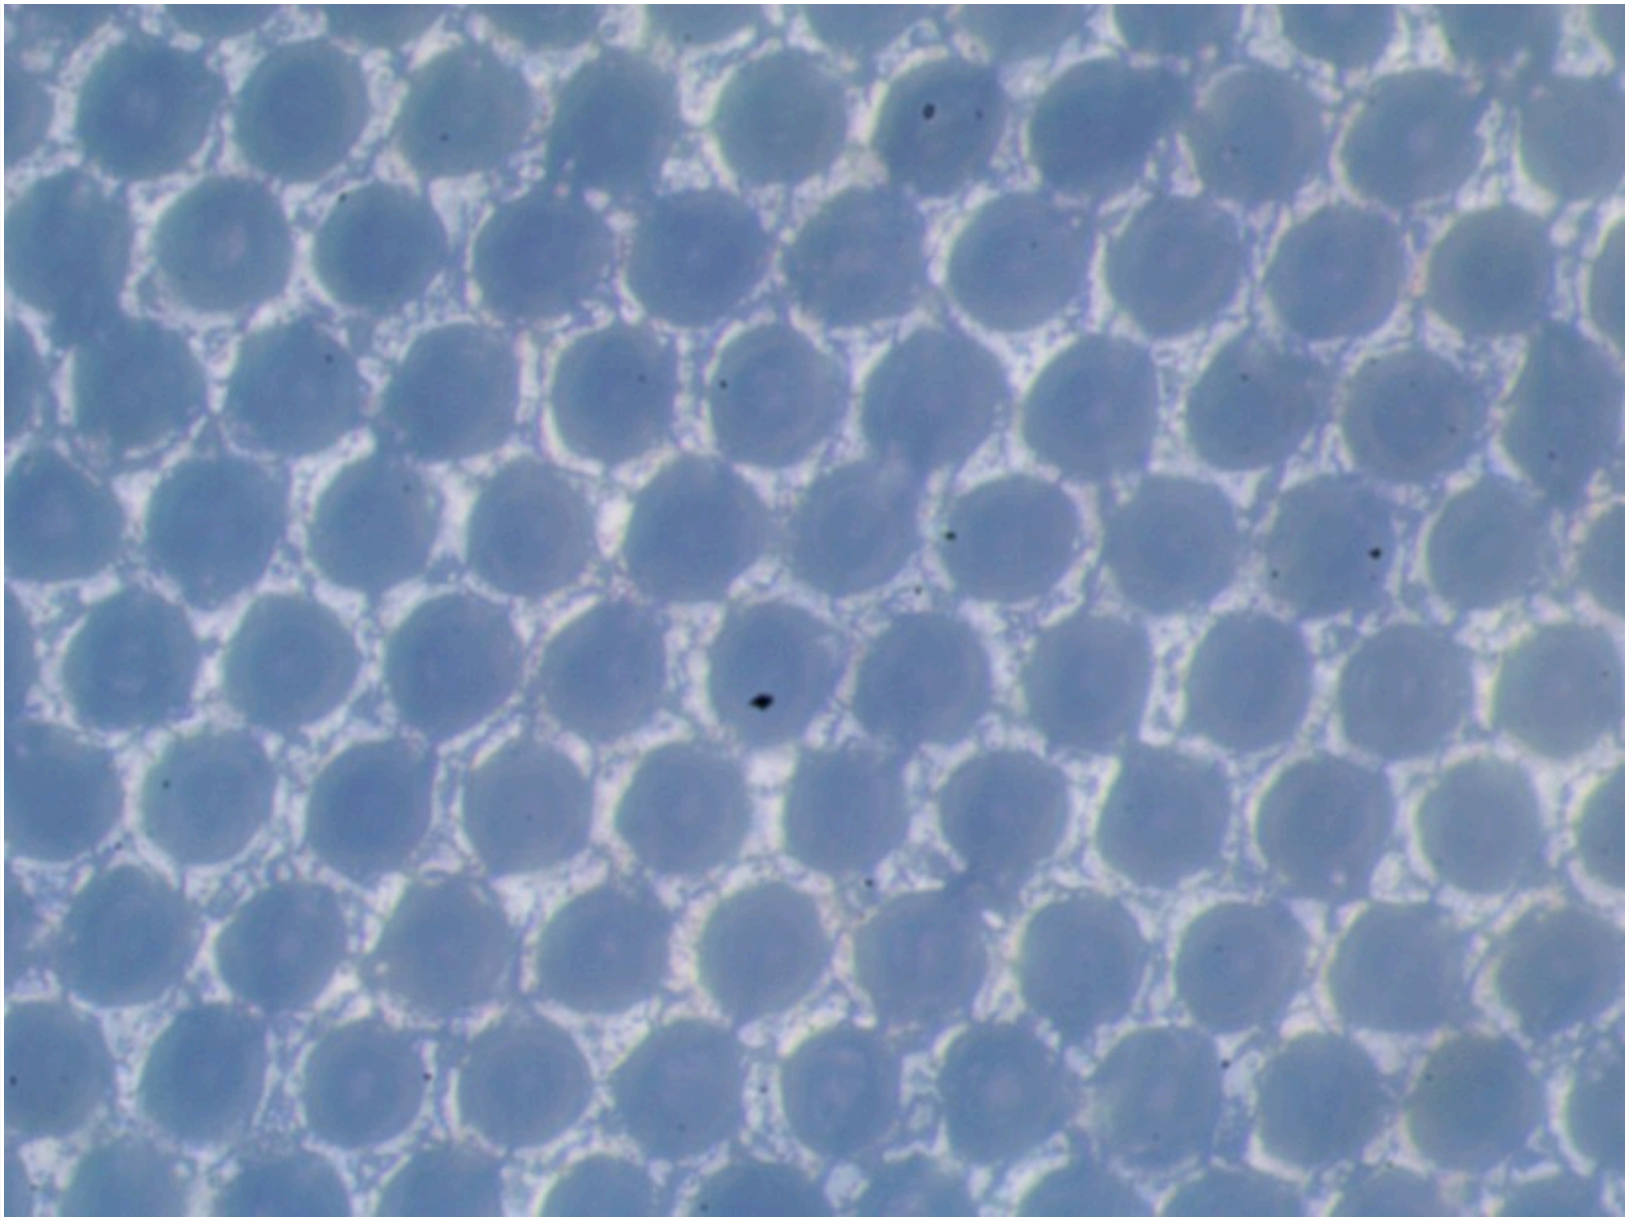
Roll "ds007093".	Photo of the anilox roll surface

Comment
dent 700 spots streaks.
Roll ground off.

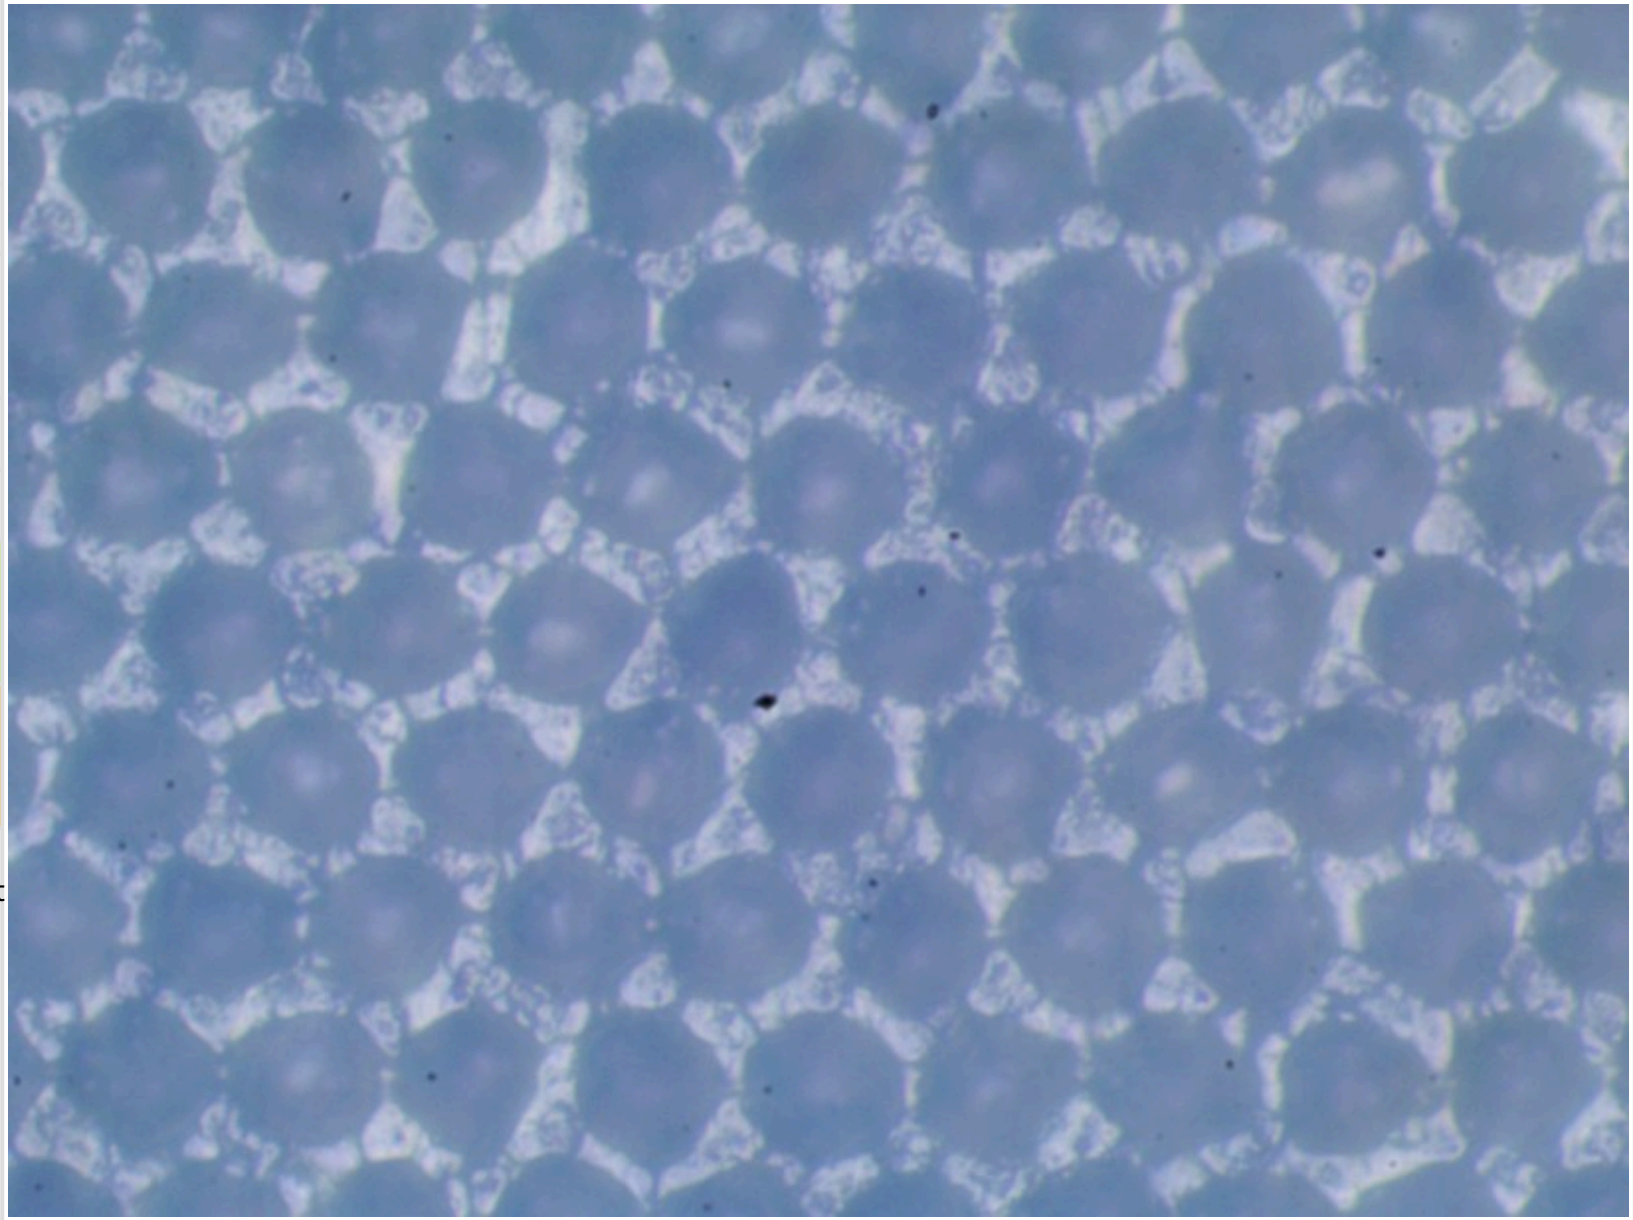
Roll "h100479-4".	Photo of the anilox roll surface

Roll ground off.

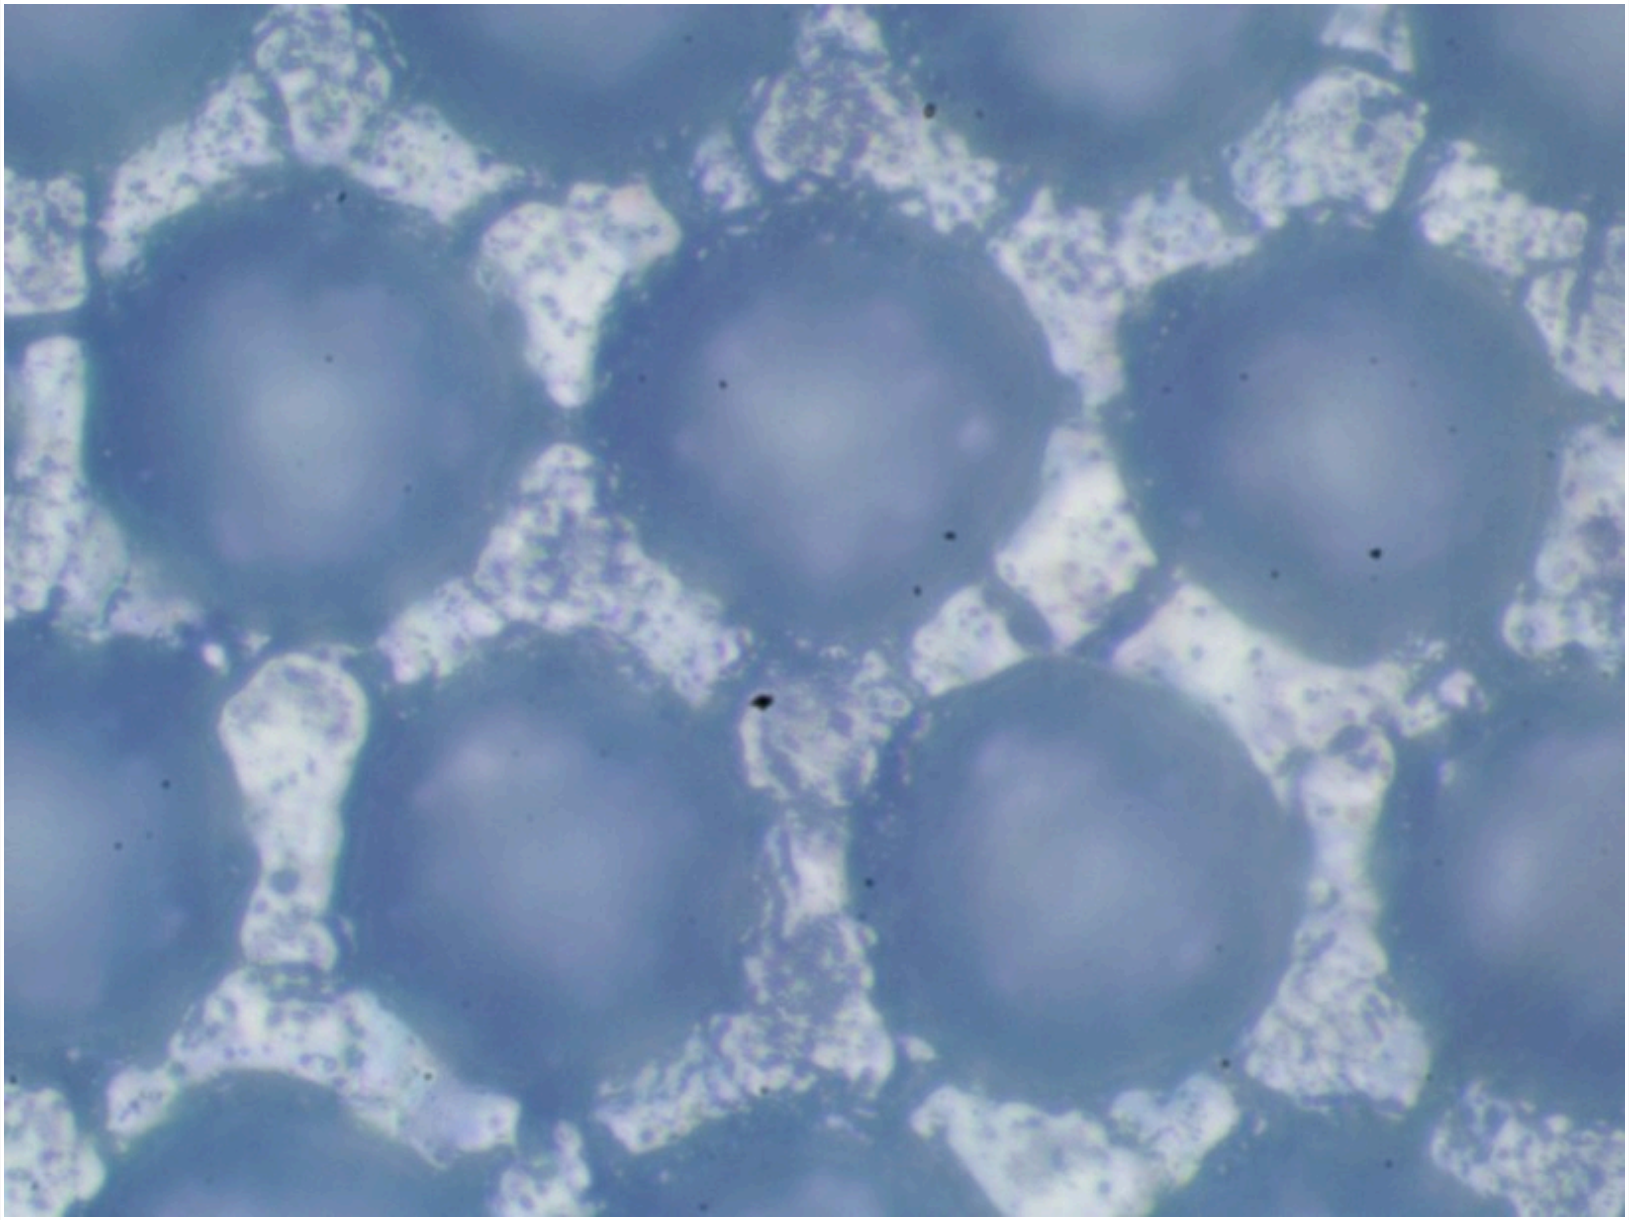
Roll "3016196-1".	Photo of the anilox roll surface

Comment
streak 740.

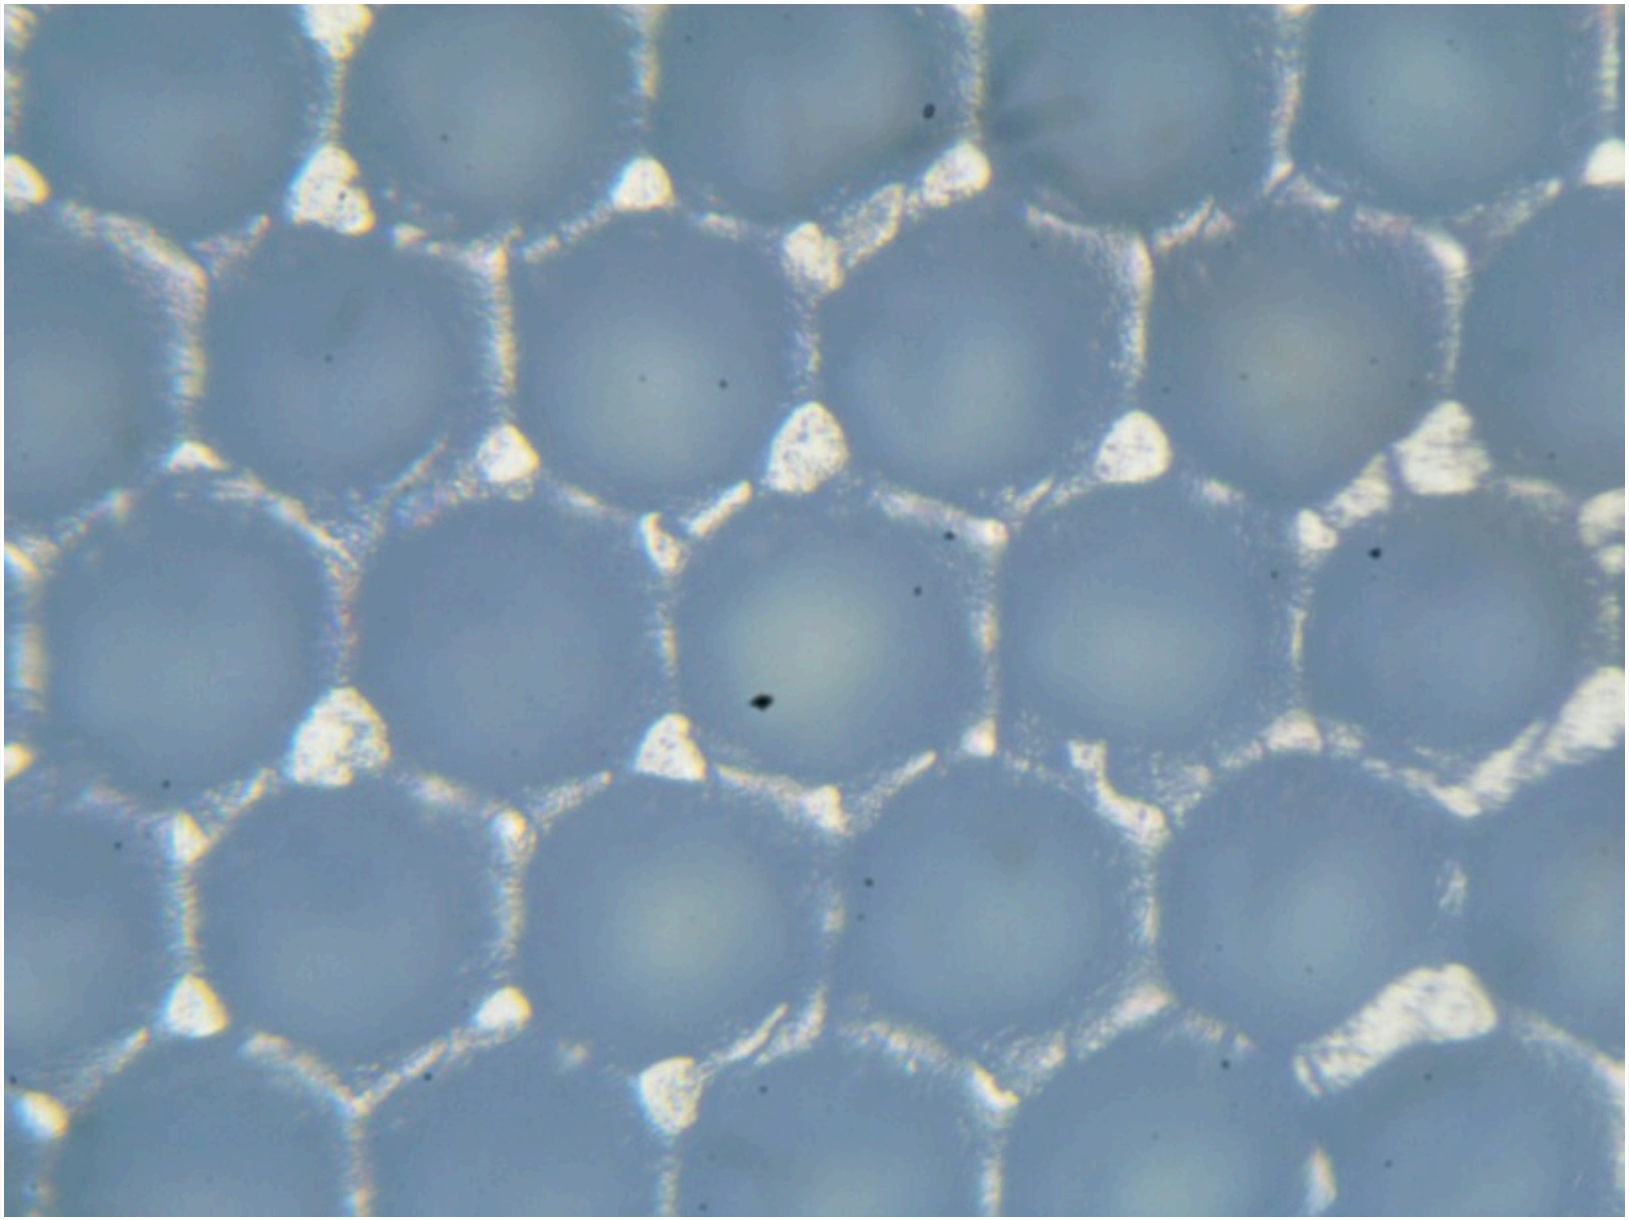
Roll "h100748-1".	Photo of the anilox roll surface

Comment
streaks.

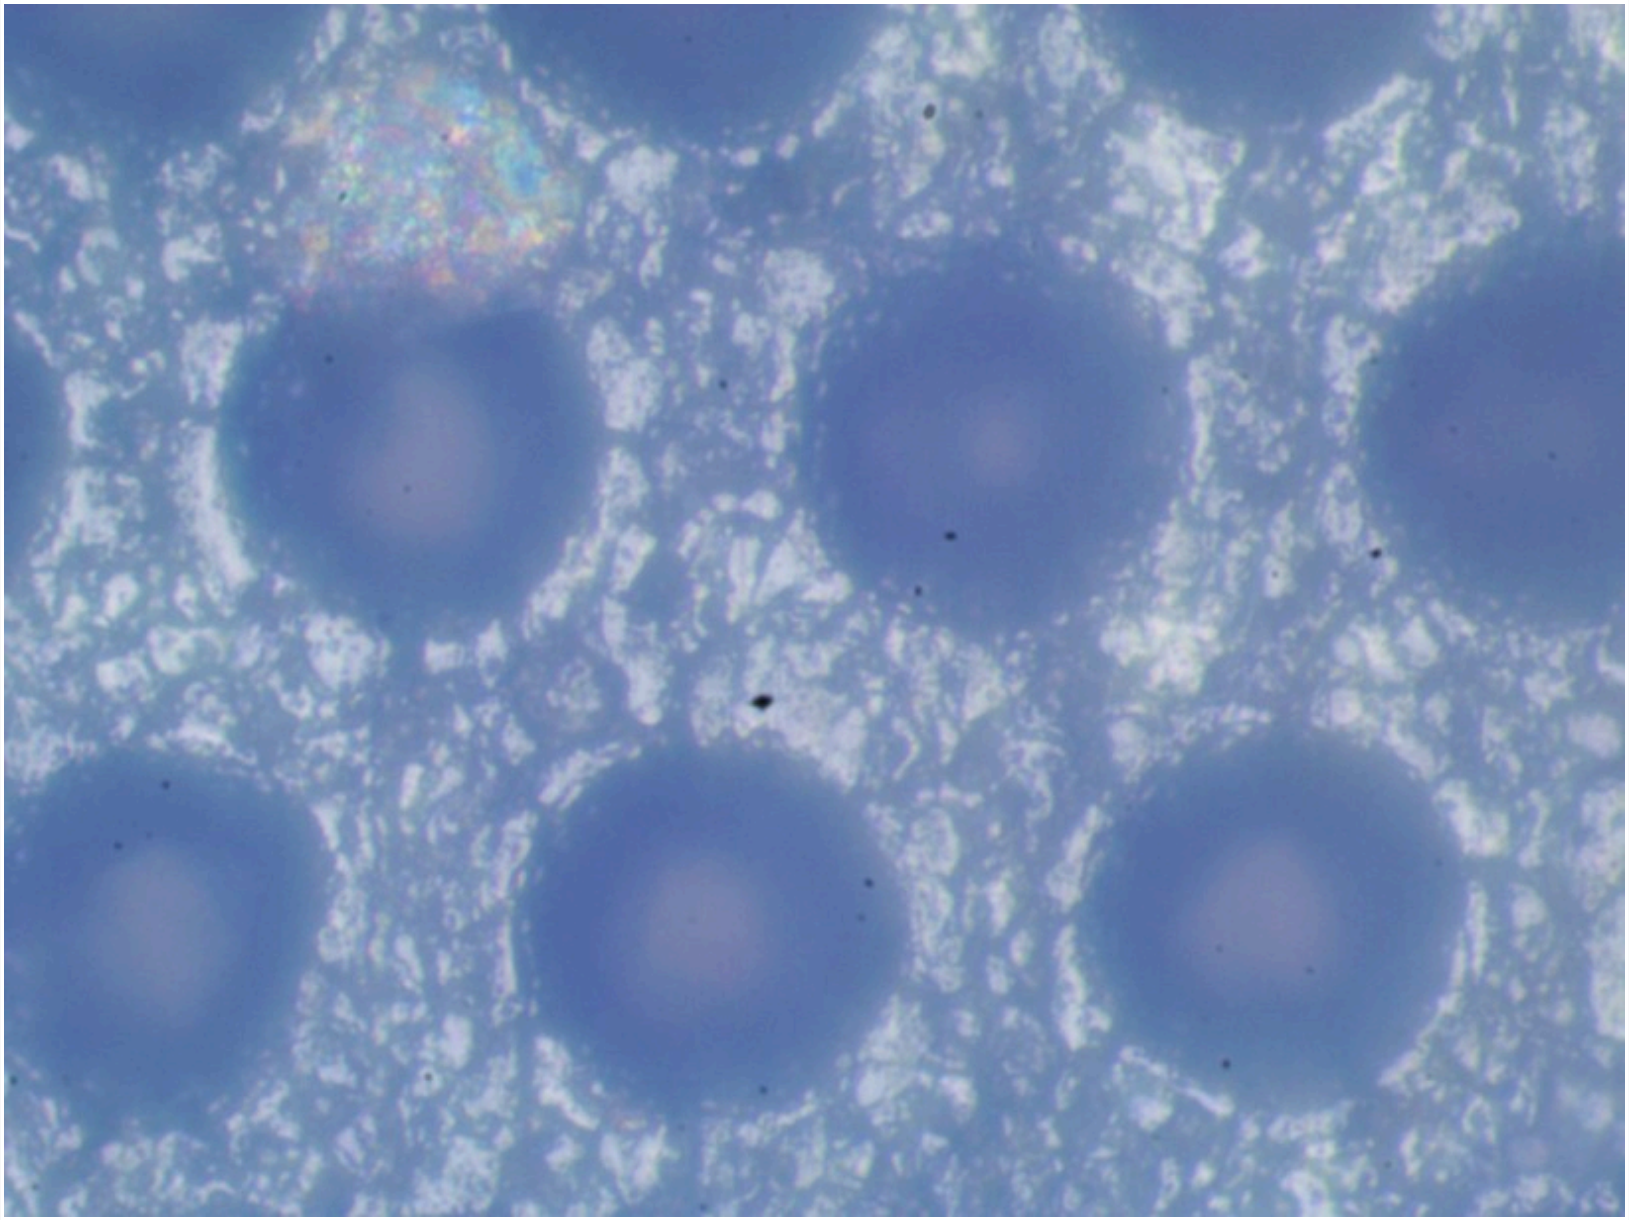
Roll "sa008588".	Photo of the anilox roll surface

9	sa008588	1300	130	10.0	130	2.7	-	-	-73.00%	1/2	1	worn streaks scratch 1290. roll heavily ground off.
10	kk97627	1300	180	7.3	180	5.8	-	-	-20.55%	1/5	1	chip 1275 1280 streak 468 947. roll ground off.
11	sa008598	1300	420	4.5	420	4.2	-	-	-6.67%	1/7	1	dent 195 250. roll slightly ground off.
12	sa008594	1300	250	7.0	260	6.5	-	-	-7.14%	1/6	1	streak 40 scratch 195 260 chip 1280. roll ground off.
13	sa008596	1300	350	5.5	340	4.8	-	-	-12.73%	1/6	1	scratch 190 145 385 350 1140 1100 chip 230. roll ground off.
14	aa2413108	1300	420	4.0	420	4.0	-	-	0.00%	1/7	1	streak 165. roll slightly ground off.
15	h100751-9	1300	160	10.5	160	7.8	-	-	-25.71%	1/5	1	scratch 40 105 380 410 440. roll ground off.
16	17011017	1300	140	9.2	140	4.4	-	-	-52.17%	1/3	1	scratch 145 dent 15 105 165 294 worn. roll heavily ground off.
17	h100750-7	1300	140	12.5	140	9.0	-	-	-28.00%	1/6	1	dent 290 245 320 streak 520 700 520 scratch 570. roll ground off.

Comment
worn streaks scratch 1290.
Roll heavily ground off.

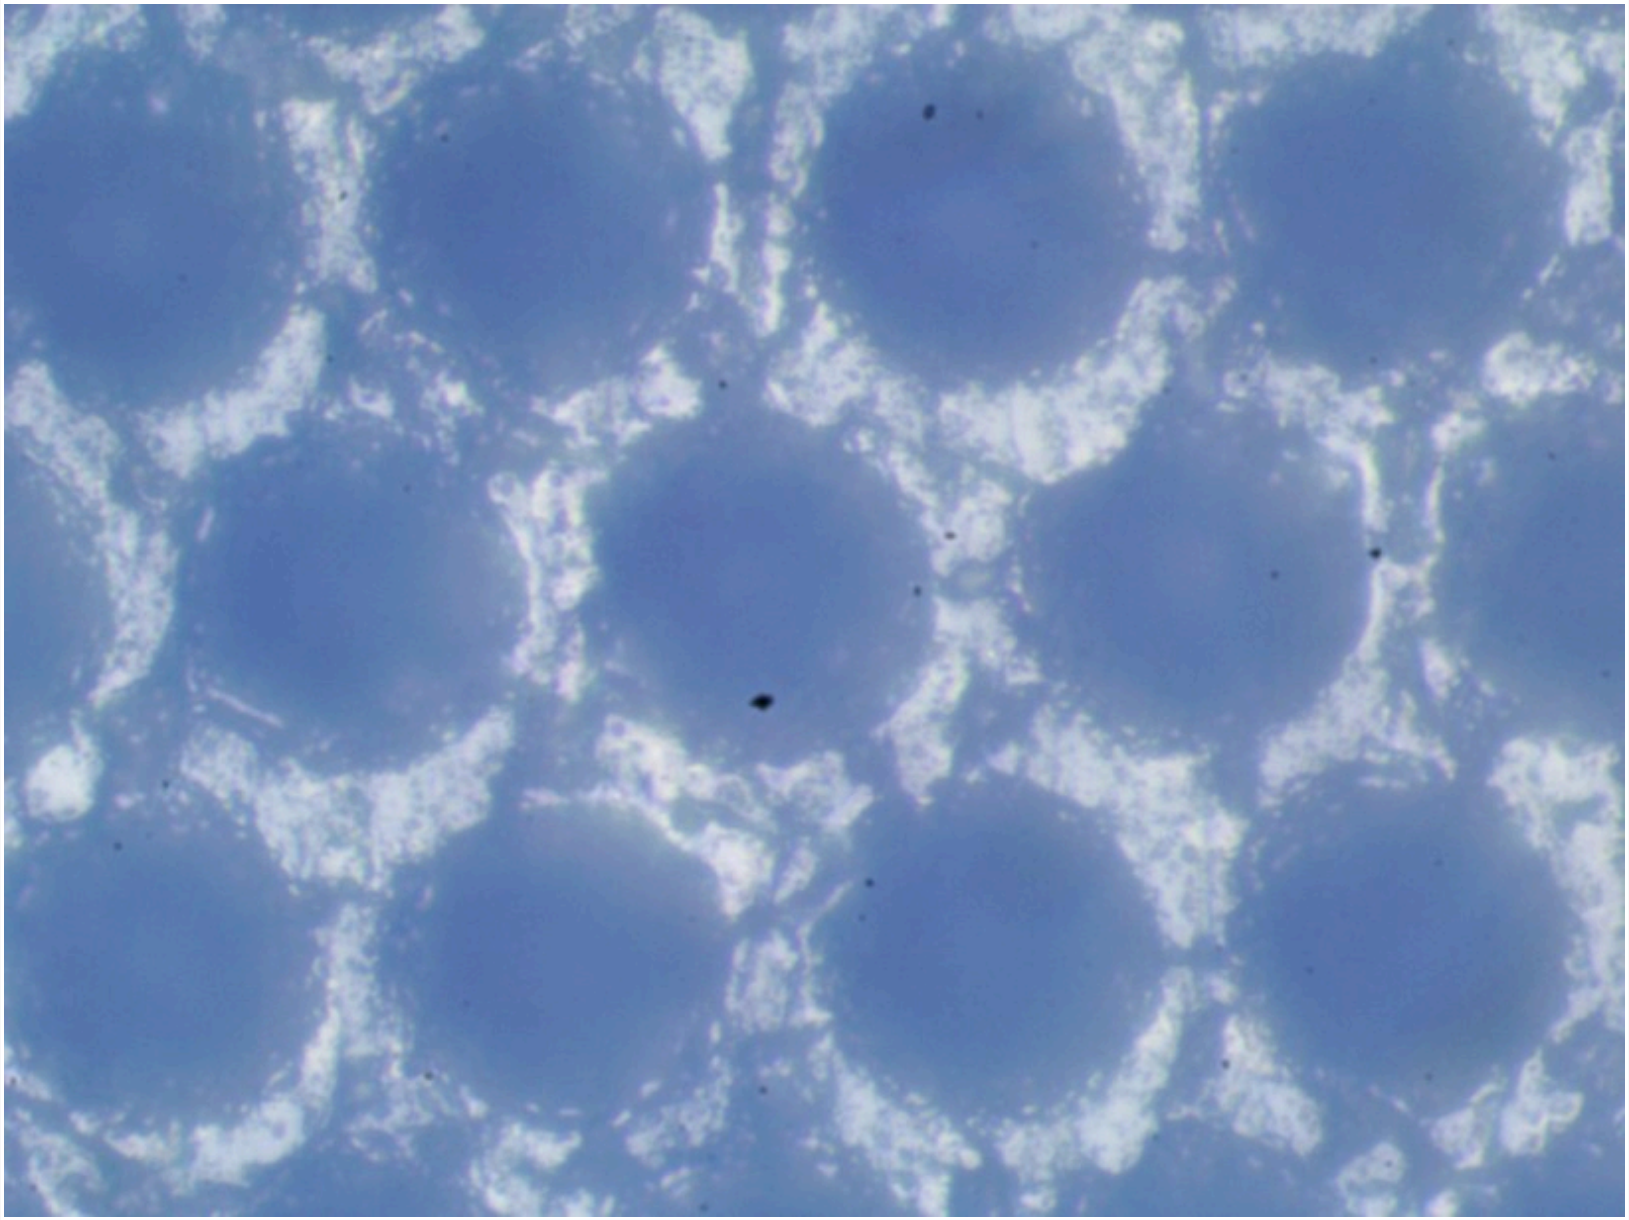
Roll "kk97627".	Photo of the anilox roll surface

Comment
chip 1275 1280 streak 468 947.
Roll ground off.

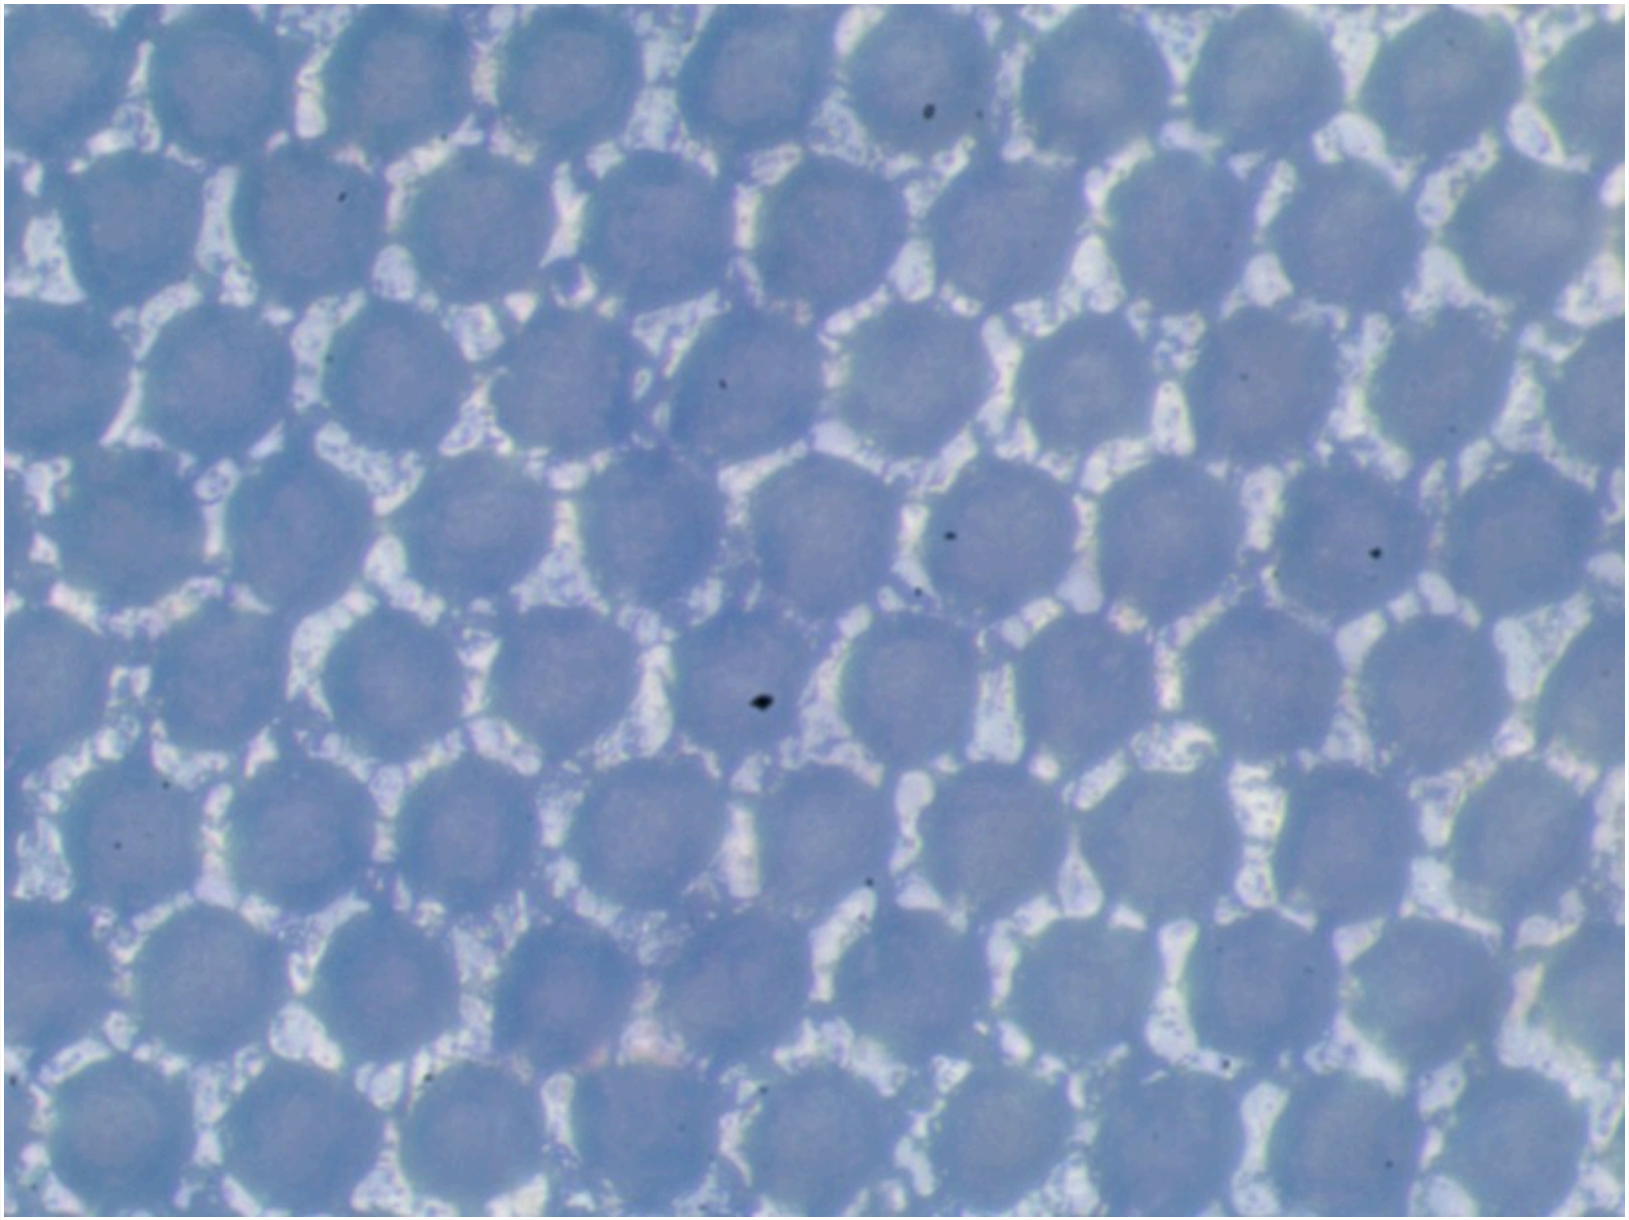
Roll "sa008598".	Photo of the anilox roll surface

Comment
dent 195 250.
Roll slightly ground off.
