RollerCheck360

Roll Inspection from 08.12.2025

Rolls: 178

We have analyzed for you 178 rolls.

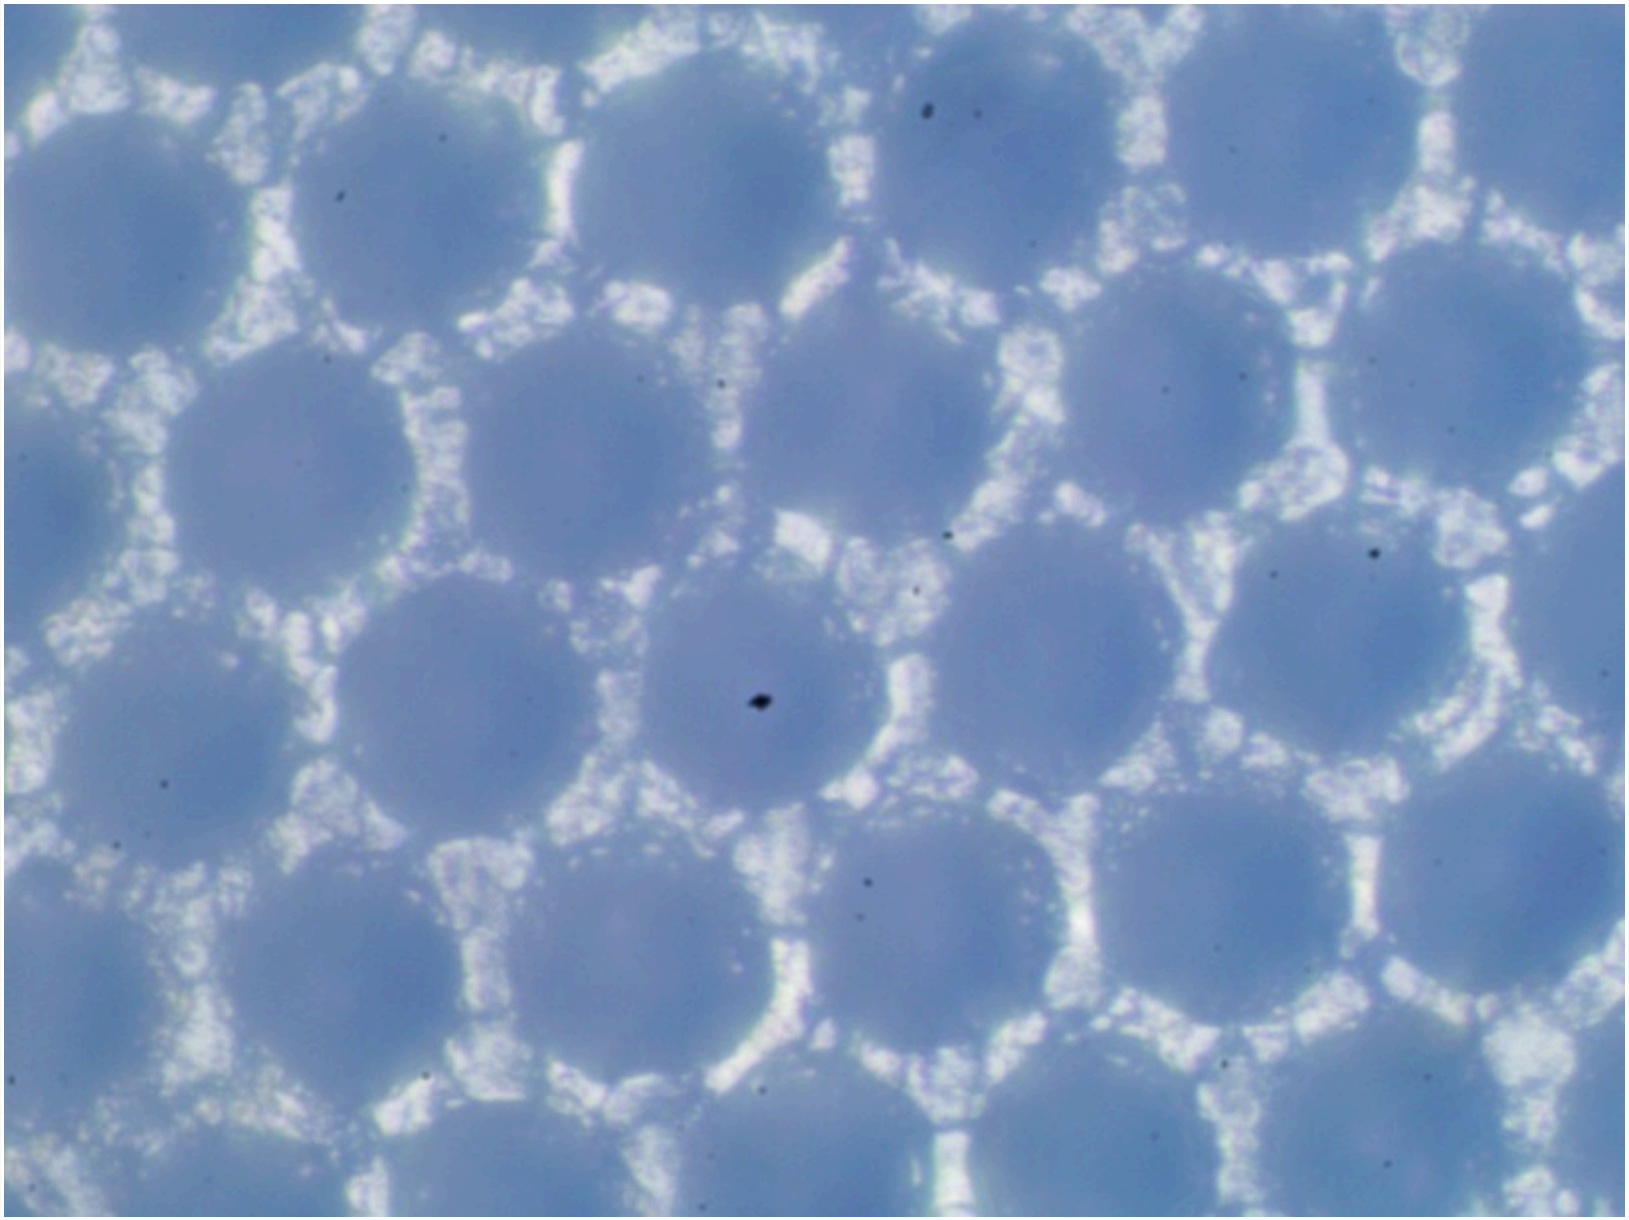
Roll "sa008594".	Photo of the anilox roll surface

Comment
streak 40 scratch 195 260 chip 1280.
Roll ground off.

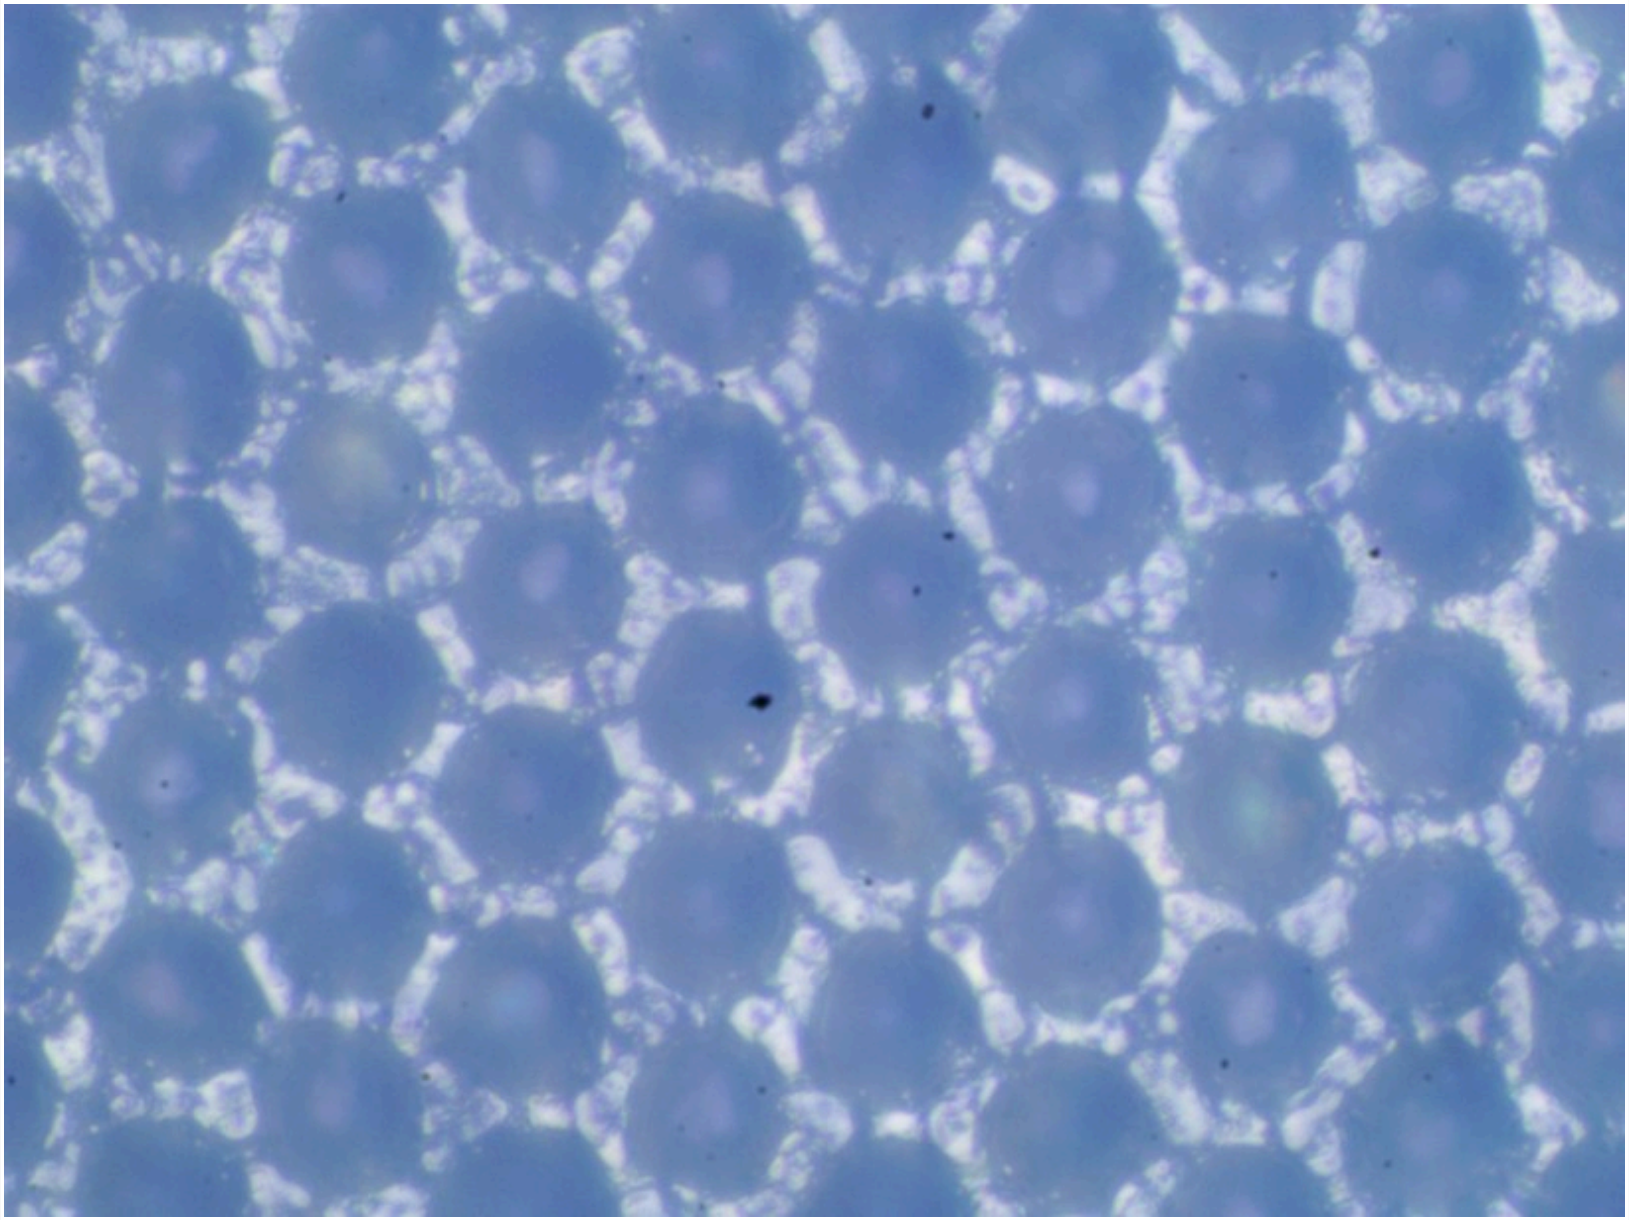
Roll "sa008596".	Photo of the anilox roll surface

Bridge / Cell: 1 / 6
Depth before / after: 16.5 / 16.5 мкм
Depth decreased by: 0%

Comment
scratch 190 145 385 350 1140 1100
chip 230.

Roll ground off.

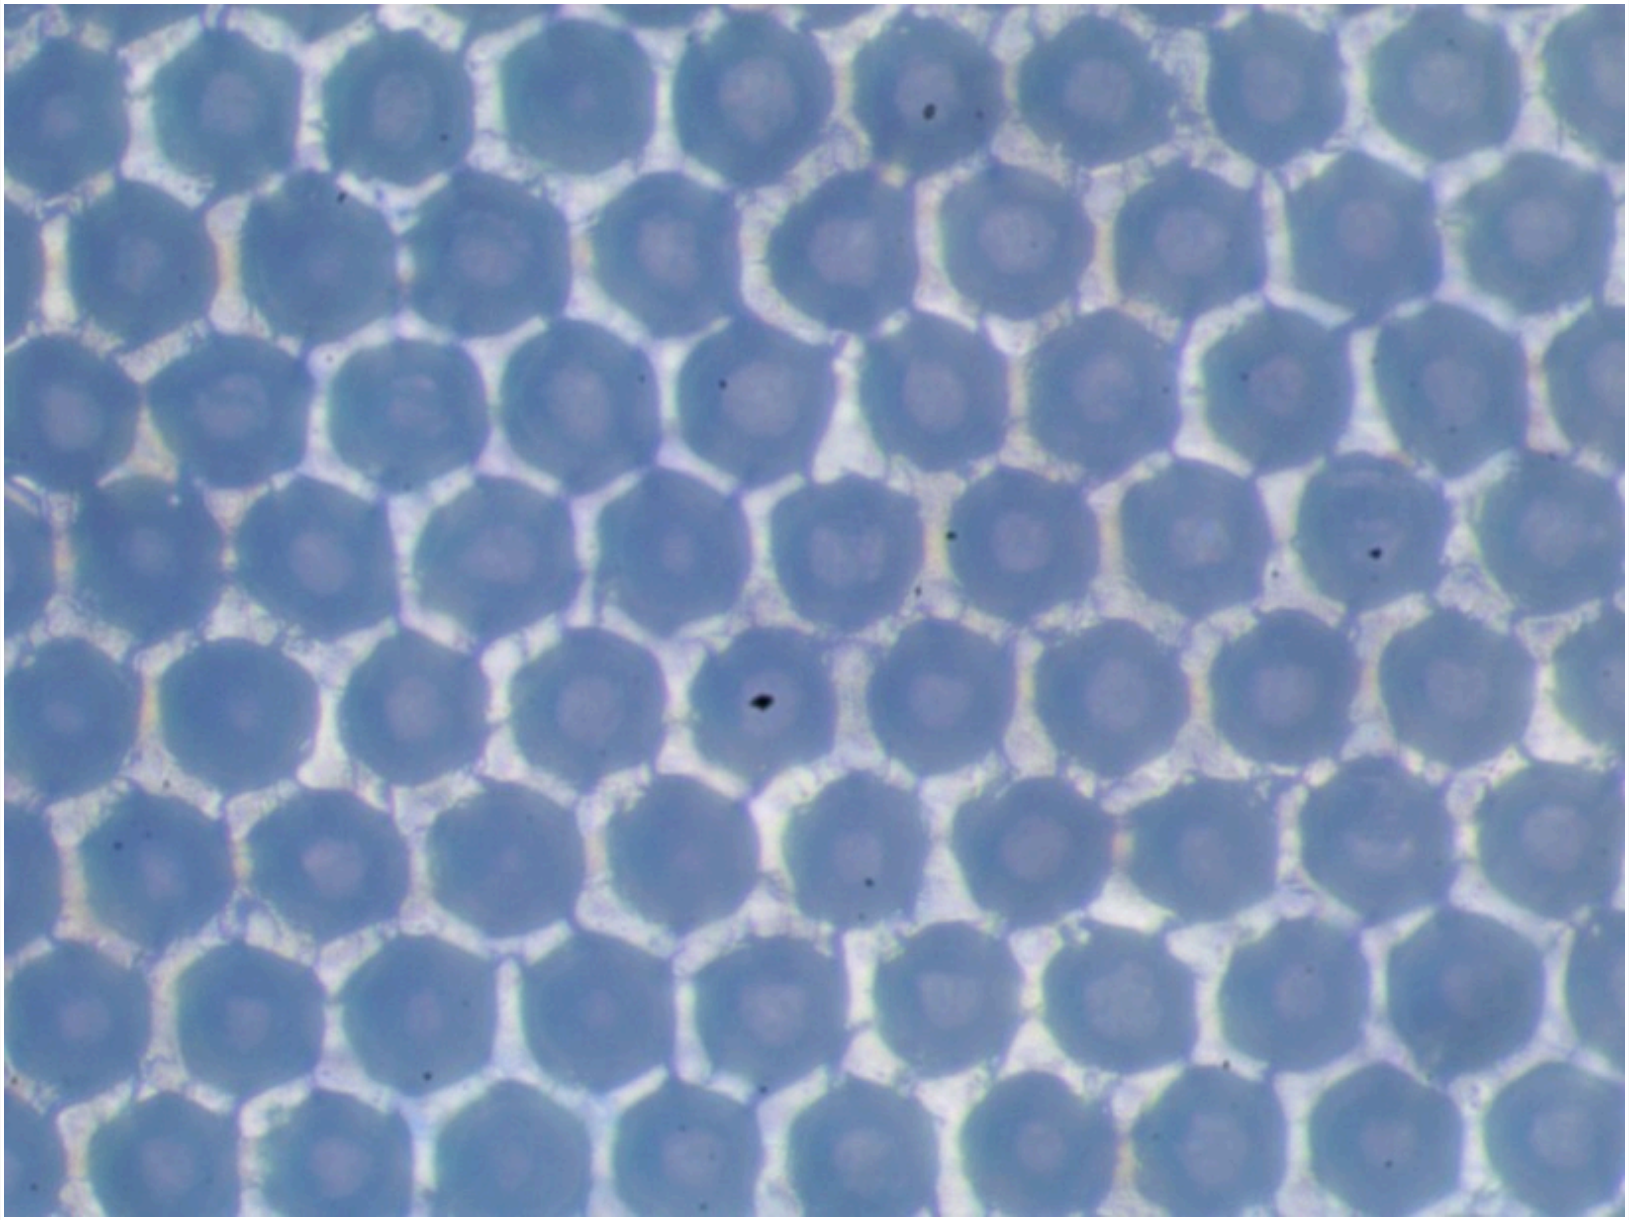
Page №15. Roll "h100751-9". Length: 1300 mm. Photos with magnificaiton: x400. Cleaning passes: 1

Roll "h100751-9".	Photo of the anilox roll surface

Ink transfer volume decrease from the passport value: 25.71%

Bridge / Cell: 1 / 5
Depth before / after: 28 / 28 мкм
Depth decreased by: 0%

Comment
scratch 40 105 380 410 440.
Roll ground off.

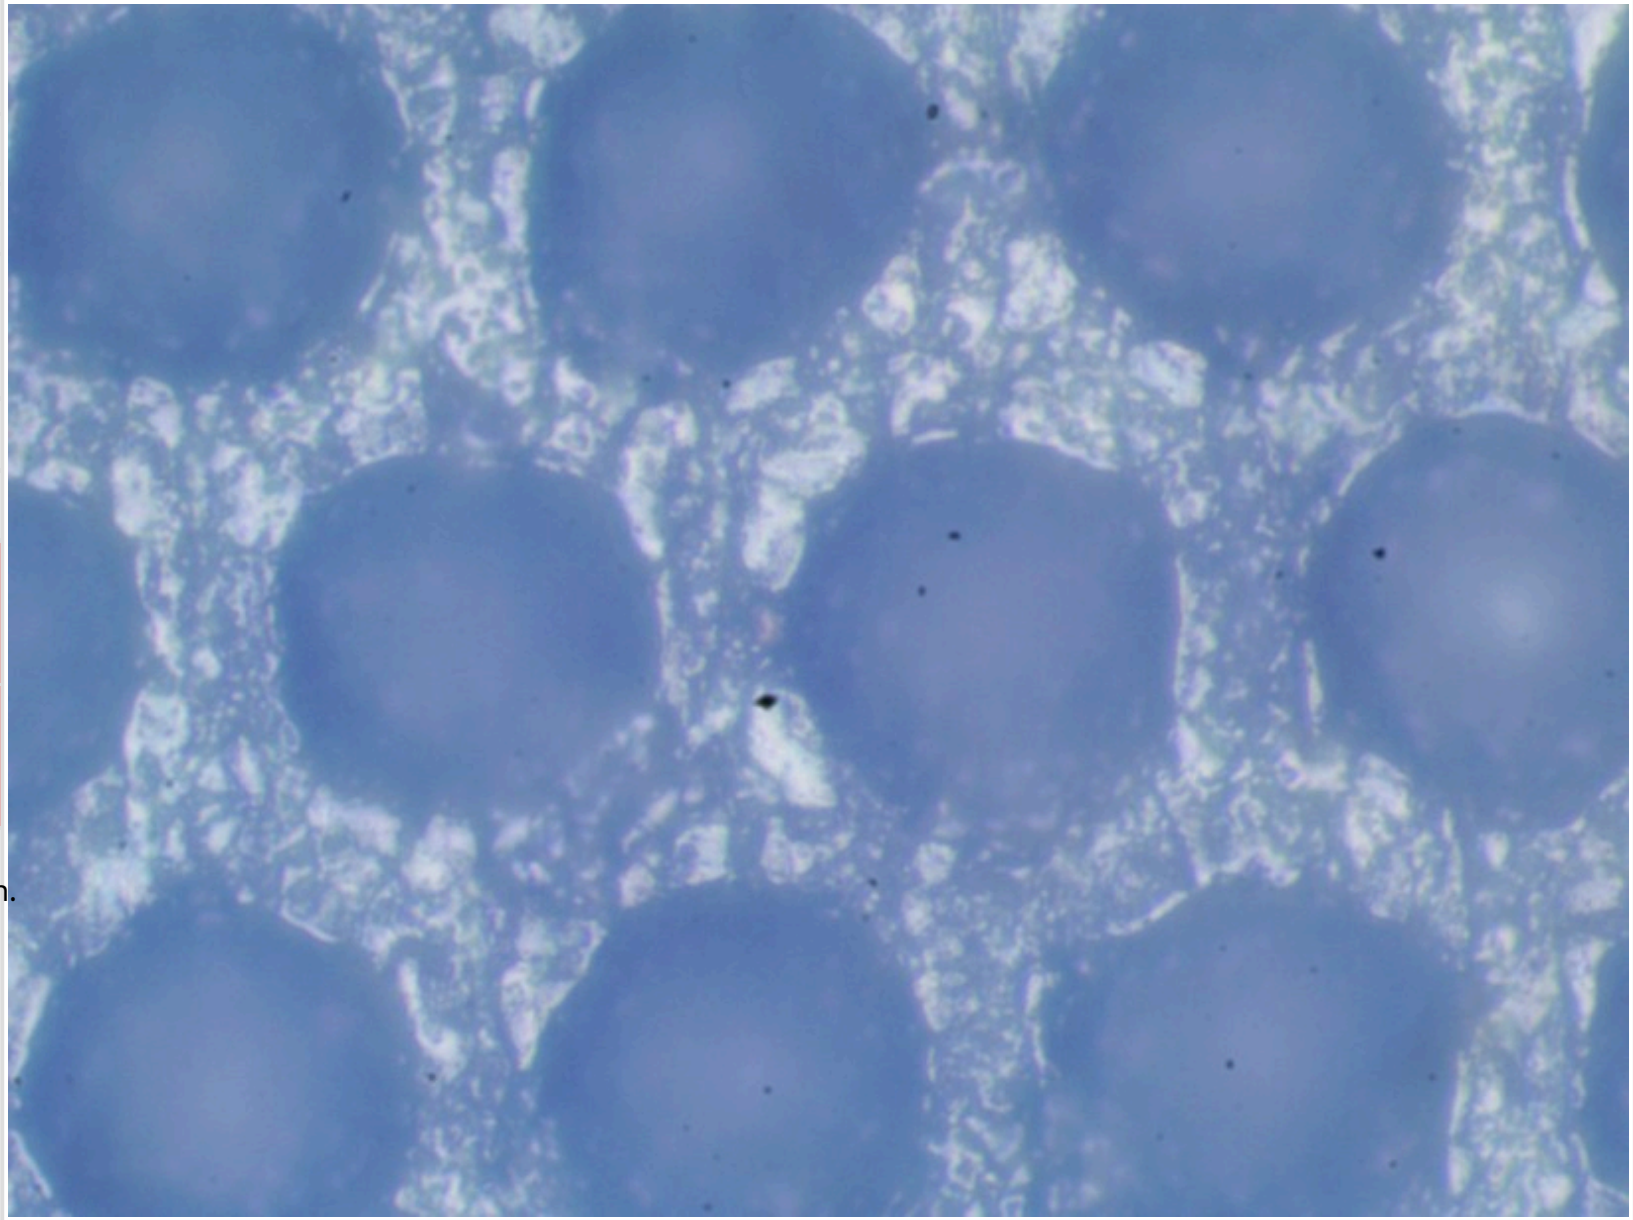
Roll "17011017".	Photo of the anilox roll surface

Comment
scratch 145 dent 15 105 165 294 worn.

Roll heavily ground off.

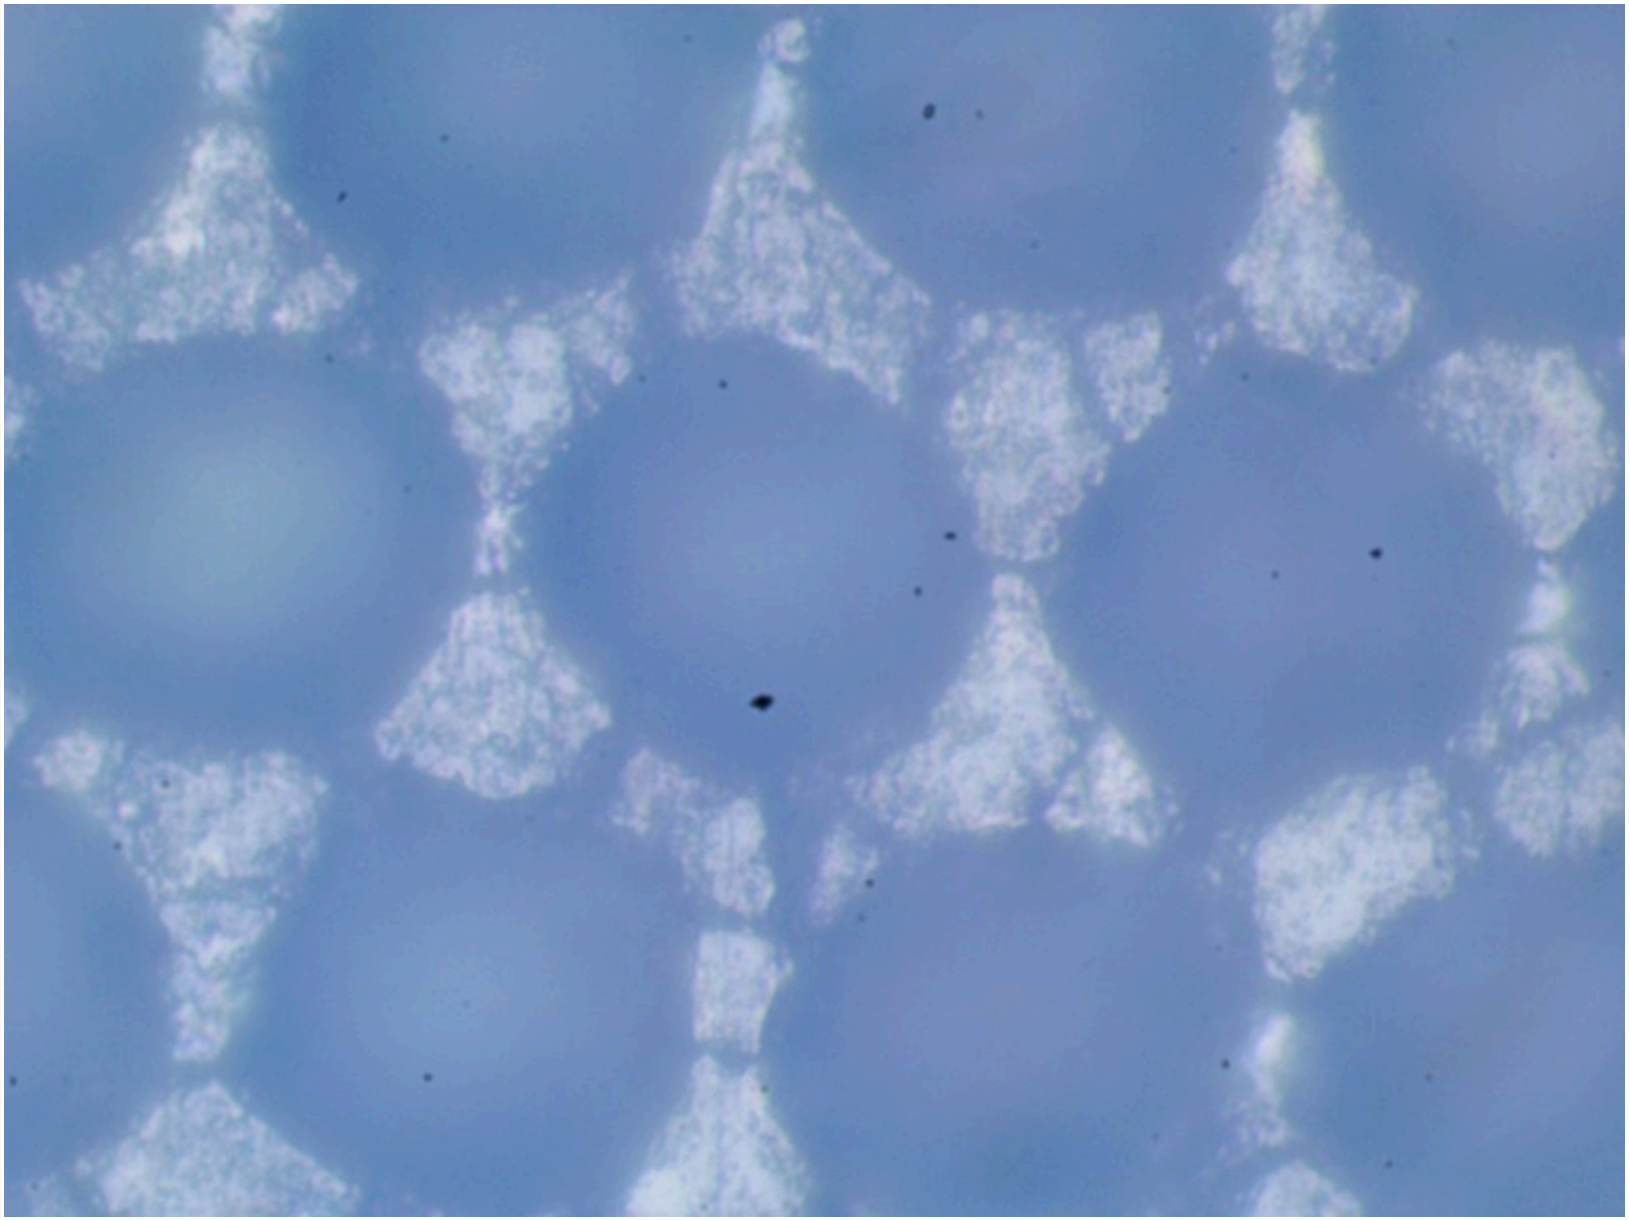
Page №18. Roll "z45231". Length: 1300 mm. Photos with magnificaiton: x400. Cleaning passes: 1

Roll "z45231".	Photo of the anilox roll surface

Ink transfer volume decrease from the passport value: 47.25%

Comment
streaks spot 290 400 770 520 dent 975 920 worn.

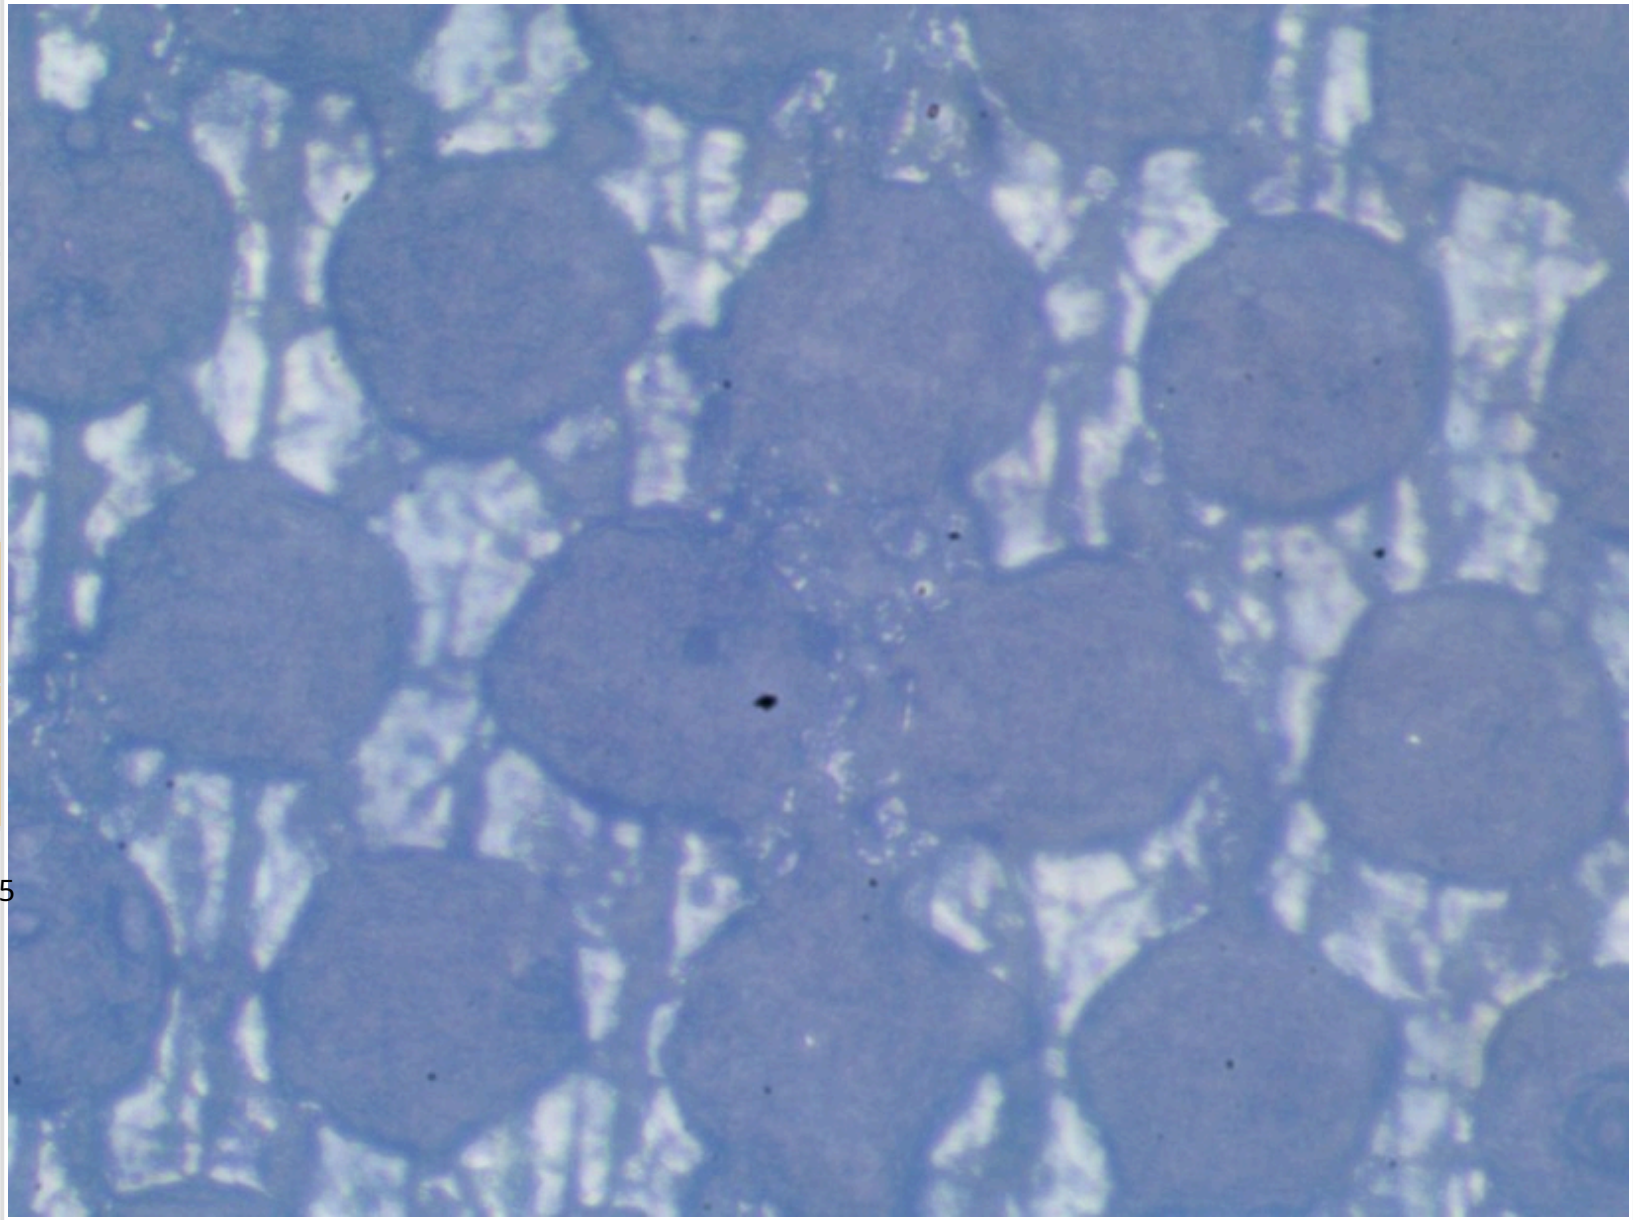
Bridge / Cell: 1 / 4
Depth before / after: 20 / 20 мкм
Depth decreased by: 0%

Roll ground off.

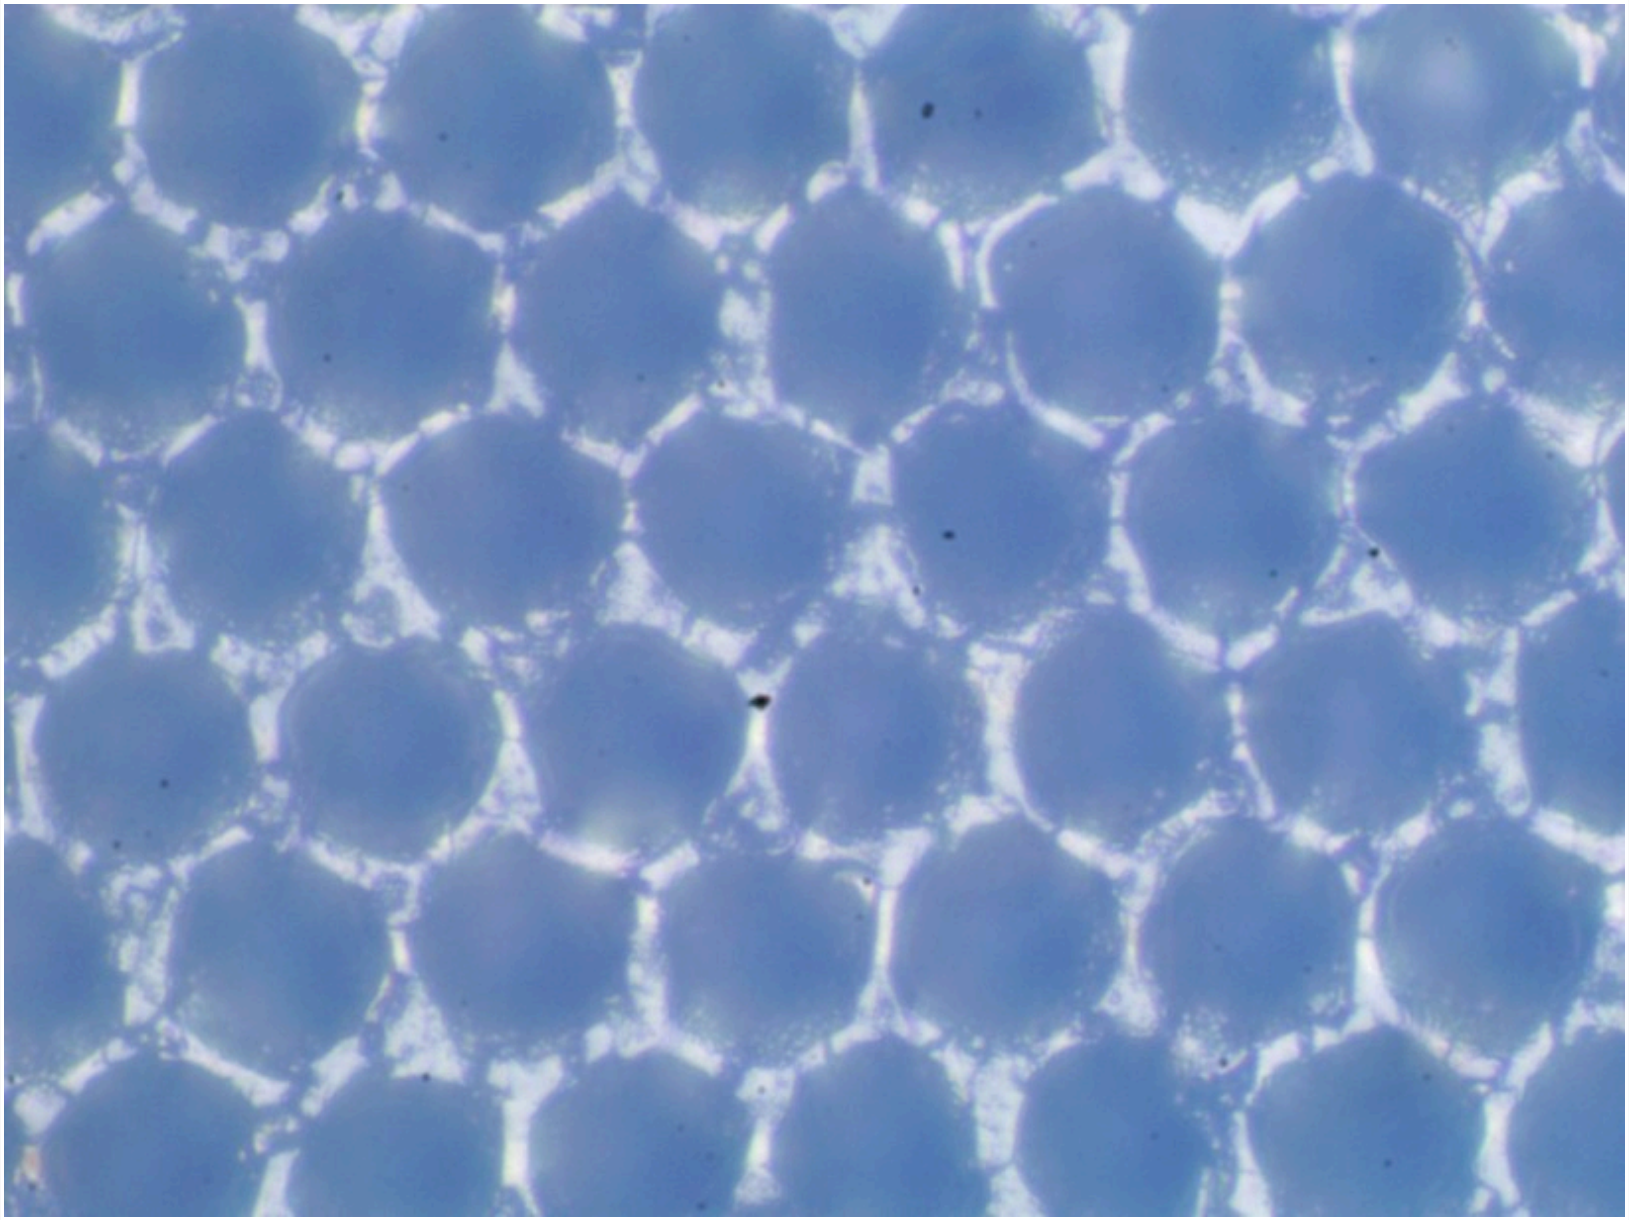
Page №20. Roll "sa008600". Length: 1300 mm. Photos with magnificaiton: x400. Cleaning passes: 1

Roll "sa008600".	Photo of the anilox roll surface

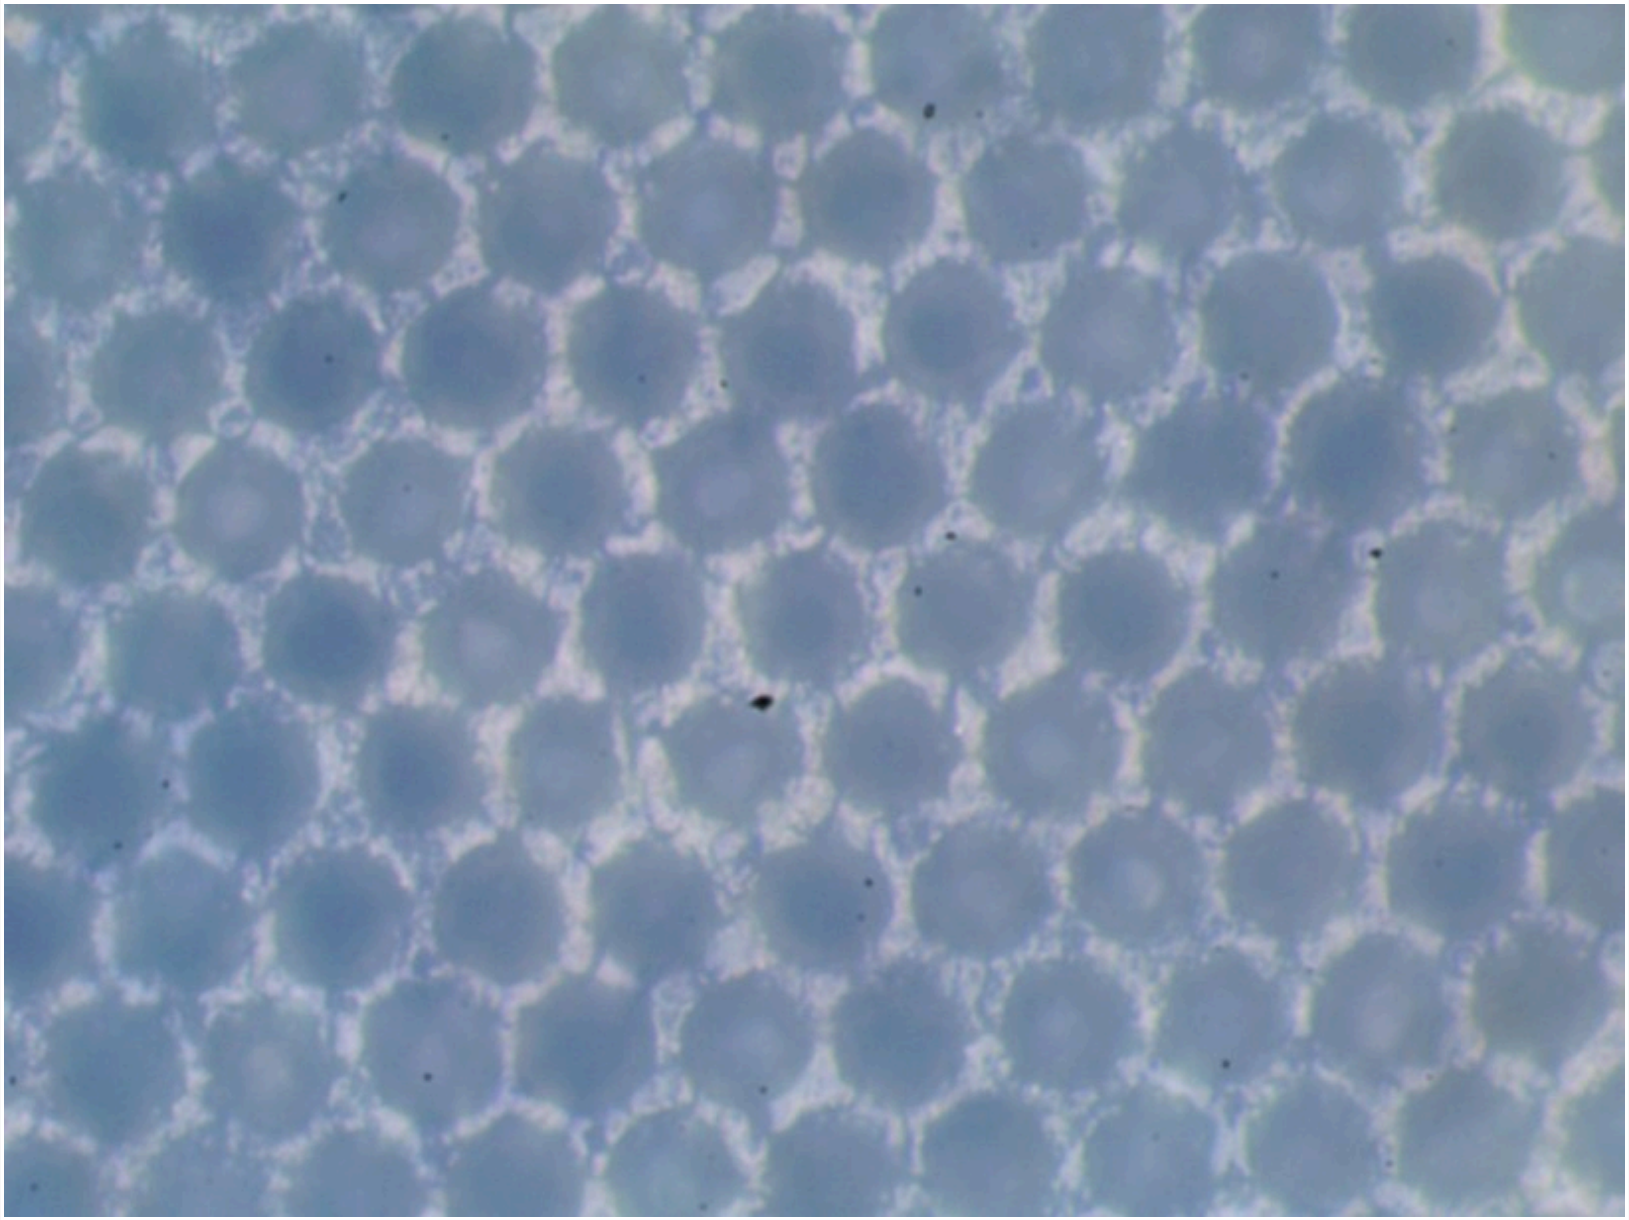
Bridge / Cell: 1 / 6
Depth before / after: 13.5 / 13.5 мкм
Depth decreased by: 0%

Comment
streaks 315 360 365 1265.
Roll ground off.

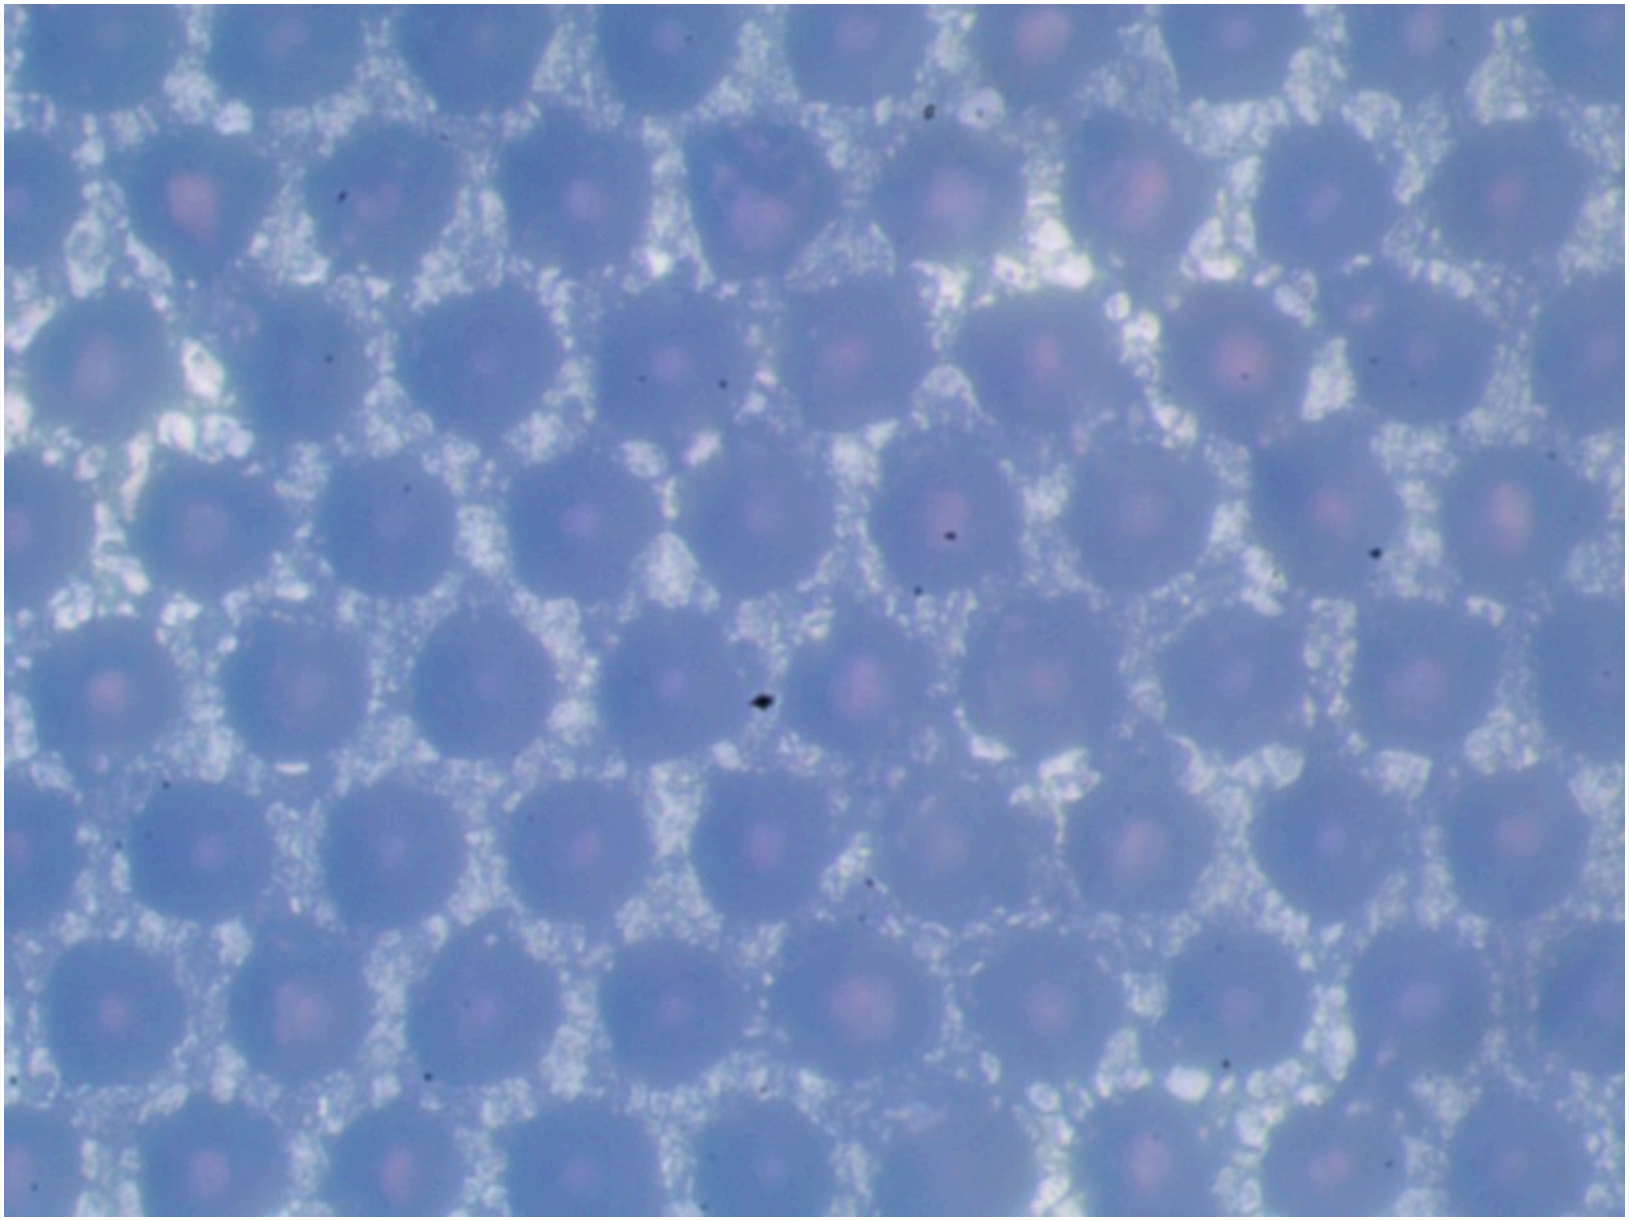
Page №22. Roll "3016199-3". Length: 1300 mm. Photos with magnificaiton: x400. Cleaning passes: 1

Roll "3016199-3".	Photo of the anilox roll surface

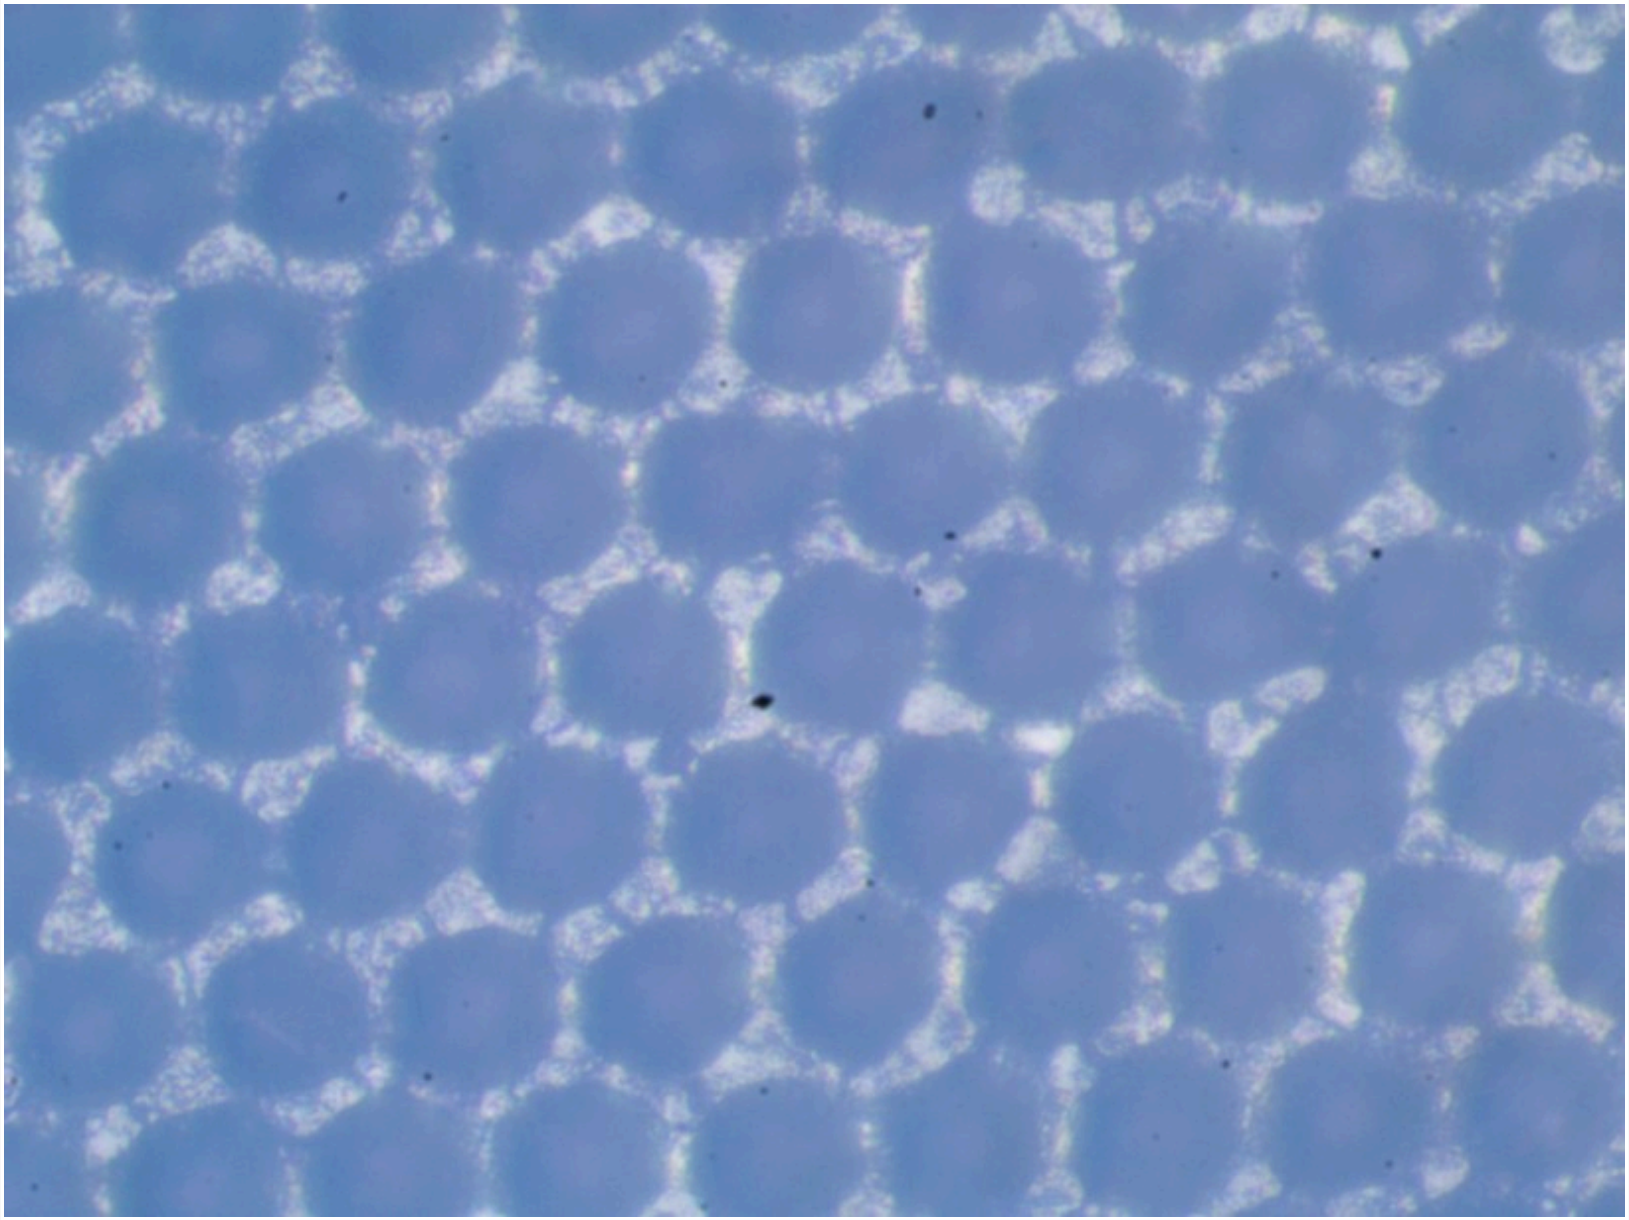
Comment
Roll ground off.

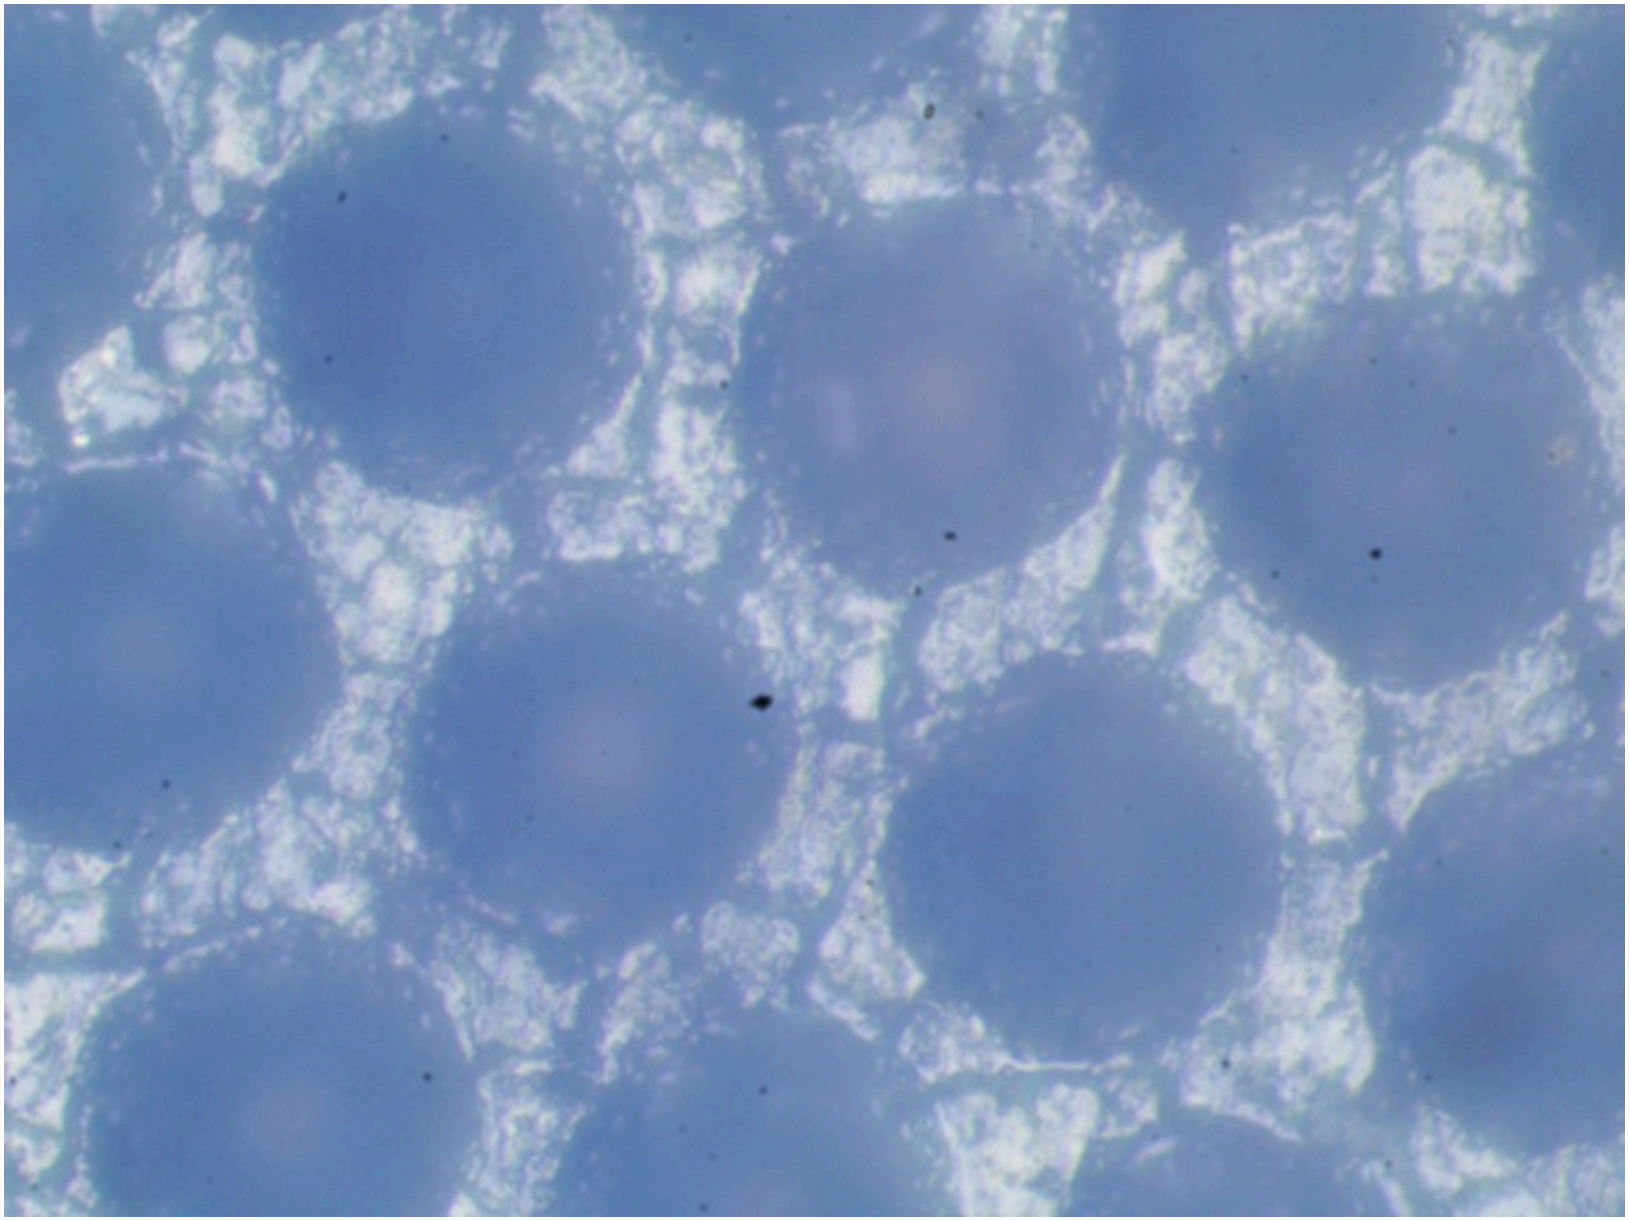
Page №24. Roll "aa2413645". Length: 1300 mm. Photos with magnificaiton: x400. Cleaning passes: 1

Roll "aa2413645".	Photo of the anilox roll surface

Bridge / Cell: 1 / 4
Depth before / after: 16 / 16 мкм
Depth decreased by: 0%

Comment
Roll ground off.
