RollerCheck360

Roll Inspection from 08.12.2025

Rolls: 178

We have analyzed for you 178 rolls.

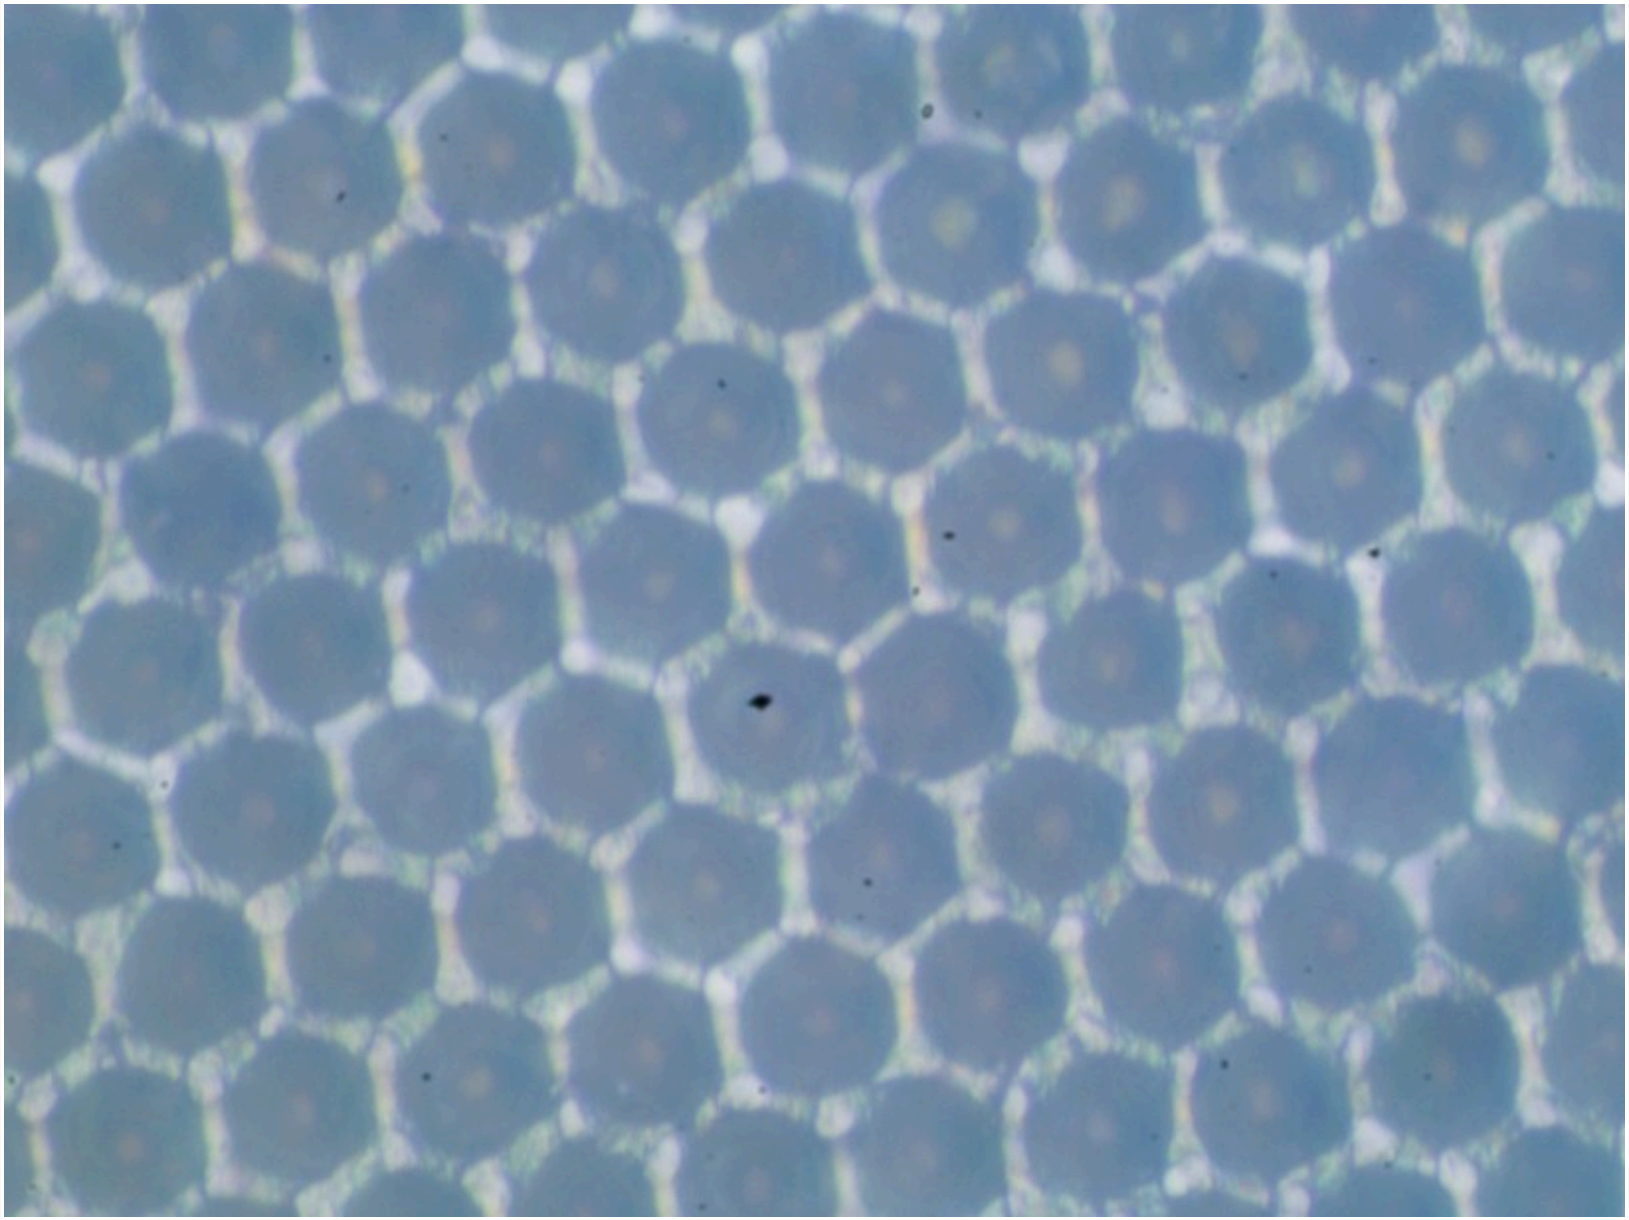
Page №25. Roll "z17011012". Length: 1300 mm. Photos with magnificaiton: x400. Cleaning passes: 1

Roll "z17011012".	Photo of the anilox roll surface

Comment
cell walls are missing streak 263 890 dent 415 475 1200

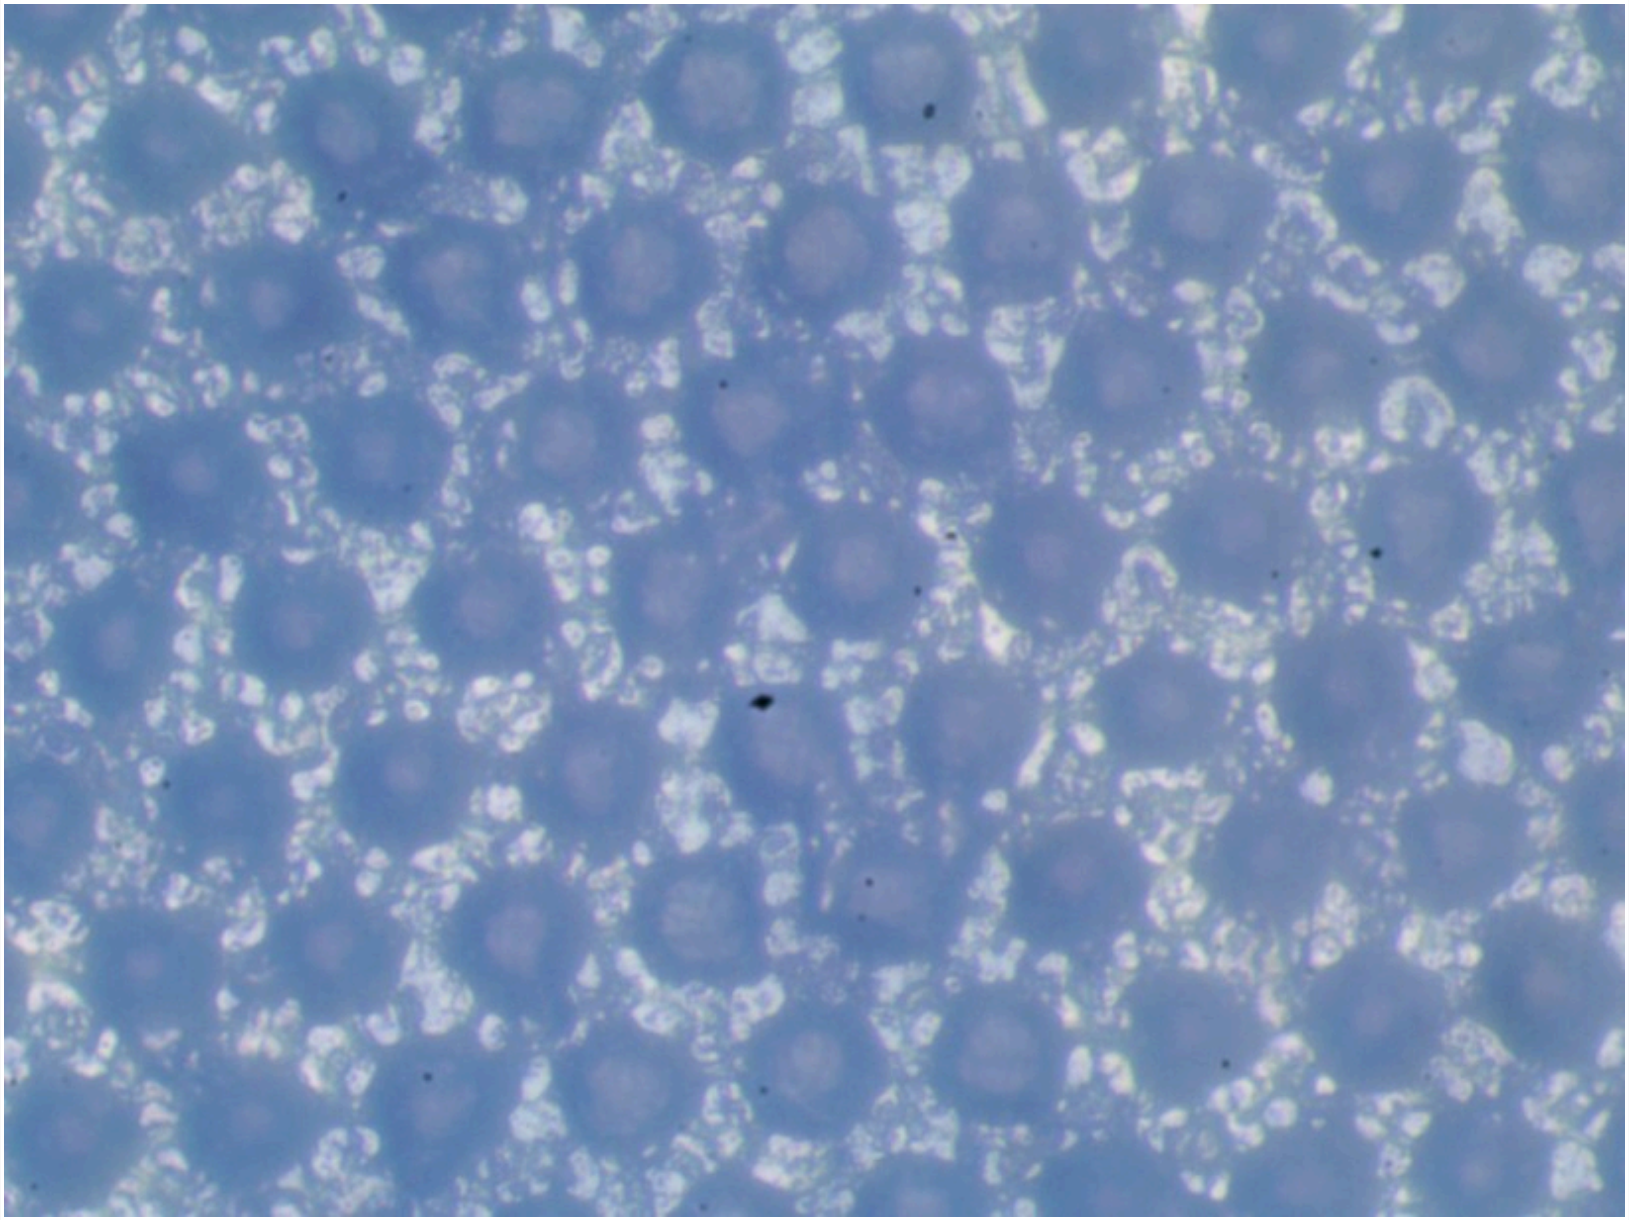
Bridge / Cell: 1 / 3
Depth before / after: 11 / 11 мкм
Depth decreased by: 0%

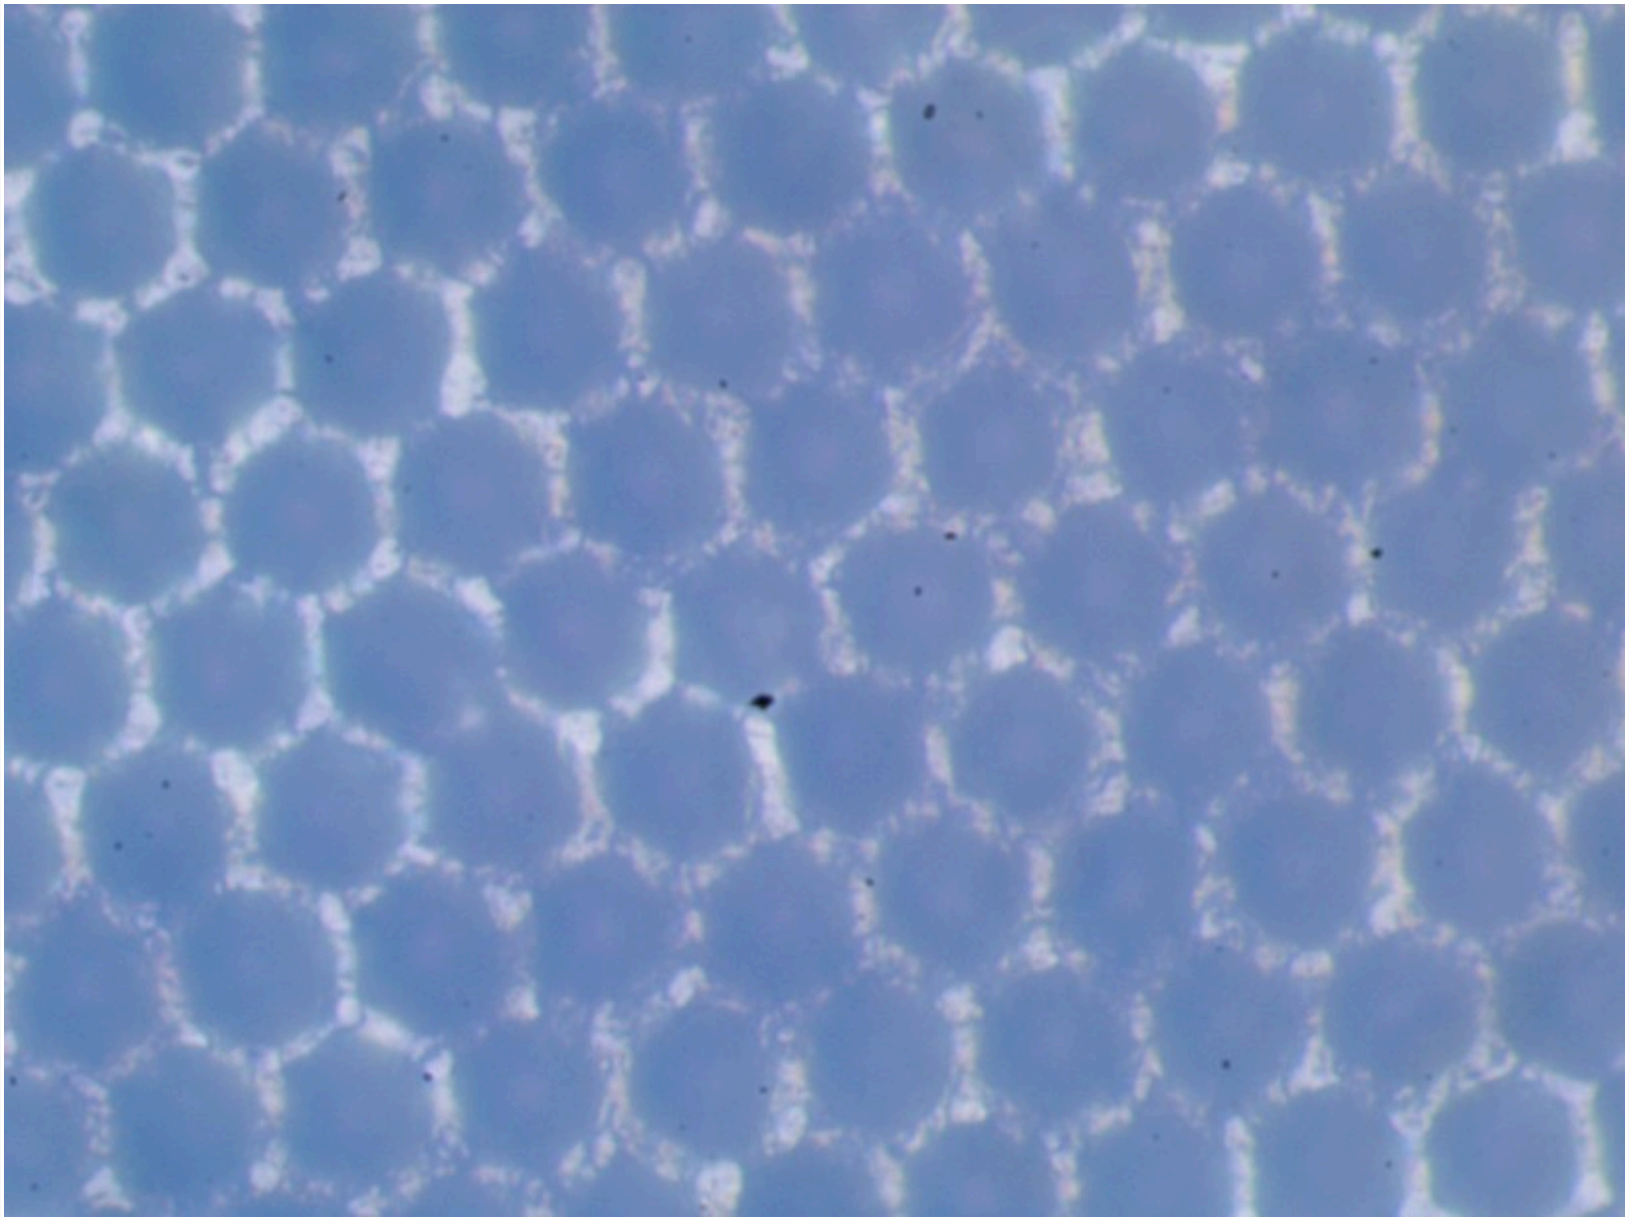
Page №27. Roll "z17011034". Length: 1300 mm. Photos with magnificaiton: x400. Cleaning passes: 1

Roll "z17011034".	Photo of the anilox roll surface

Comment
streak 75 85 110 245 1040 1268 dent 1130 1205 1115 1085.

Roll ground off.

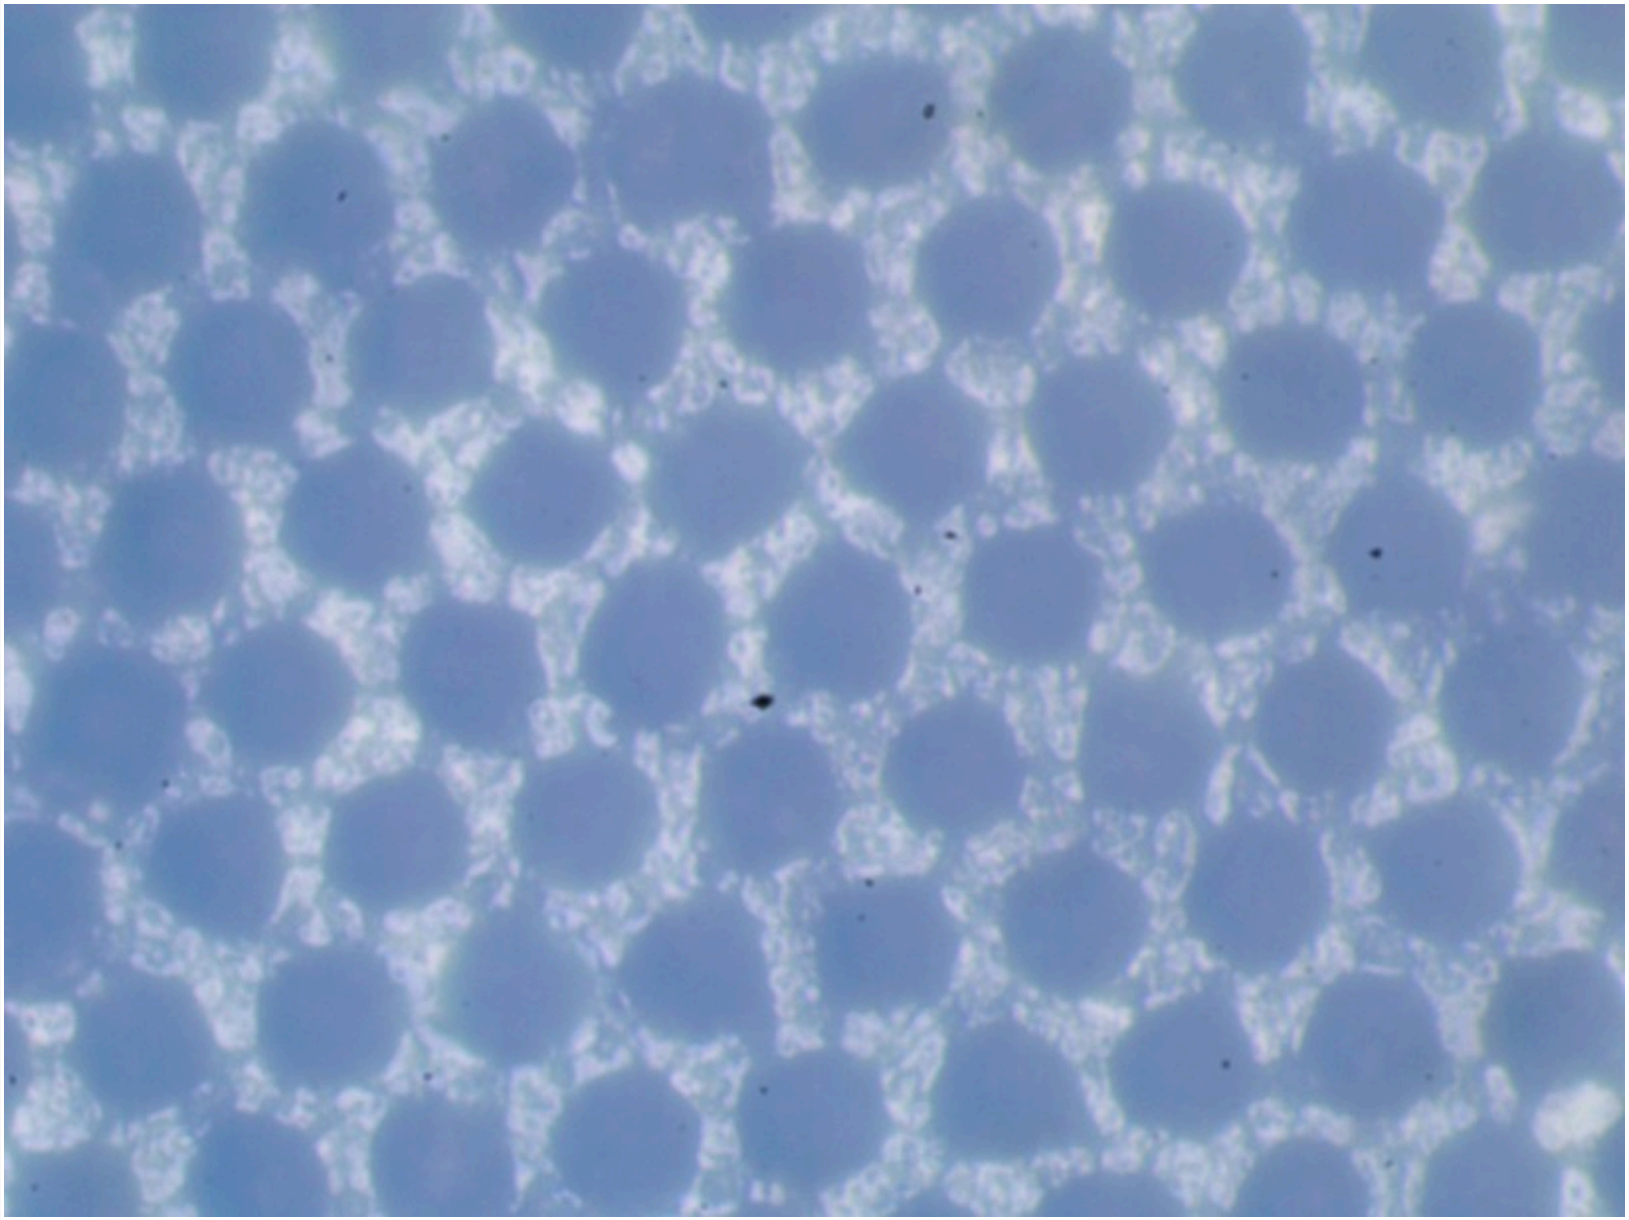
Page №28. Roll "z26268". Length: 1300 mm. Photos with magnificaiton: x400. Cleaning passes: 1

Roll "z26268".	Photo of the anilox roll surface

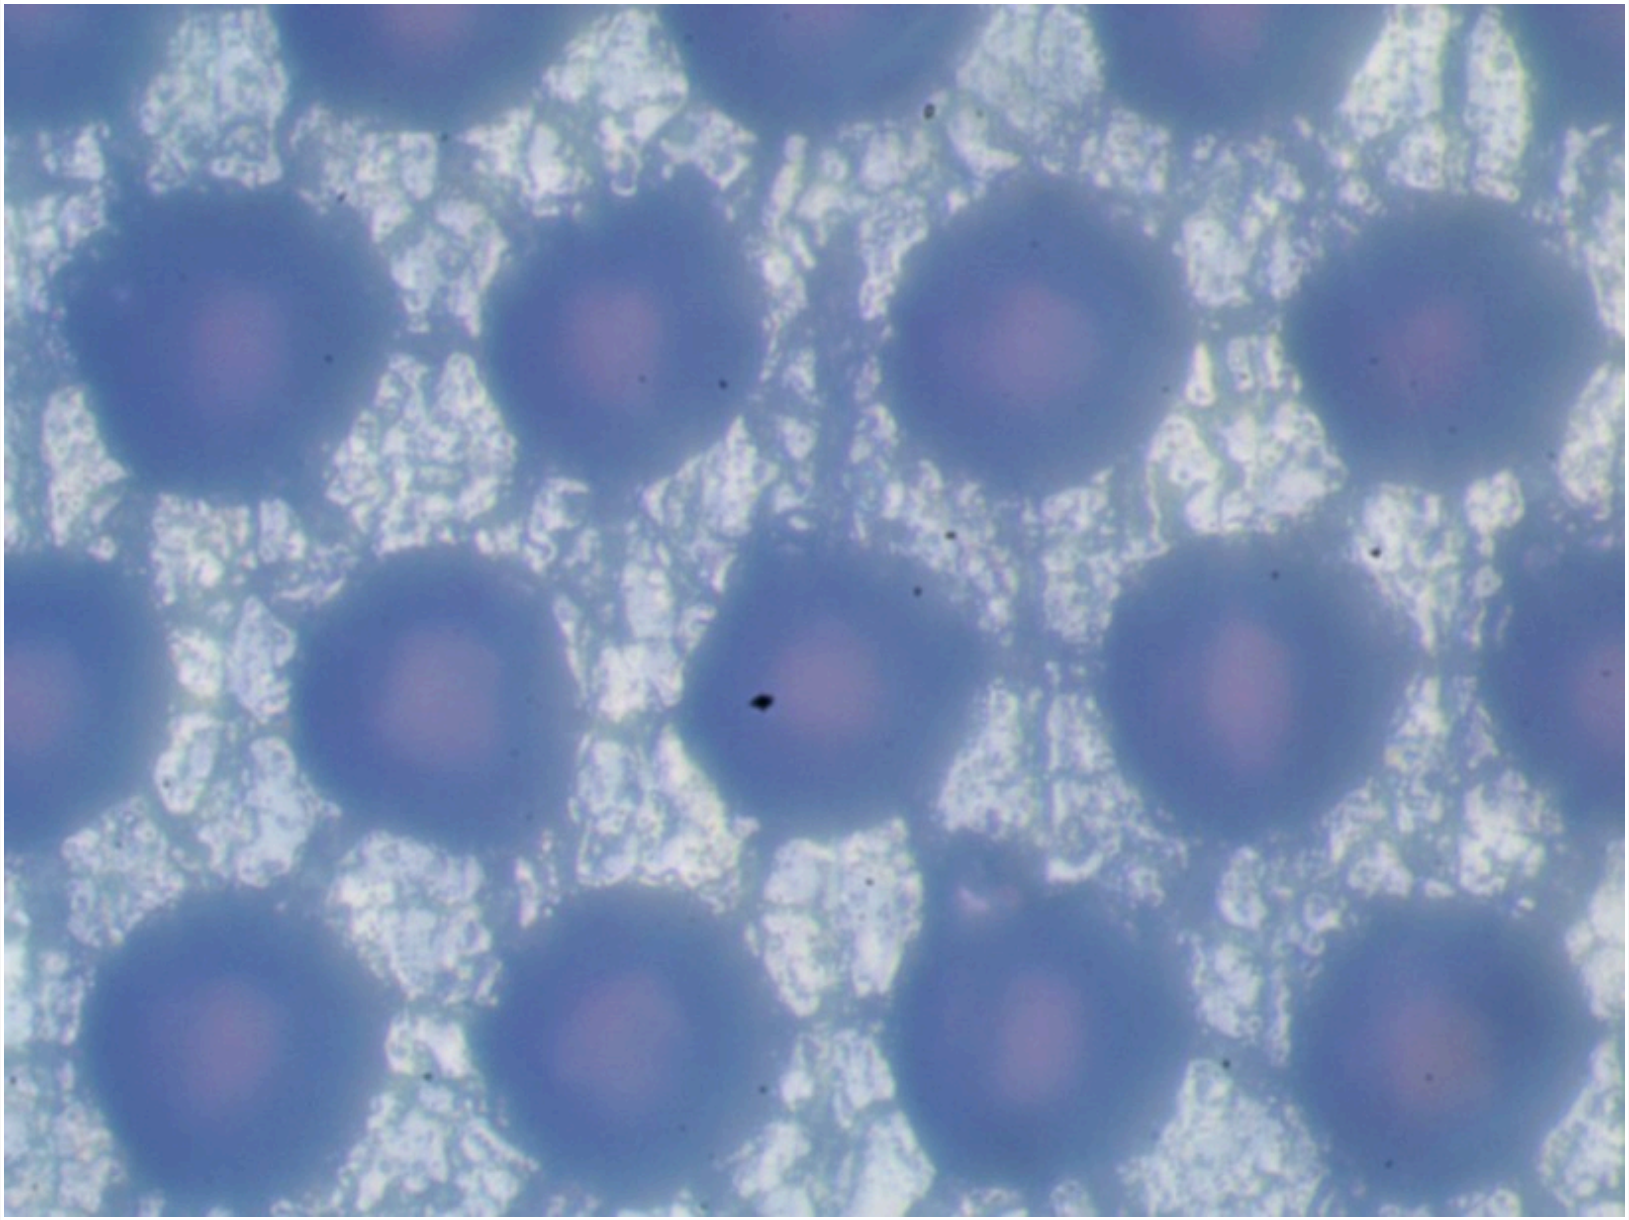
Bridge / Cell: 1 / 3
Depth before / after: 23 / 23 мкм
Depth decreased by: 0%

Comment
dent 30 210 250 270 300 350
1170 1230 350 370 565.
Roll heavily ground off.

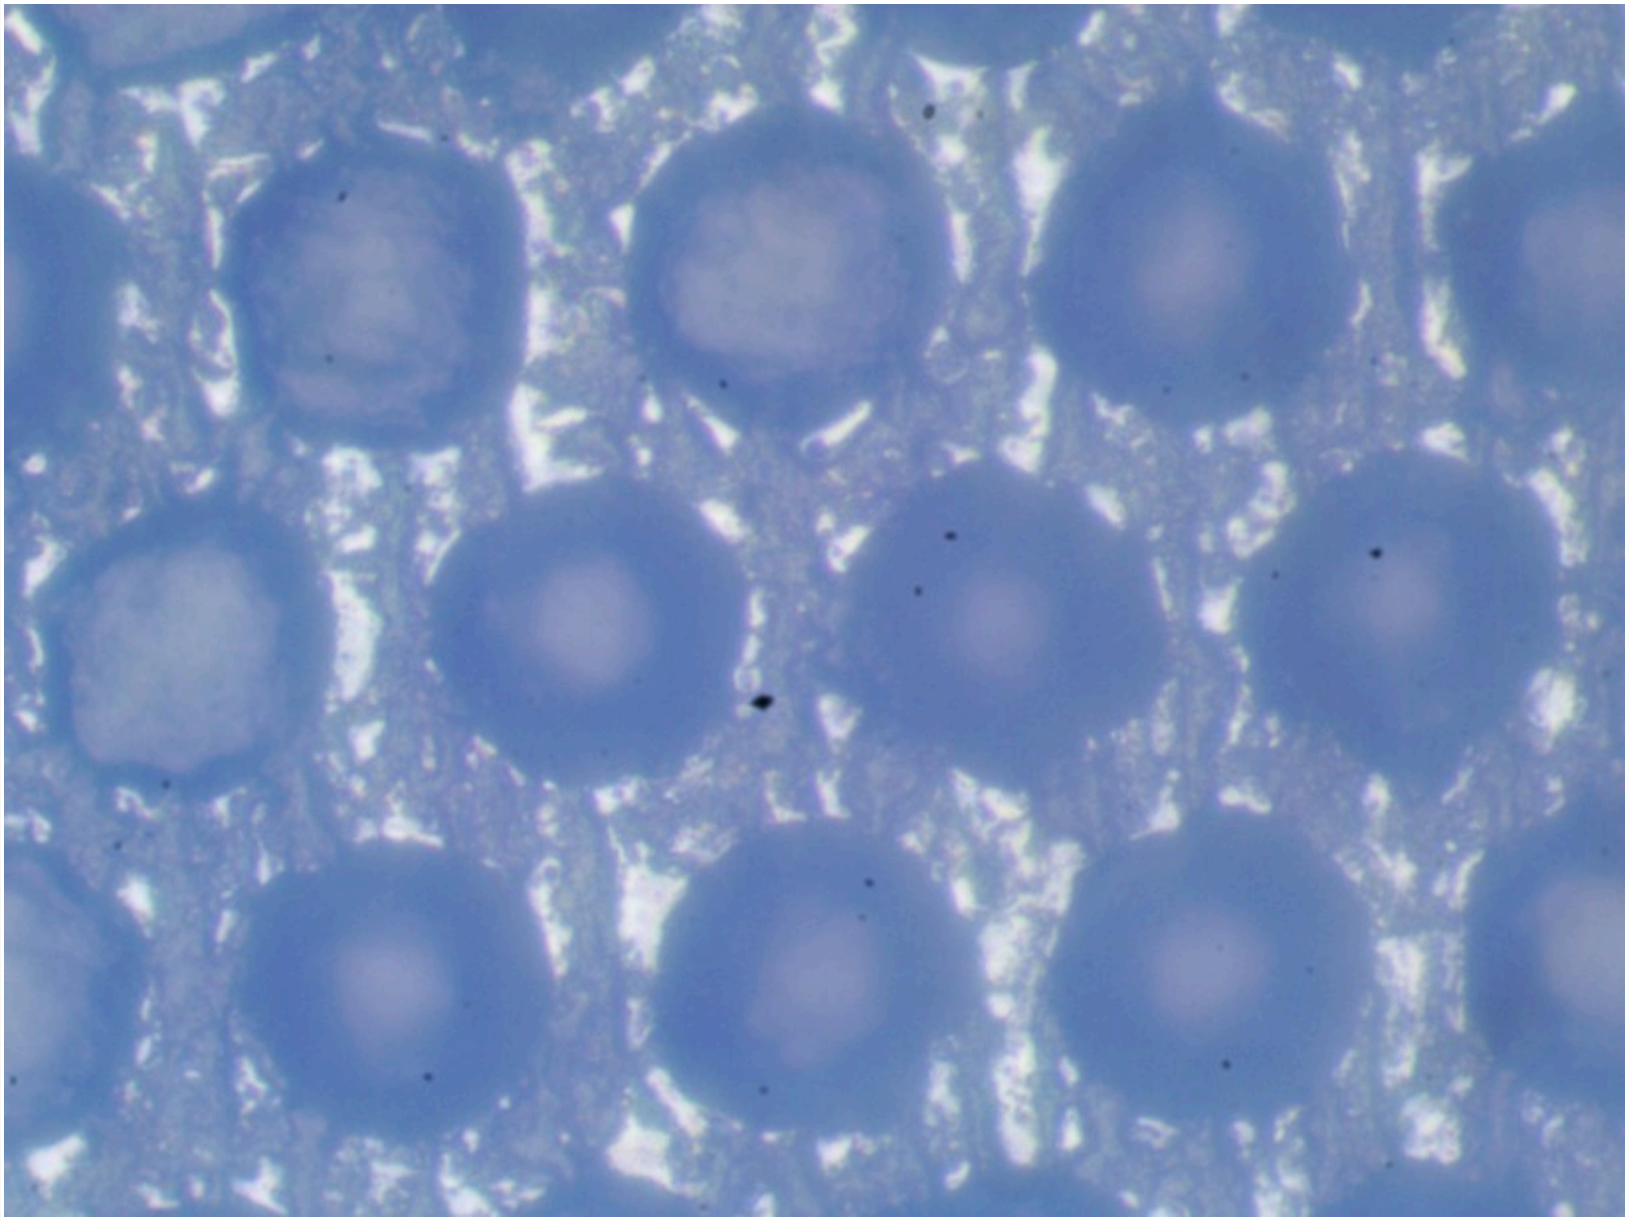
Page №32. Roll "z56916". Length: 1300 mm. Photos with magnificaiton: x400. Cleaning passes: 1

Roll "z56916".	Photo of the anilox roll surface

Bridge / Cell: 1 / 5
Depth before / after: 14.5 / 14.5 мкм
Depth decreased by: 0%

Comment
streaks 1140 dent 1195 1250.
Roll ground off.

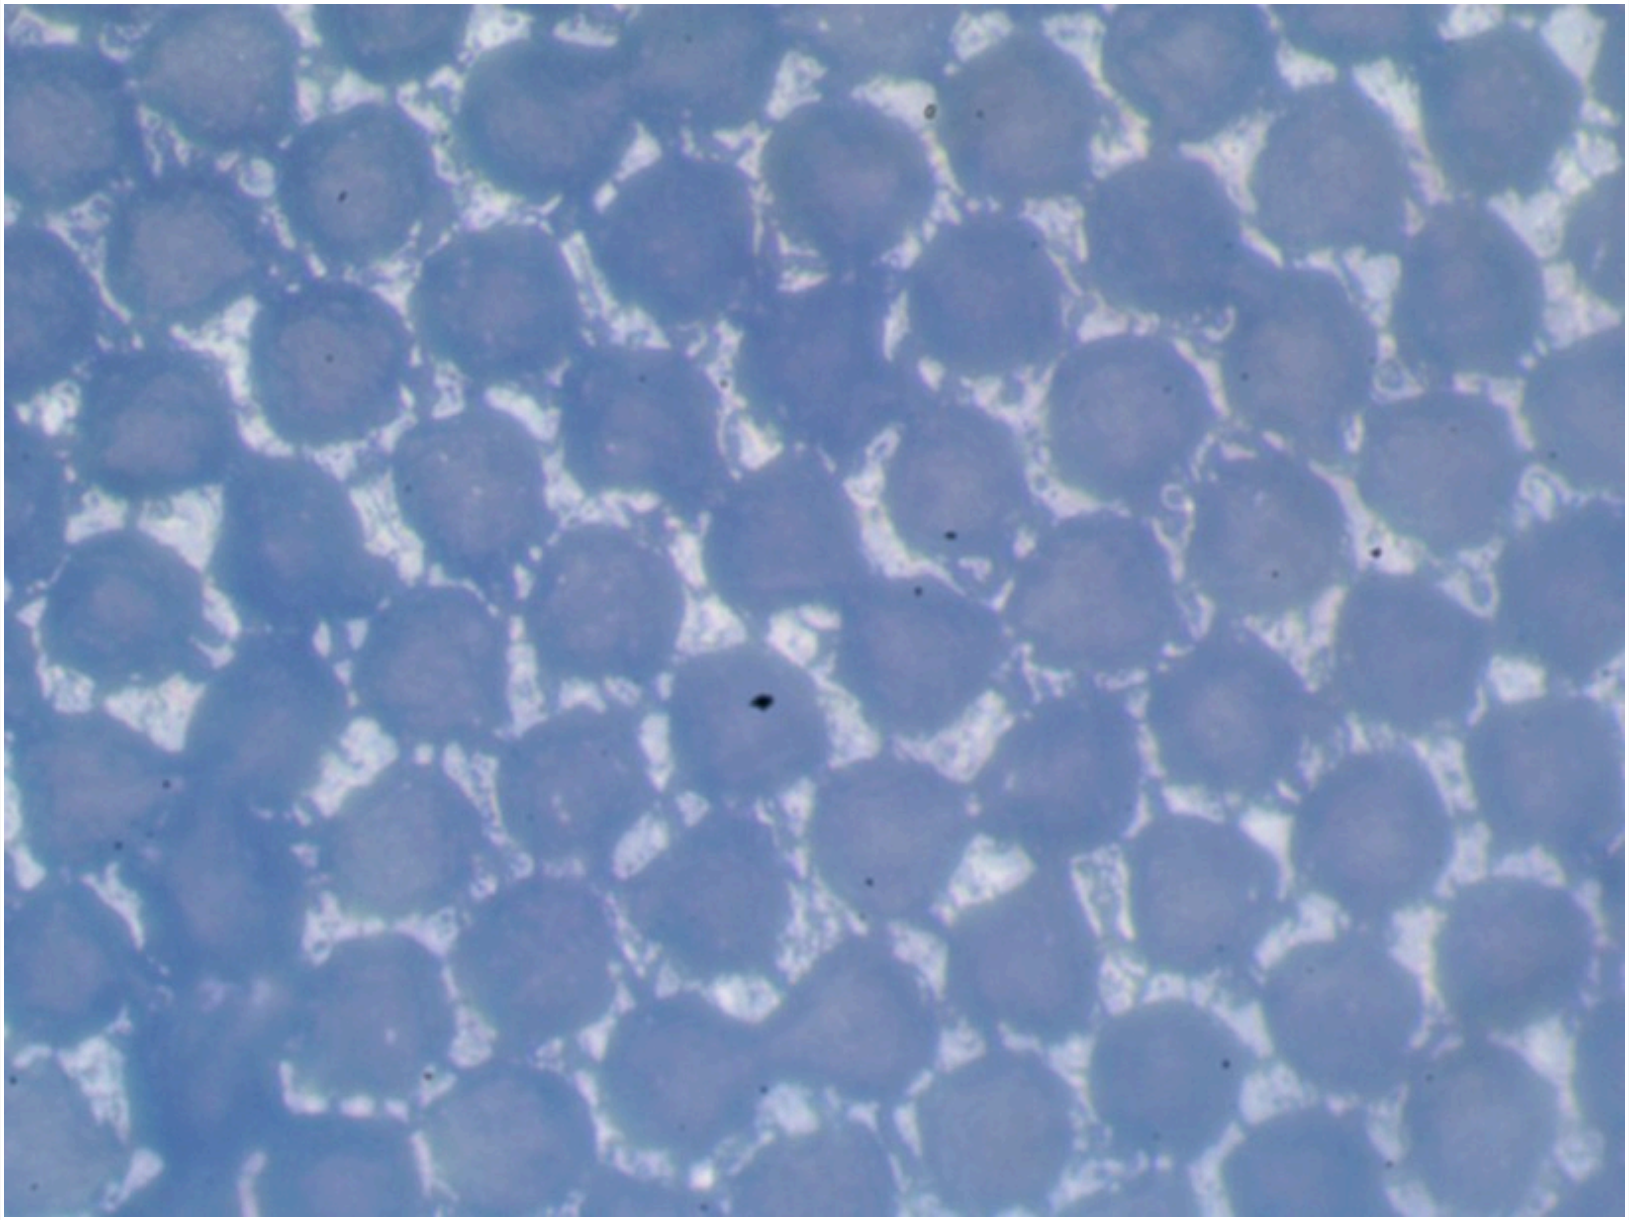
Page №33. Roll "h100751-6". Length: 1300 mm. Photos with magnificaiton: x400. Cleaning passes: 1

Roll "h100751-6".	Photo of the anilox roll surface

Ink transfer volume decrease from the passport value: 23.81%

Bridge / Cell: 1 / 6
Depth before / after: 28 / 28 мкм
Depth decreased by: 0%

Comment
streaks.
Roll ground off.

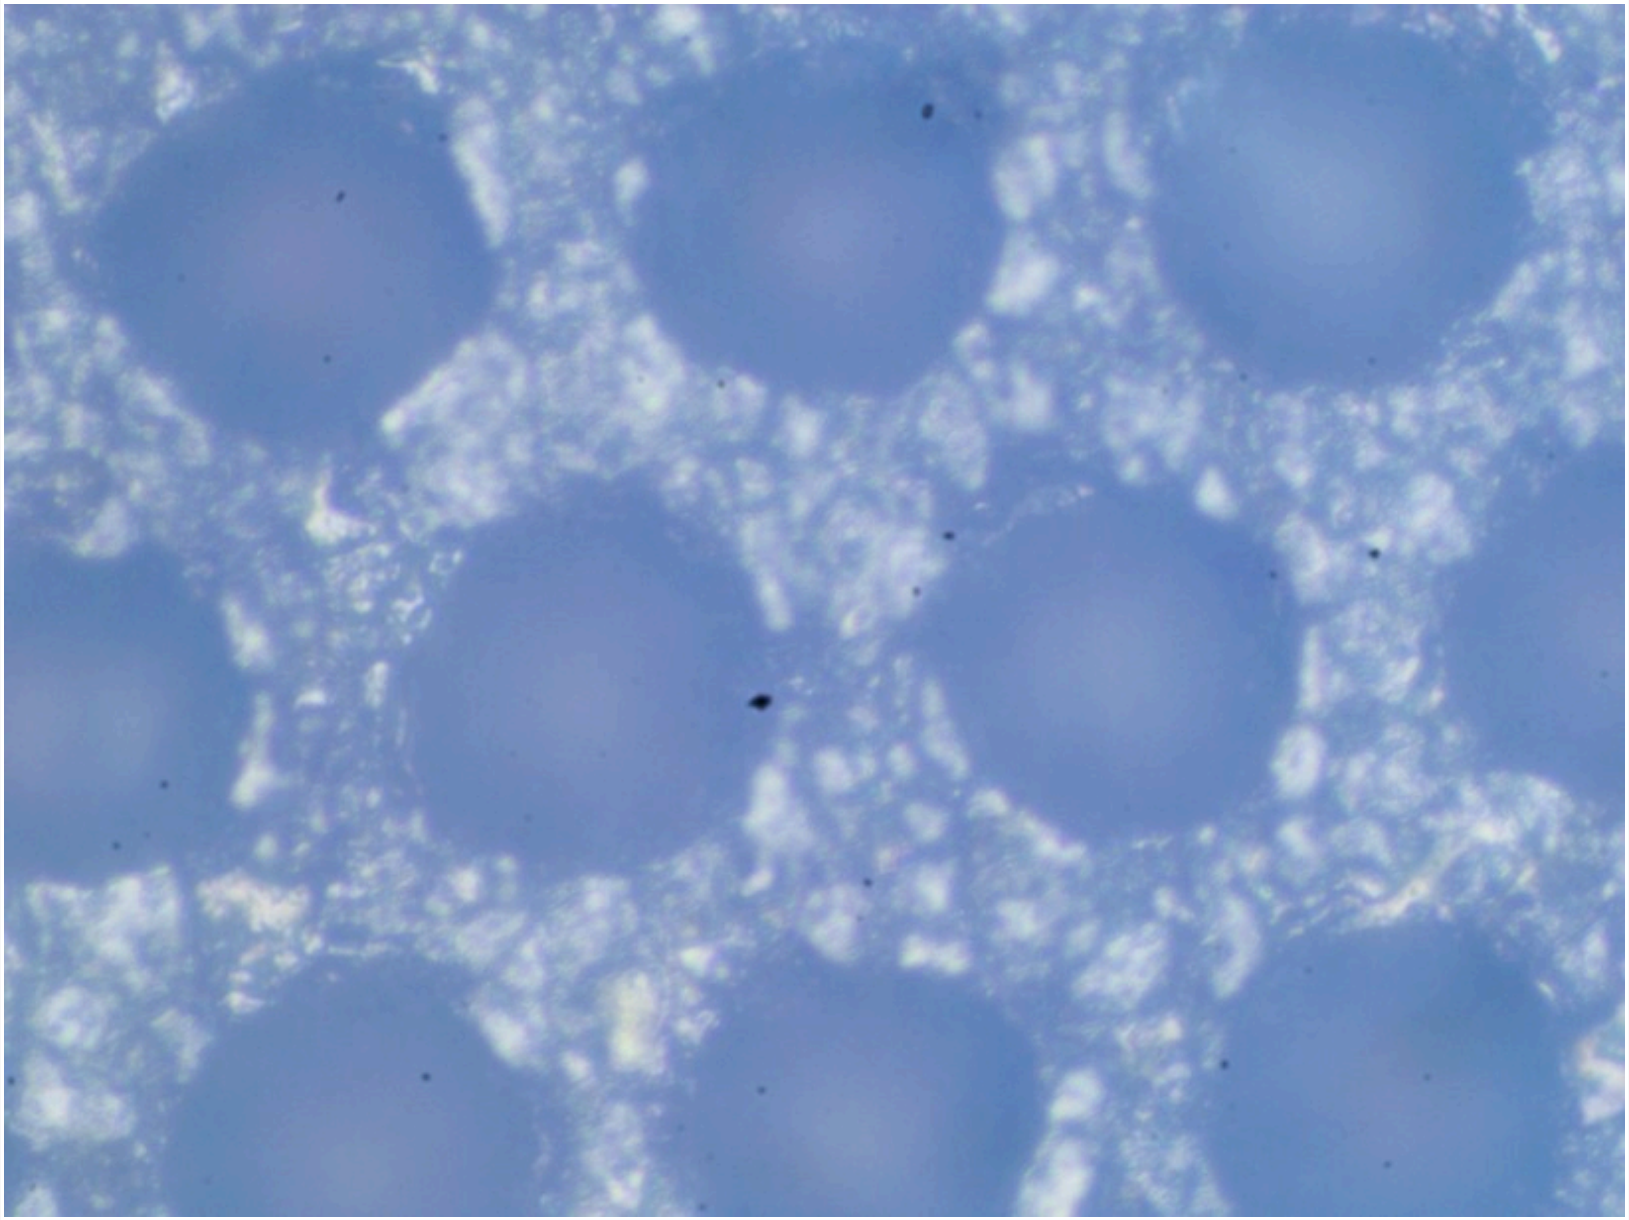
Page №35. Roll "sa008618". Length: 1320 mm. Photos with magnificaiton: x400. Cleaning passes: 1

Roll "sa008618".	Photo of the anilox roll surface

Bridge / Cell: 1 / 7
Depth before / after: 28 / 28 мкм
Depth decreased by: 0%

Comment
Roll slightly ground off.

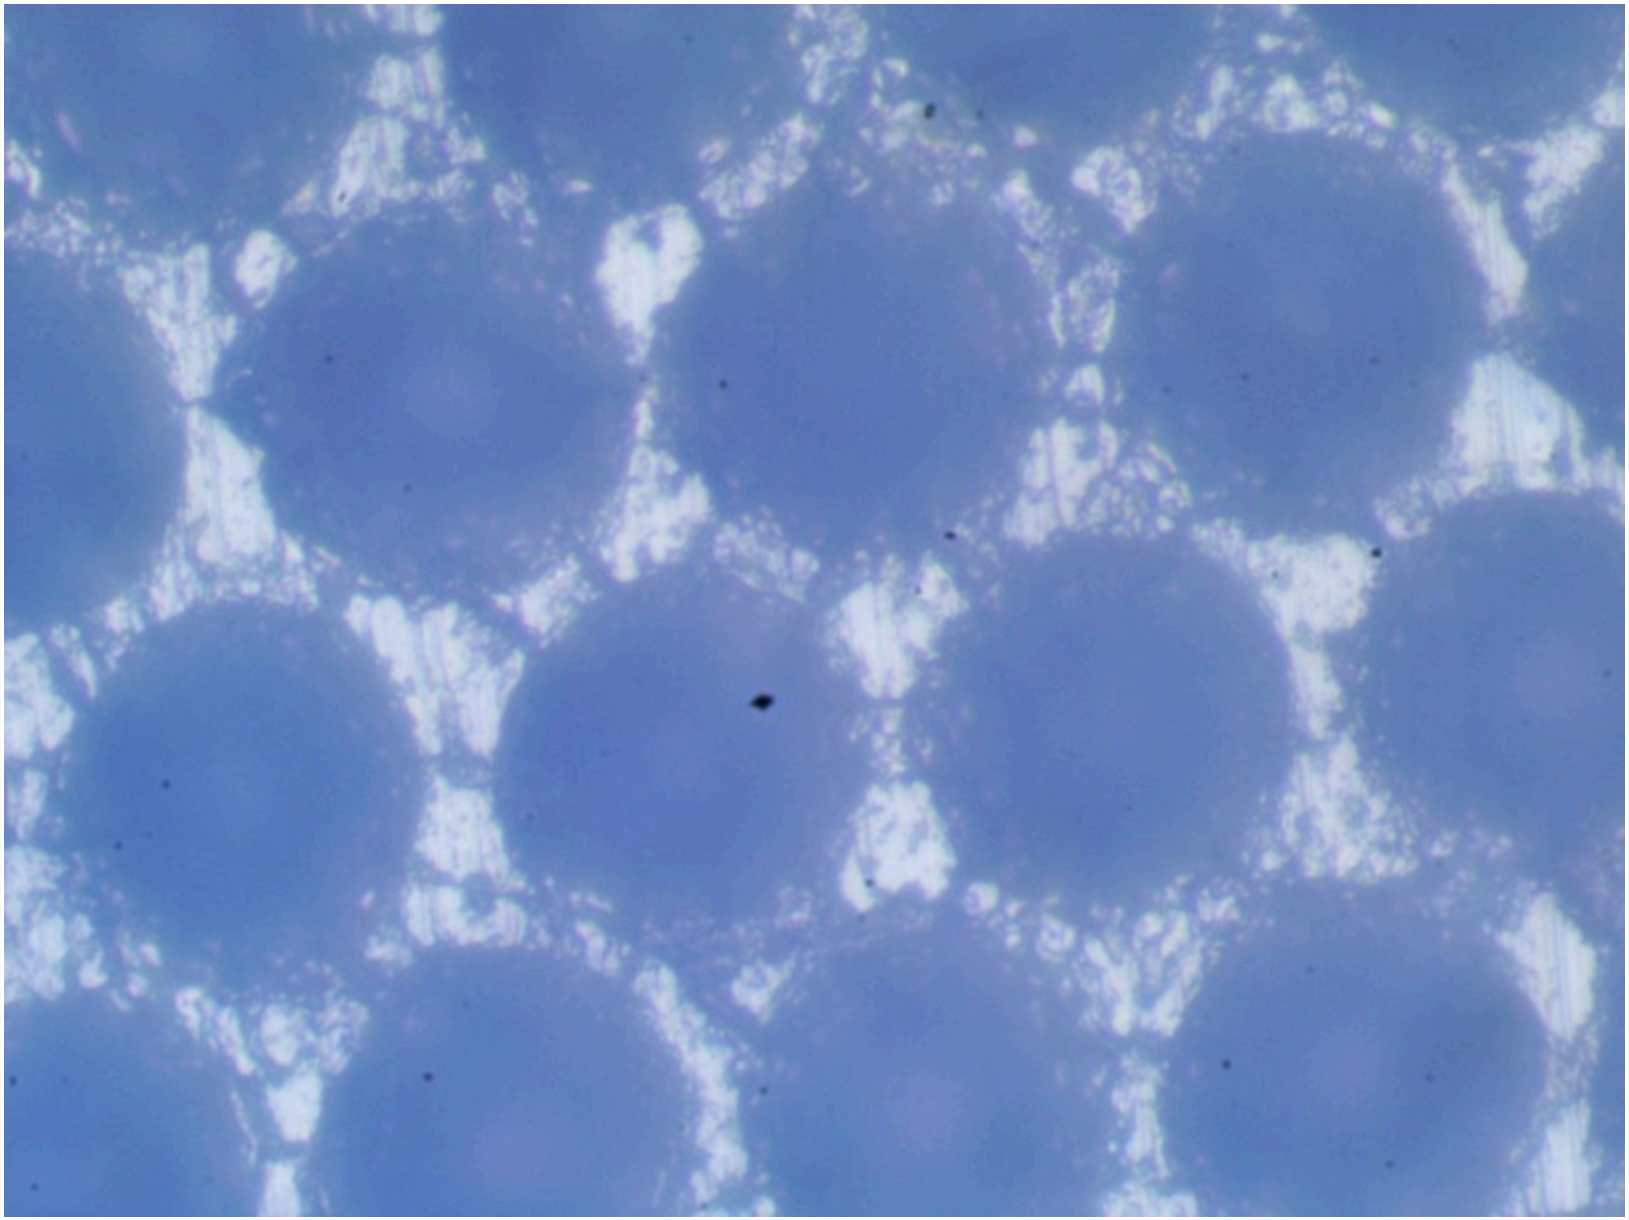
Page №36. Roll "sa008621". Length: 1320 mm. Photos with magnificaiton: x400. Cleaning passes: 1

Roll "sa008621".	Photo of the anilox roll surface

Bridge / Cell: 1 / 9
Depth before / after: 24 / 24 мкм
Depth decreased by: 0%

Comment
streak 1265 dent 1175 1150.

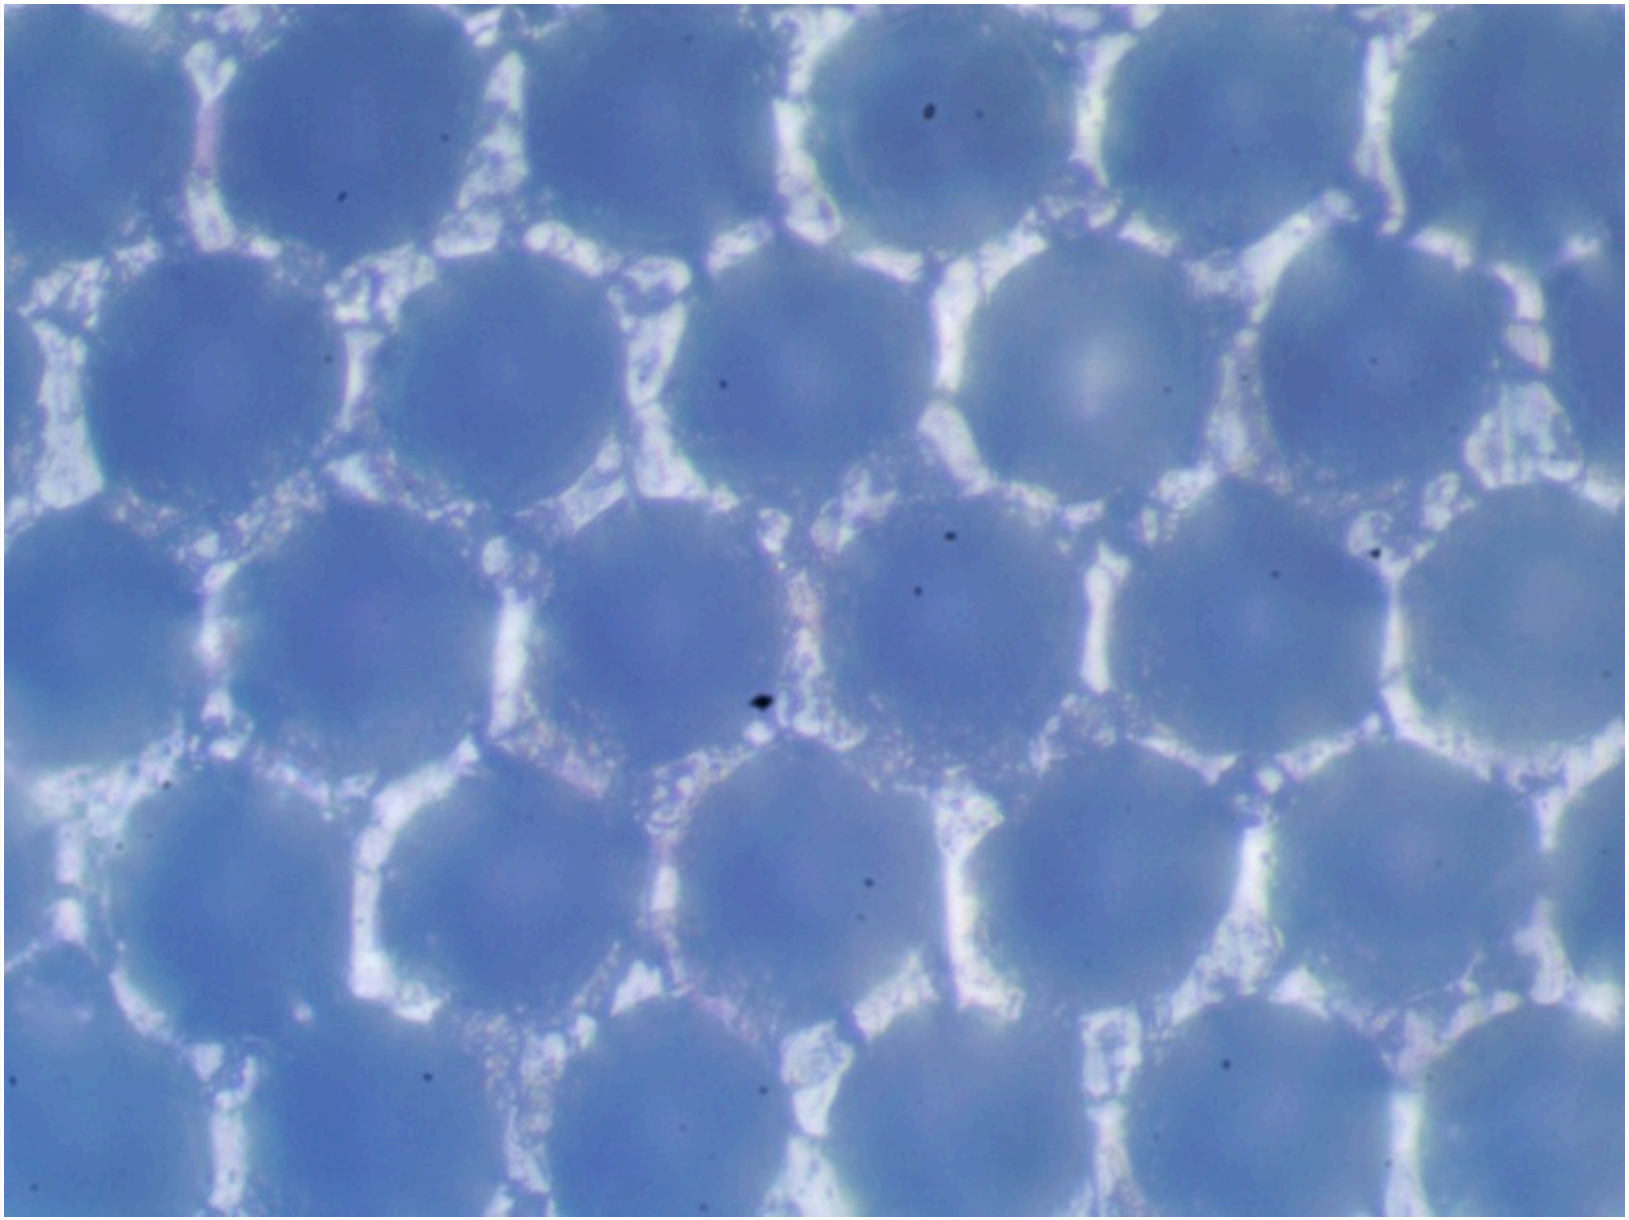
Page №37. Roll "z18008066". Length: 1320 mm. Photos with magnificaiton: x400. Cleaning passes: 1

Roll "z18008066".	Photo of the anilox roll surface

Comment
worn streak 1034 415 674 973 1265
dent 1005 1015 1023.

Roll heavily ground off.

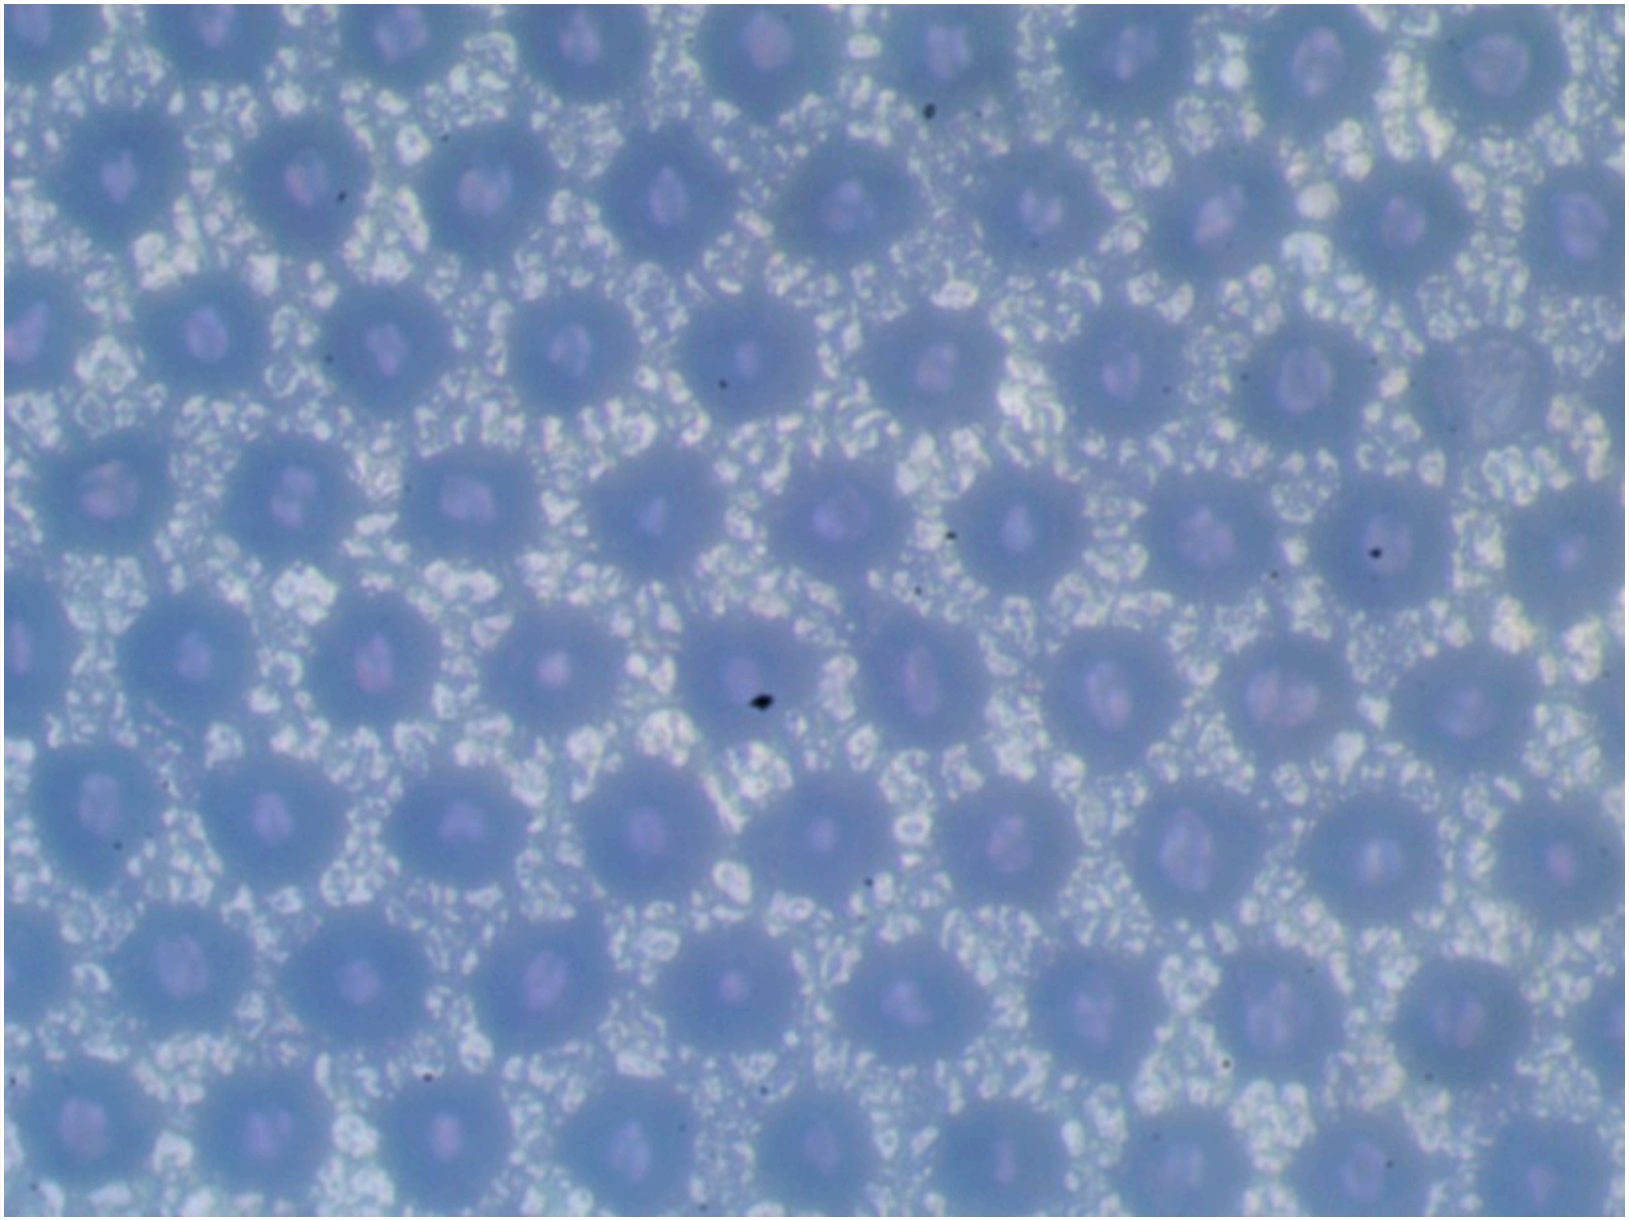
Page №38. Roll "h100479-2". Length: 1320 mm. Photos with magnificaiton: x400. Cleaning passes: 1

Roll "h100479-2".	Photo of the anilox roll surface

Ink transfer volume decrease from the passport value: 18%

Bridge / Cell: 1 / 4
Depth before / after: 16 / 16 мкм
Depth decreased by: 0%

Comment
streaks.
Roll ground off.
