RollerCheck360

Roll Inspection from 08.12.2025

Rolls: 178

We have analyzed for you 178 rolls.

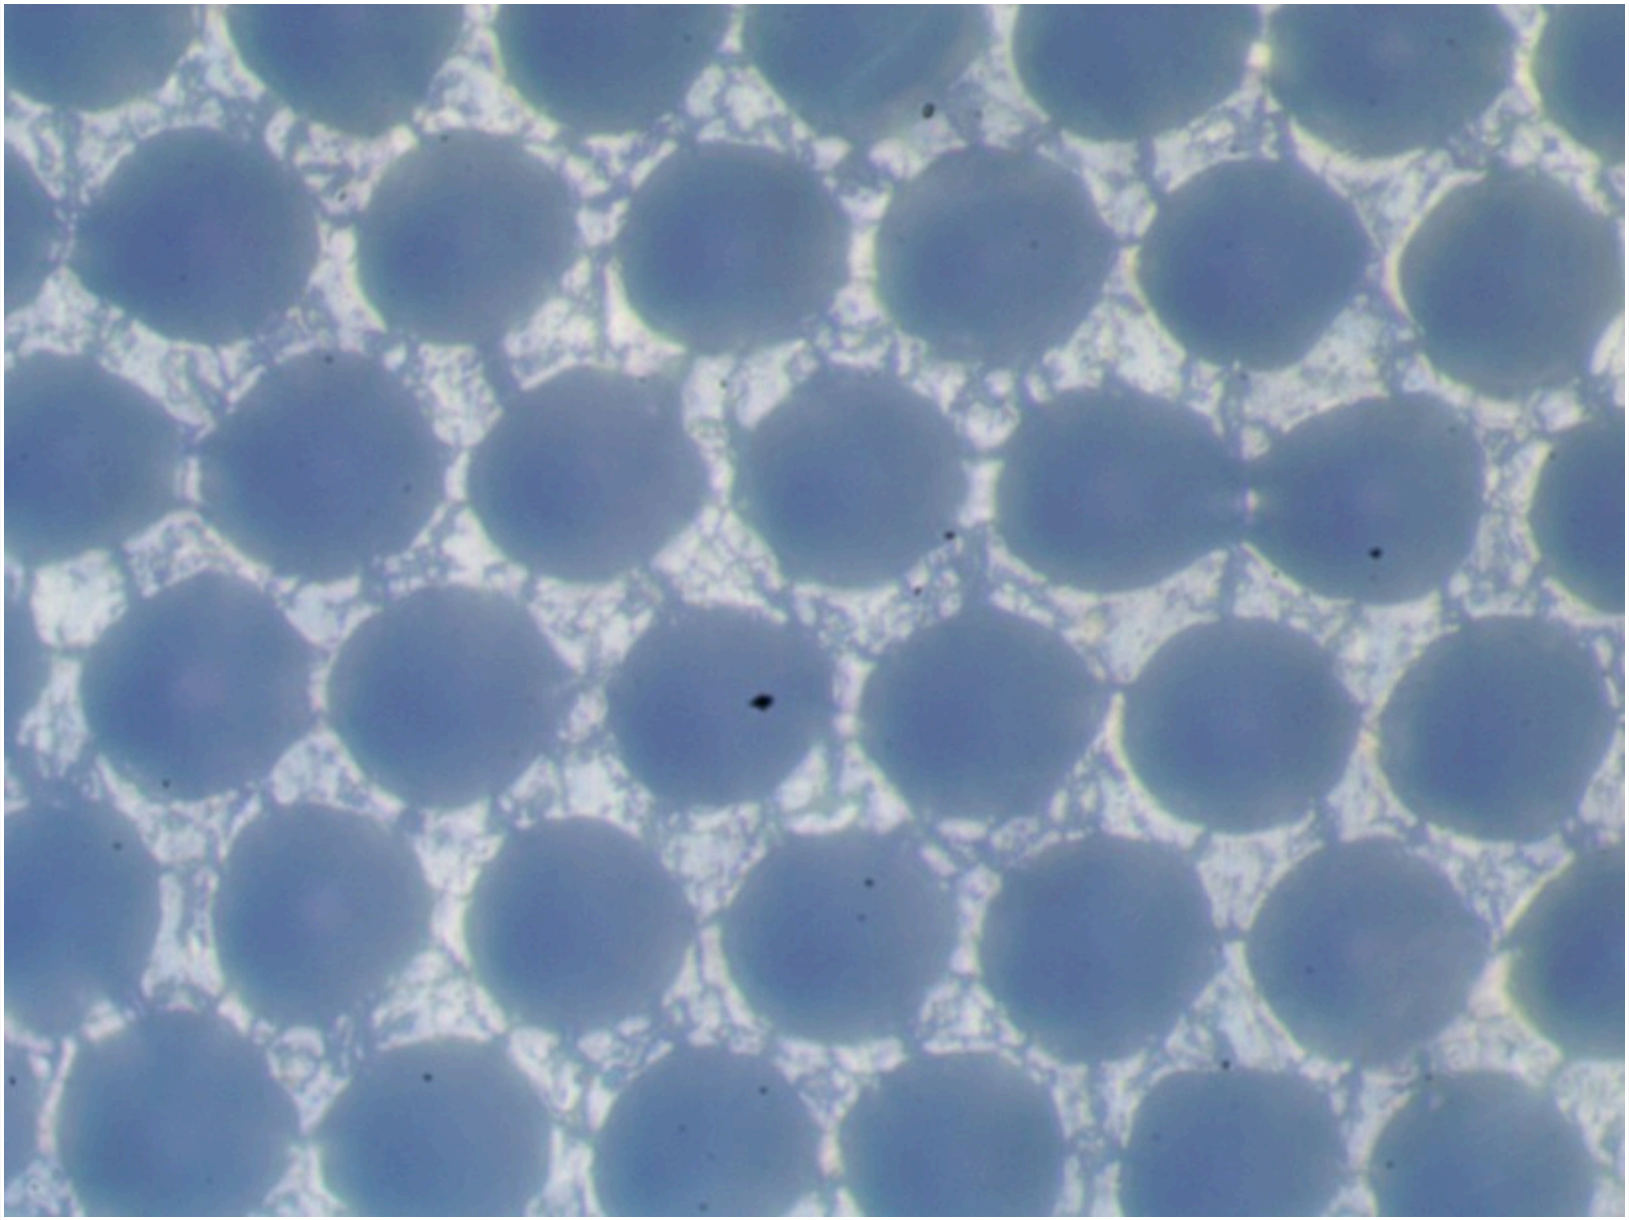
Page №40. Roll "sa008625". Length: 1320 mm. Photos with magnificaiton: x400. Cleaning passes: 1

Roll "sa008625".	Photo of the anilox roll surface

Bridge / Cell: 1 / 5
Depth before / after: 19 / 19 мкм
Depth decreased by: 0%

Comment
streaks scratch 268.
Roll ground off.

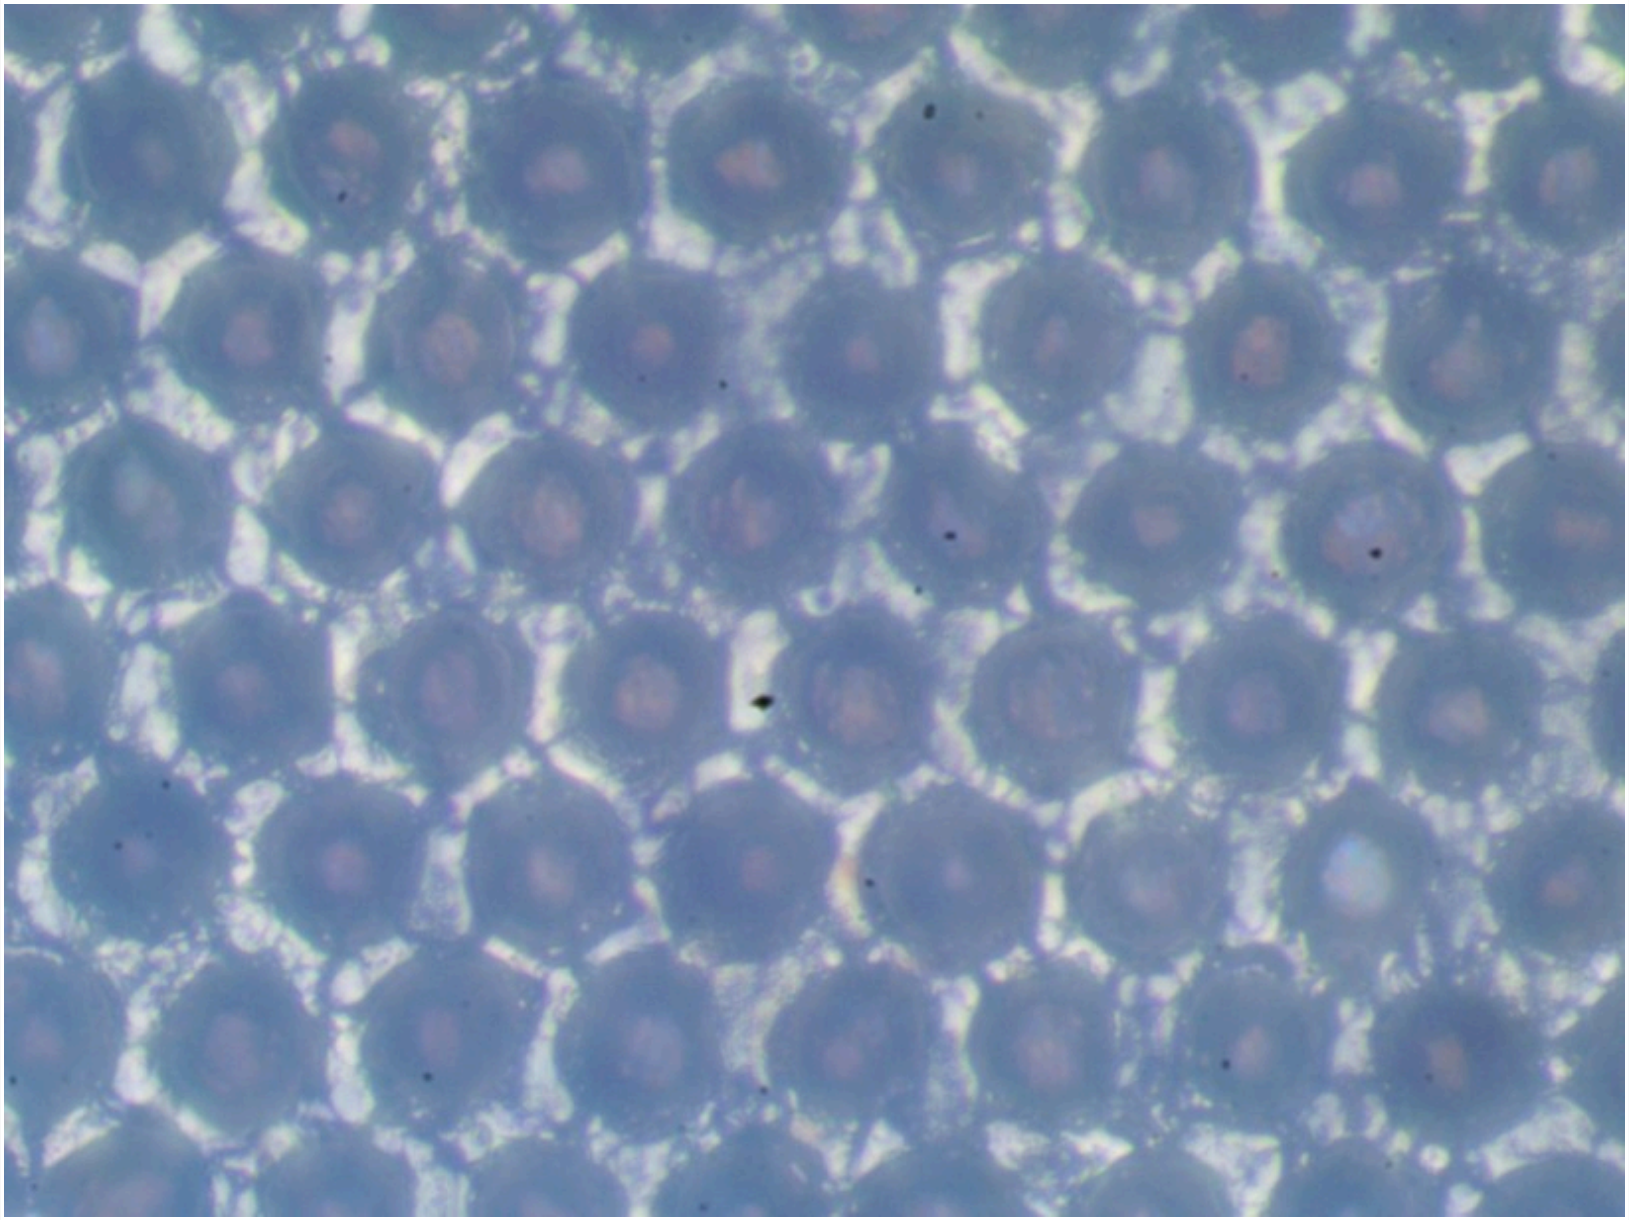
Page №41. Roll "sa008624". Length: 1320 mm. Photos with magnificaiton: x400. Cleaning passes: 1

Roll "sa008624".	Photo of the anilox roll surface

Bridge / Cell: 1 / 6
Depth before / after: 18 / 18 мкм
Depth decreased by: 0%

Comment
streak 602 670 scratch 760.
Roll ground off.

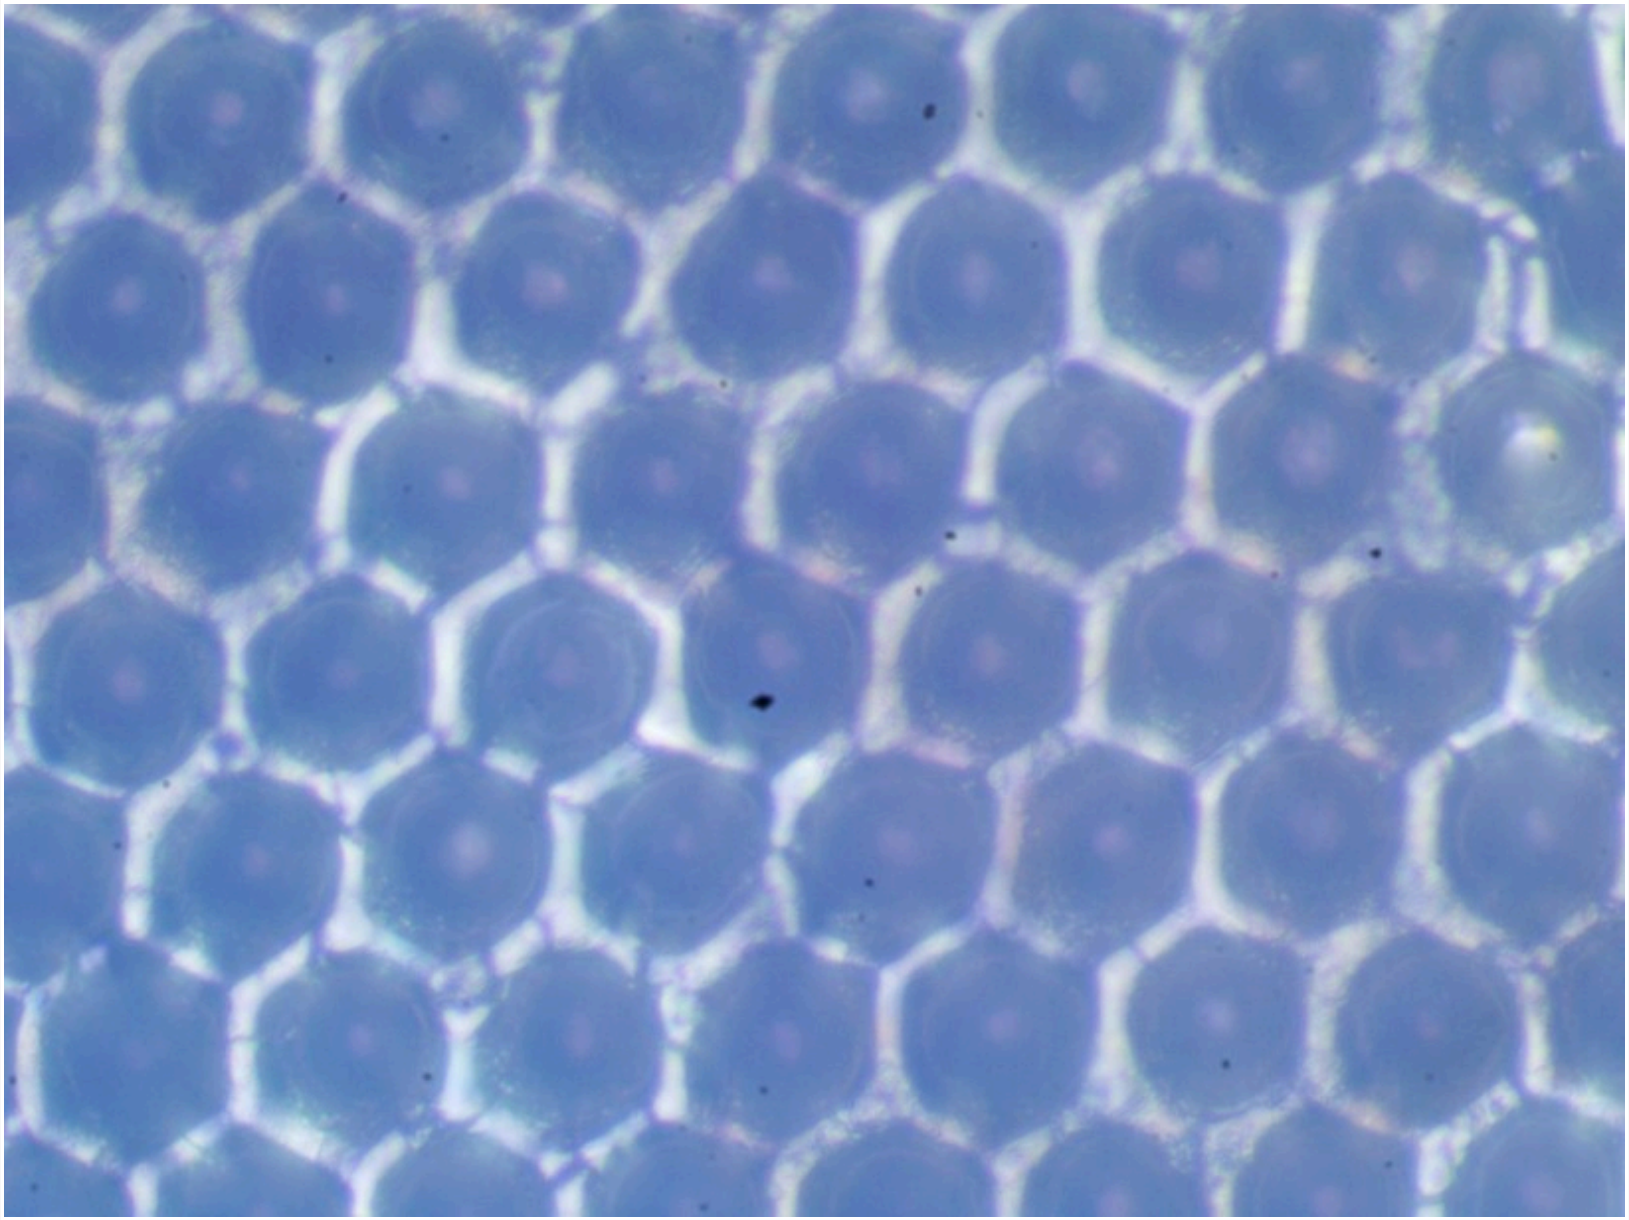
Page №42. Roll "h100479-1". Length: 1320 mm. Photos with magnificaiton: x400. Cleaning passes: 1

Roll "h100479-1".	Photo of the anilox roll surface

Bridge / Cell: 1 / 6
Depth before / after: 16 / 16 мкм
Depth decreased by: 0%

Comment
spots across the entire surface.
Roll ground off.

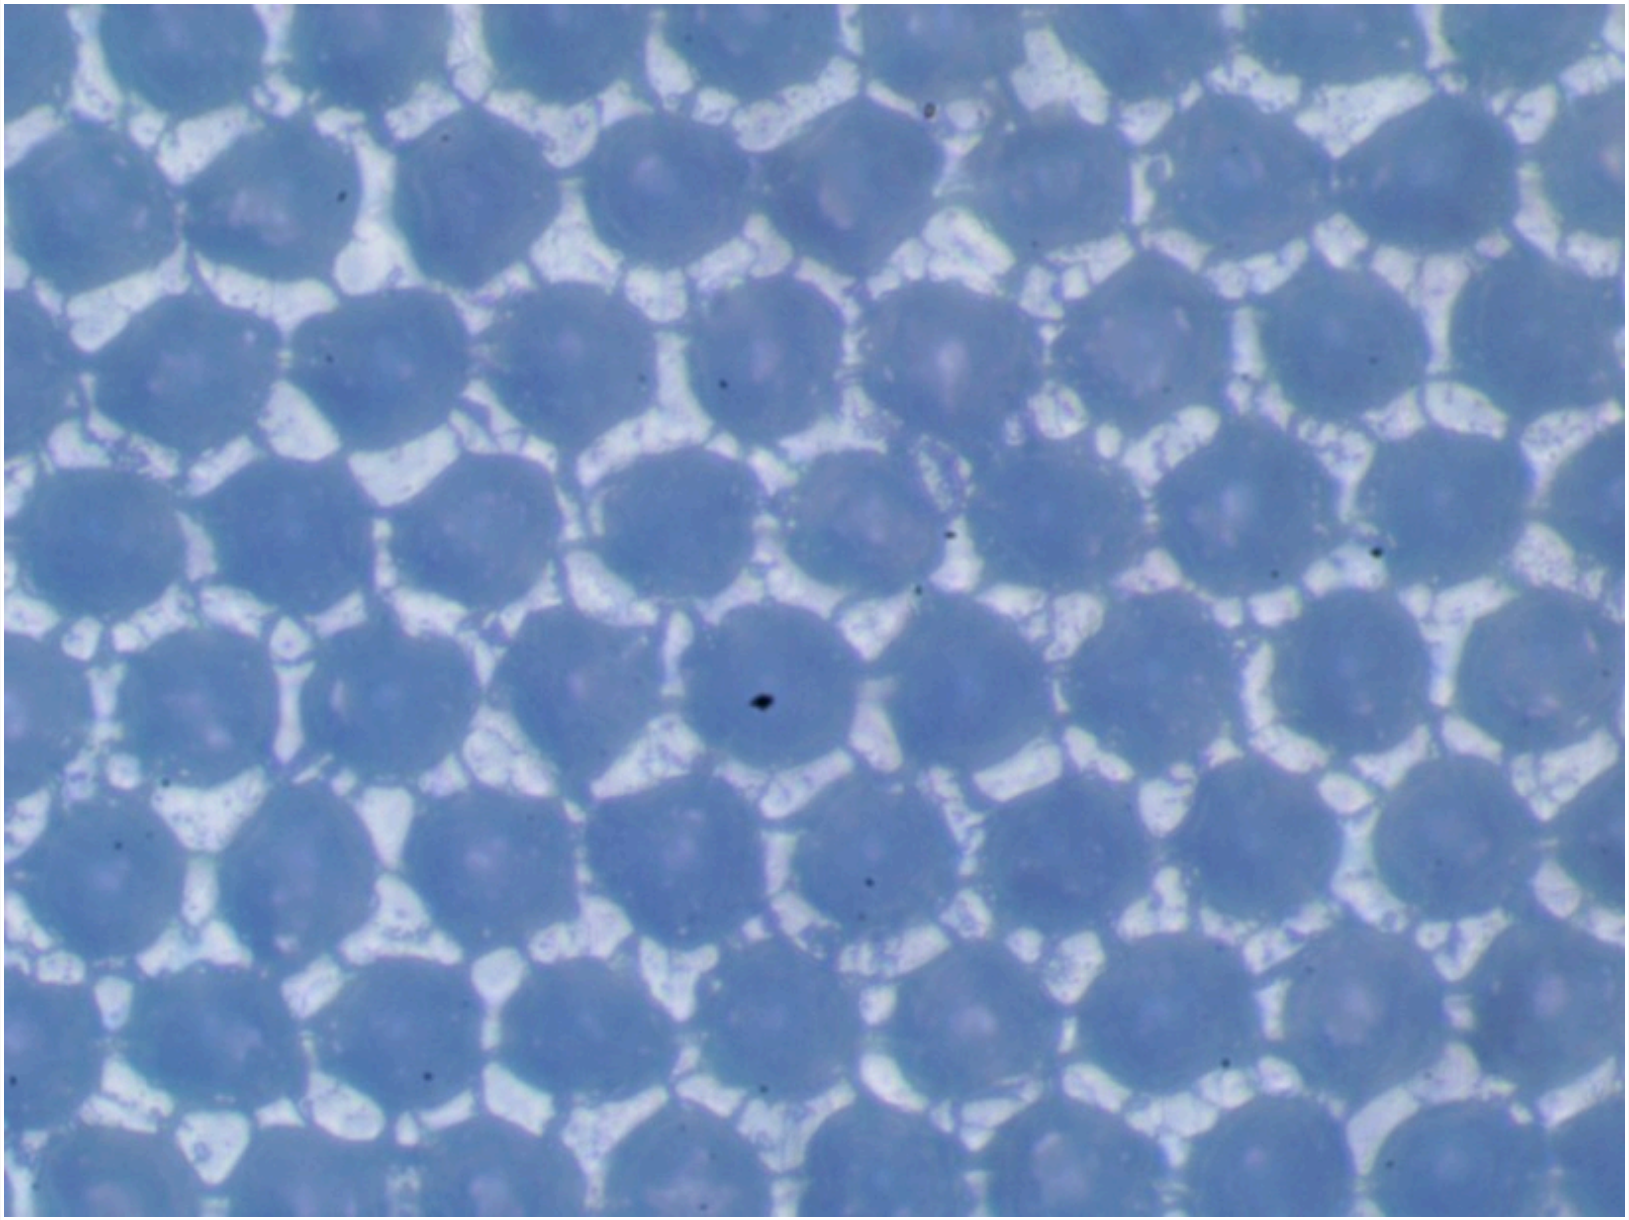
Page №43. Roll "3016196-2". Length: 1320 mm. Photos with magnificaiton: x400. Cleaning passes: 1

Roll "3016196-2".	Photo of the anilox roll surface

Bridge / Cell: 1 / 5
Depth before / after: 28 / 28 мкм
Depth decreased by: 0%

Comment
worn streak 896 767.
Roll ground off.

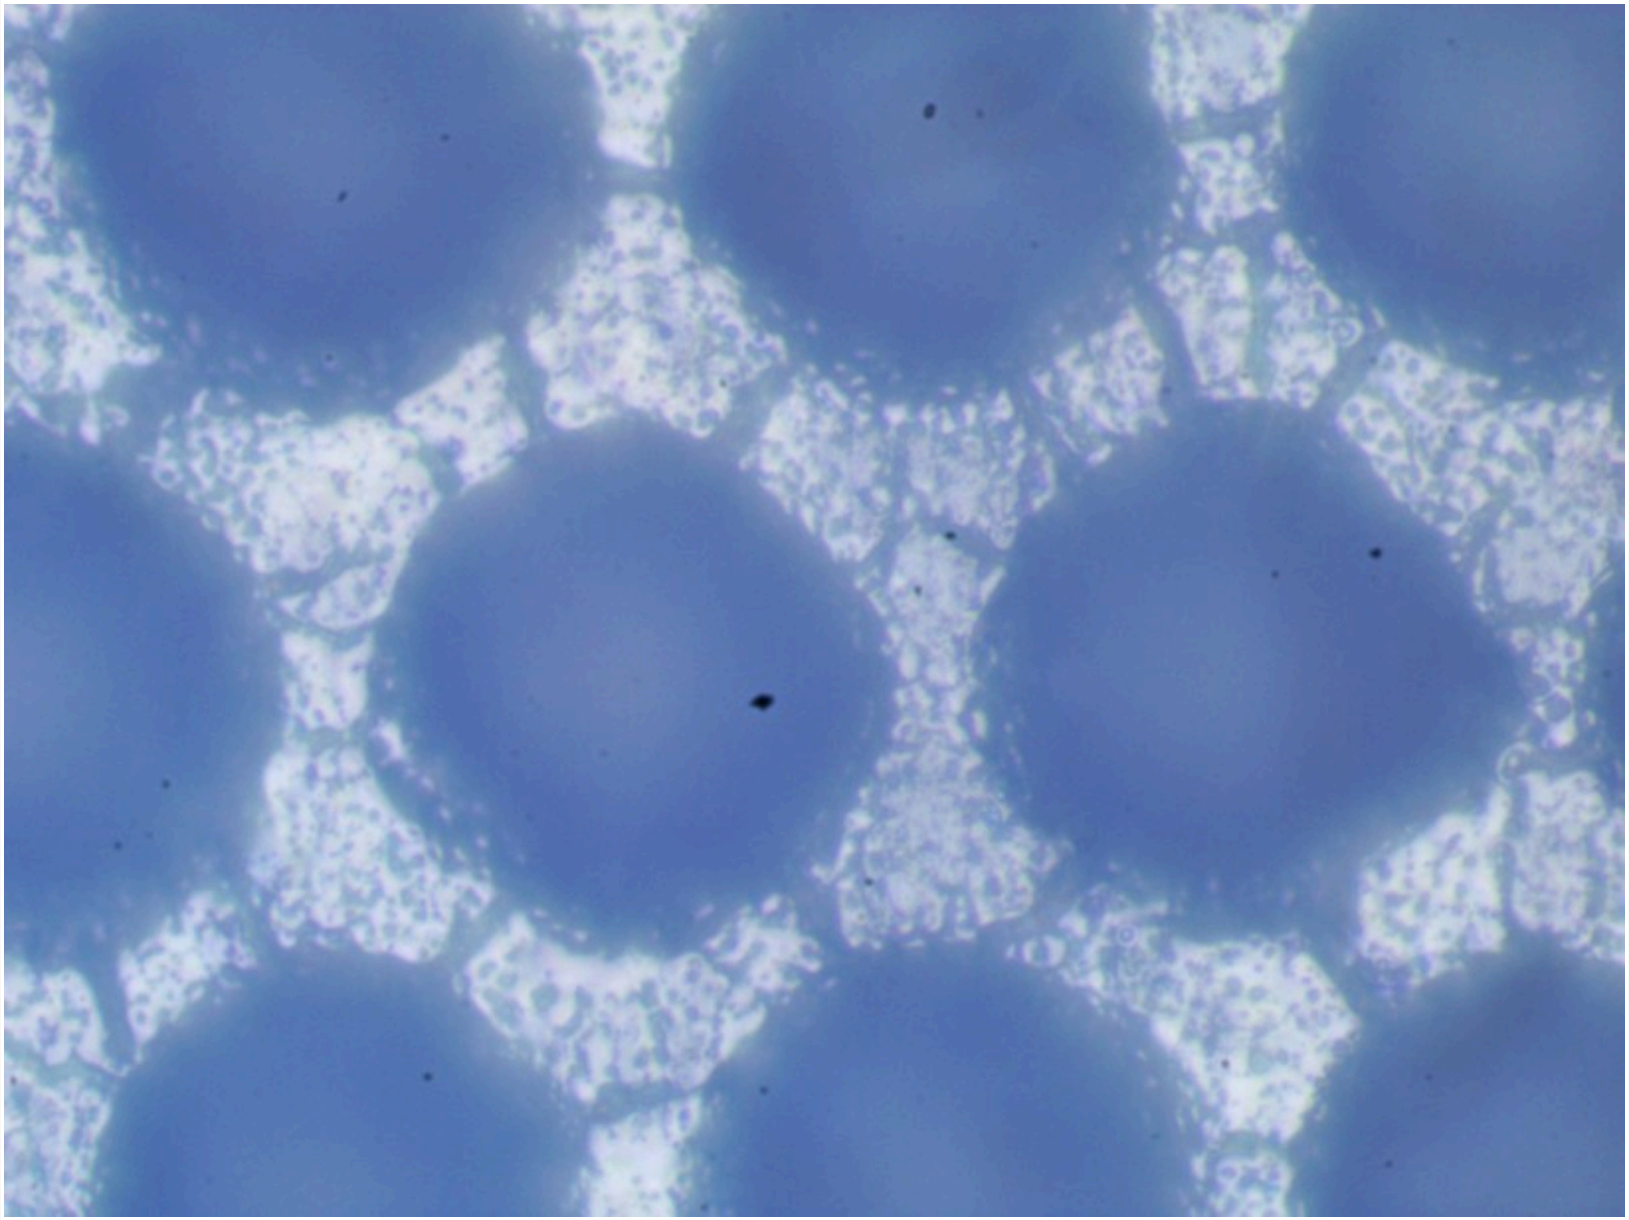
Page №44. Roll "z18008076". Length: 1320 mm. Photos with magnificaiton: x400. Cleaning passes: 1

Roll "z18008076".	Photo of the anilox roll surface

Ink transfer volume decrease from the passport value: 24.81%

Bridge / Cell: 1 / 5
Depth before / after: 36 / 36 мкм
Depth decreased by: 0%

Comment
streaks.
Roll ground off.

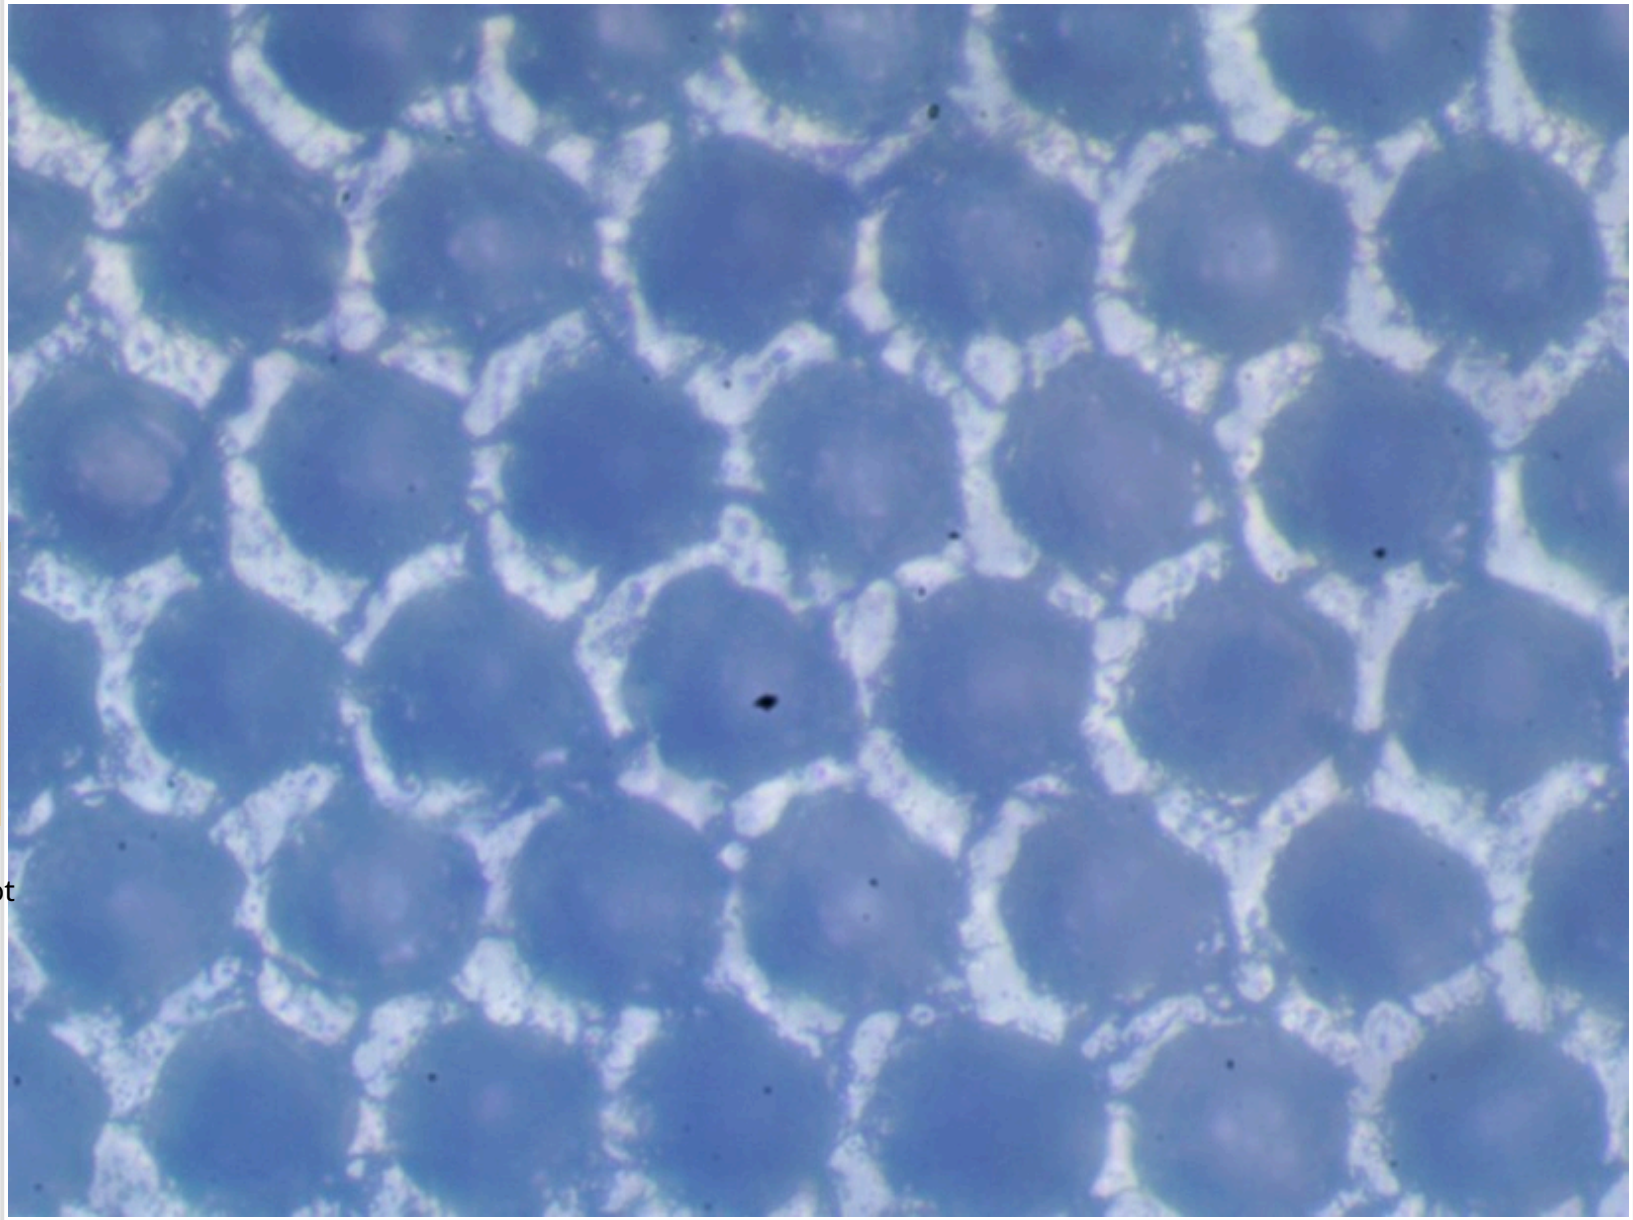
Page №46. Roll "z18008069". Length: 1320 mm. Photos with magnificaiton: x400. Cleaning passes: 1

Roll "z18008069".	Photo of the anilox roll surface

Comment
scratch 1219 1290 1050 450 spot 505 streak 217.

Roll slightly ground off.

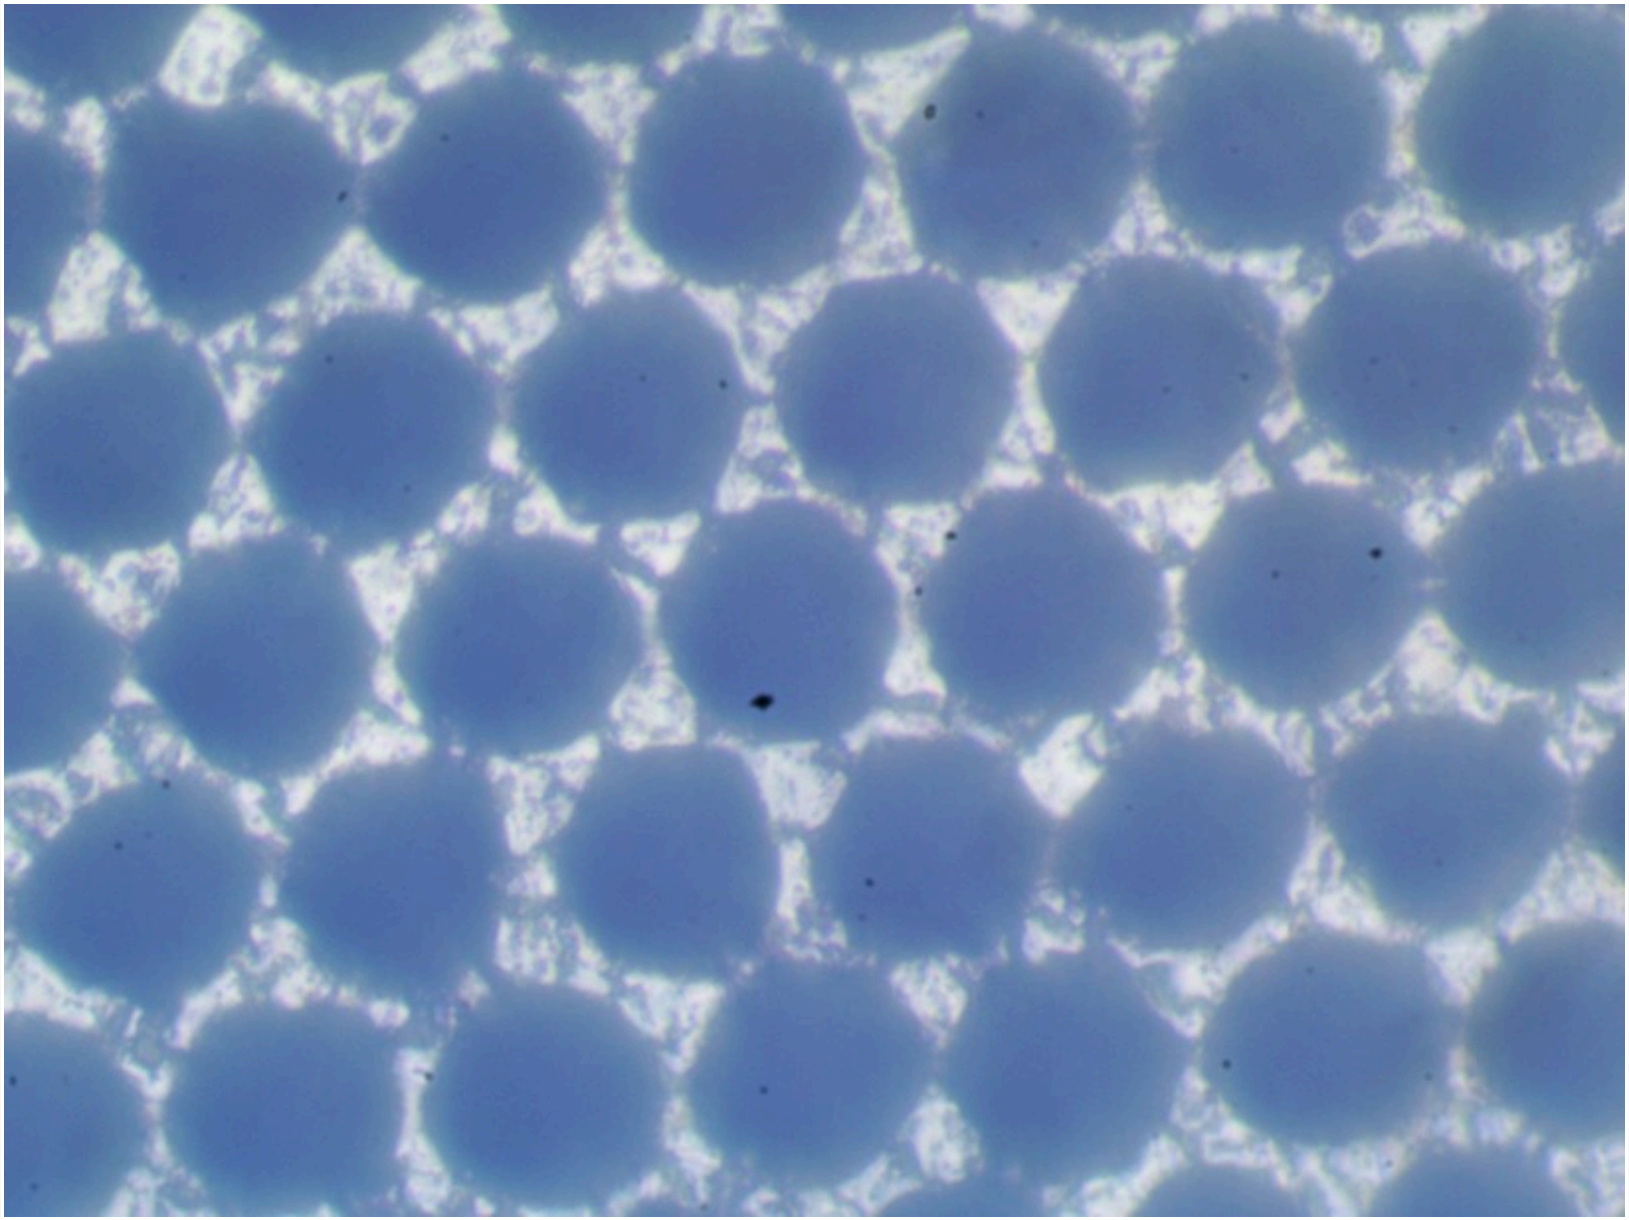
Page №47. Roll "z18008080". Length: 1320 mm. Photos with magnificaiton: x400. Cleaning passes: 1

Roll "z18008080".	Photo of the anilox roll surface

Comment
streak 363 630 687 714 1057 dent 1130 1150 scratch 530

340.
Roll ground off.

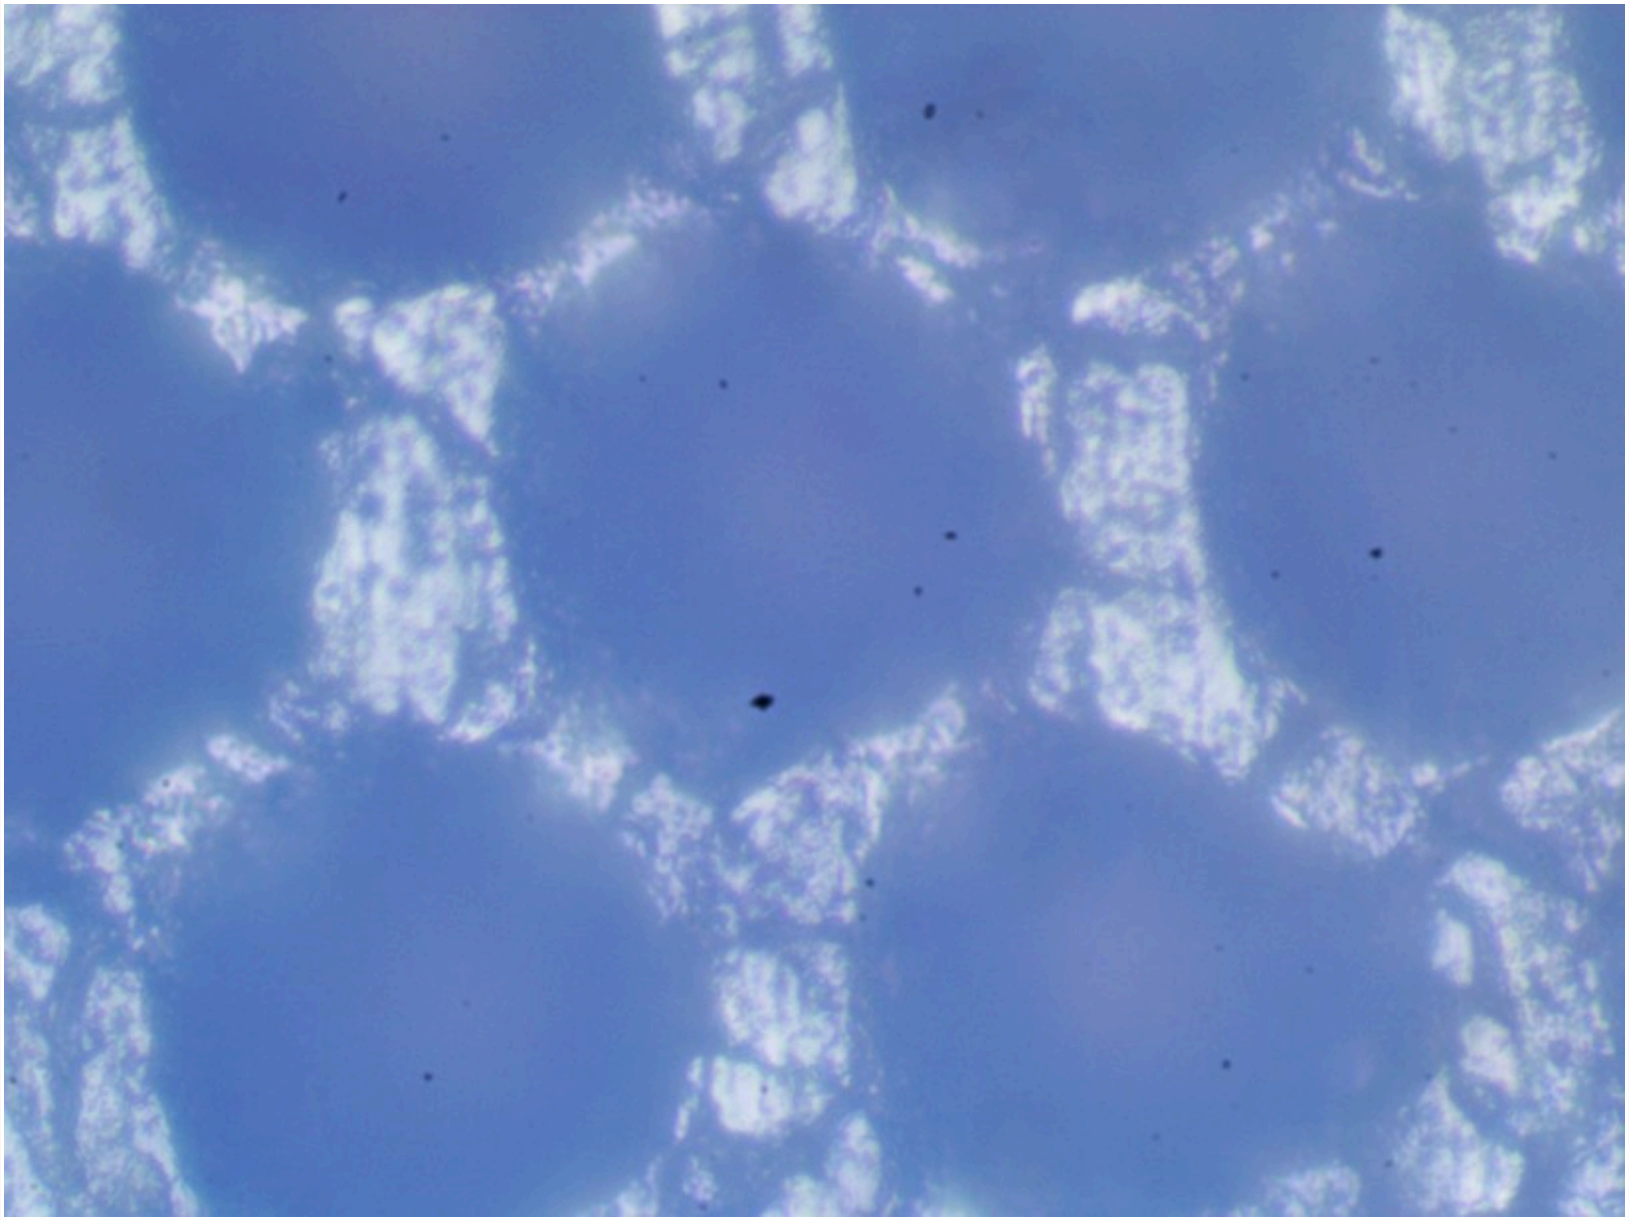
Page №48. Roll "z18008072". Length: 1320 mm. Photos with magnificaiton: x400. Cleaning passes: 1

Roll "z18008072".	Photo of the anilox roll surface

Comment
worn streak 410 1021 scratch 345 1200.

Roll ground off.

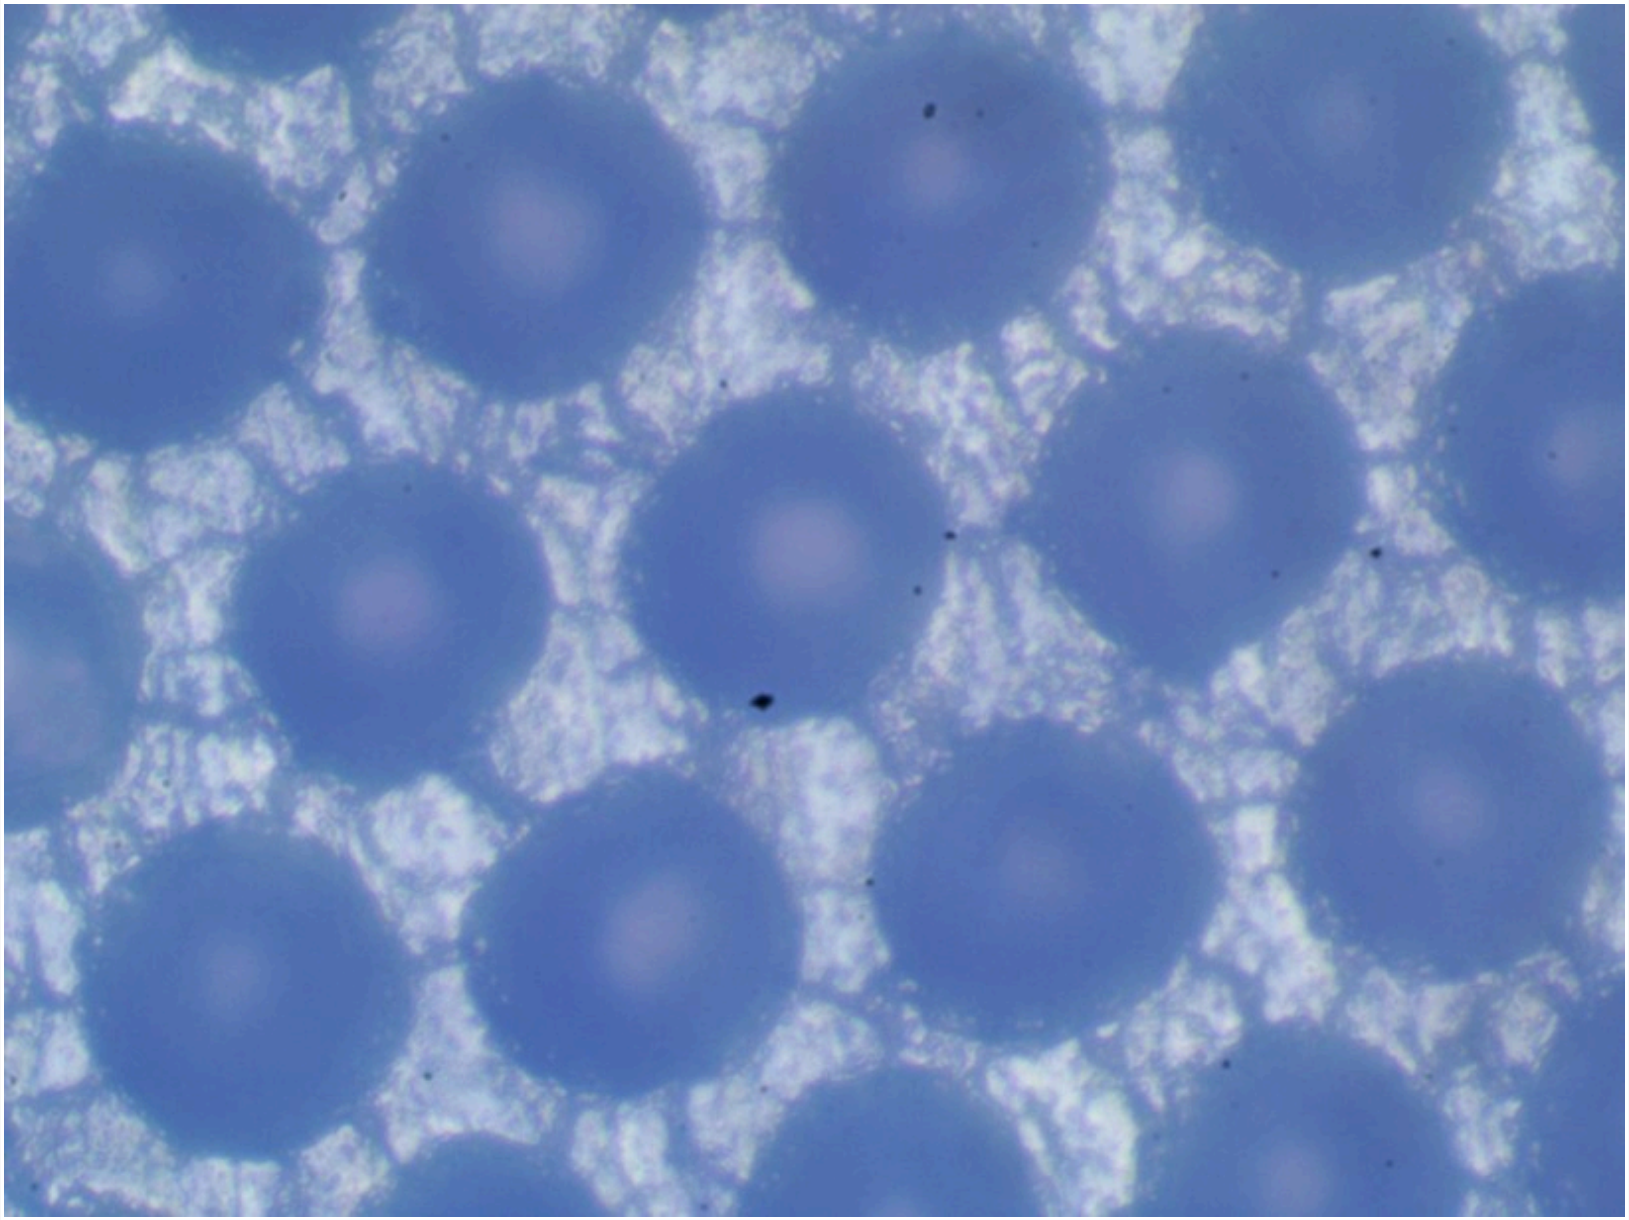
Page №49. Roll "z18008068". Length: 1320 mm. Photos with magnificaiton: x400. Cleaning passes: 1

Roll "z18008068".	Photo of the anilox roll surface

Comment
streaks spot 270 wide streaks 110 293 661 805 1045

1160.
Roll ground off.

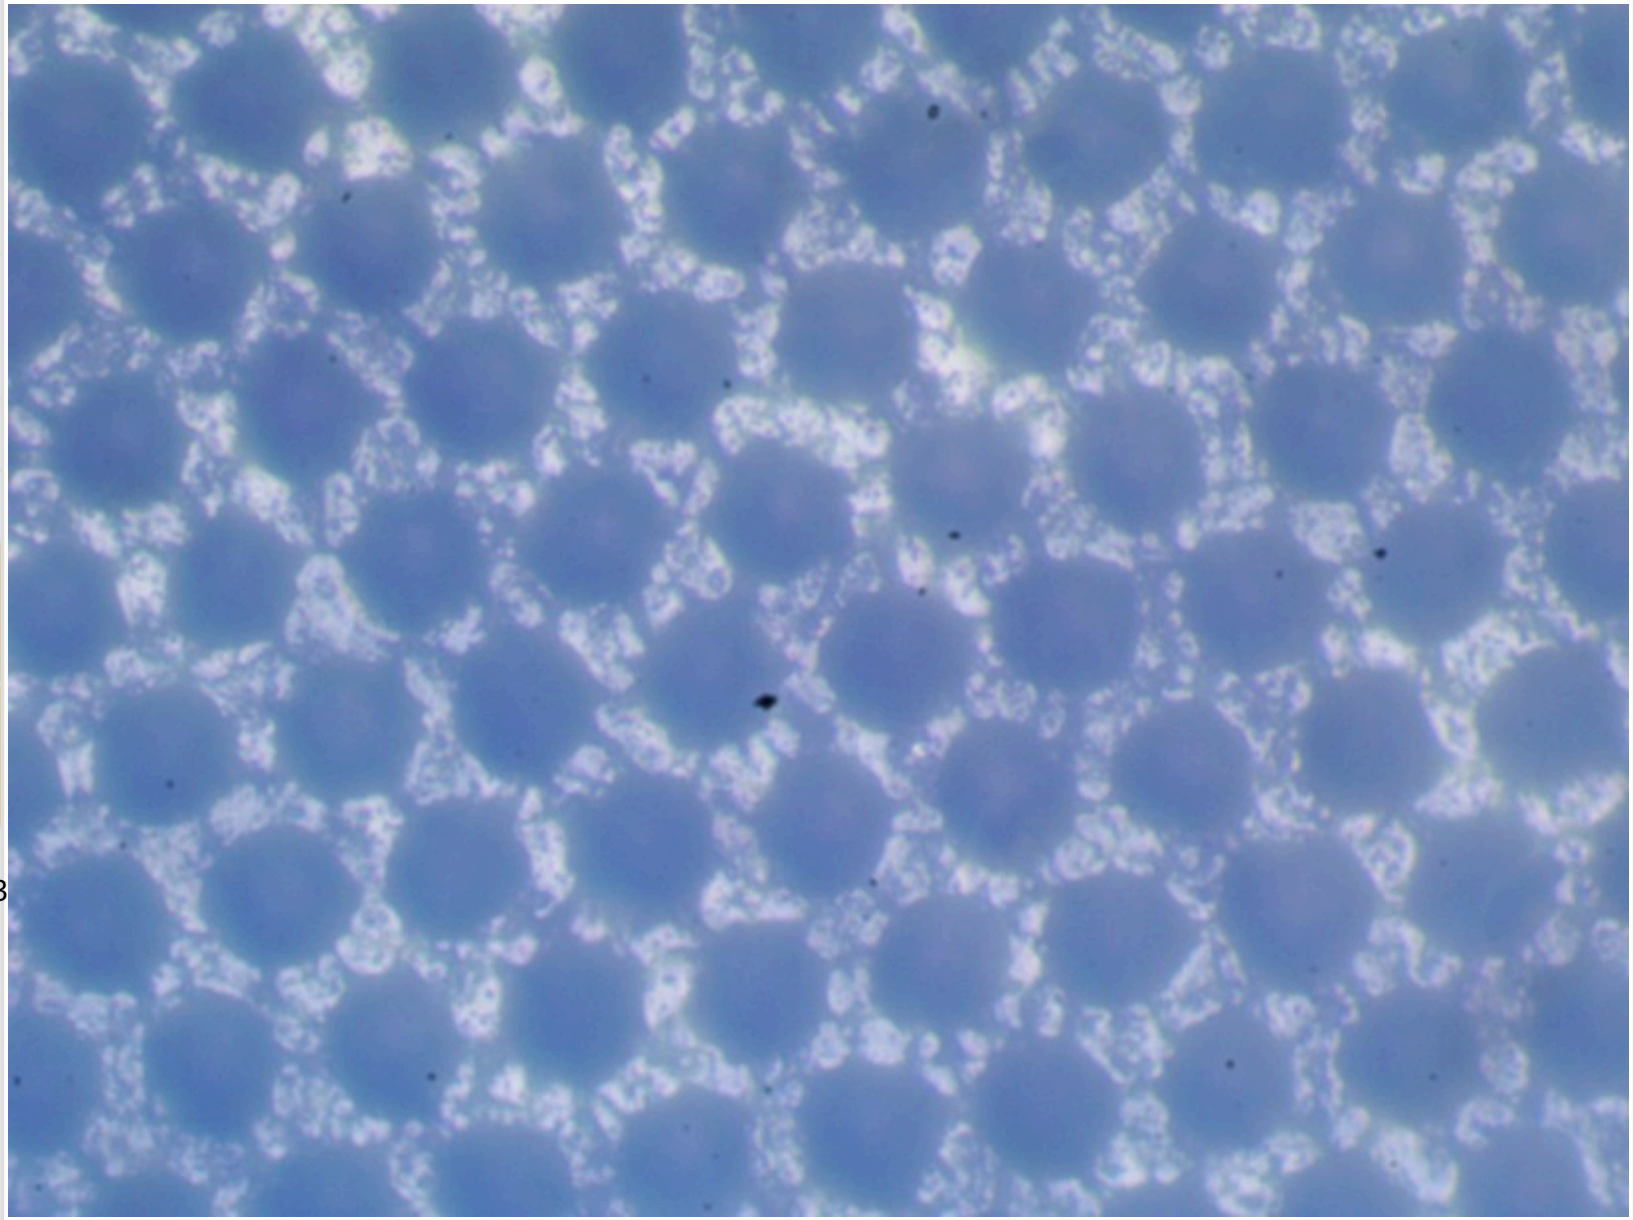
Page №50. Roll "3016196-02". Length: 1320 mm. Photos with magnificaiton: x400. Cleaning passes: 1

Roll "3016196-02".	Photo of the anilox roll surface

Bridge / Cell: 1 / 7
Depth before / after: 28.5 / 28.5 мкм
Depth decreased by: 0%

Comment
chips at edges scratch 260.
Roll slightly ground off.

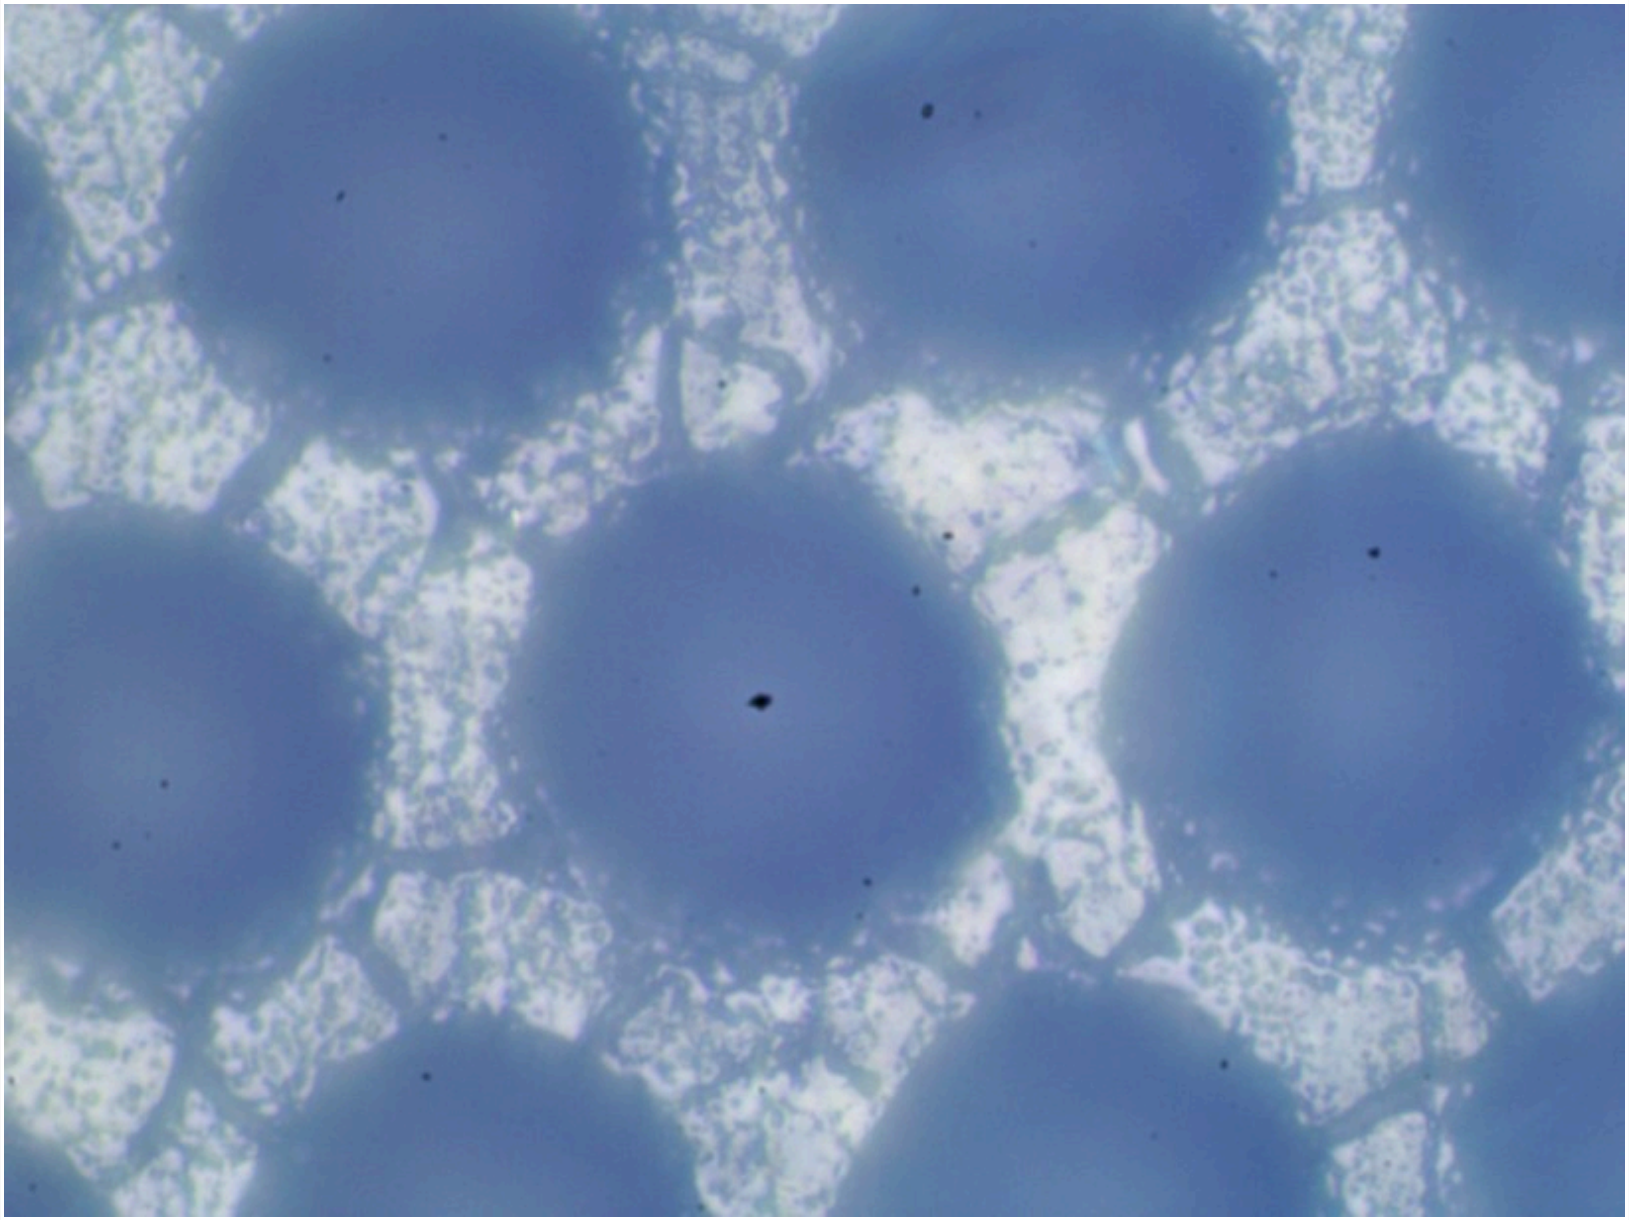
Page №51. Roll "z19012420". Length: 1320 mm. Photos with magnificaiton: x400. Cleaning passes: 1

Roll "z19012420".	Photo of the anilox roll surface

Comment
streak 94 356 dent 270 282 302 scratch 594 722.

Roll heavily ground off.
