RollerCheck360

Roll Inspection from 08.12.2025

Rolls: 178

We have analyzed for you 178 rolls.

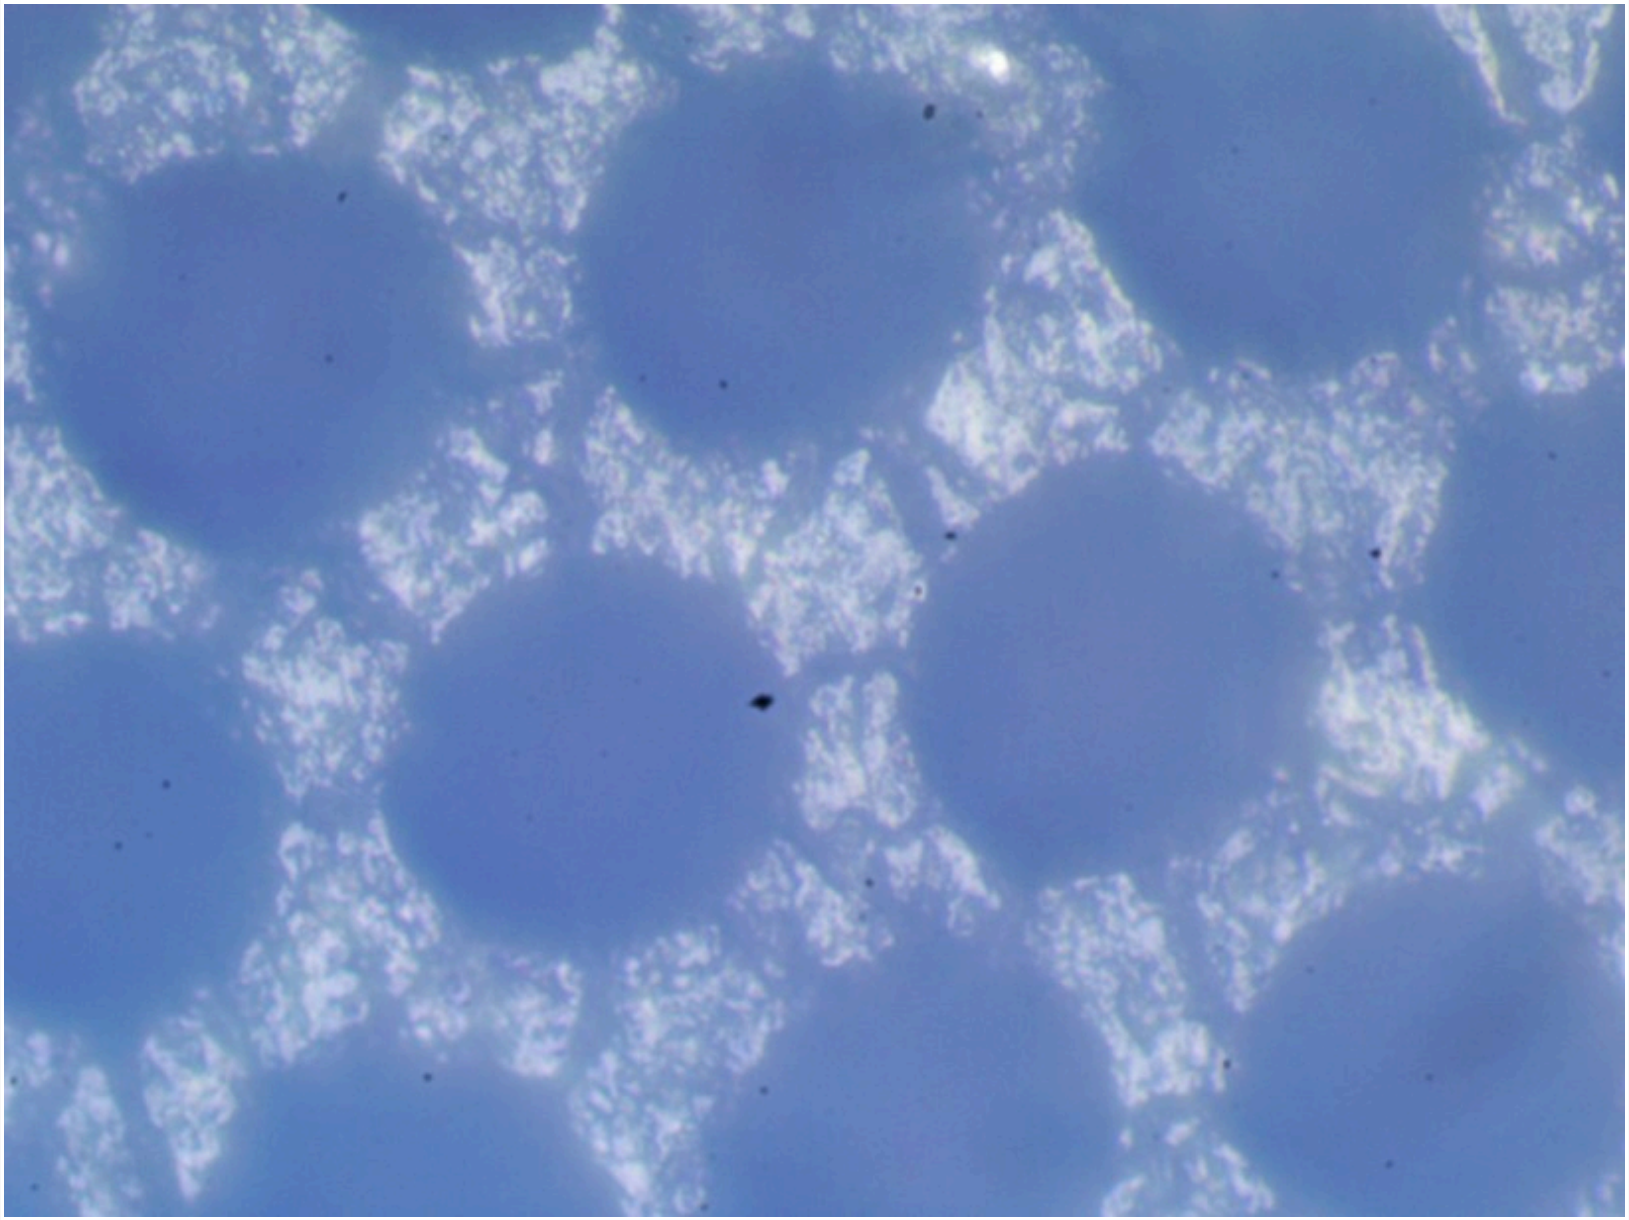
Page №52. Roll "h100479-3". Length: 1320 mm. Photos with magnificaiton: x400. Cleaning passes: 1

Roll "h100479-3".	Photo of the anilox roll surface

Bridge / Cell: 1 / 11
Depth before / after: 11 / 11 мкм
Depth decreased by: 0%

Comment
streak 1233 603.

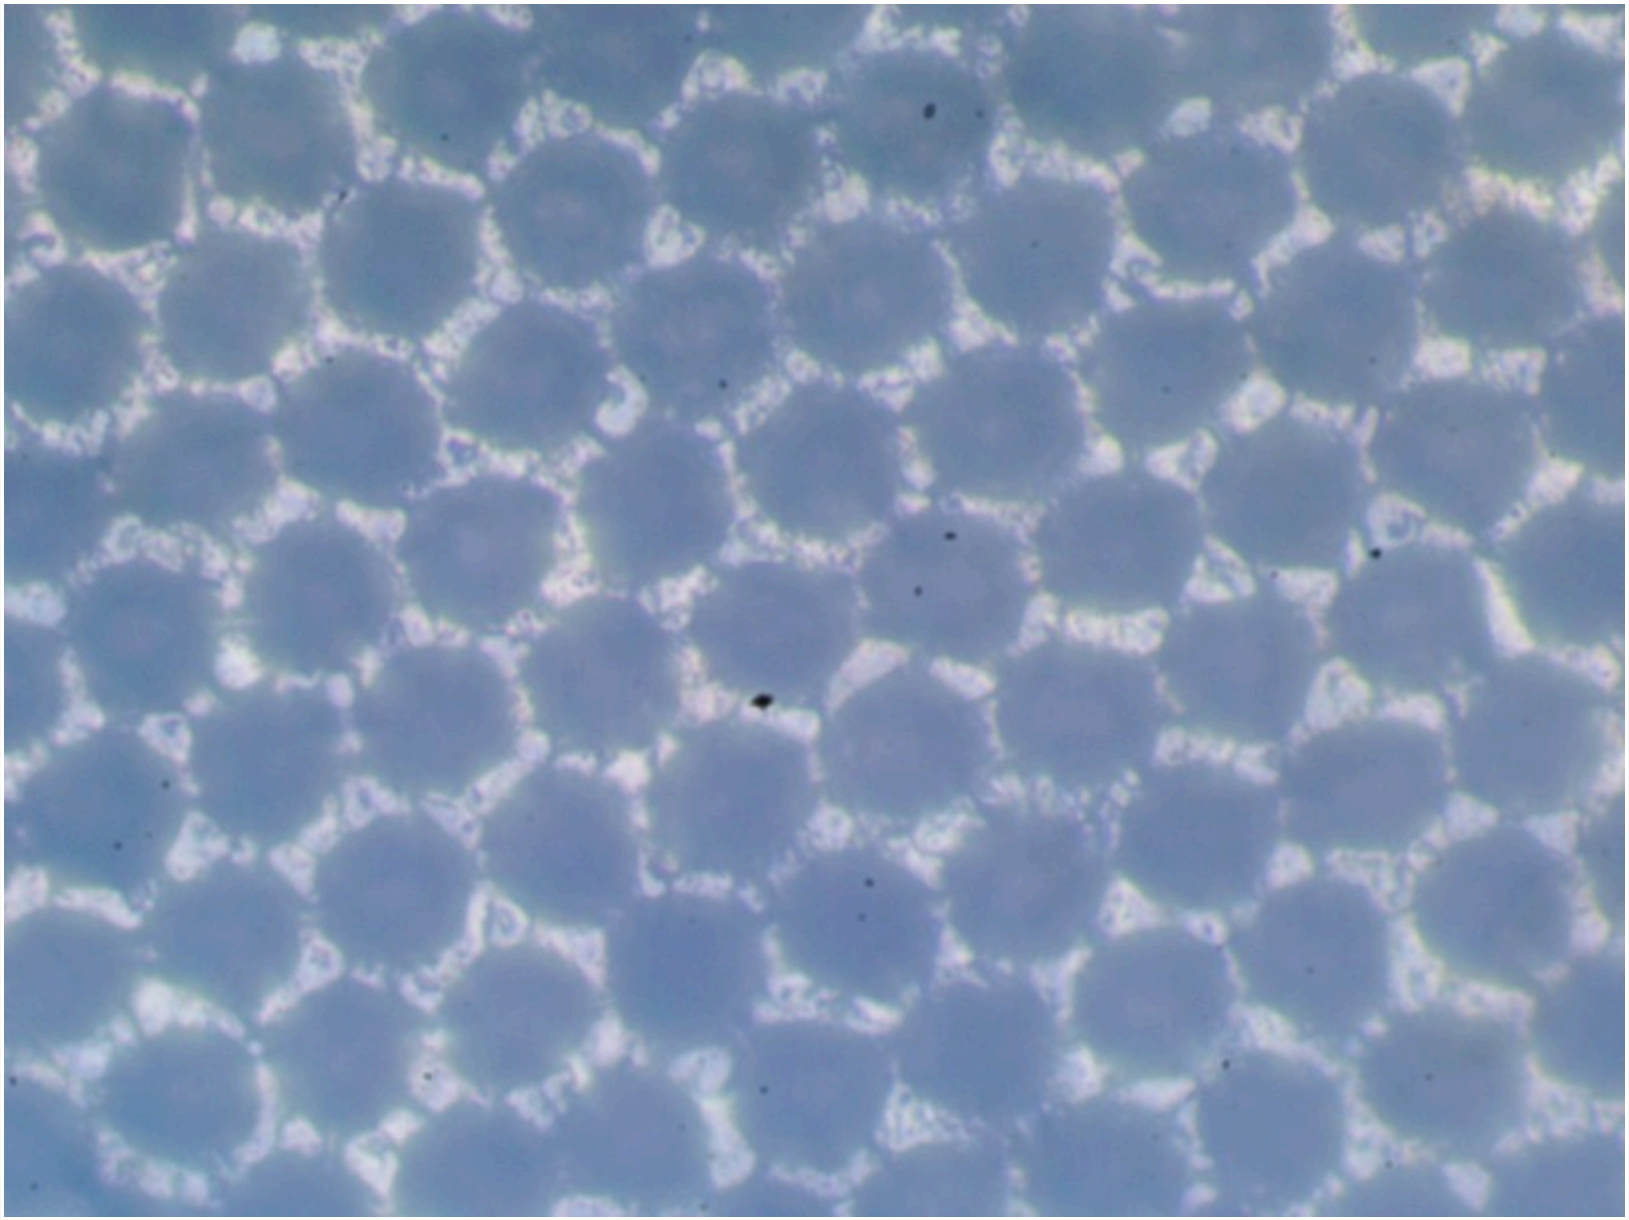
Page №53. Roll "sa008619". Length: 1320 mm. Photos with magnificaiton: x400. Cleaning passes: 1

Roll "sa008619".	Photo of the anilox roll surface

Bridge / Cell: 1 / 6
Depth before / after: 25 / 25 мкм
Depth decreased by: 0%

Comment
spot 60 70.
Roll ground off.

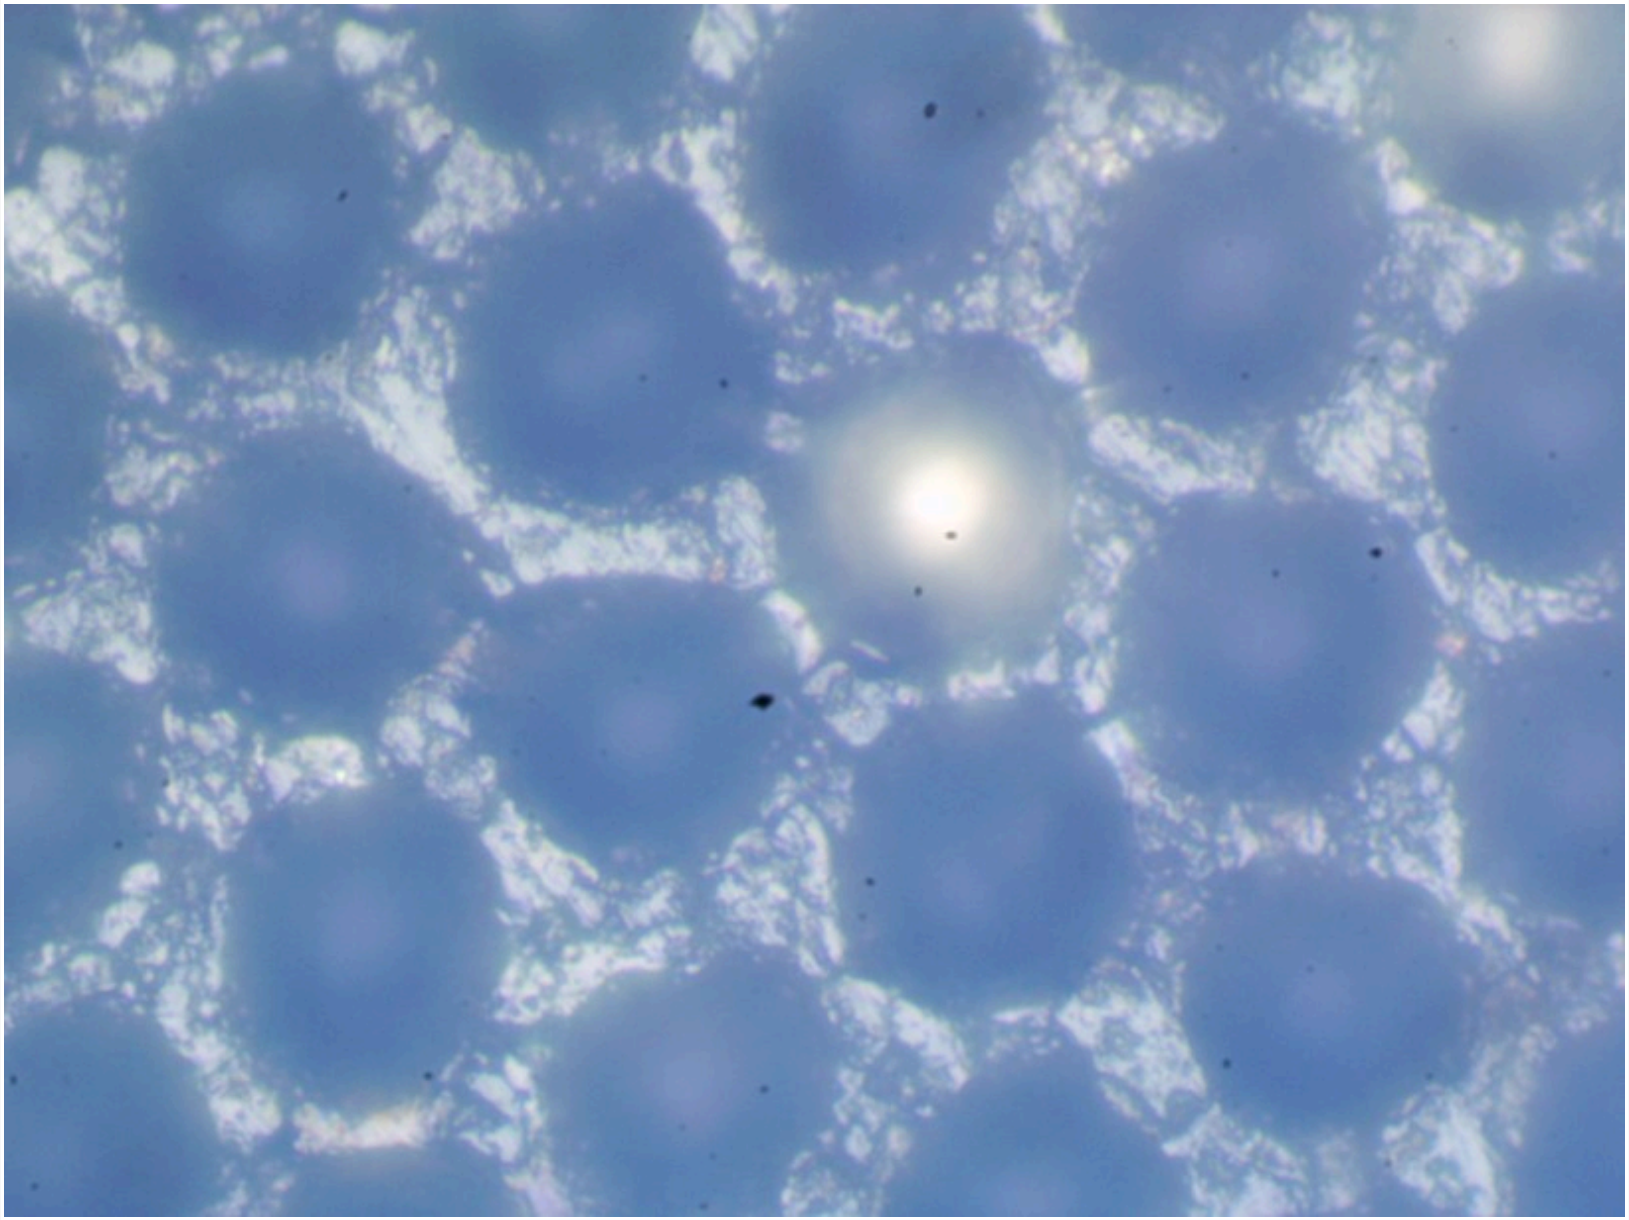
Page №54. Roll "z18008073". Length: 1320 mm. Photos with magnificaiton: x400. Cleaning passes: 1

Roll "z18008073".	Photo of the anilox roll surface

Ink transfer volume decrease from the passport value: 62.22%

Bridge / Cell: 1 / 2
Depth before / after: 18 / 18 мкм
Depth decreased by: 0%

Comment
mechanical wear chips 640 660 585 320 360 streak 320 885.

Roll heavily ground off.

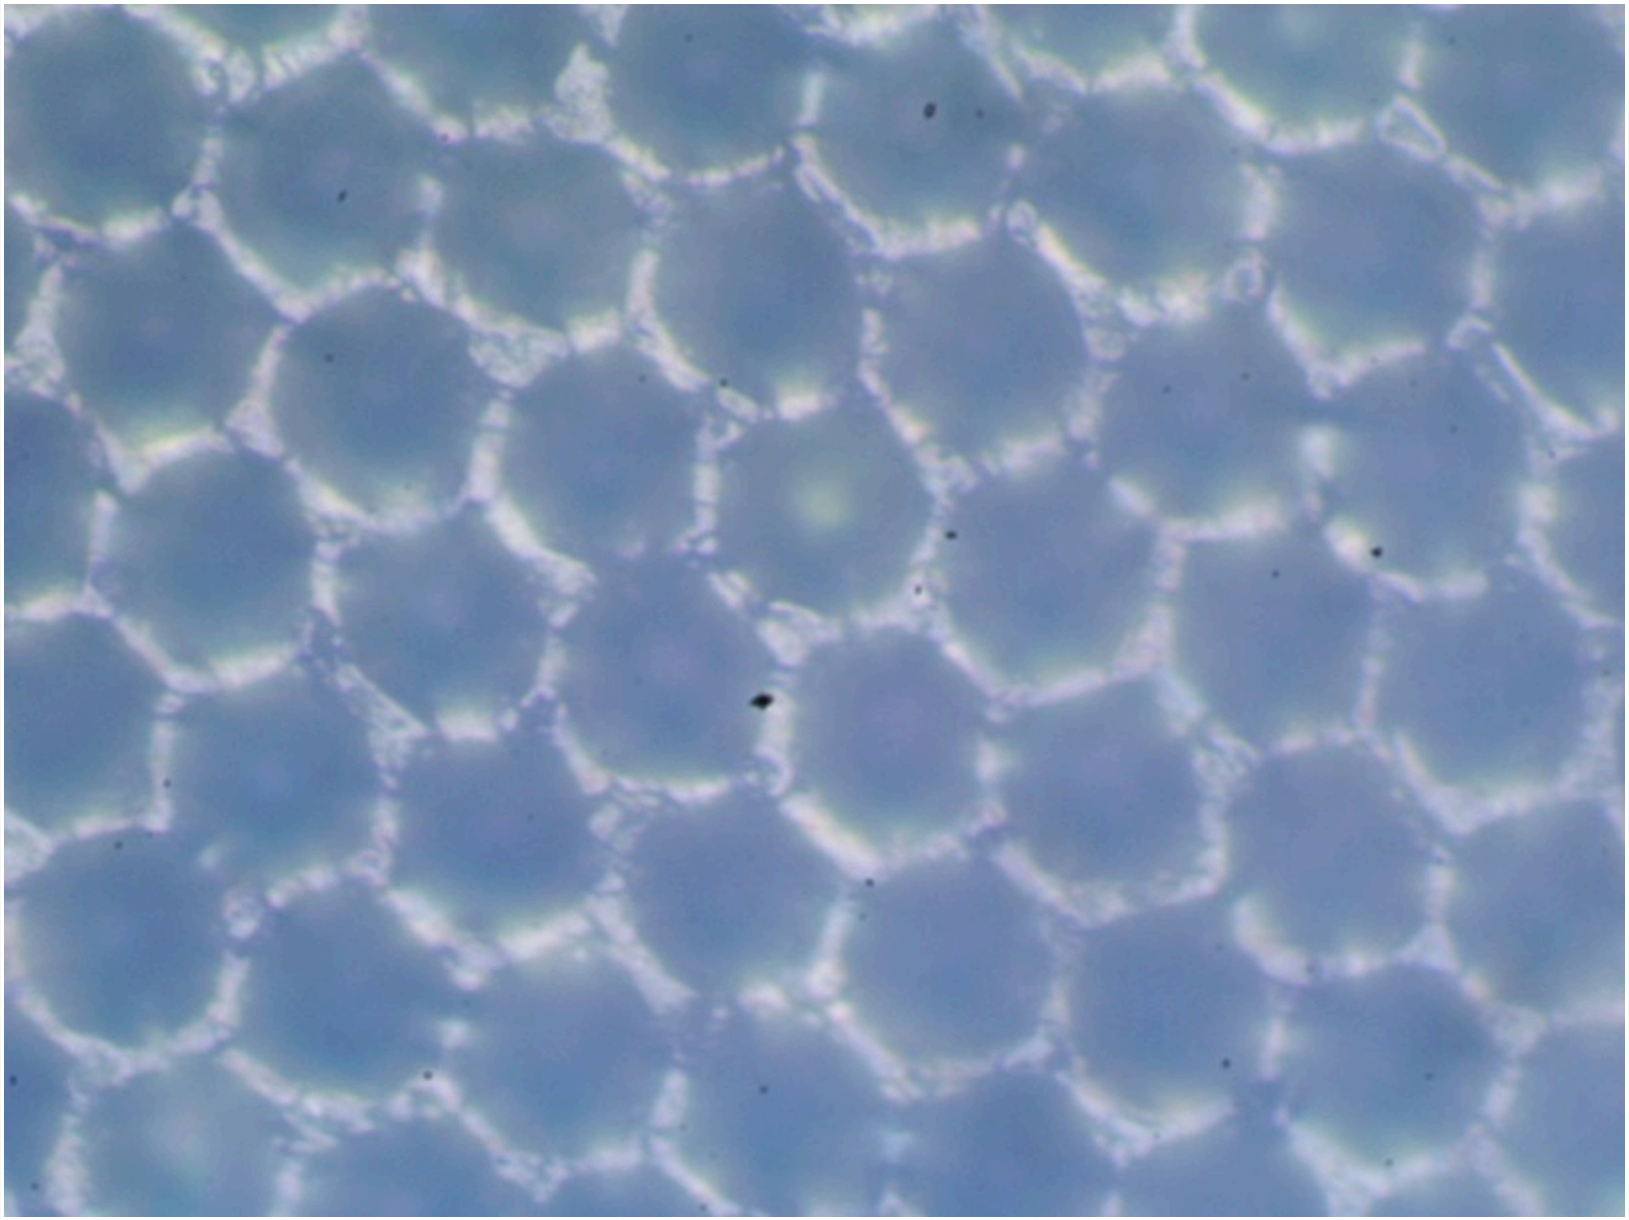
Page №56. Roll "h100749-4". Length: 1320 mm. Photos with magnificaiton: x400. Cleaning passes: 1

Roll "h100749-4".	Photo of the anilox roll surface

Bridge / Cell: 1 / 16
Depth before / after: 17 / 17 мкм
Depth decreased by: 0%

Comment
chip 890.

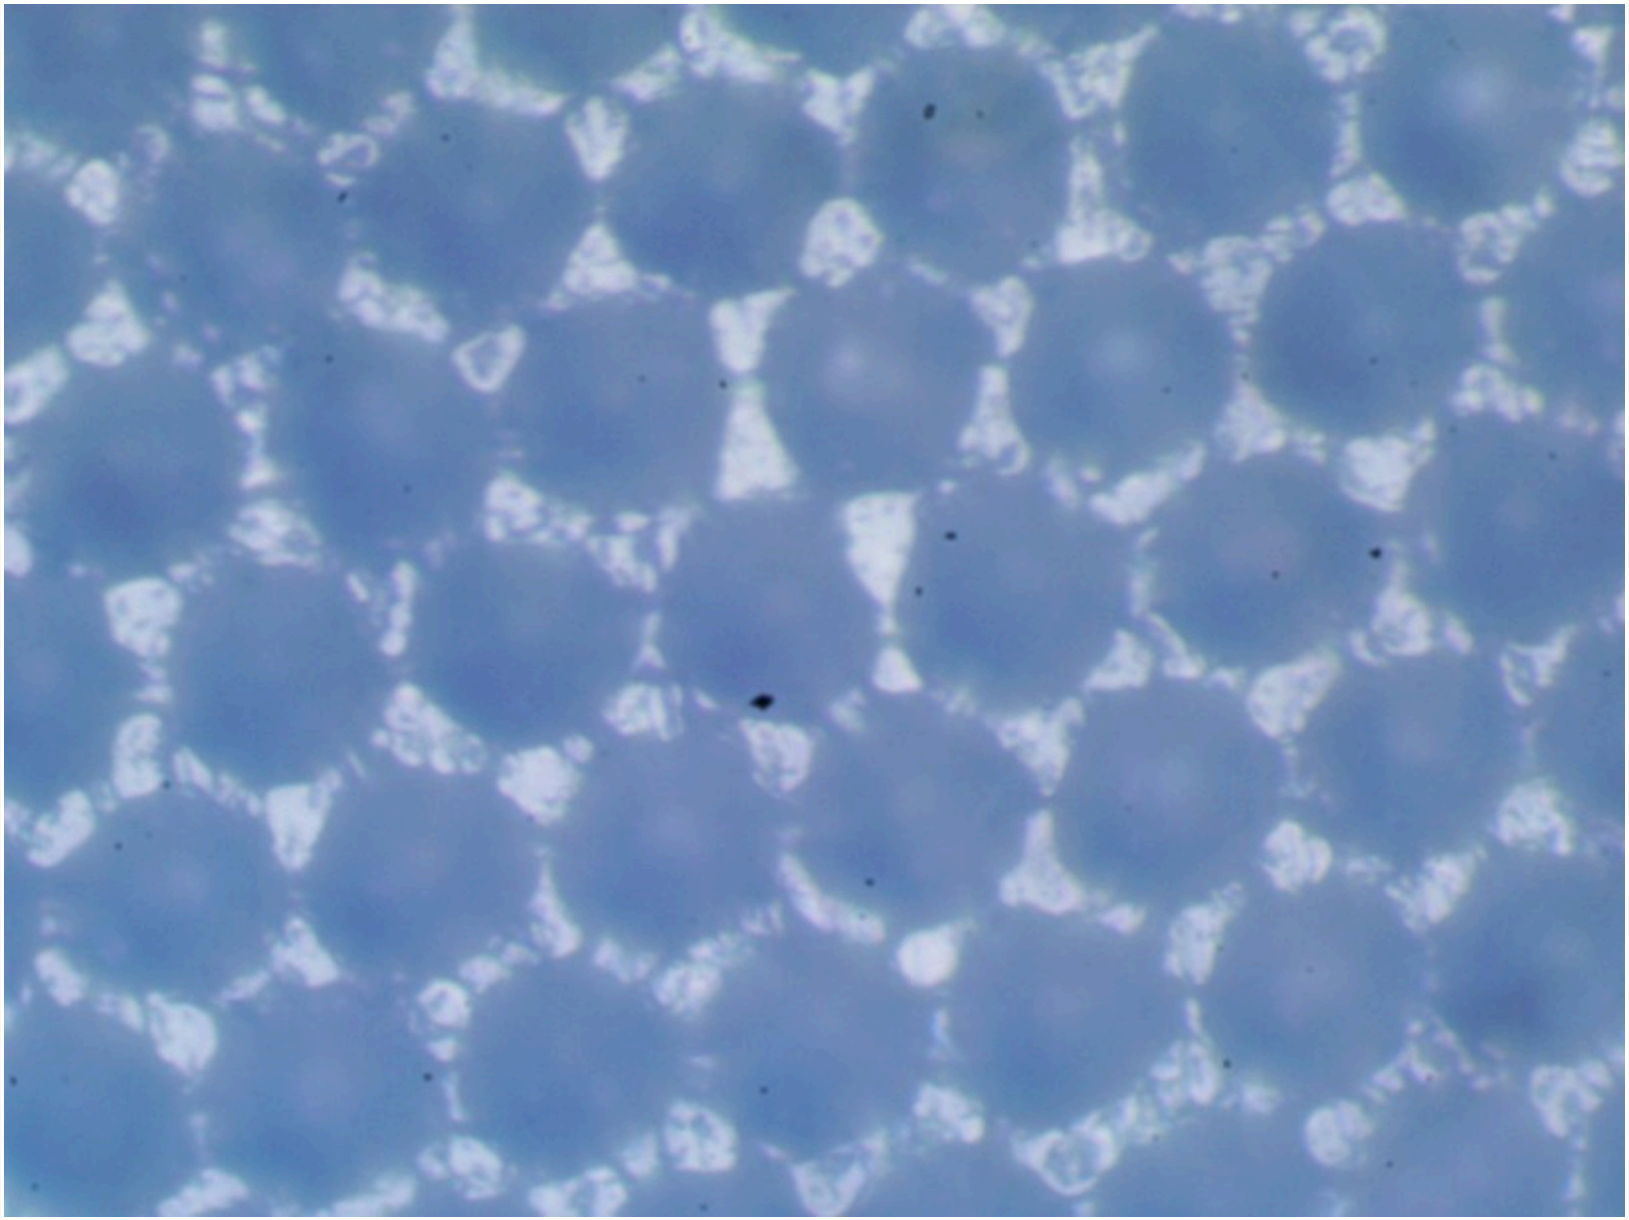
Page №57. Roll "sa008616". Length: 1320 mm. Photos with magnificaiton: x400. Cleaning passes: 1

Roll "sa008616".	Photo of the anilox roll surface

Bridge / Cell: 1 / 2
Depth before / after: 36 / 36 мкм
Depth decreased by: 0%

Comment
worn streaks scratch 220.
Roll heavily ground off.

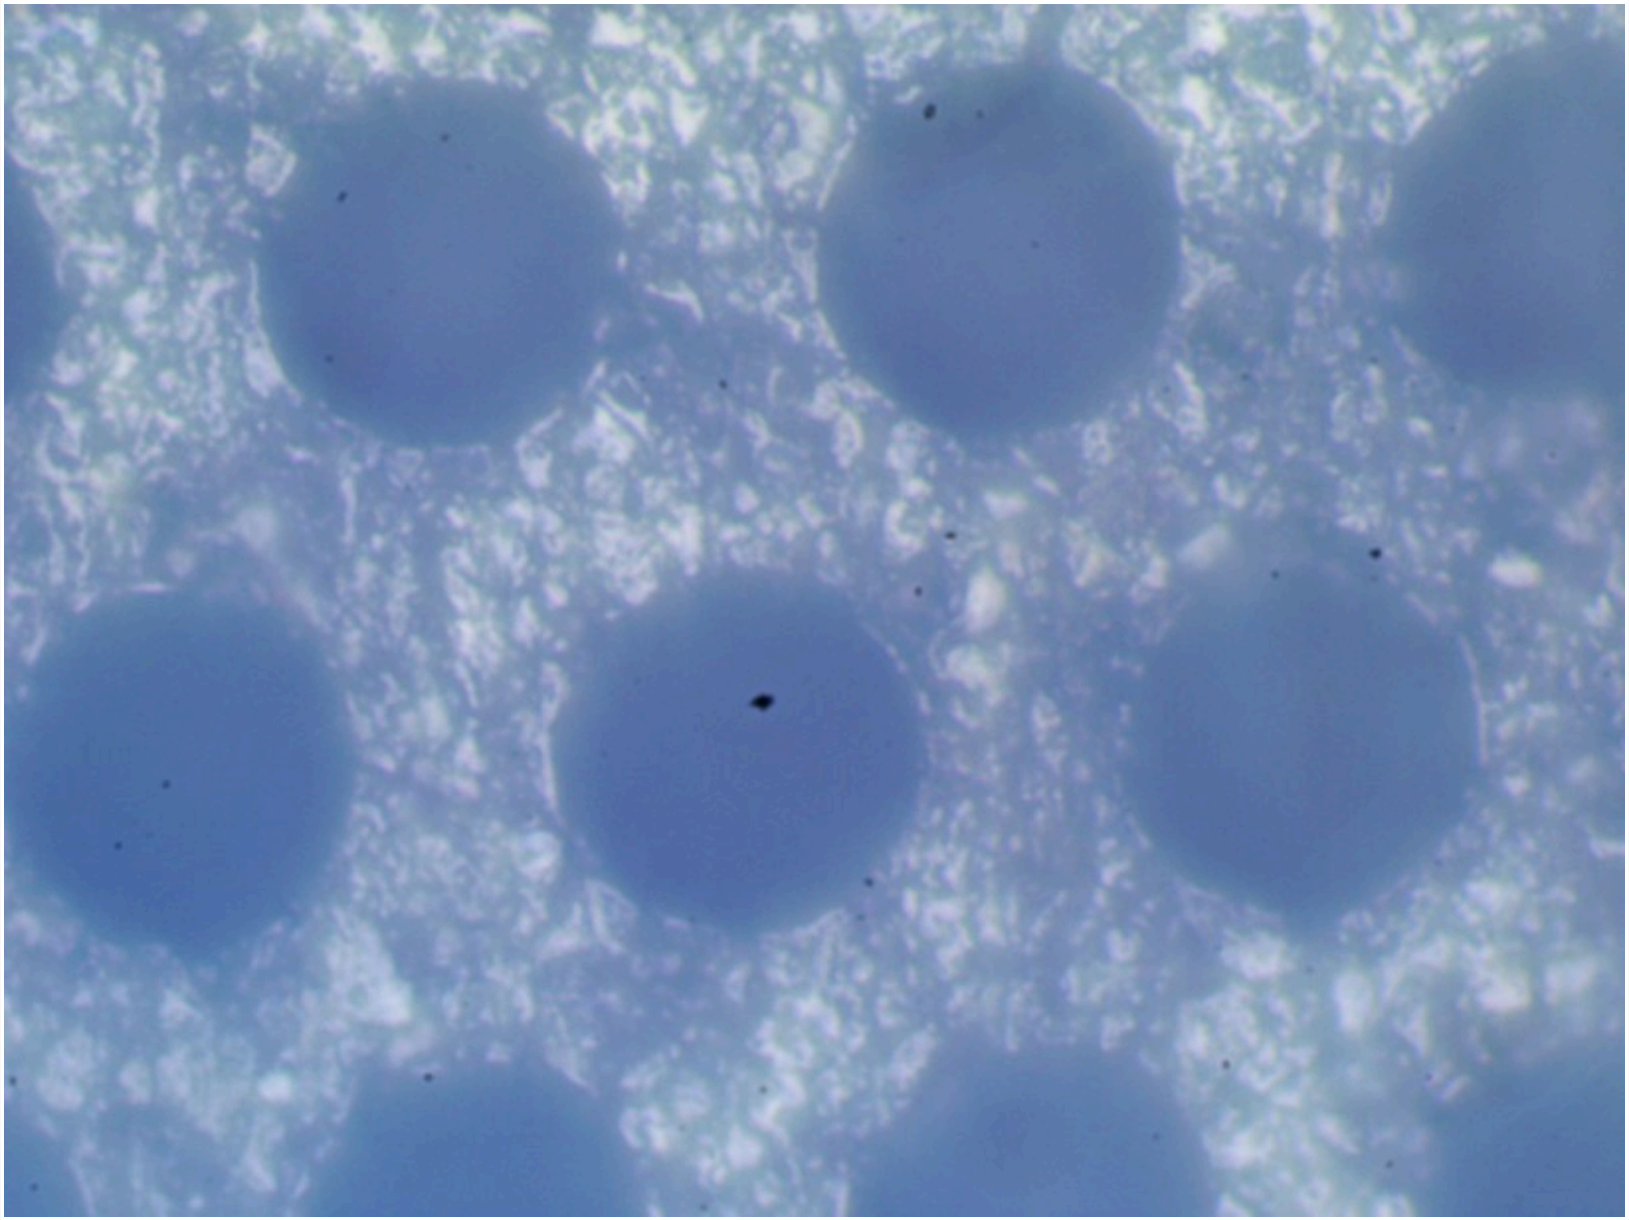
Page №58. Roll "s2401739". Length: 1320 mm. Photos with magnificaiton: x400. Cleaning passes: 1

Roll "s2401739".	Photo of the anilox roll surface

Bridge / Cell: 1 / 14
Depth before / after: 11 / 11 мкм
Depth decreased by: 0%

Comment
streak 30 1210 dent 1125.

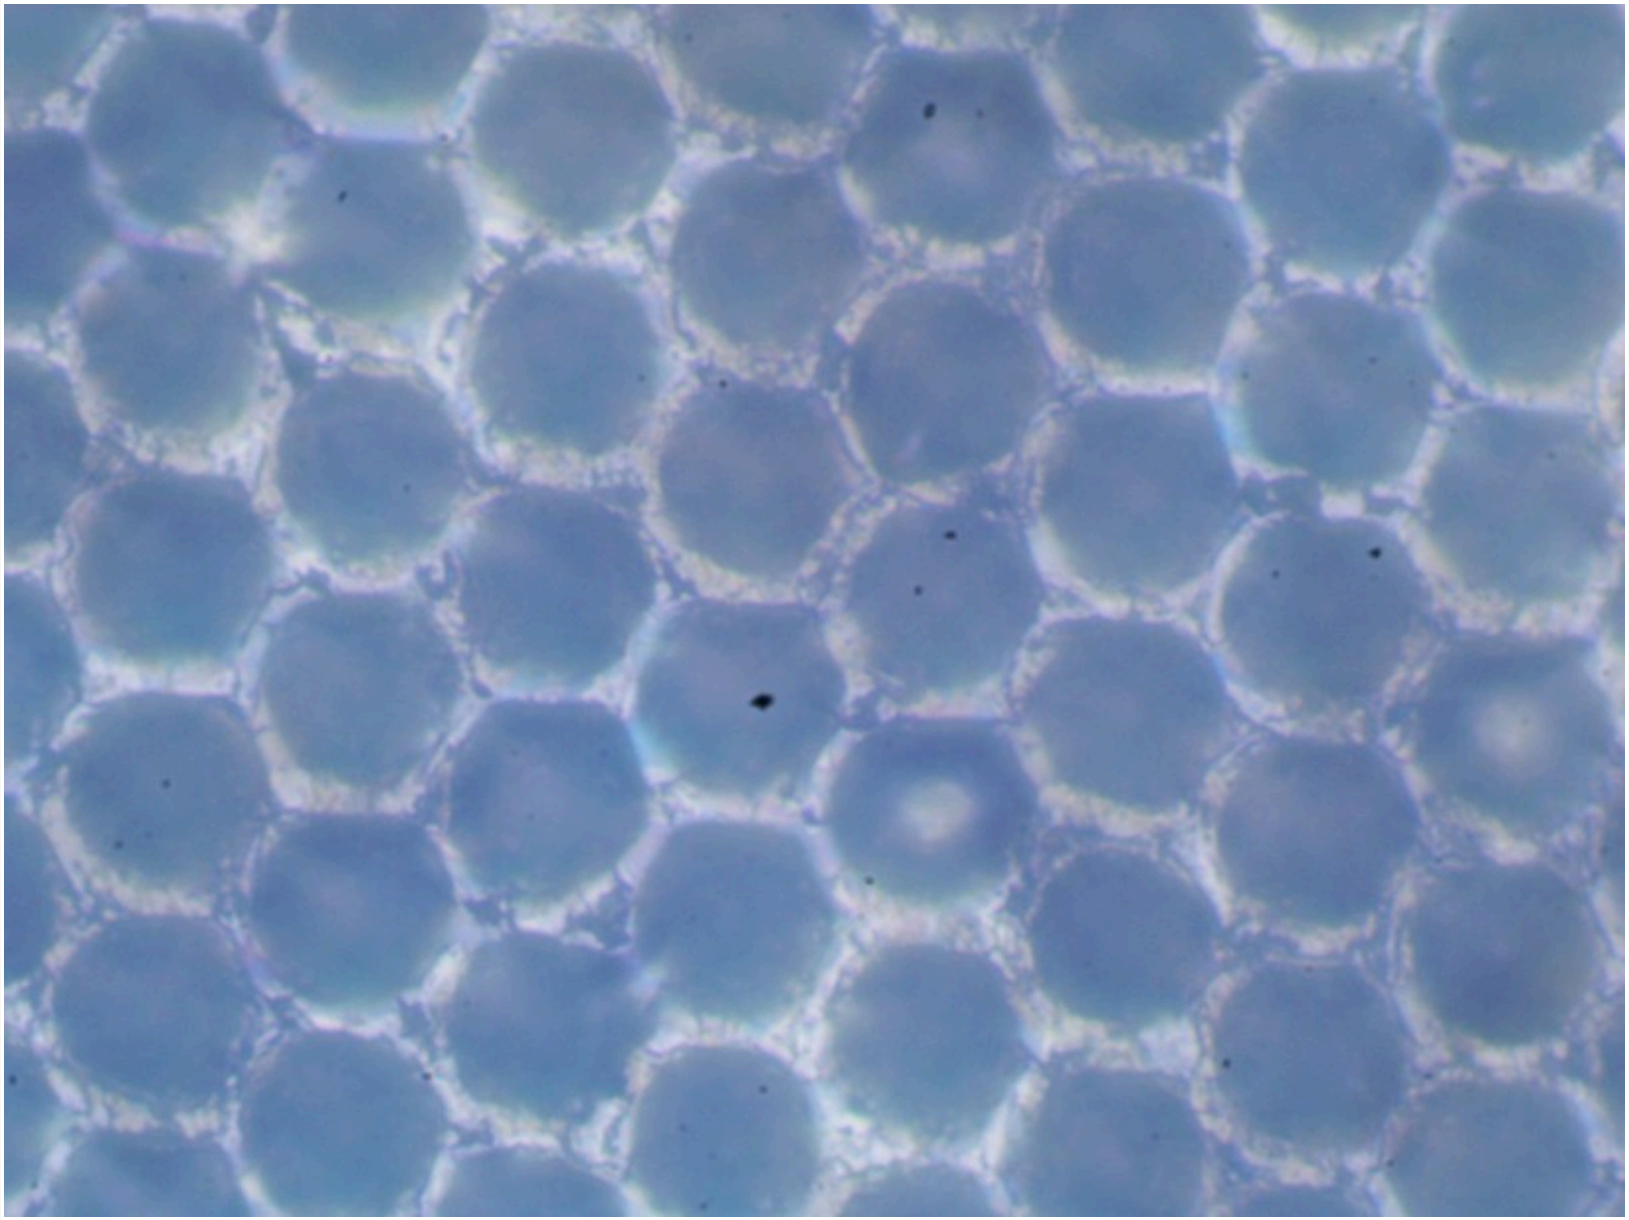
Page №59. Roll "aa2413647". Length: 1320 mm. Photos with magnificaiton: x400. Cleaning passes: 1

Roll "aa2413647".	Photo of the anilox roll surface

Bridge / Cell: 1 / 18
Depth before / after: 26 / 26 мкм
Depth decreased by: 0%

Comment
streaks streak 30.

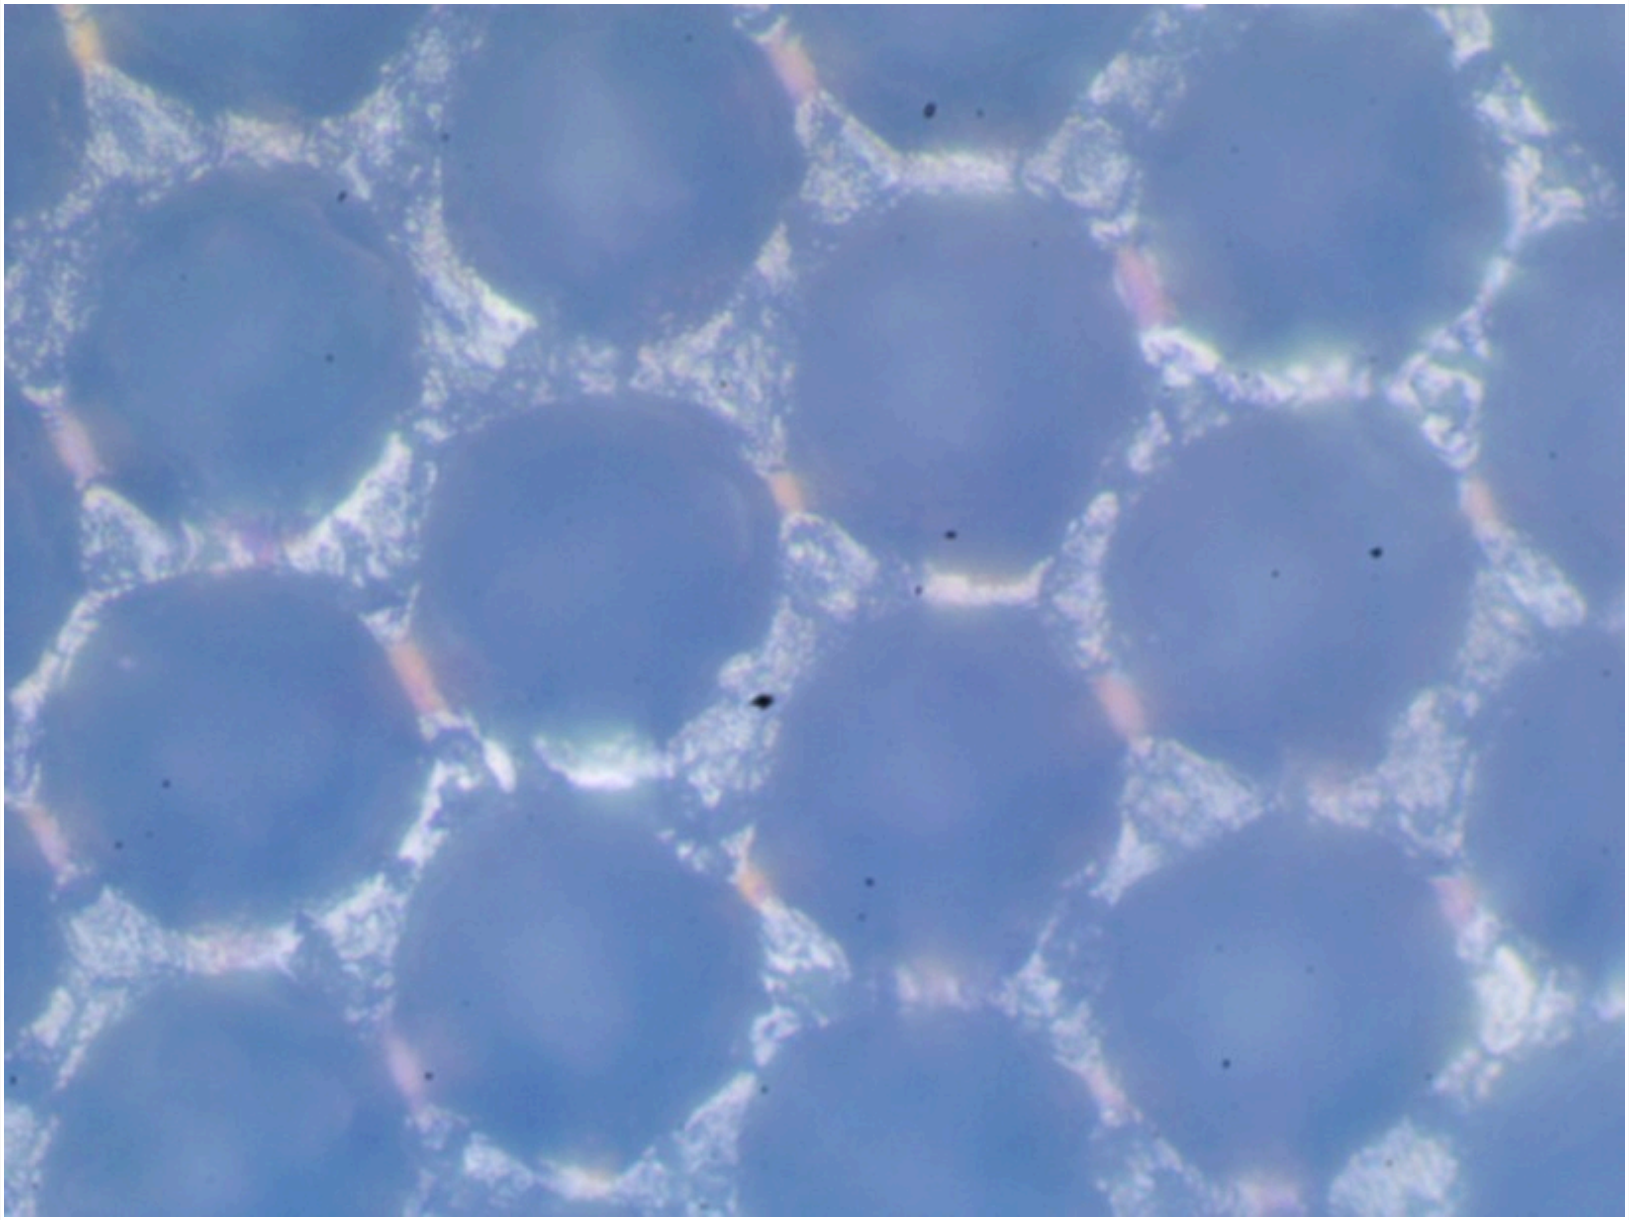
Page №60. Roll "z18008078". Length: 1320 mm. Photos with magnificaiton: x400. Cleaning passes: 1

Roll "z18008078".	Photo of the anilox roll surface

Comment
mechanical damage 80 scratch 1310 dent 270 300 streak 340 spot 150.

Roll heavily ground off.

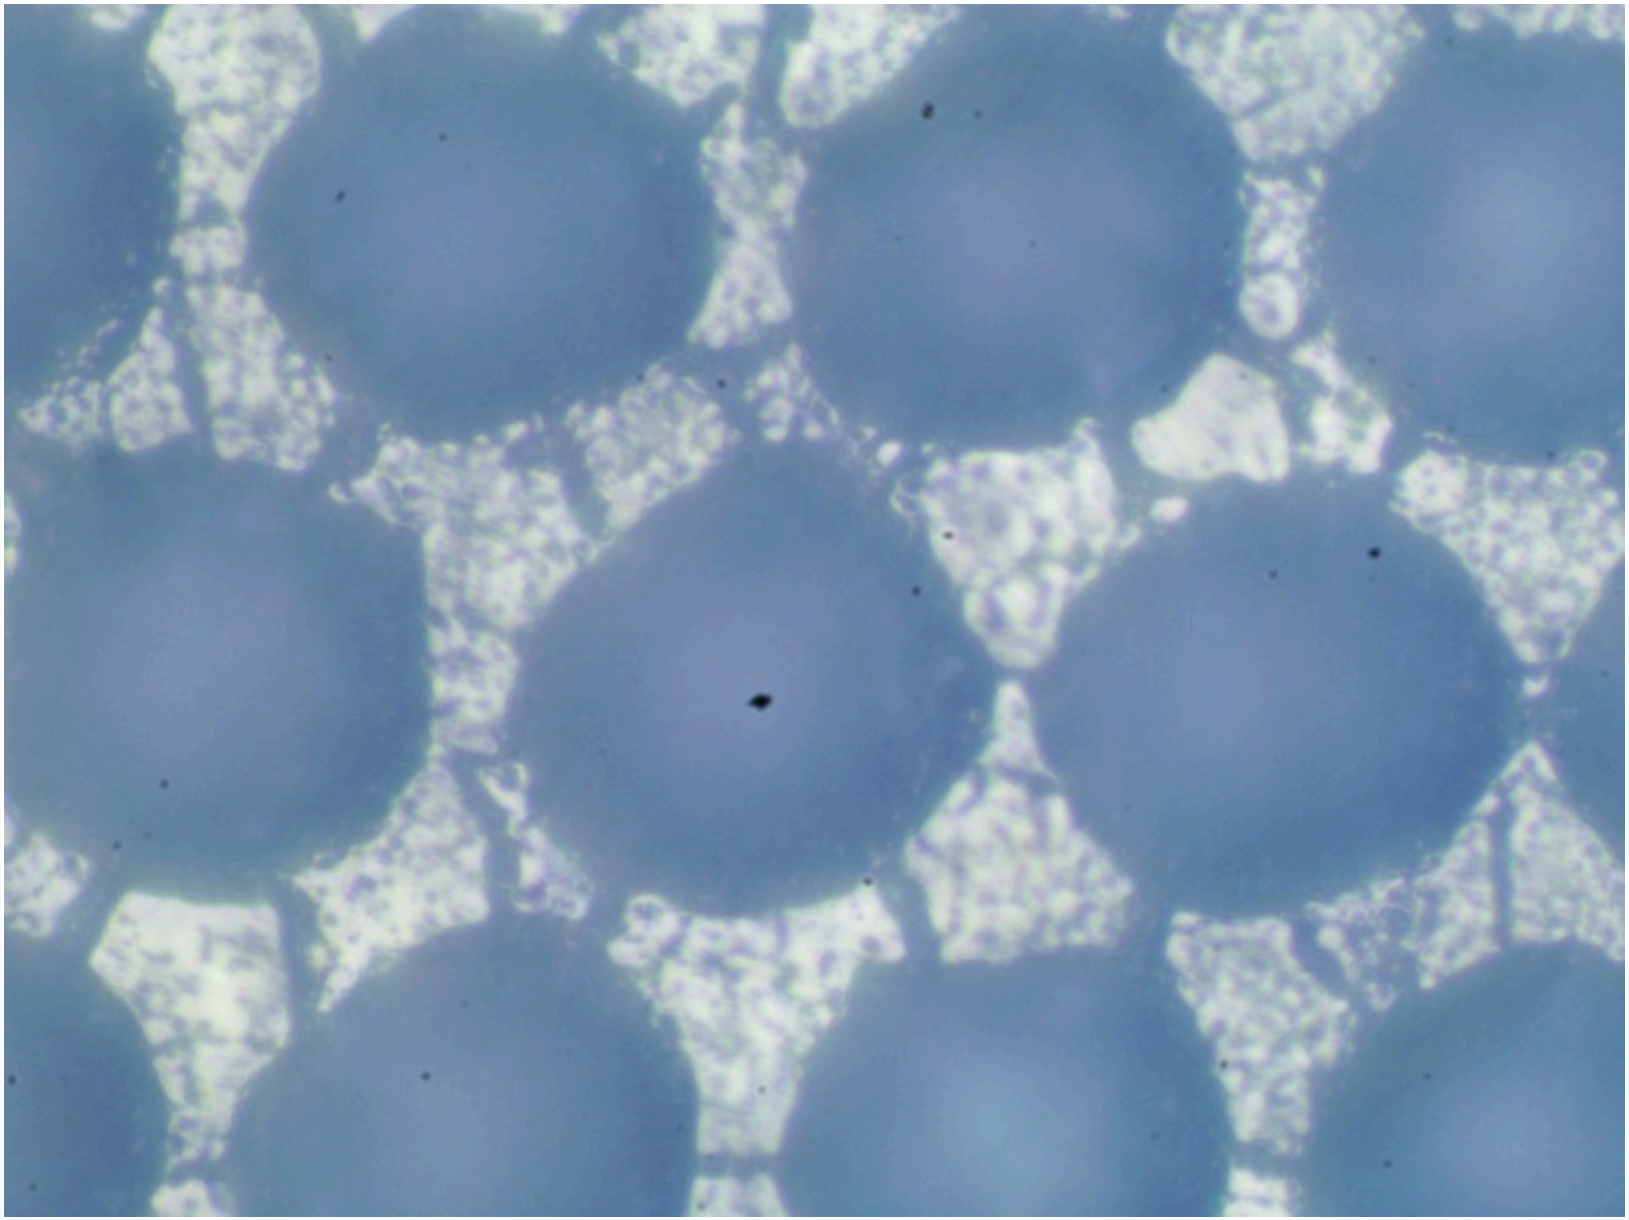
Page №62. Roll "h100479-5". Length: 1320 mm. Photos with magnificaiton: x400. Cleaning passes: 1

Ink transfer volume decrease from the passport value: 10%

Bridge / Cell: 1 / 11
Depth before / after: 11 / 11 мкм
Depth decreased by: 0%

Comment
dent 740 1000 1160 1250 fine streaks.

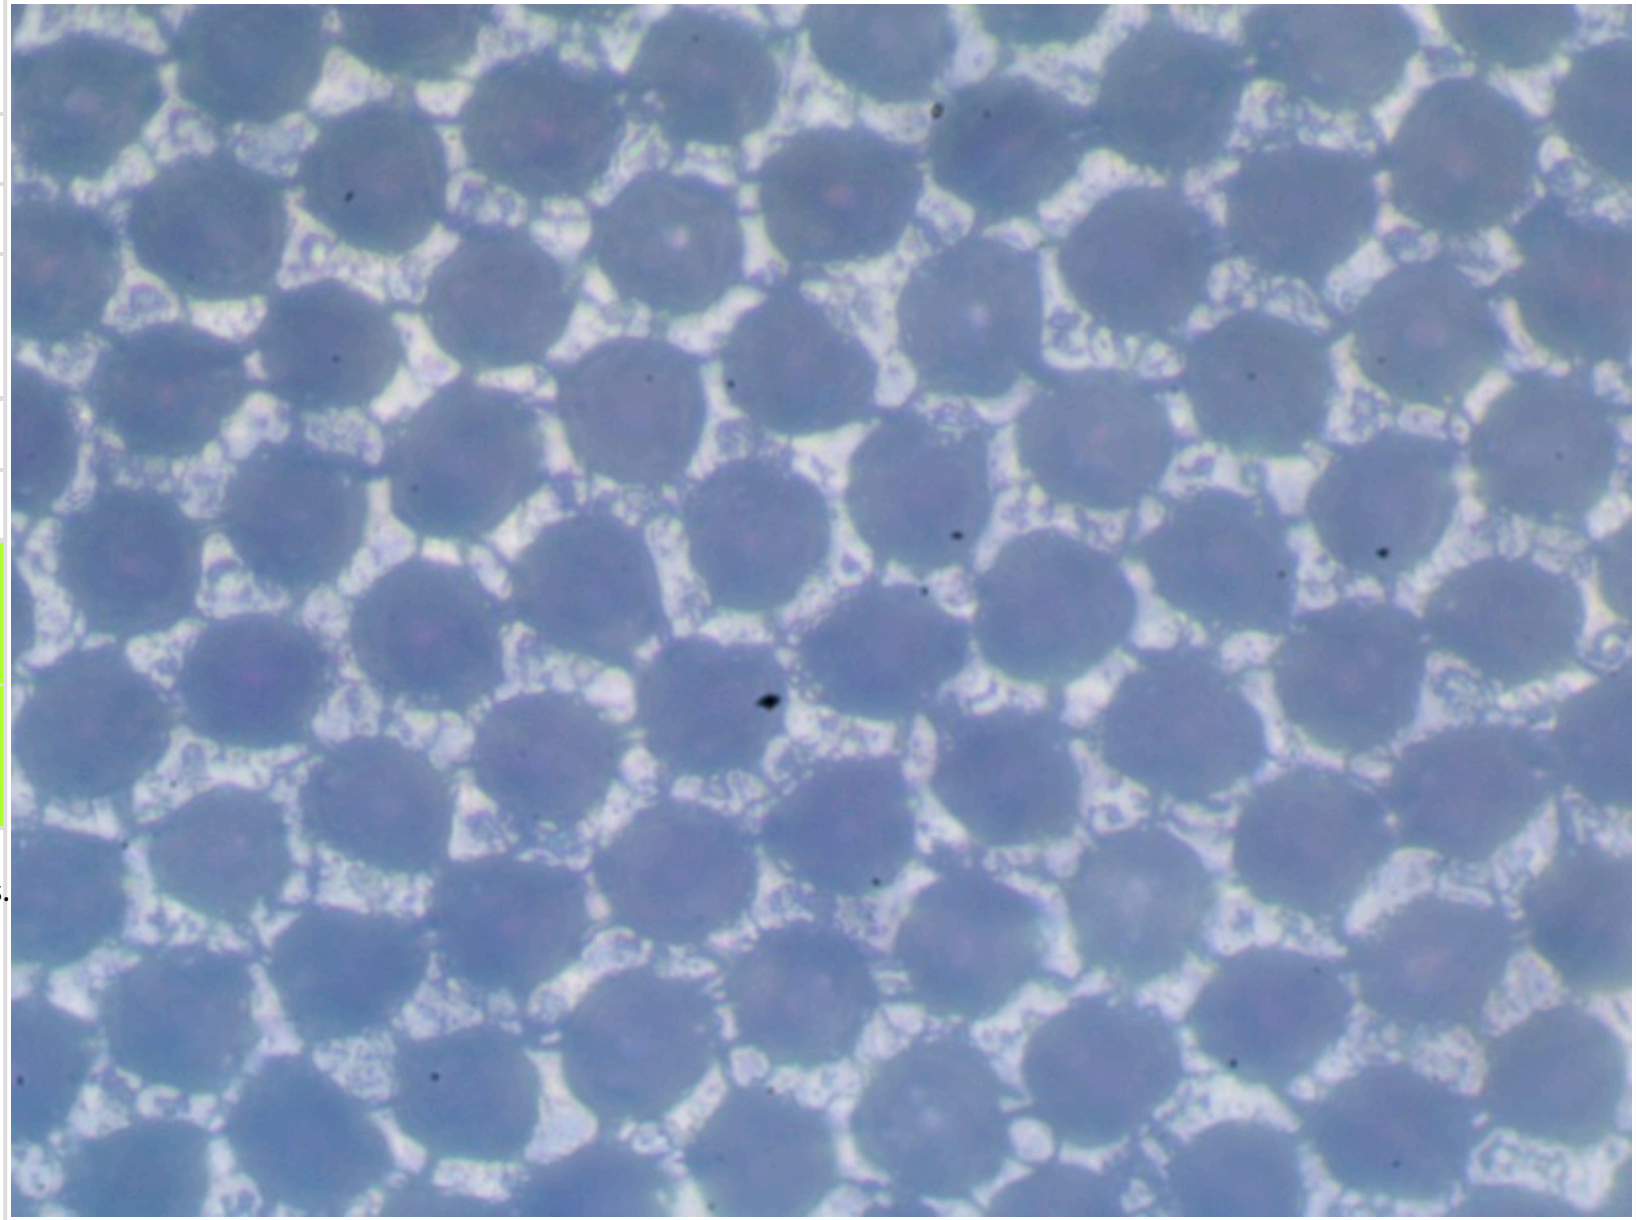
Page №63. Roll "sd007092". Length: 1320 mm. Photos with magnificaiton: x400. Cleaning passes: 1

Ink transfer volume decrease from the passport value: 5.26%

Comment
streak 687 590 118 900.

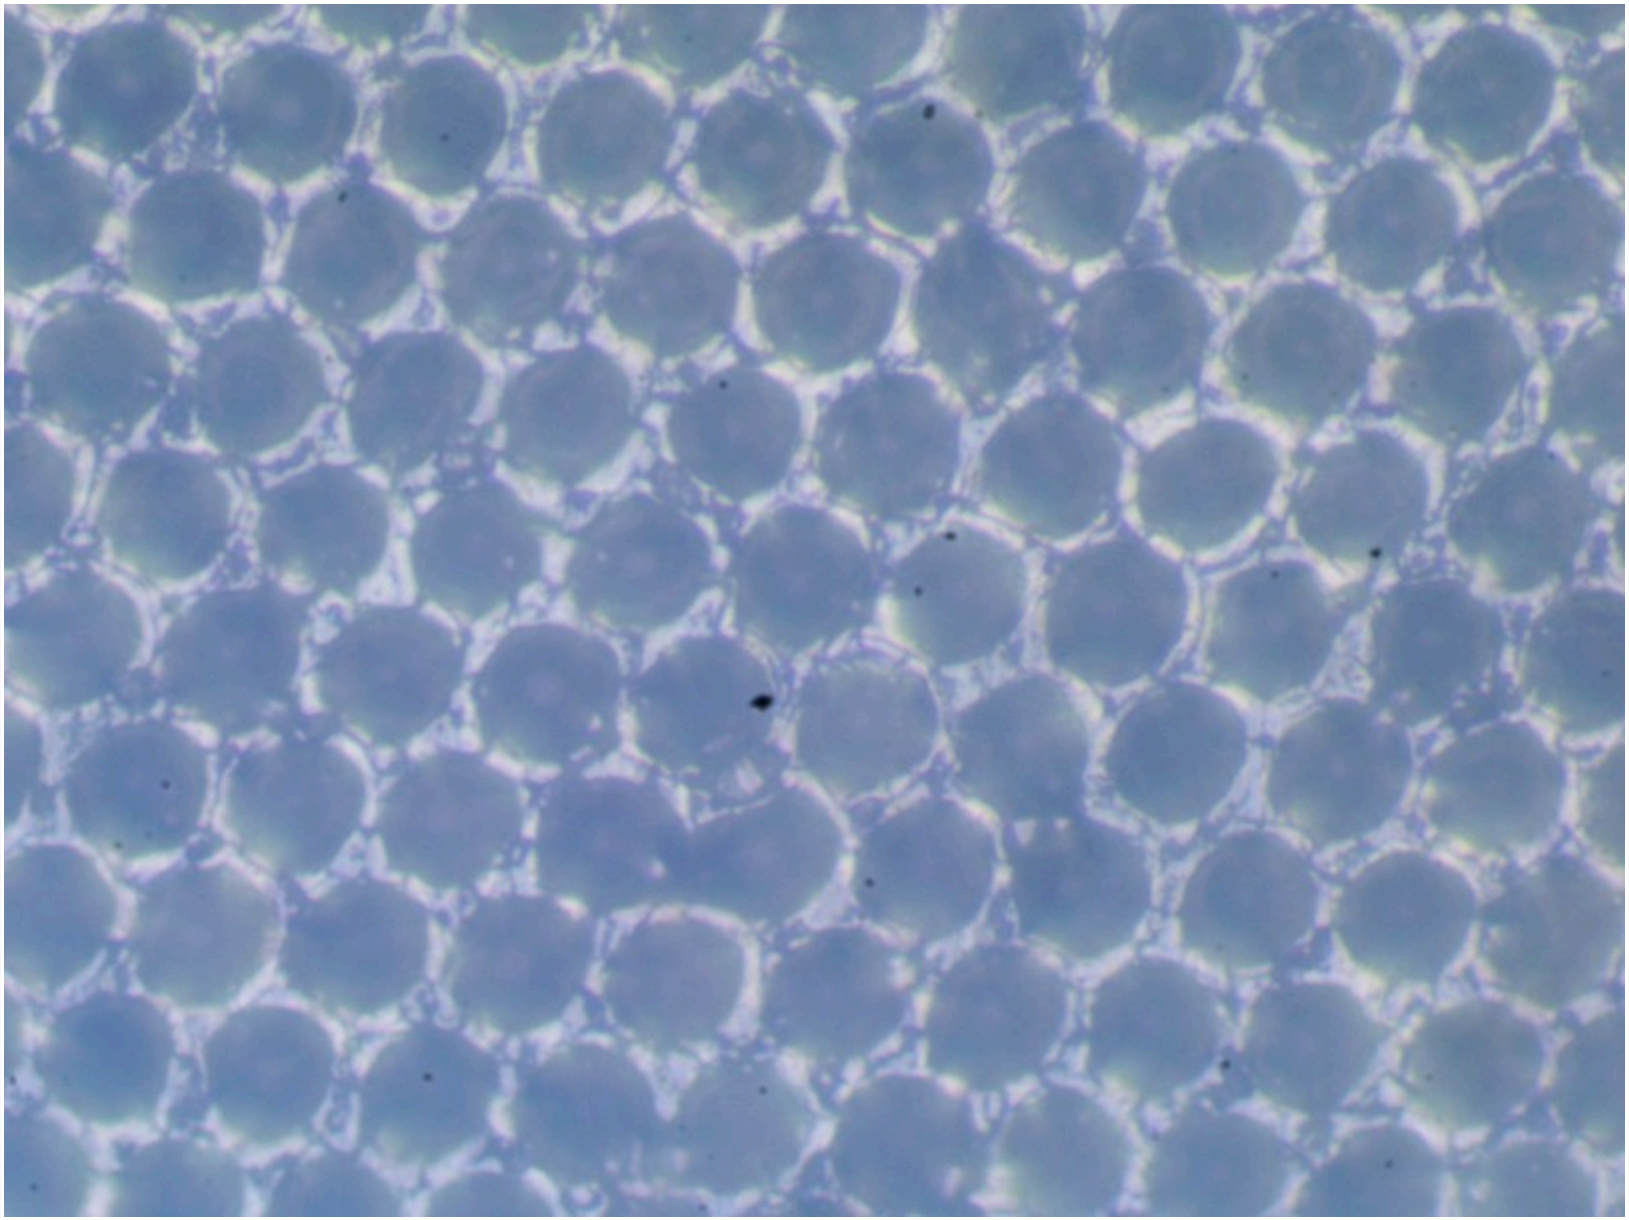
Page №64. Roll "h100479-6". Length: 1320 mm. Photos with magnificaiton: x400. Cleaning passes: 1

Ink transfer volume decrease from the passport value: 27.5%

Bridge / Cell: 1 / 5
Depth before / after: 11 / 11 мкм
Depth decreased by: 0%
