RollerCheck360

Roll Inspection from 08.12.2025

Rolls: 178

We have analyzed for you 178 rolls.

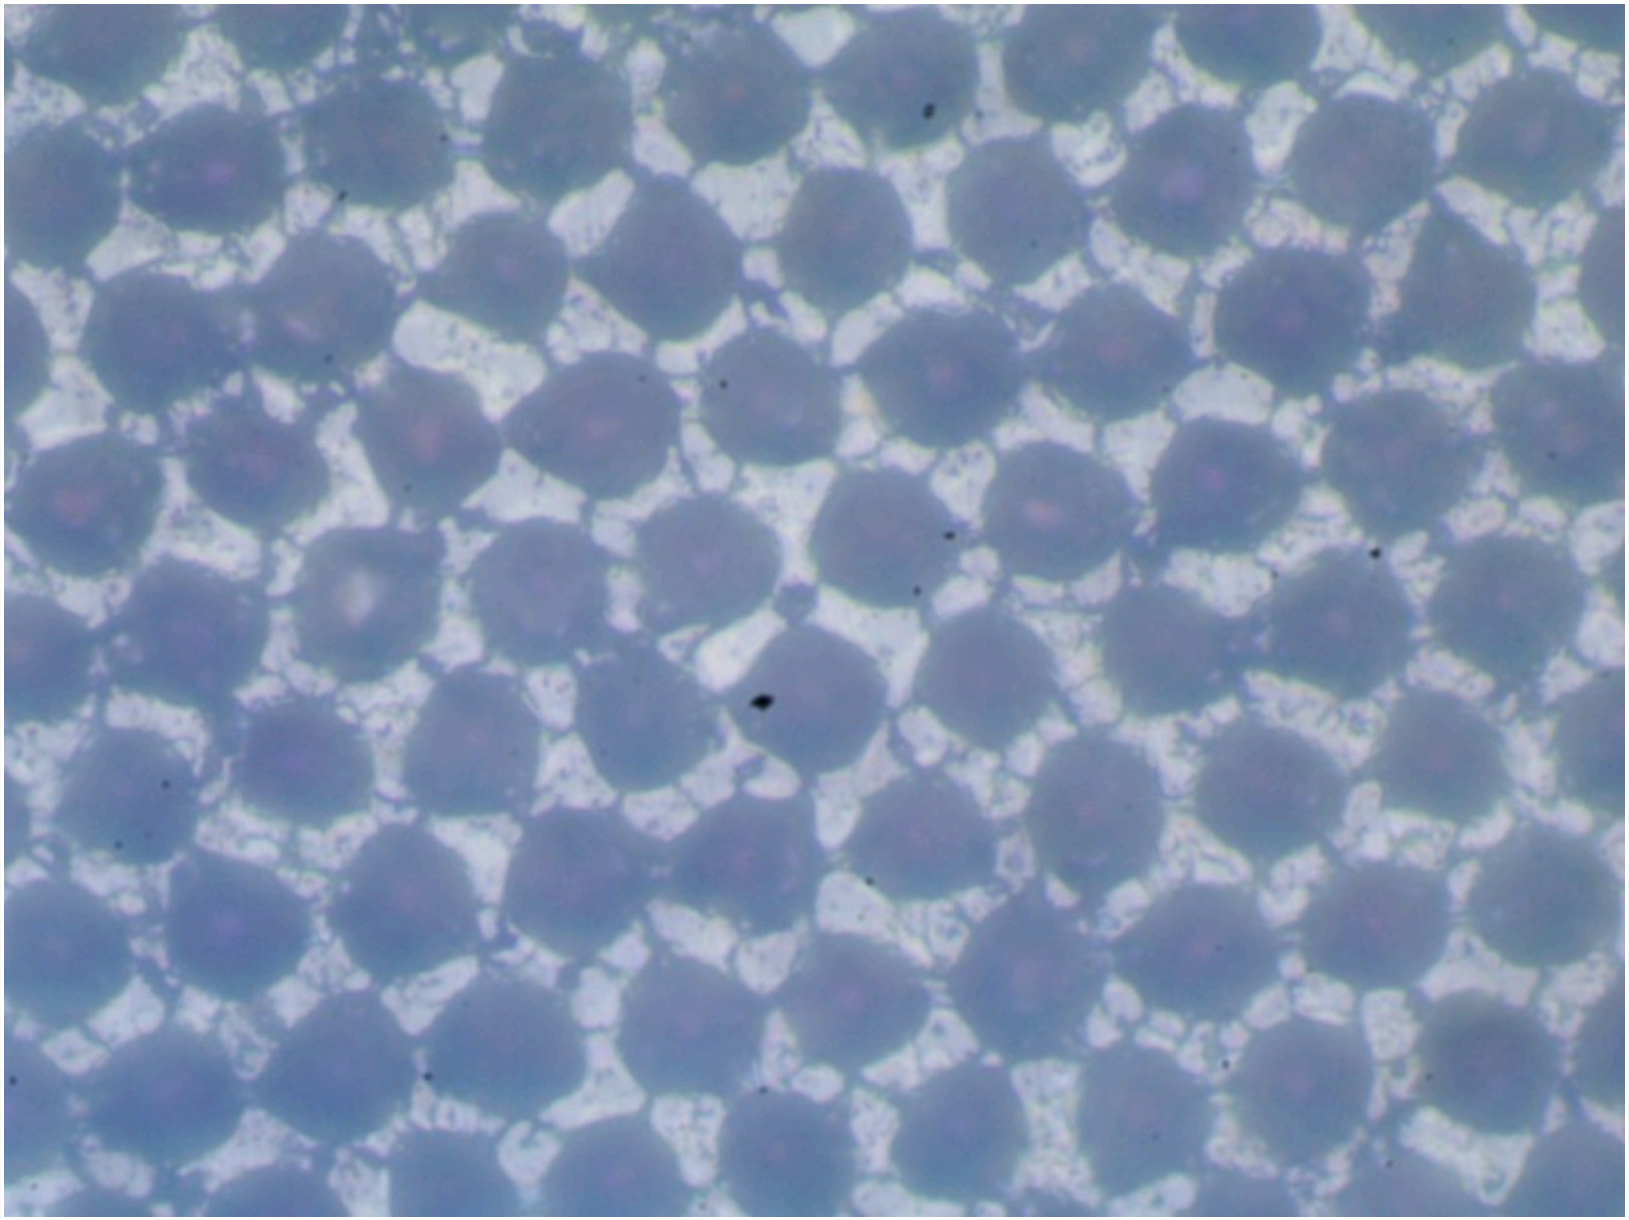
Page №65. Roll "s2401742". Length: 1320 mm. Photos with magnificaiton: x400. Cleaning passes: 1

Ink transfer volume decrease from the passport value: 10.77%

Comment
streak 270.

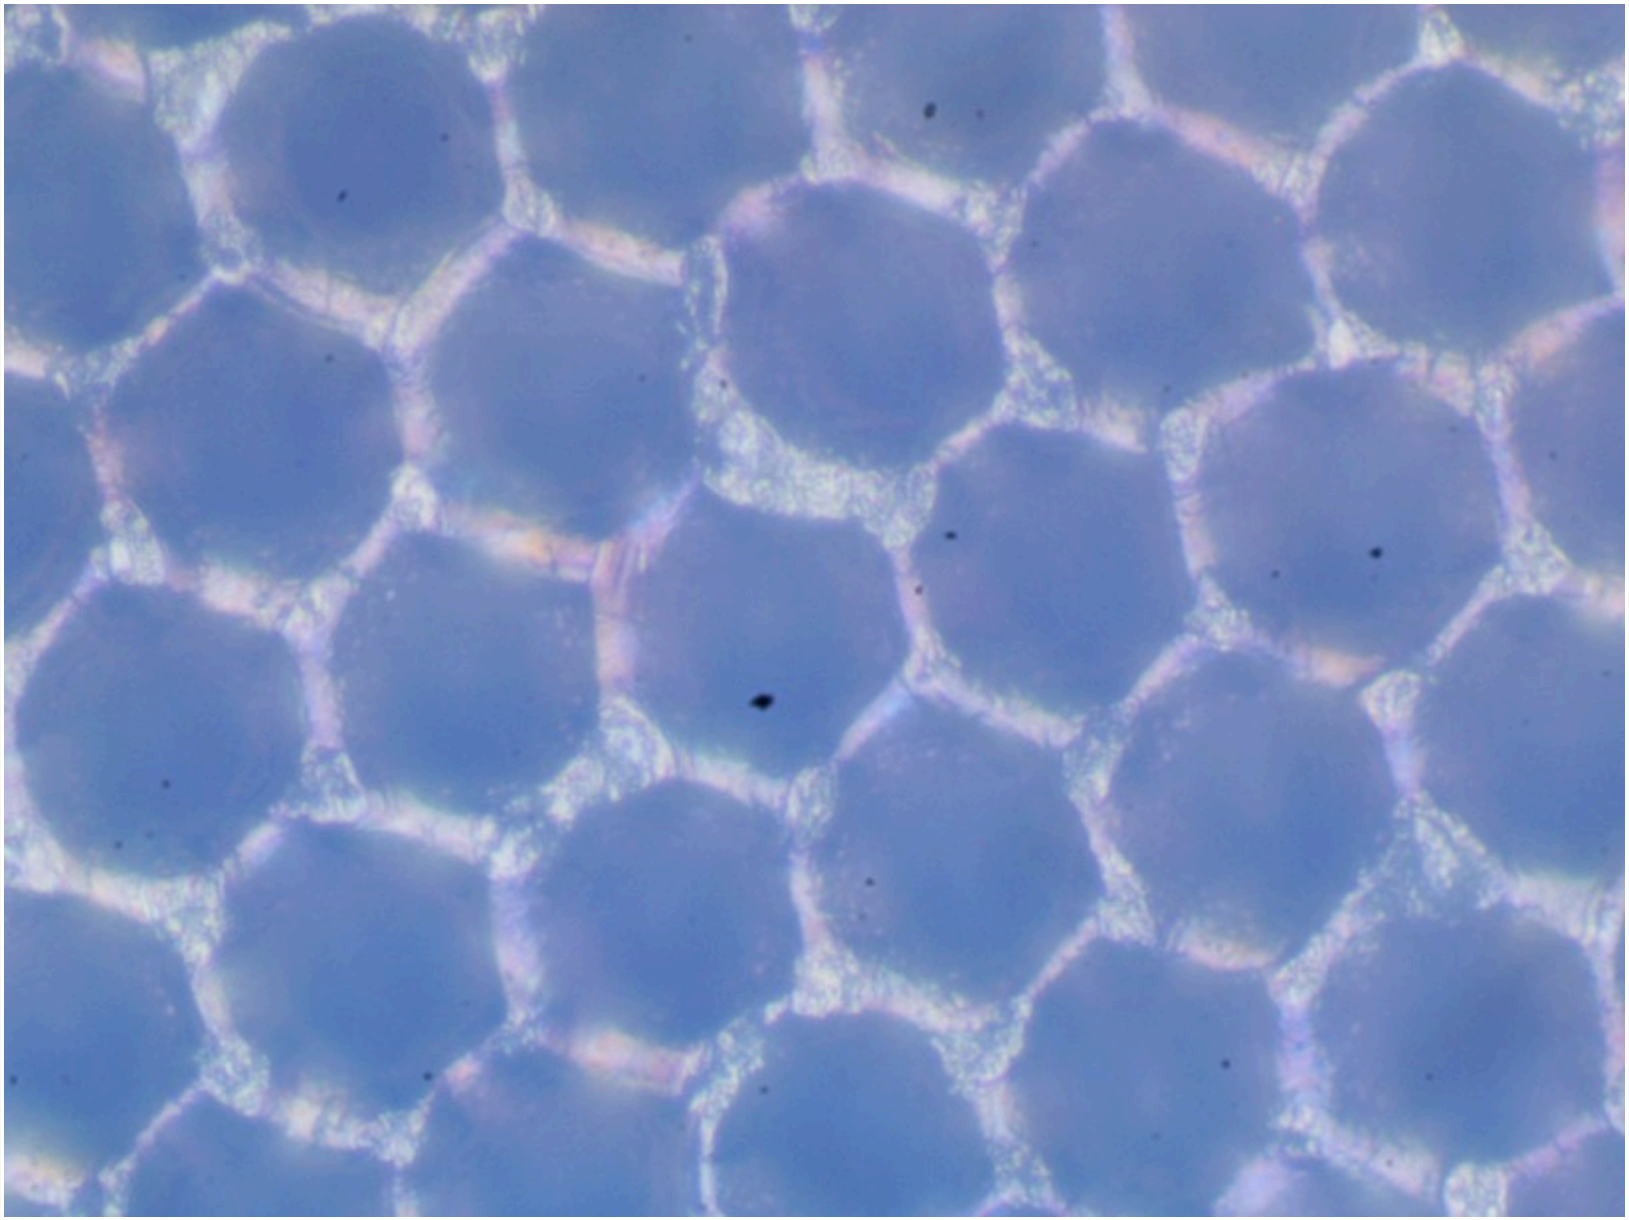
Page №66. Roll "s2401659". Length: 1320 mm. Photos with magnificaiton: x400. Cleaning passes: 1

Ink transfer volume decrease from the passport value: 15.79%

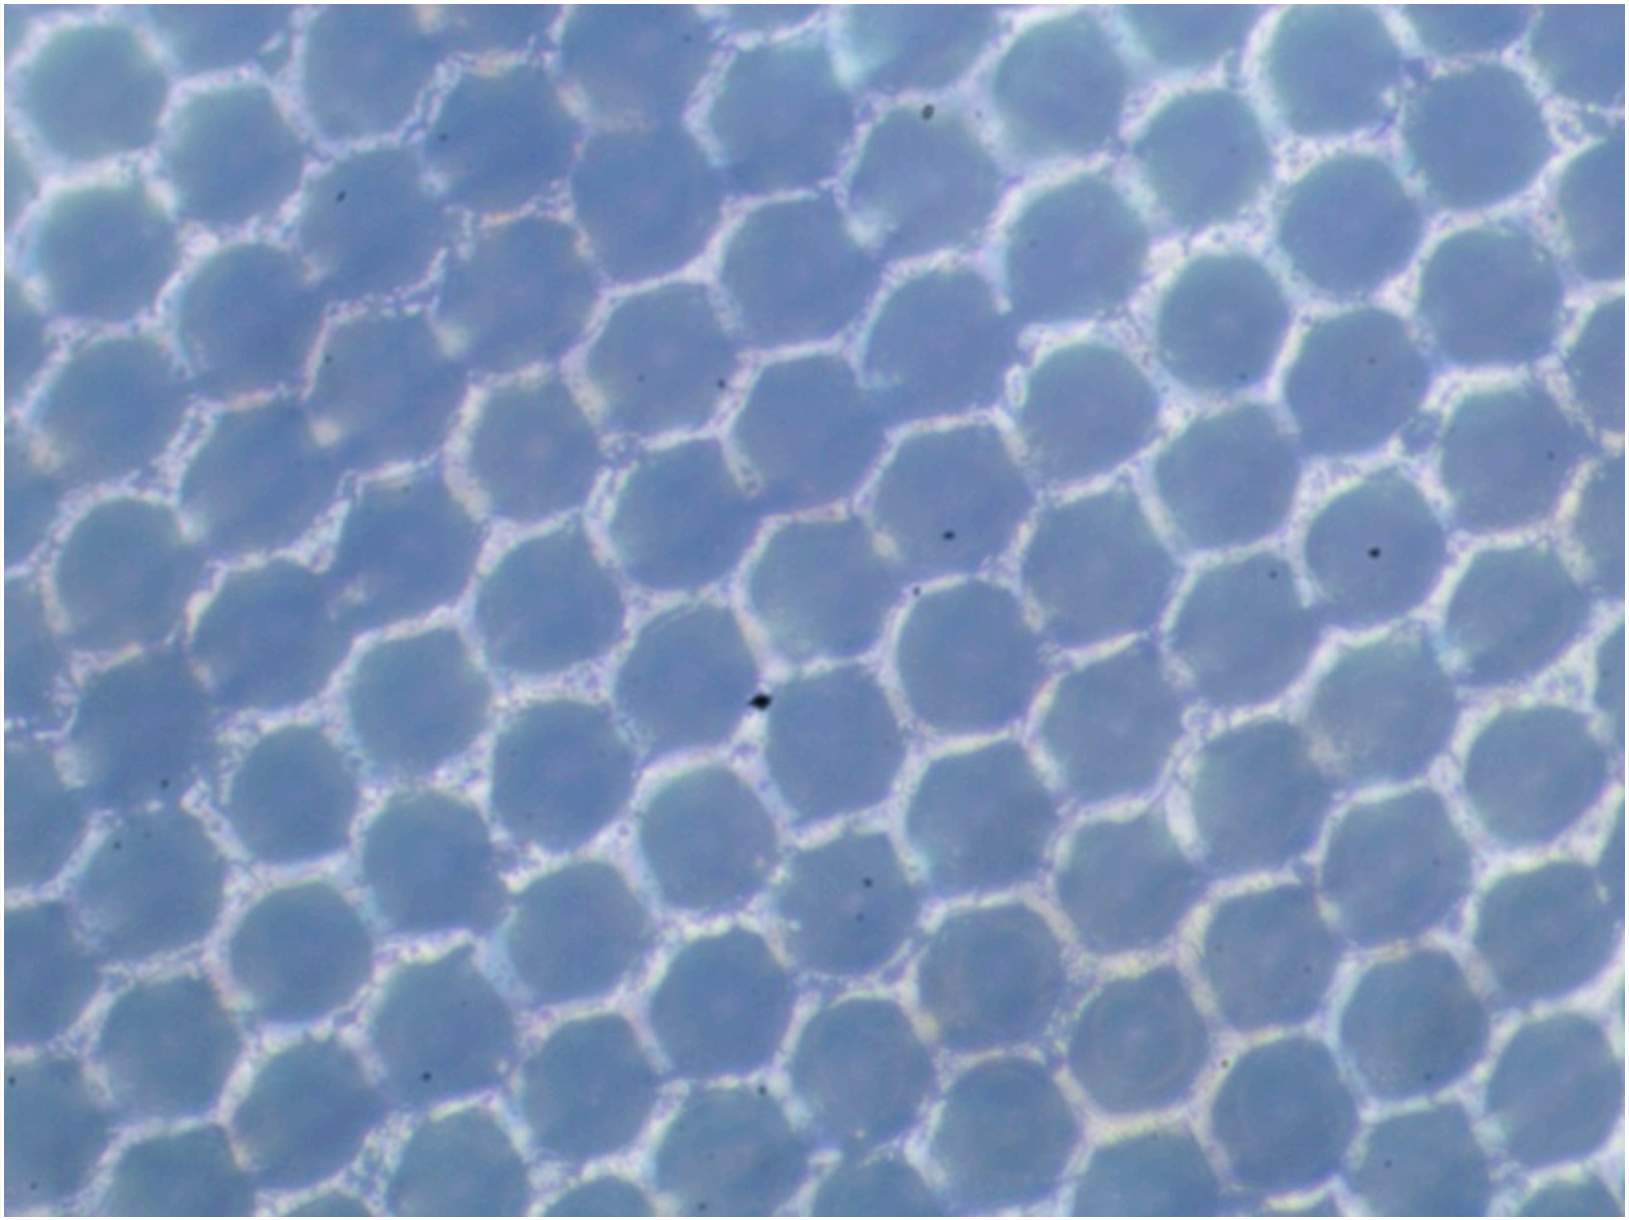
Page №67. Roll "aa2413648". Length: 1320 mm. Photos with magnificaiton: x400. Cleaning passes: 1

Ink transfer volume decrease from the passport value: 10.67%

Comment
Roll ground off.

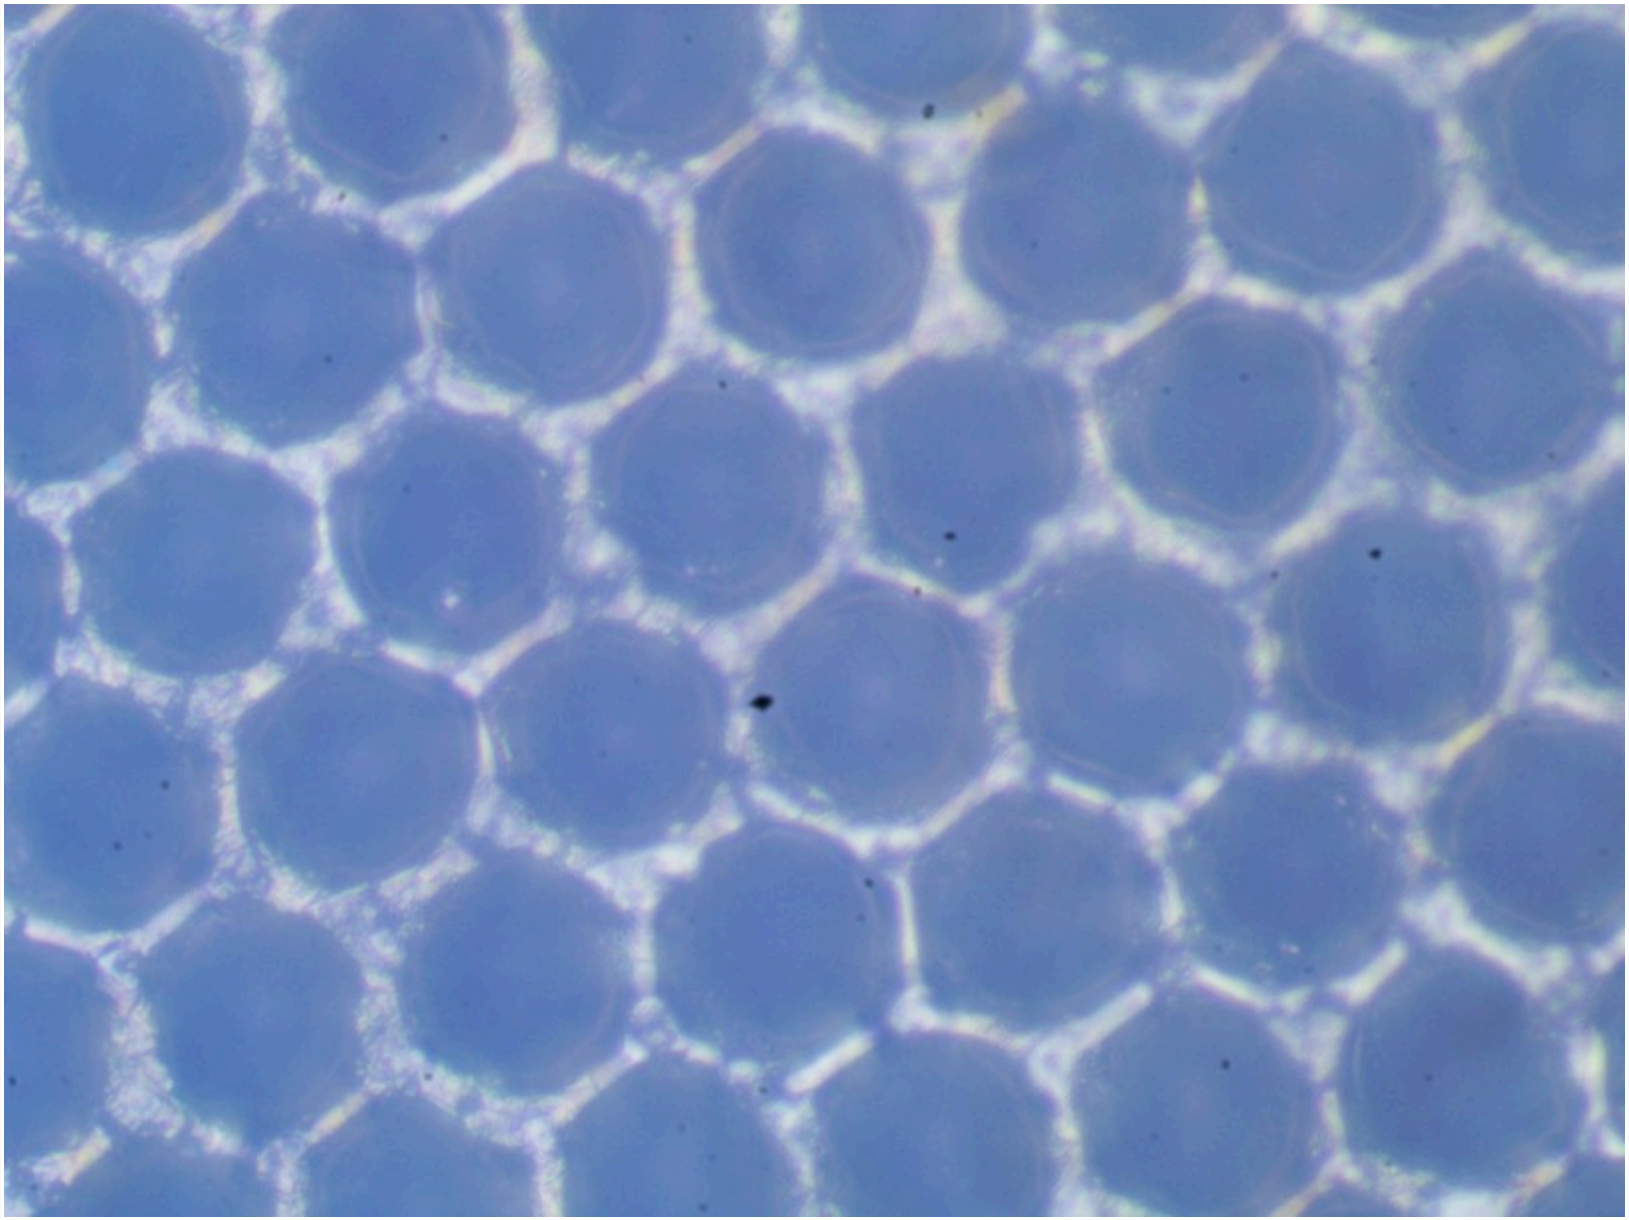
Page №68. Roll "aa2413649". Length: 1320 mm. Photos with magnificaiton: x400. Cleaning passes: 1

Ink transfer volume decrease from the passport value: 24%

Bridge / Cell: 1 / 4
Depth before / after: 15 / 15 мкм
Depth decreased by: 0%

Comment
streak 175.
Roll ground off.

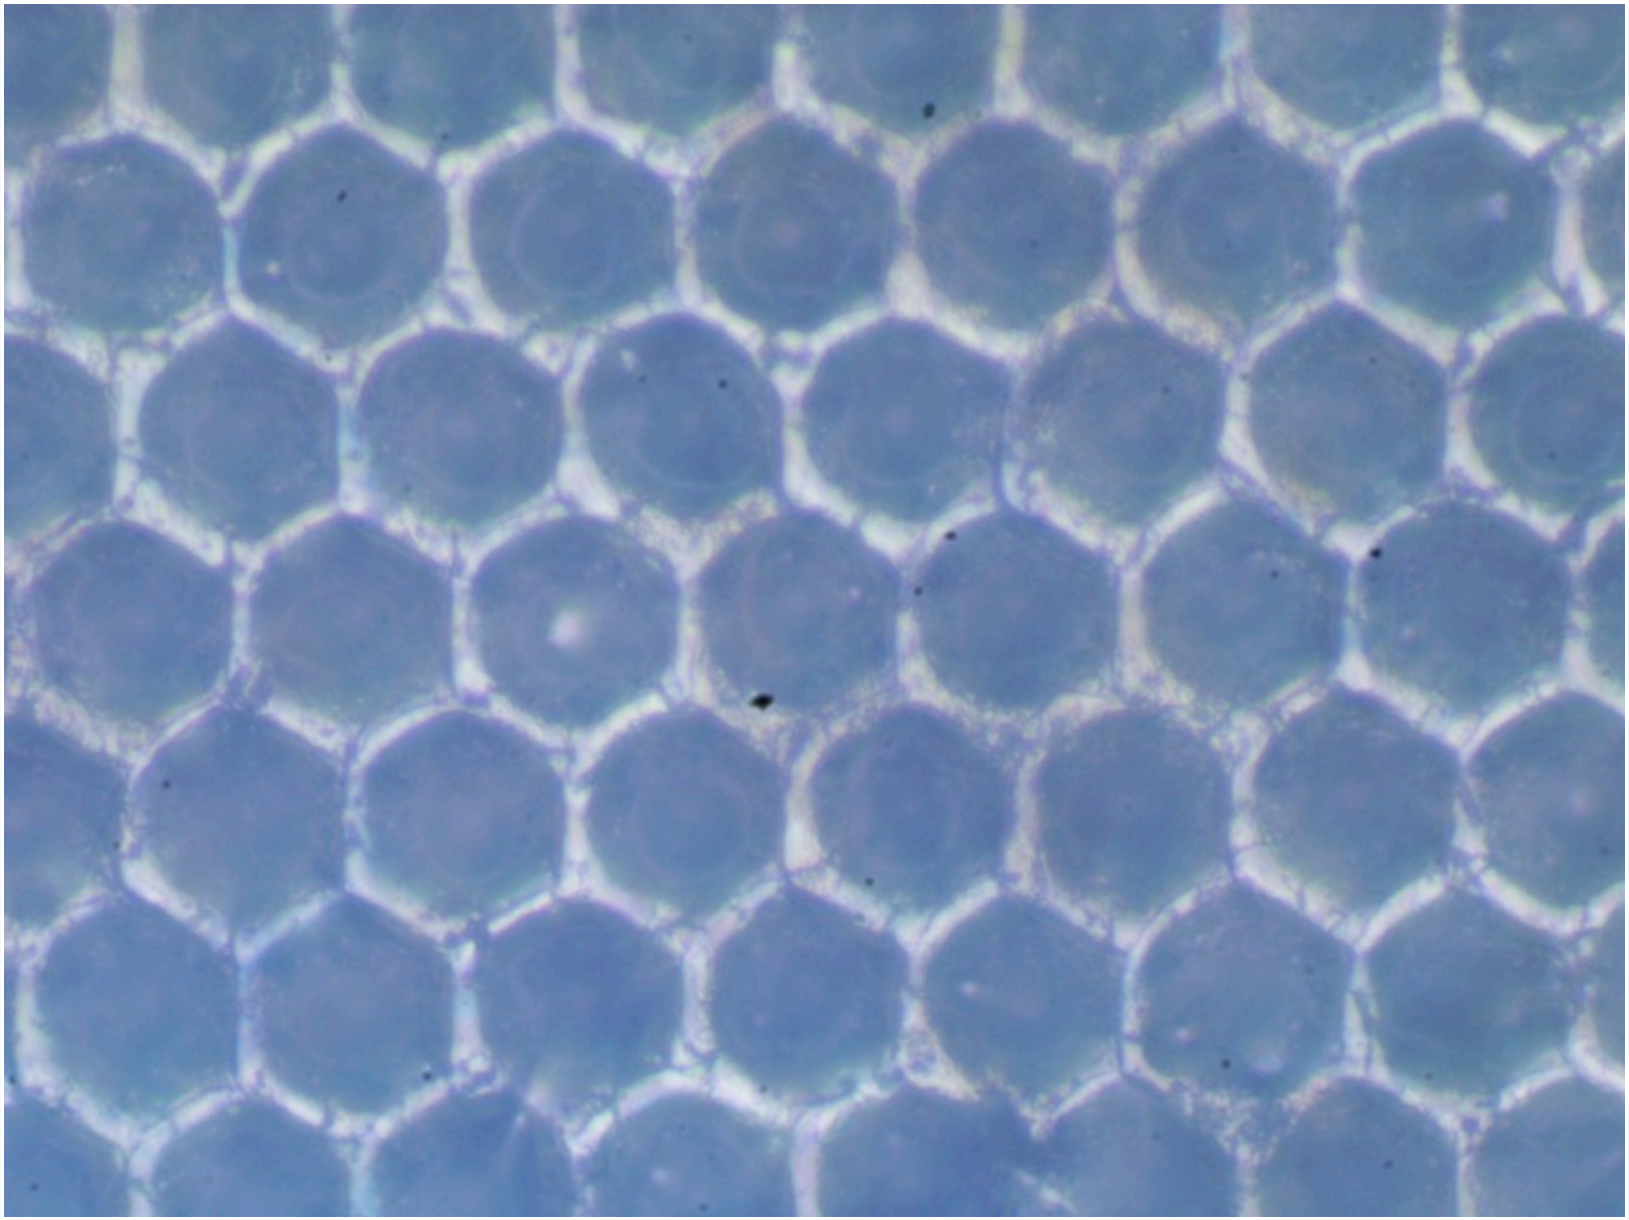
Page №70. Roll "s2401741". Length: 1320 mm. Photos with magnificaiton: x400. Cleaning passes: 1

Comment
Roll ground off.

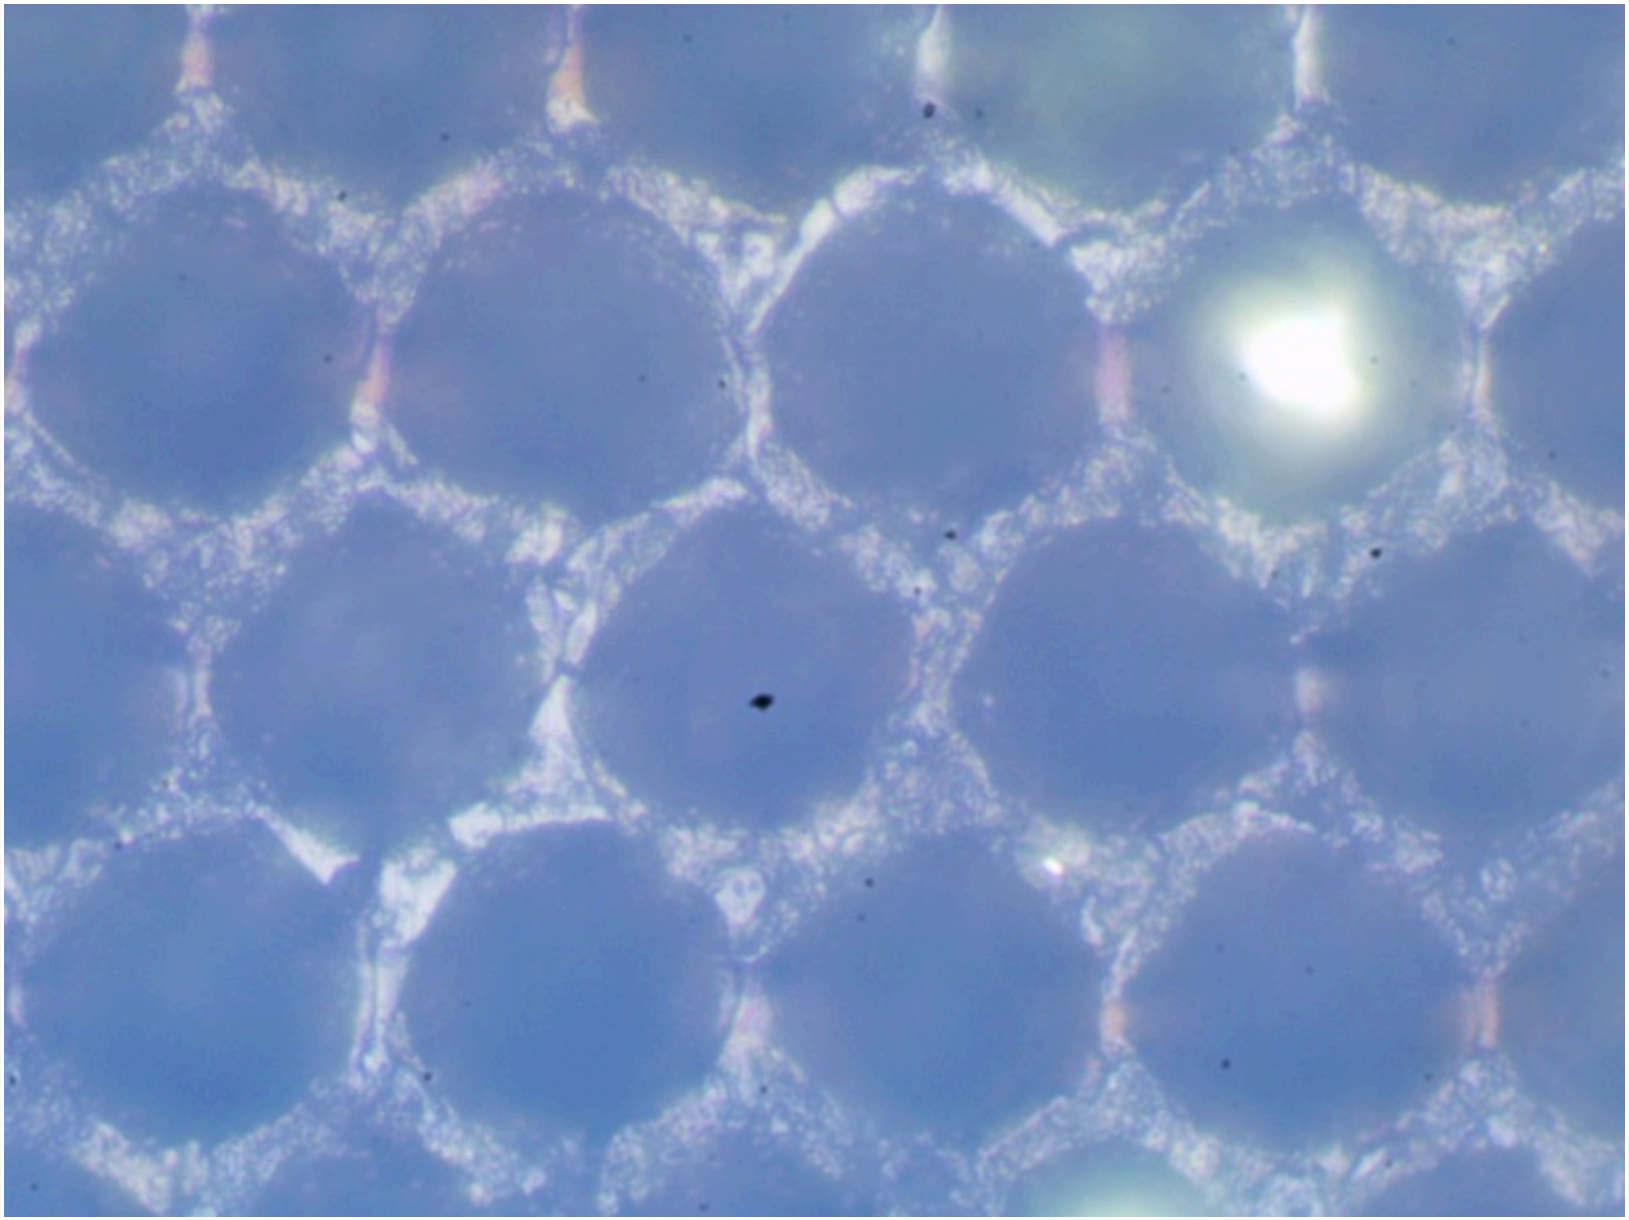
Page №71. Roll "aa2013651". Length: 1320 mm. Photos with magnificaiton: x400. Cleaning passes: 1

Comment
streak 150 272 478 530 912.
Roll ground off.

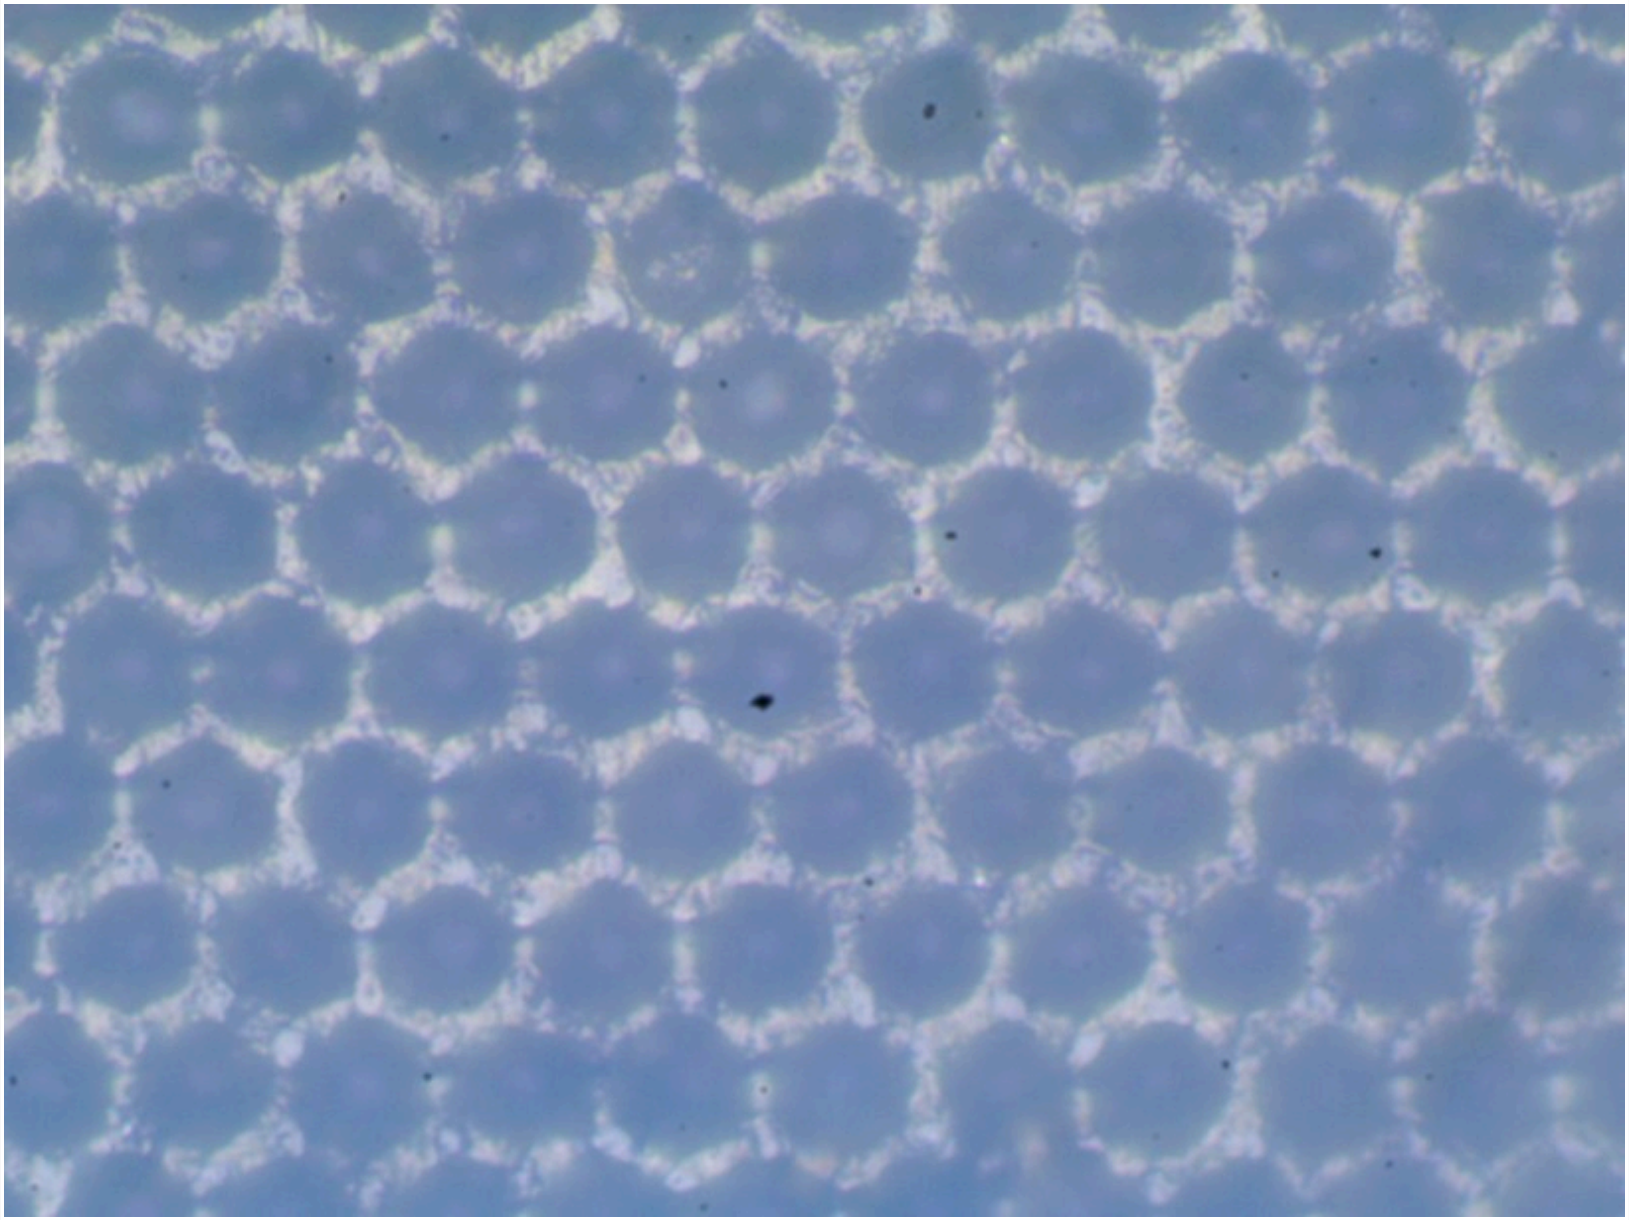
Page №72. Roll "sg4904612". Length: 1360 mm. Photos with magnificaiton: x400. Cleaning passes: 1

Comment
Roll slightly ground off.

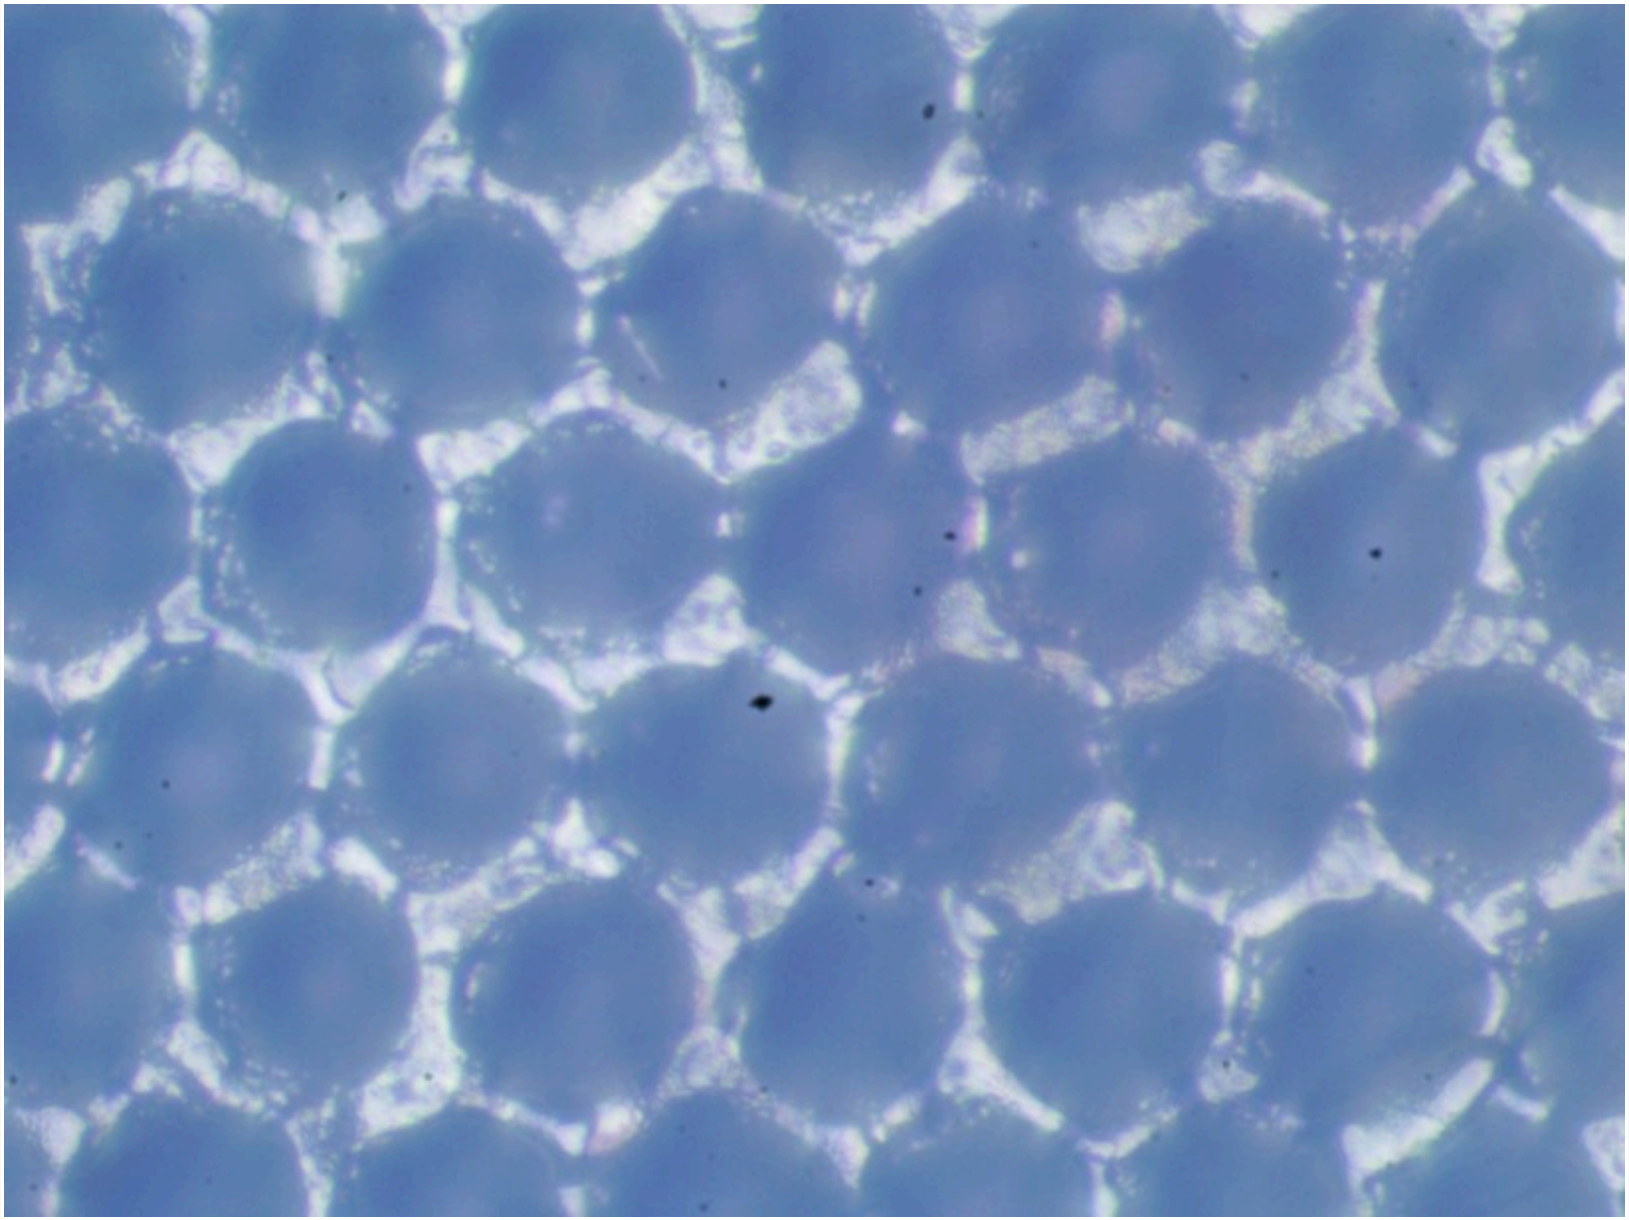
Page №73. Roll "s2401718". Length: 1320 mm. Photos with magnificaiton: x400. Cleaning passes: 1

Comment
Roll ground off.

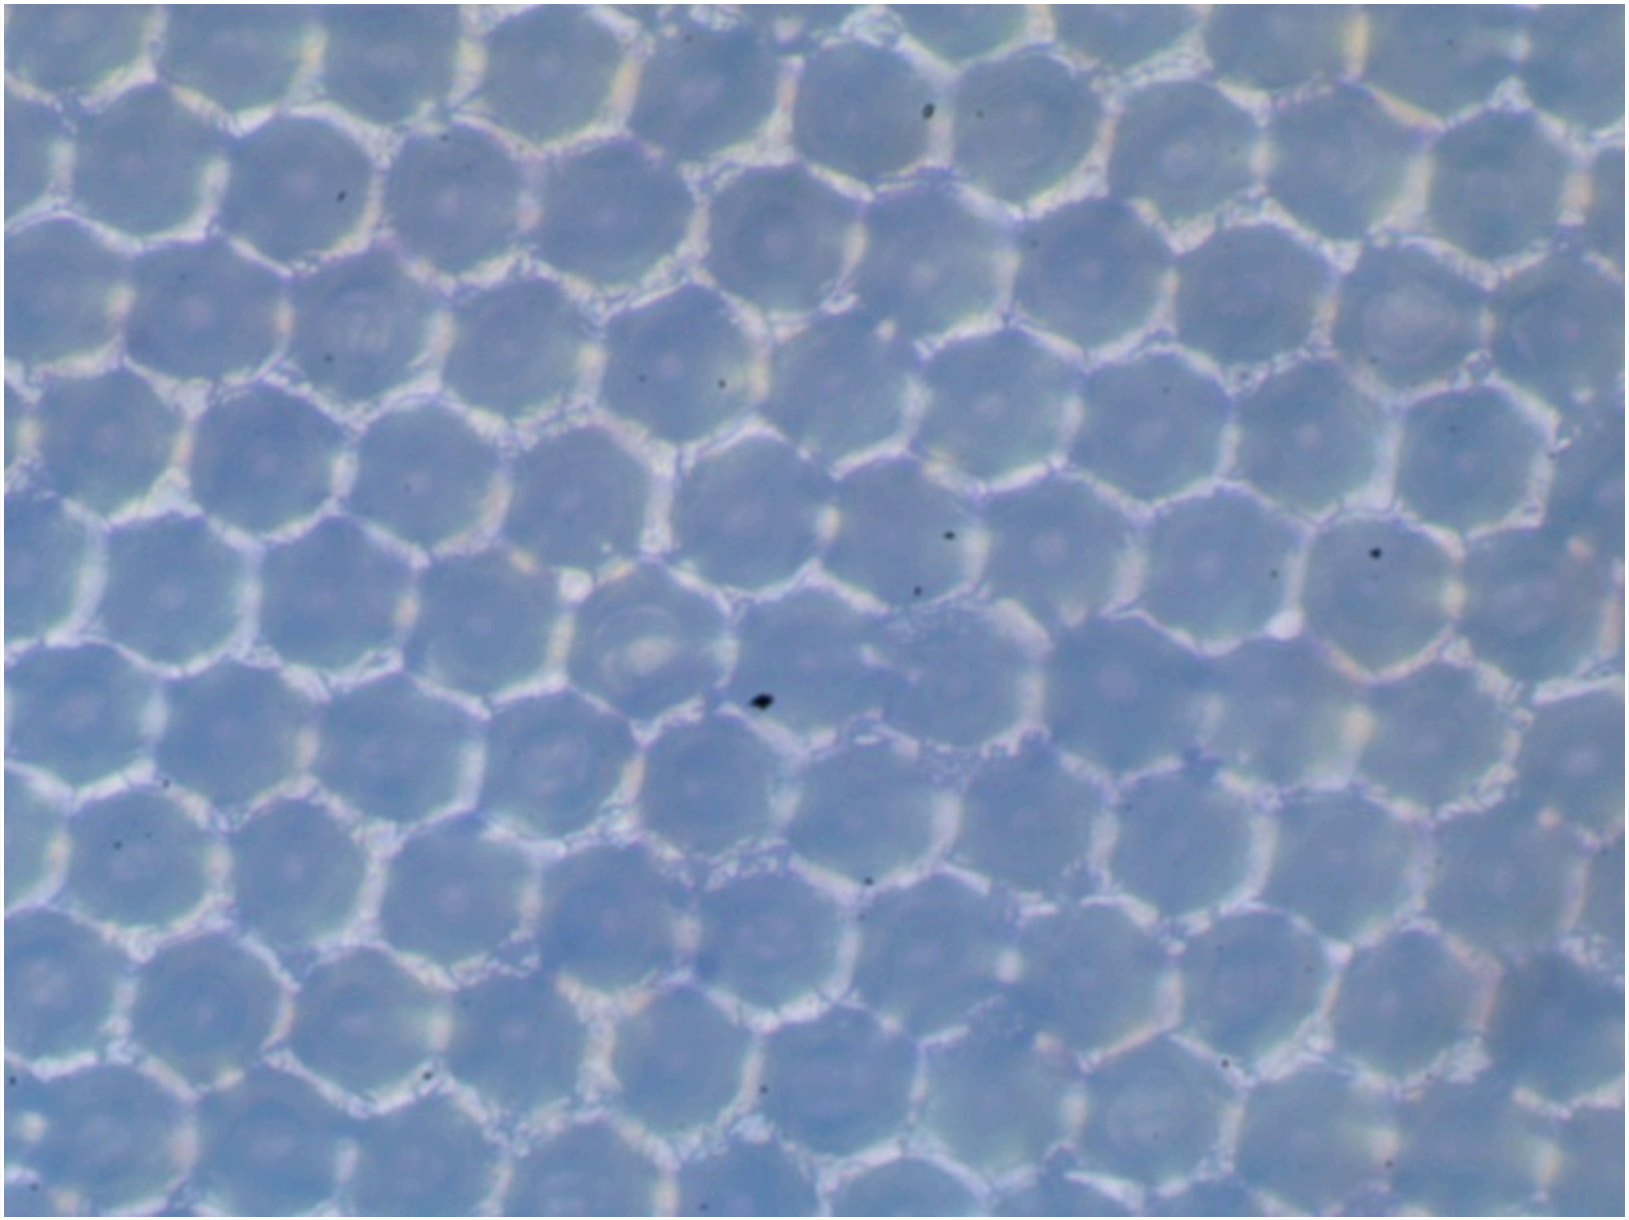
Page №74. Roll "aa2413652". Length: 1320 mm. Photos with magnificaiton: x400. Cleaning passes: 1

Comment
streak 575 600.
Roll ground off.

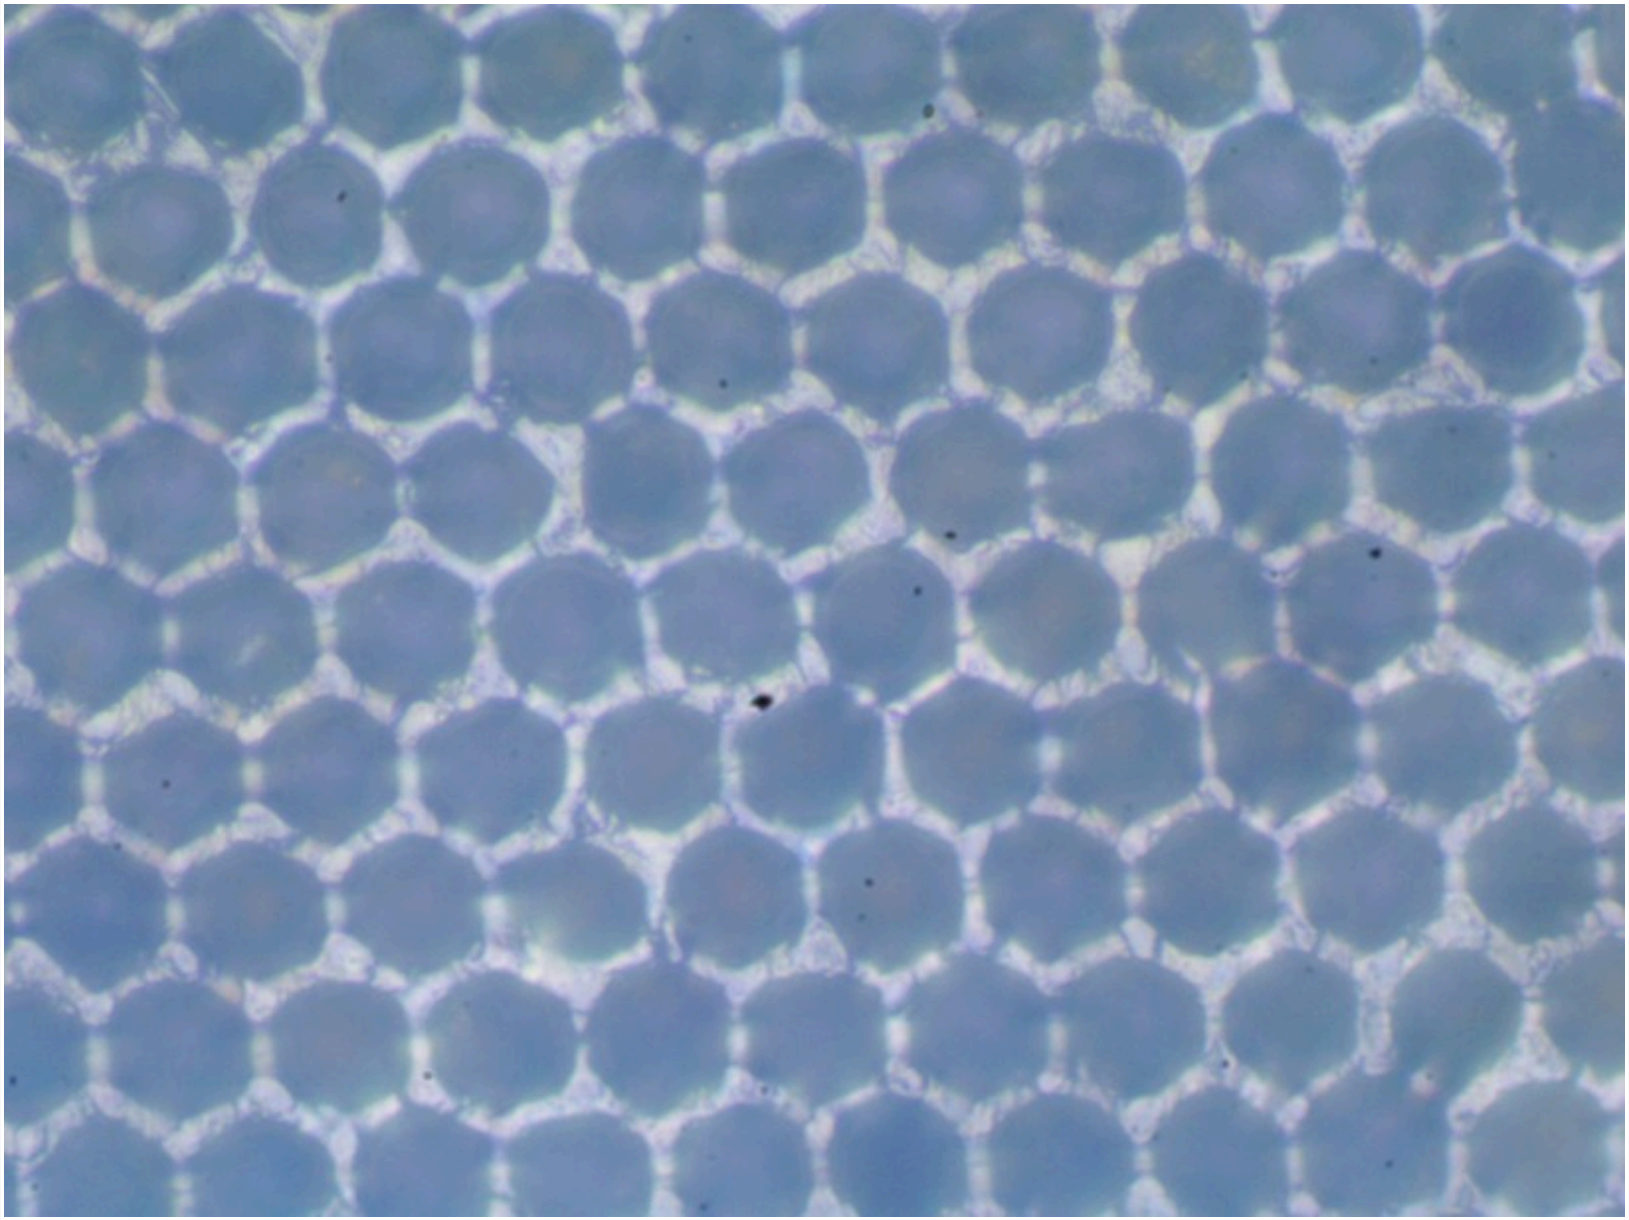
Page №75. Roll "s2401660". Length: 1320 mm. Photos with magnificaiton: x400. Cleaning passes: 1

Comment
streaks scratches 250.

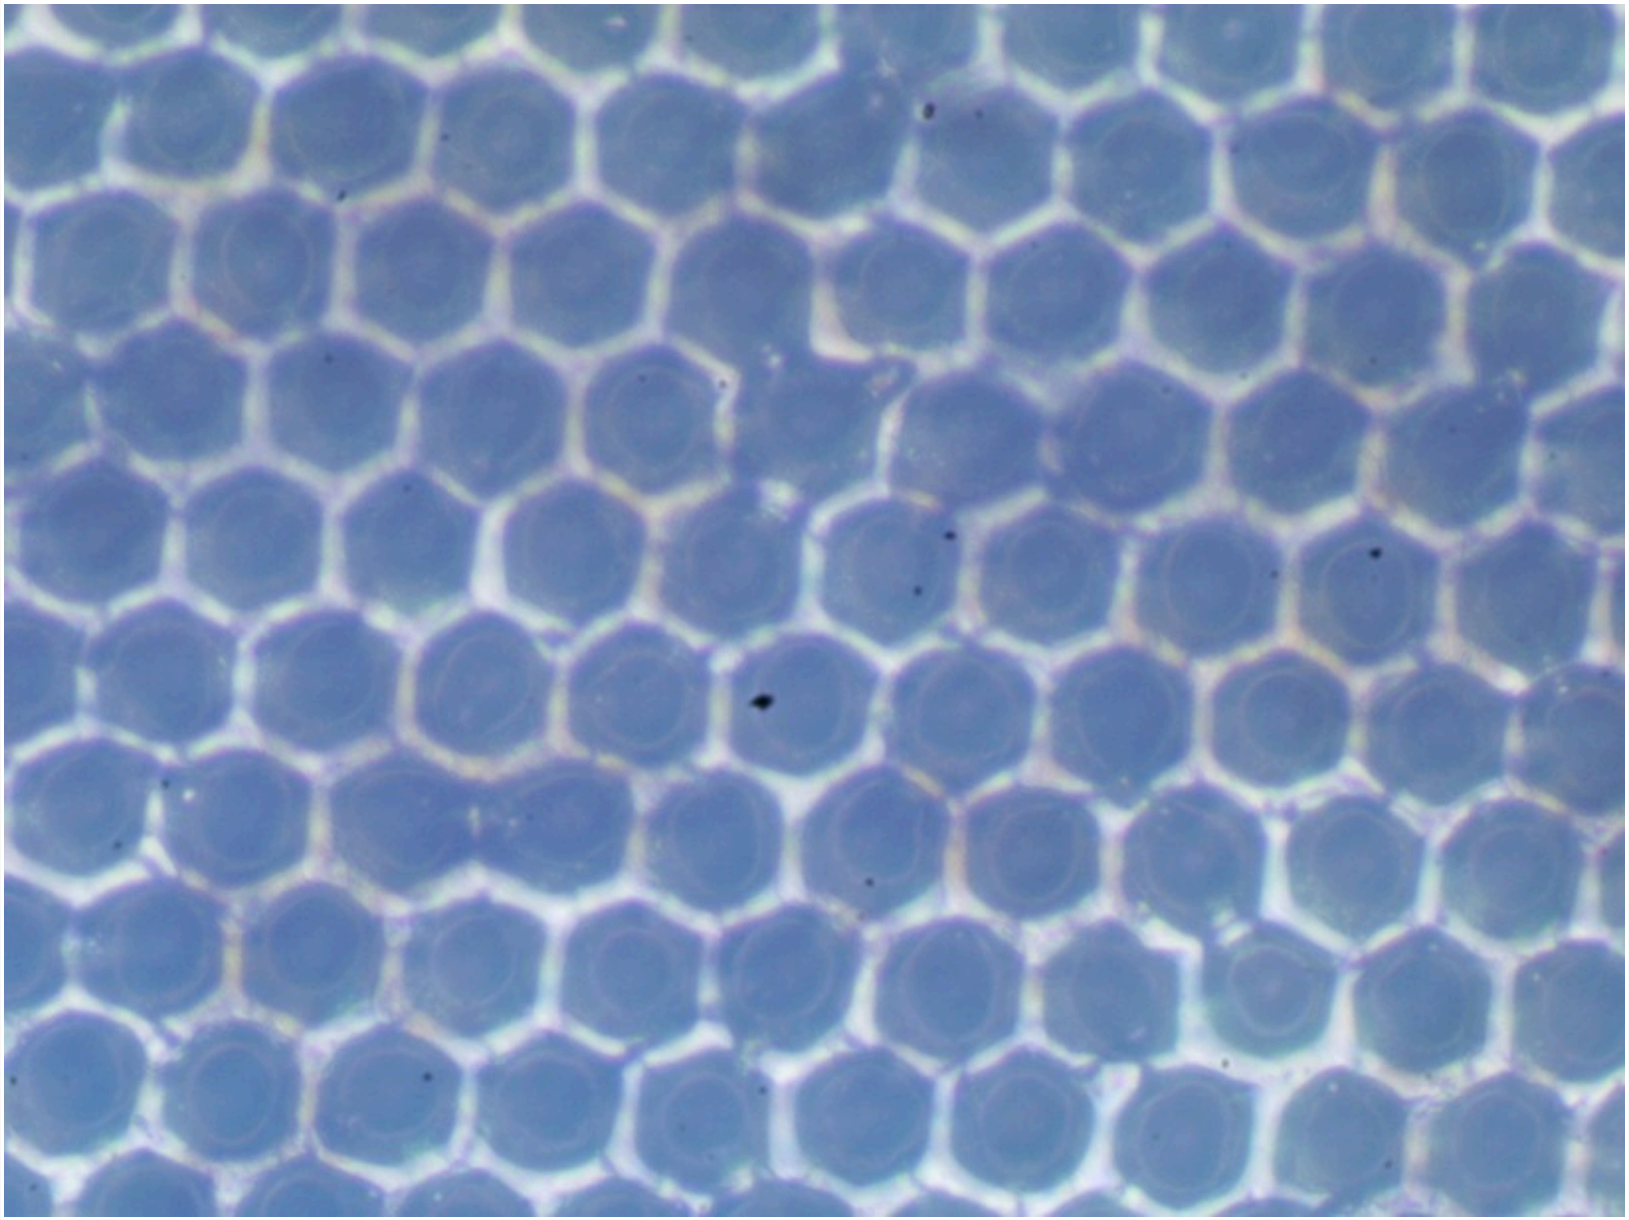
Page №76. Roll "z17011027". Length: 1300 mm. Photos with magnificaiton: x400. Cleaning passes: 1

Bridge / Cell: 1 / 2
Depth before / after: 20 / 20 мкм
Depth decreased by: 0%

Comment
worn.
Roll heavily ground off.
