RollerCheck360

Roll Inspection from 08.12.2025

Rolls: 178

We have analyzed for you 178 rolls.

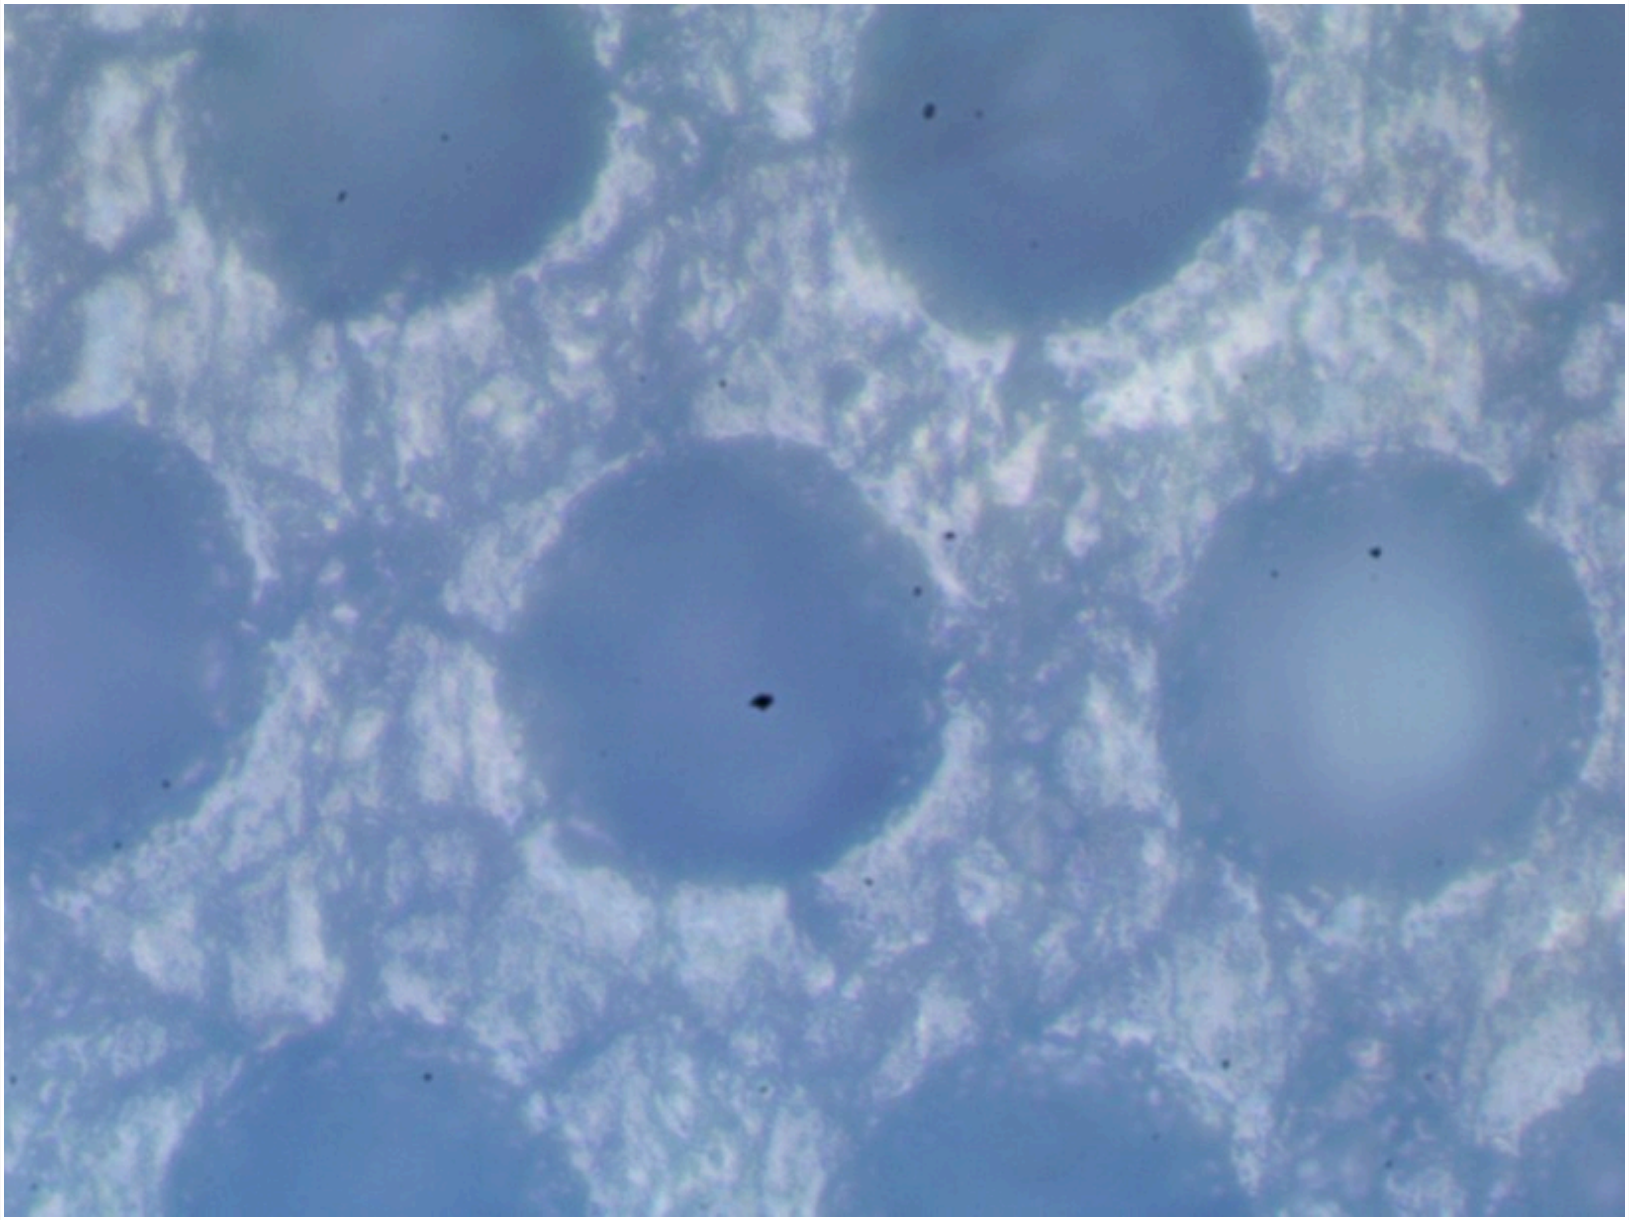
Page №77. Roll "sa008587". Length: 1300 mm. Photos with magnificaiton: x400. Cleaning passes: 1

Comment
scratch 1030 1070 streak 938 280 worn.

Roll heavily ground off.

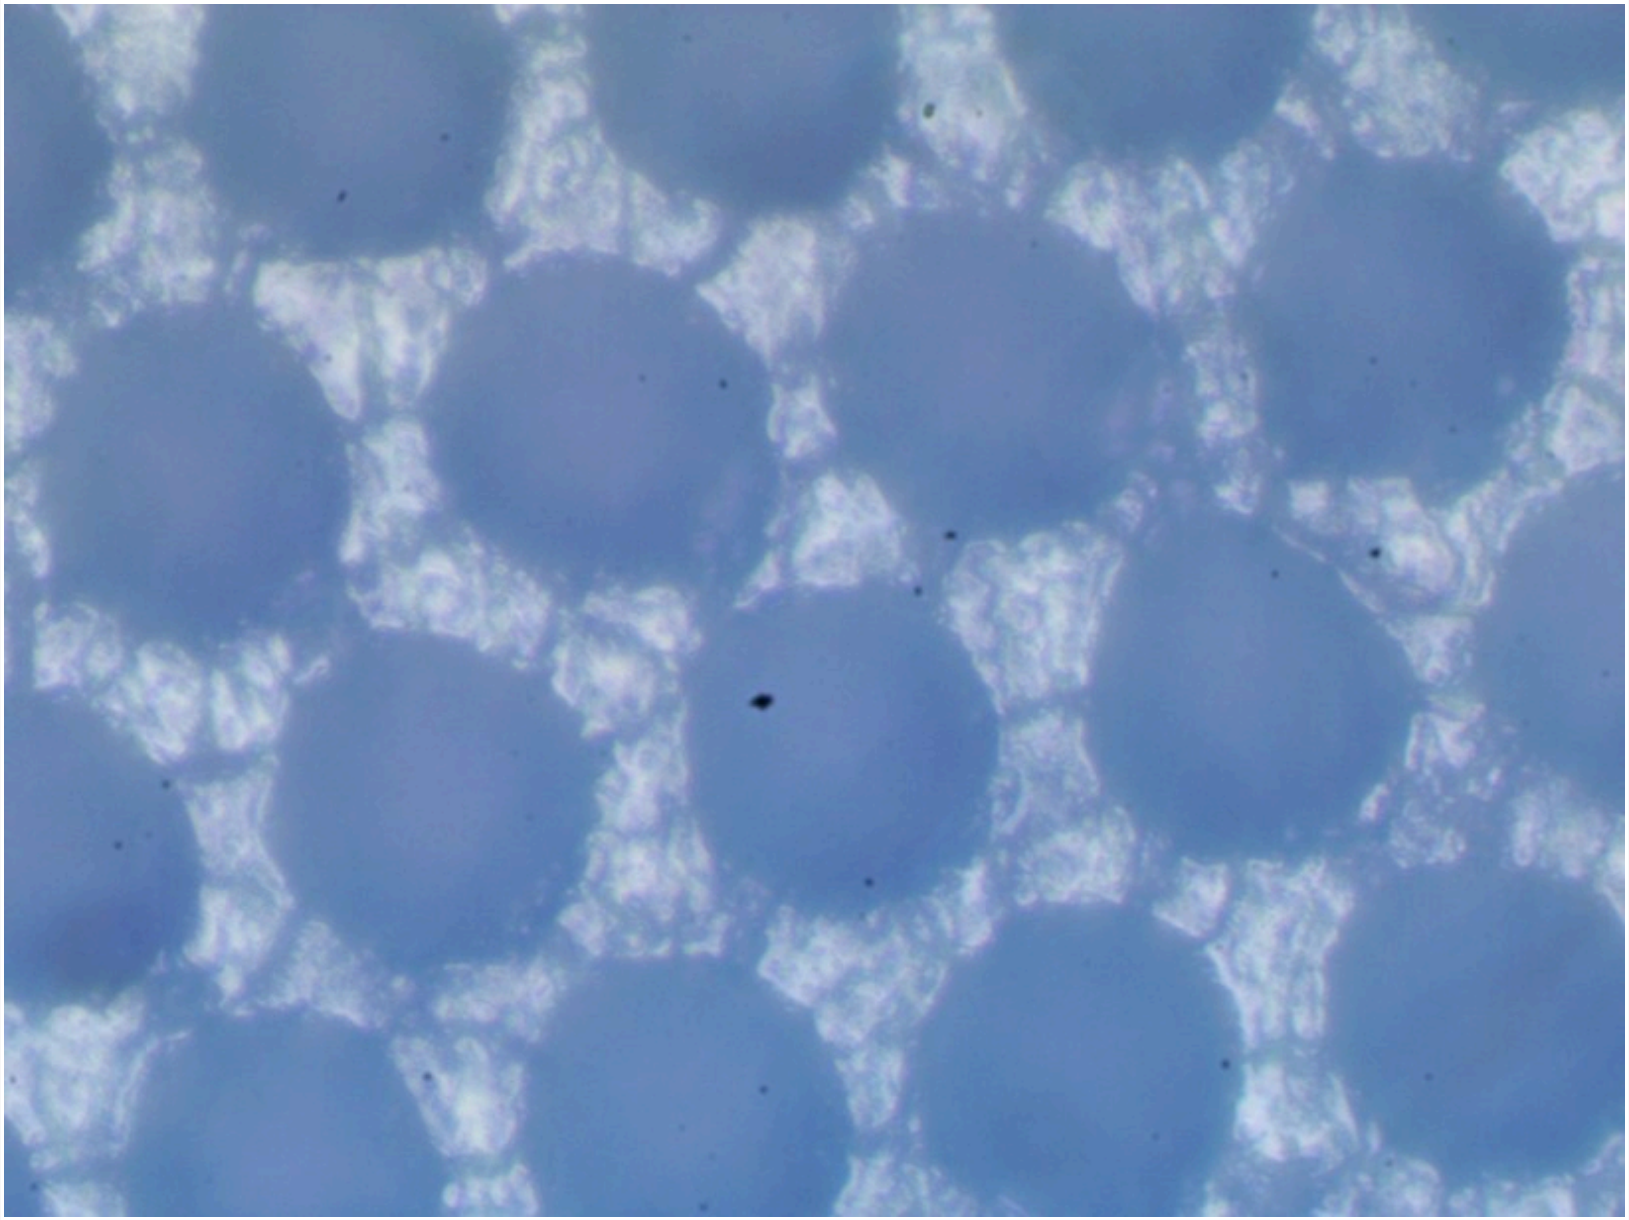
Page №79. Roll "z17011037". Length: 1300 mm. Photos with magnificaiton: x400. Cleaning passes: 1

Comment
streaks streak 734 dent 1125
1175 1220.
Roll ground off.

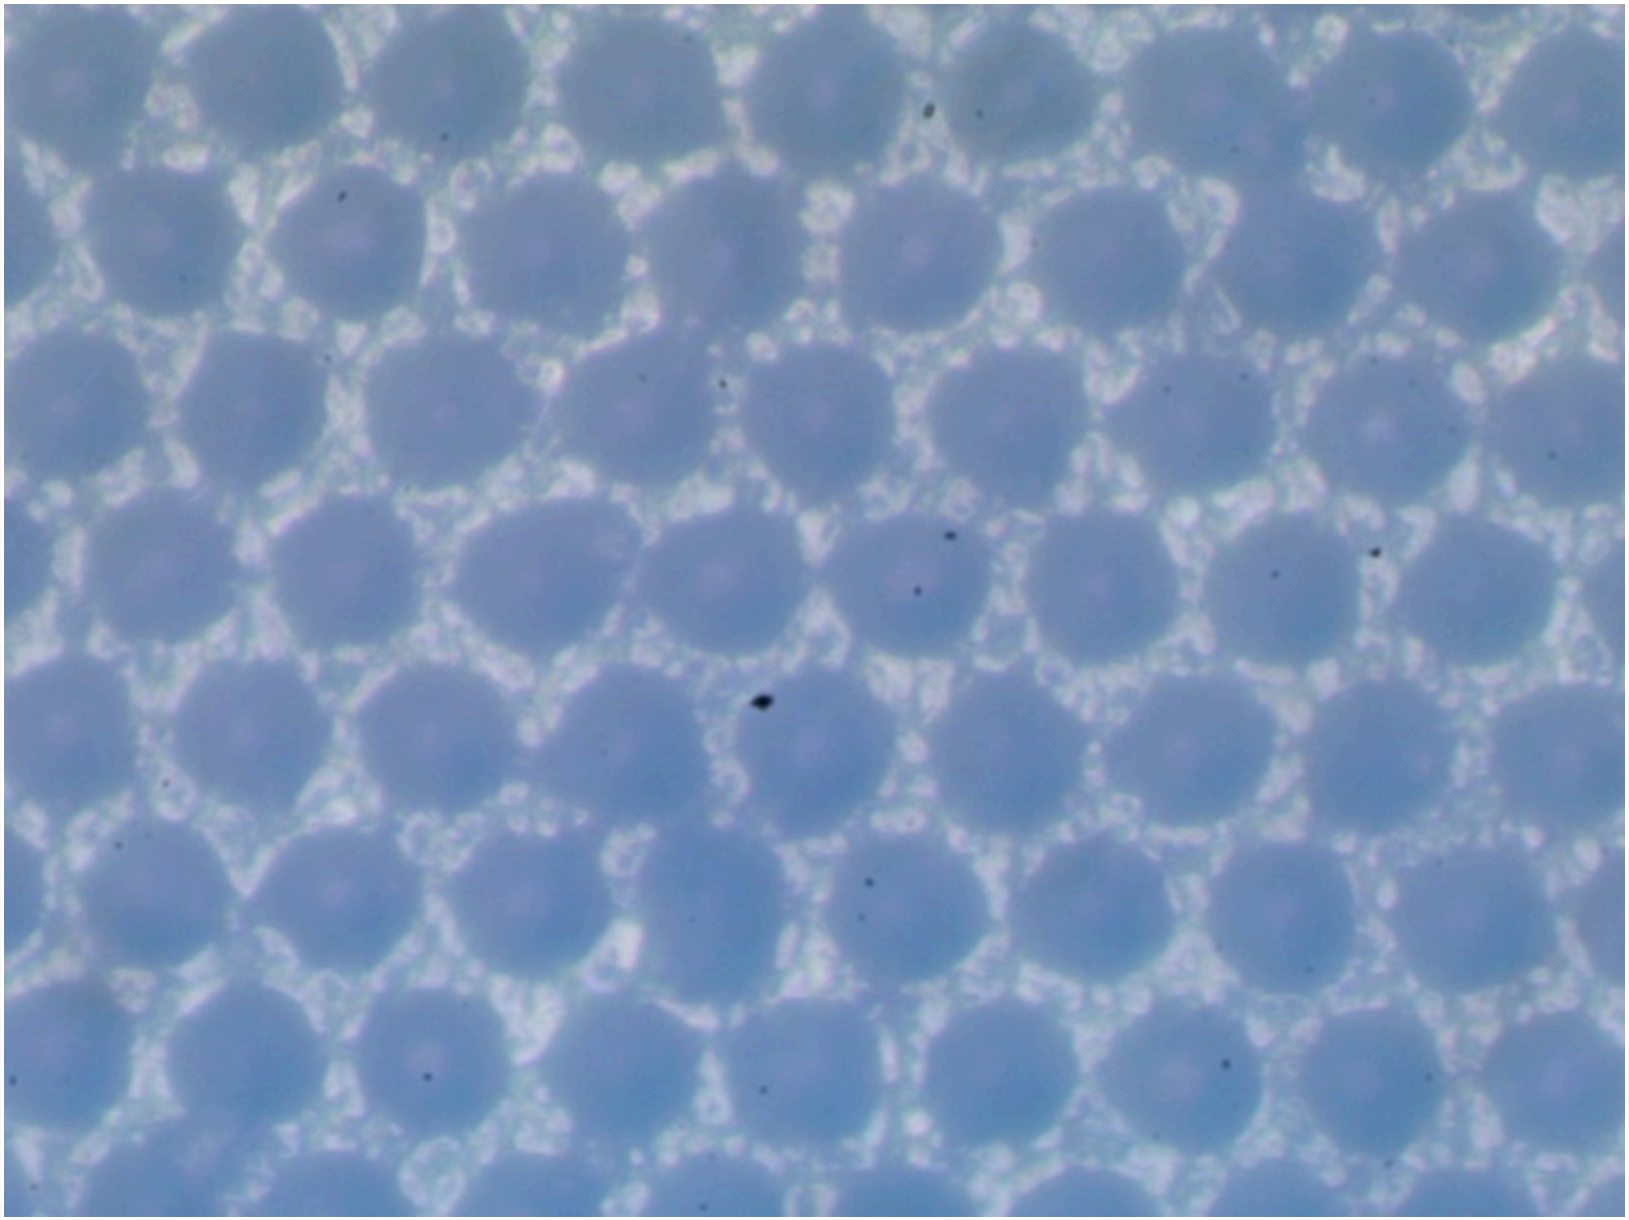
Page №80. Roll "z48070". Length: 1300 mm. Photos with magnificaiton: x400. Cleaning passes: 1

Comment
streaks streak 55 128 1032 dent 222 231 257 1160 1000.

Roll ground off.

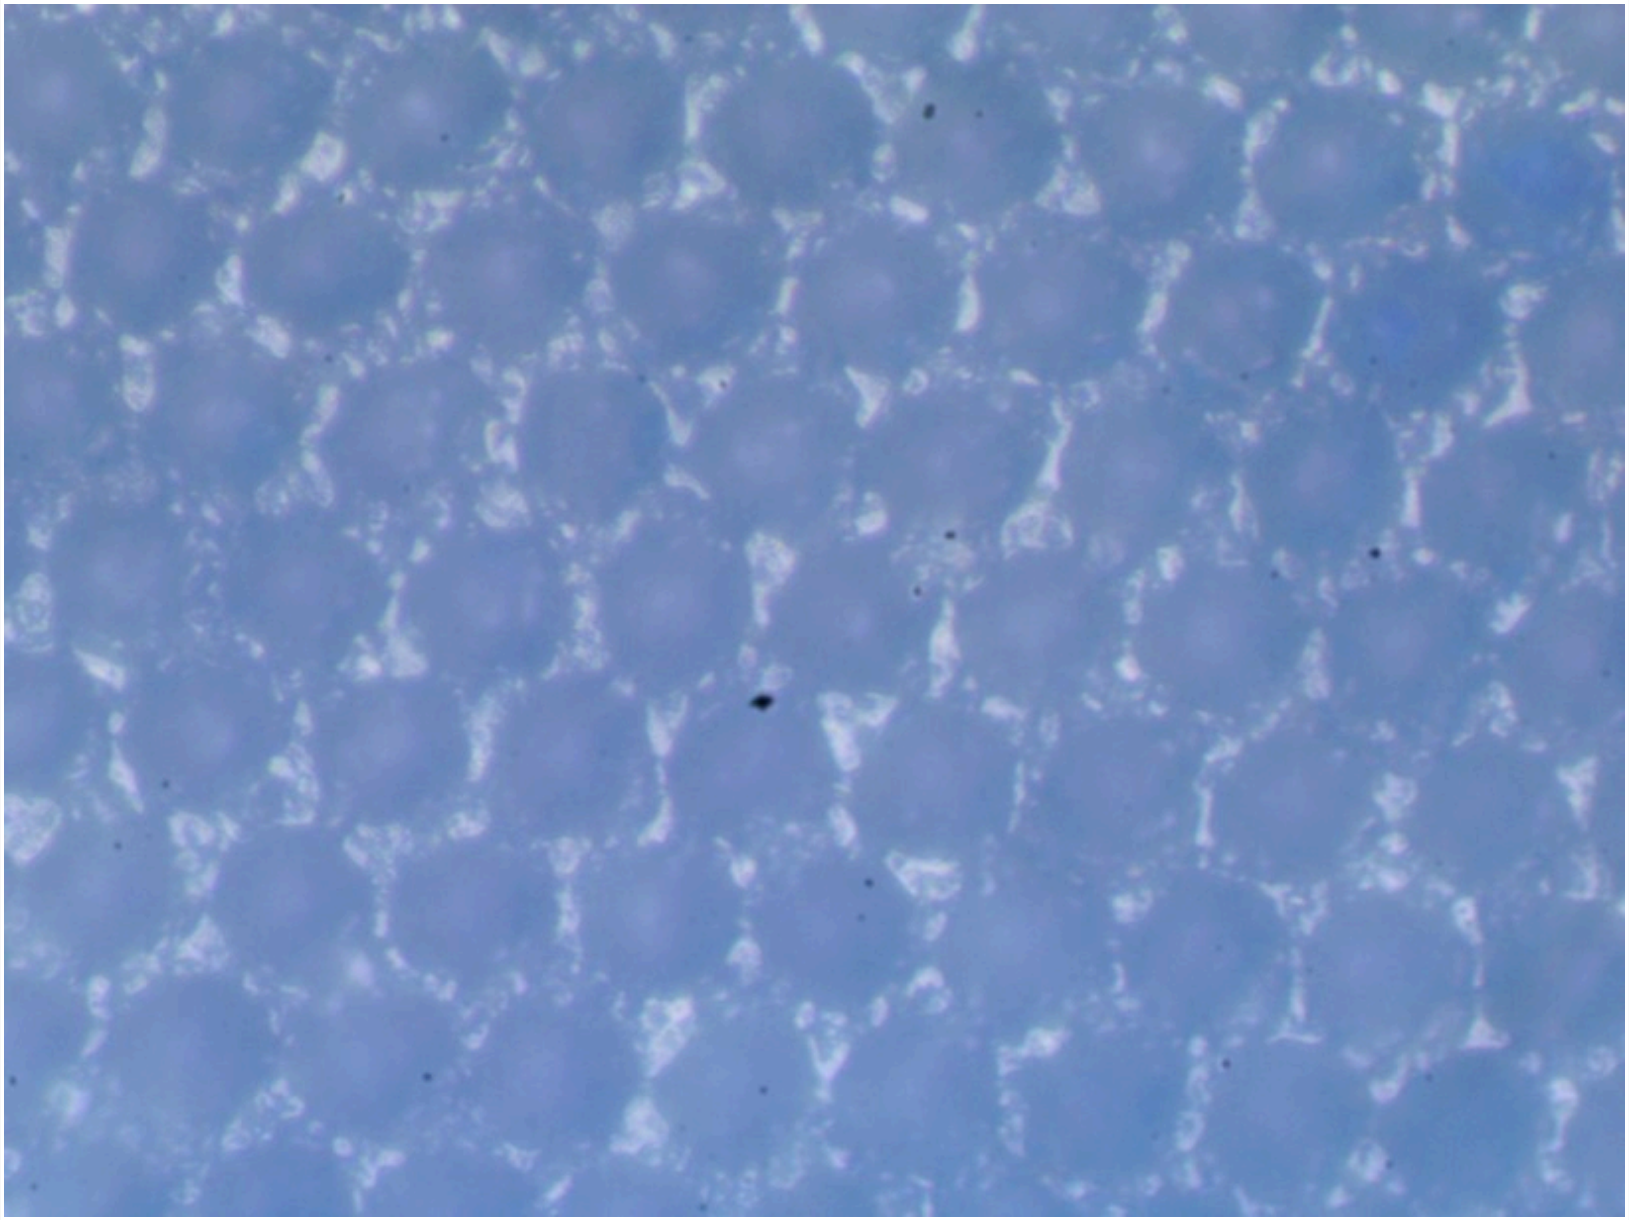
Page №81. Roll "046633". Length: 1300 mm. Photos with magnificaiton: x400. Cleaning passes: 1

Comment
streak 34 747.
Roll heavily ground off.

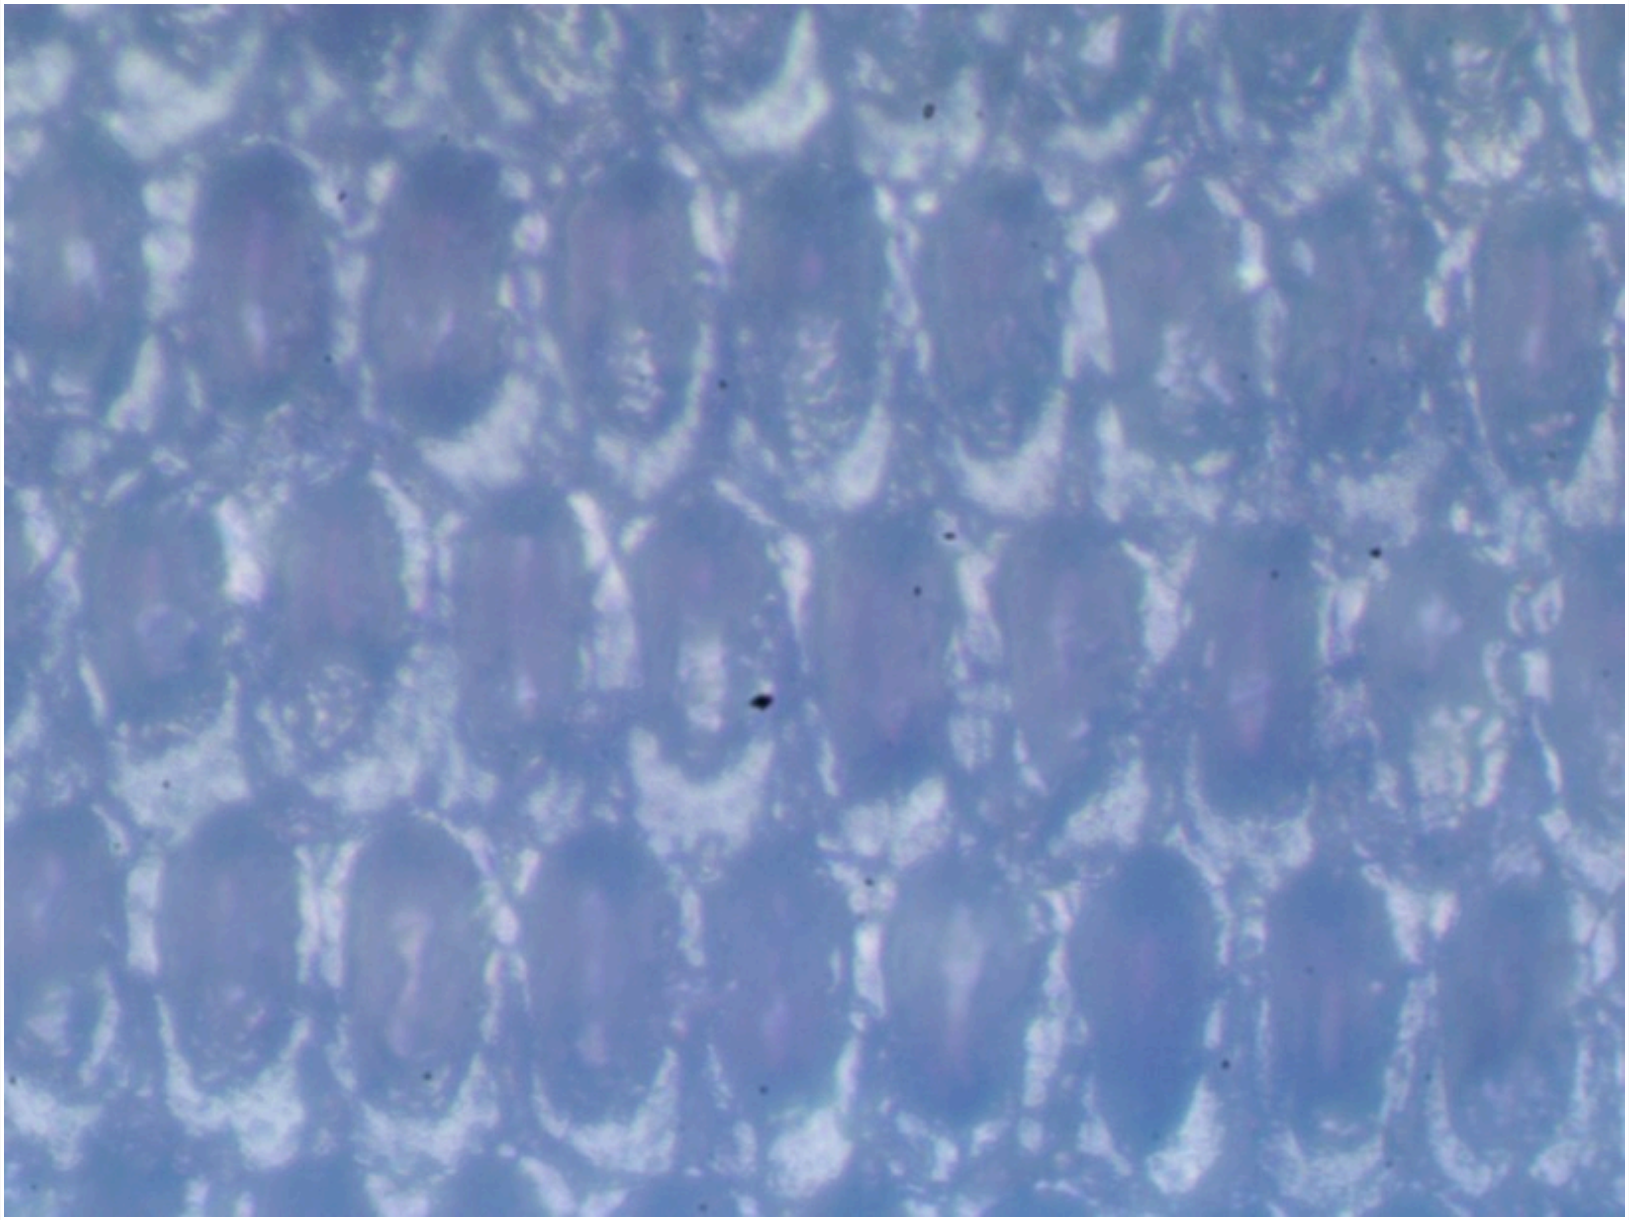
Page №82. Roll "046634". Length: 1300 mm. Photos with magnificaiton: x400. Cleaning passes: 1

Comment
streak 650 798 1172.
Roll ground off.

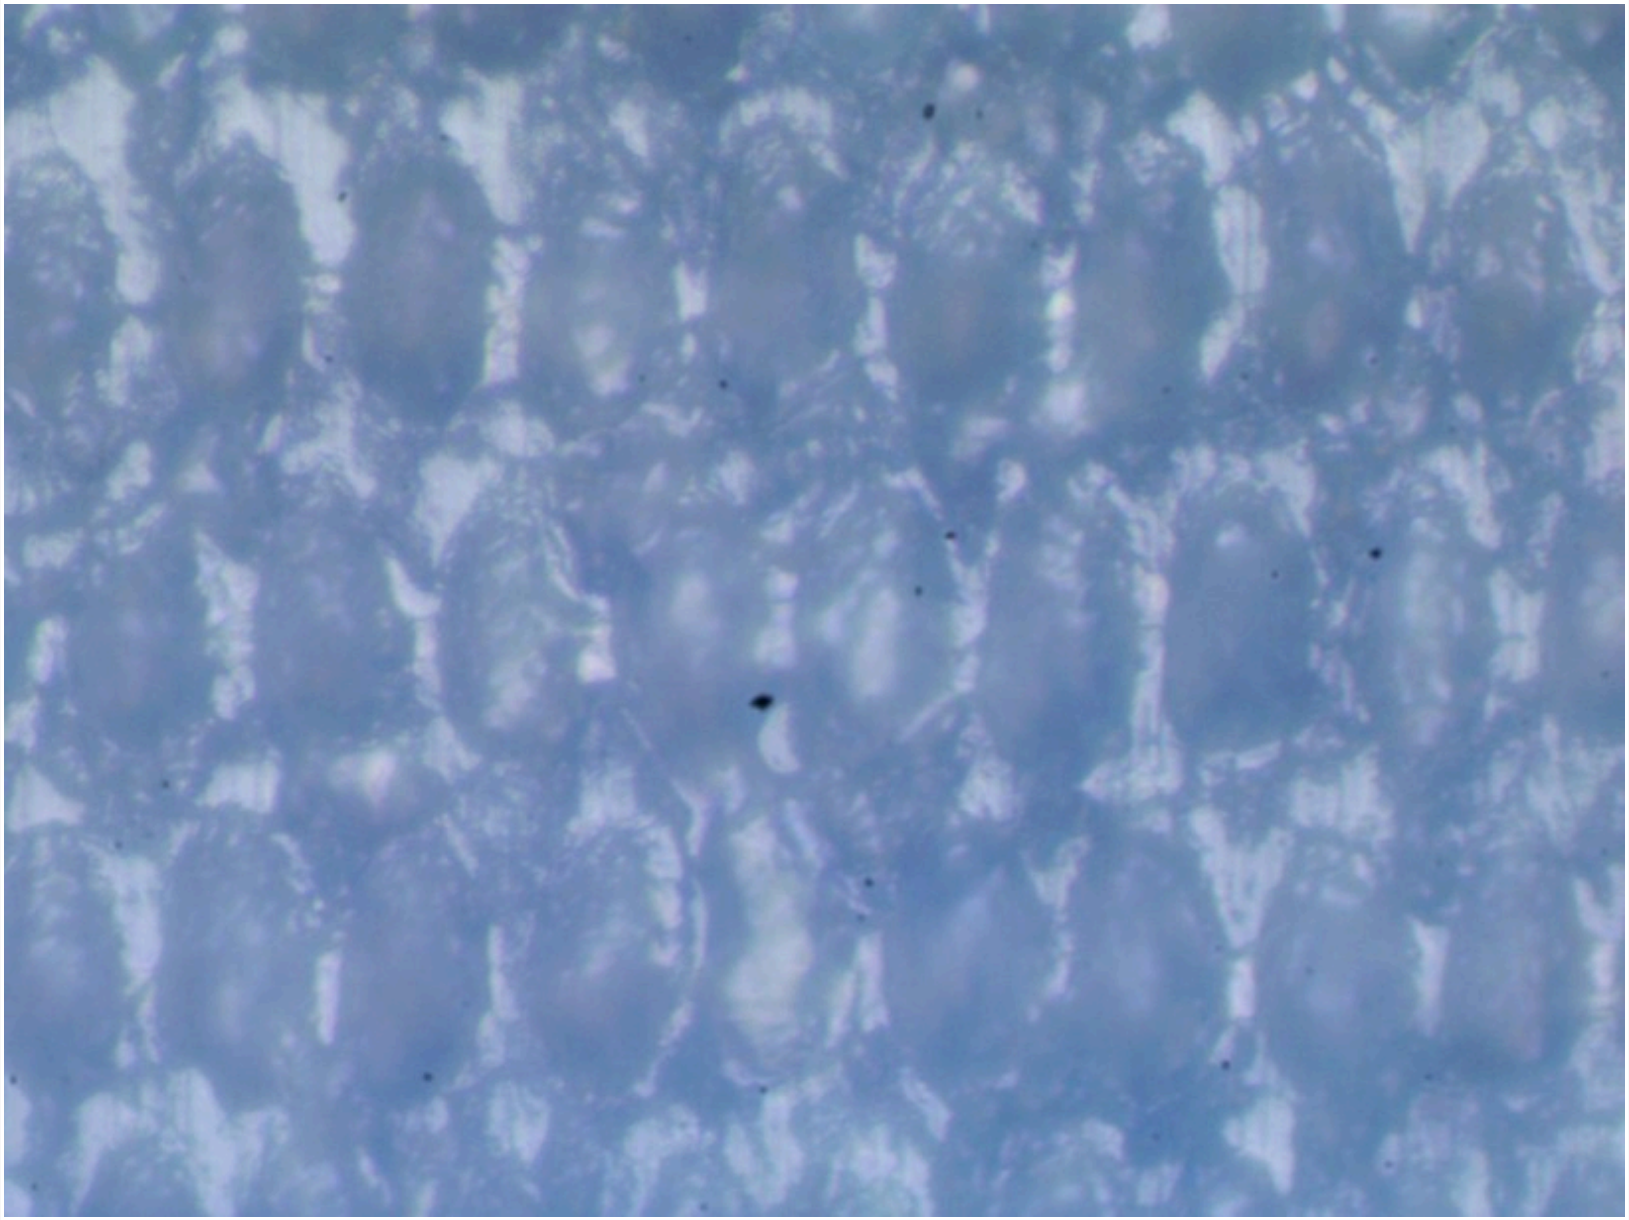
Page №83. Roll "sg49046-30". Length: 1360 mm. Photos with magnificaiton: x400. Cleaning passes: 1

Comment
streaks in places cell walls are missing.

Roll heavily ground off.

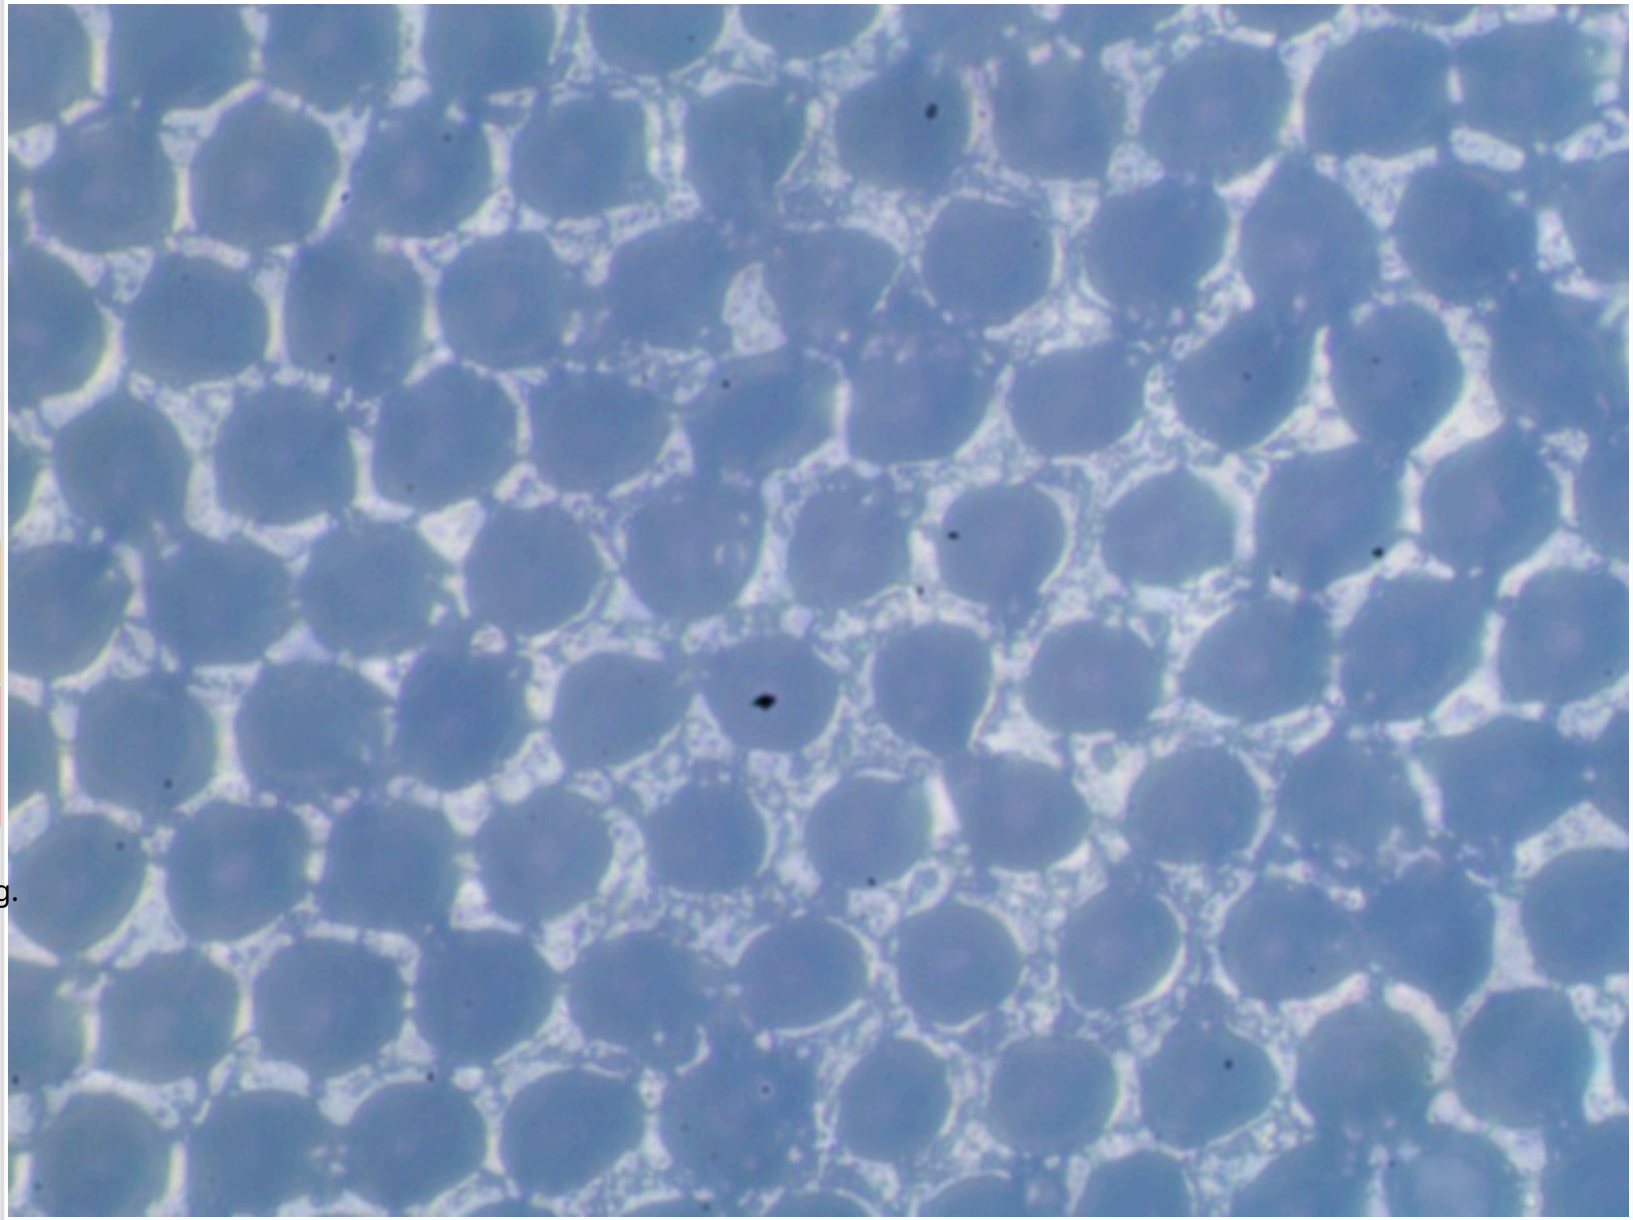
Page №84. Roll "h100750-1". Length: 1300 mm. Photos with magnificaiton: x400. Cleaning passes: 1

Comment
dent 255 268 273 273 303.
Roll ground off.

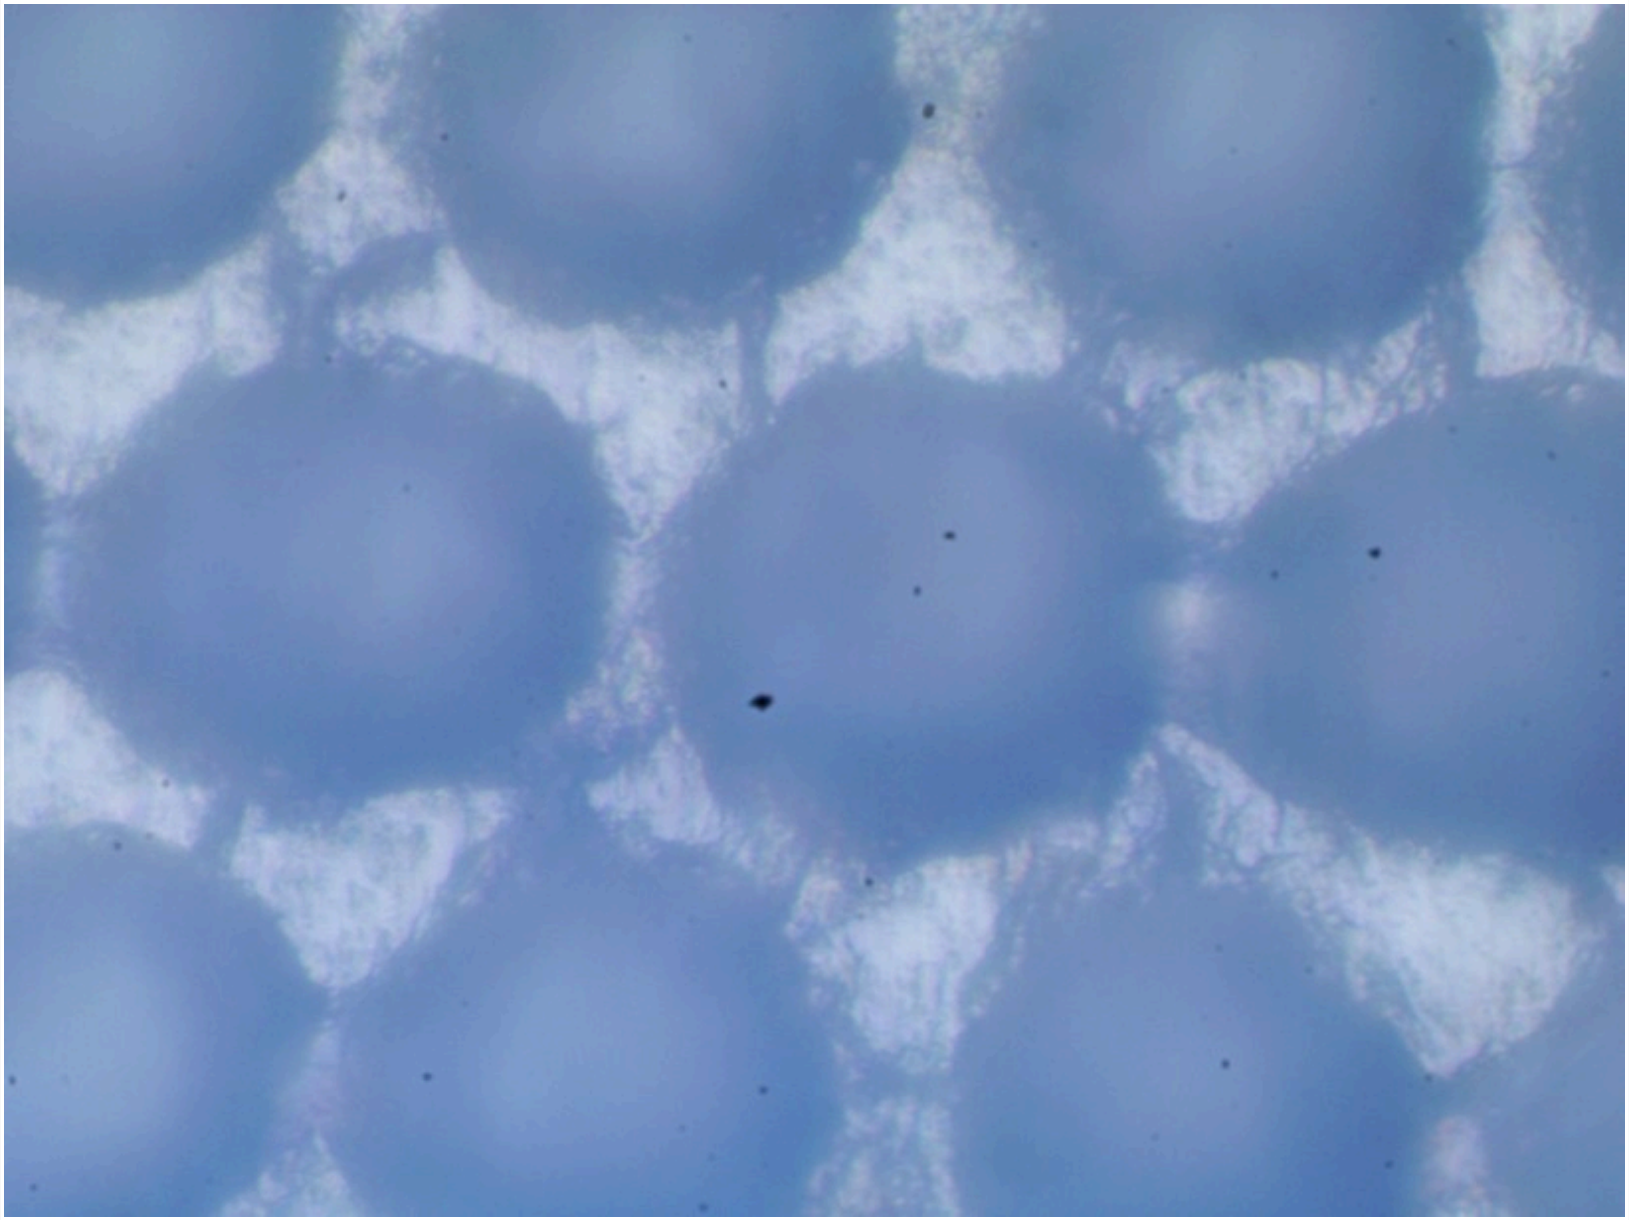
Page №85. Roll "z17011030". Length: 1300 mm. Photos with magnificaiton: x400. Cleaning passes: 1

Comment
streak 285 835 dent 460.
Roll ground off.

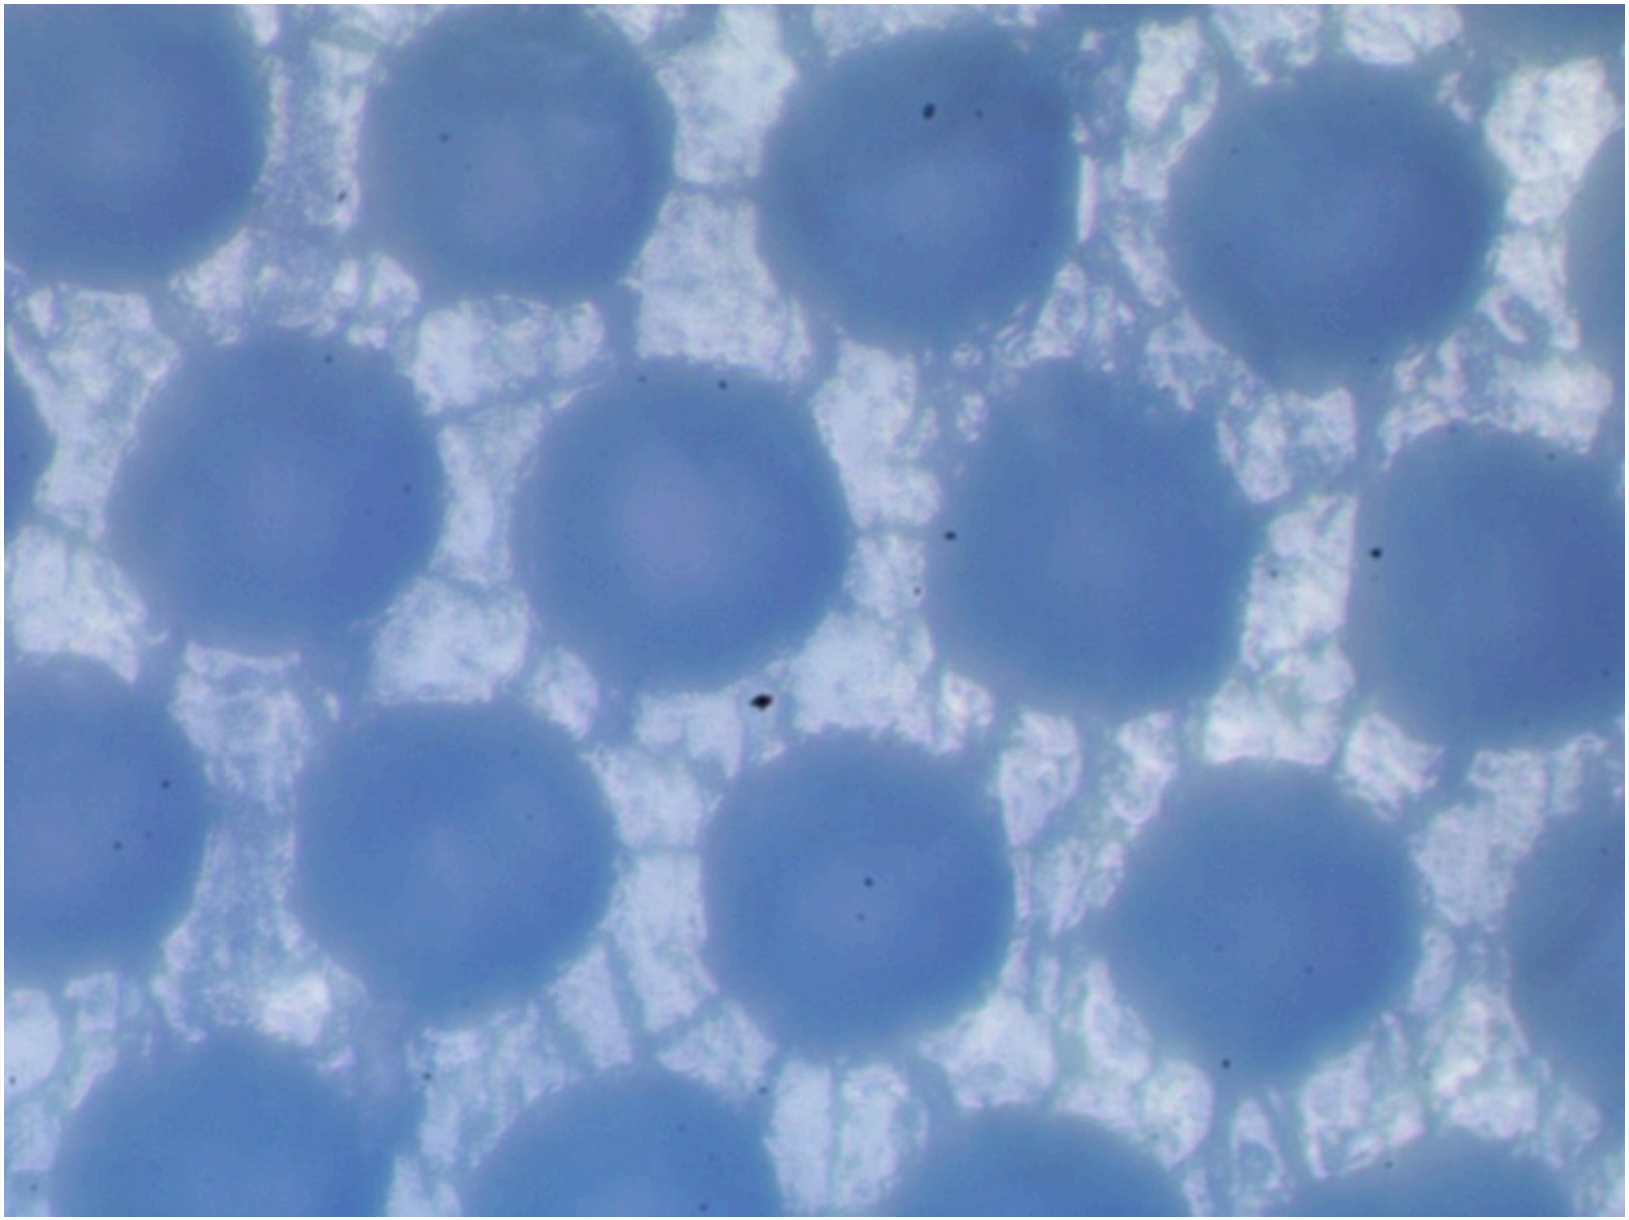
Page №86. Roll "z17011014". Length: 1300 mm. Photos with magnificaiton: x400. Cleaning passes: 1

Ink transfer volume decrease from the passport value: 47.22%

Comment
cell walls are missing streak dent 330 340 362 342 300
36 52 163 239 1228 842 970

1165 1280.
Roll heavily ground off.

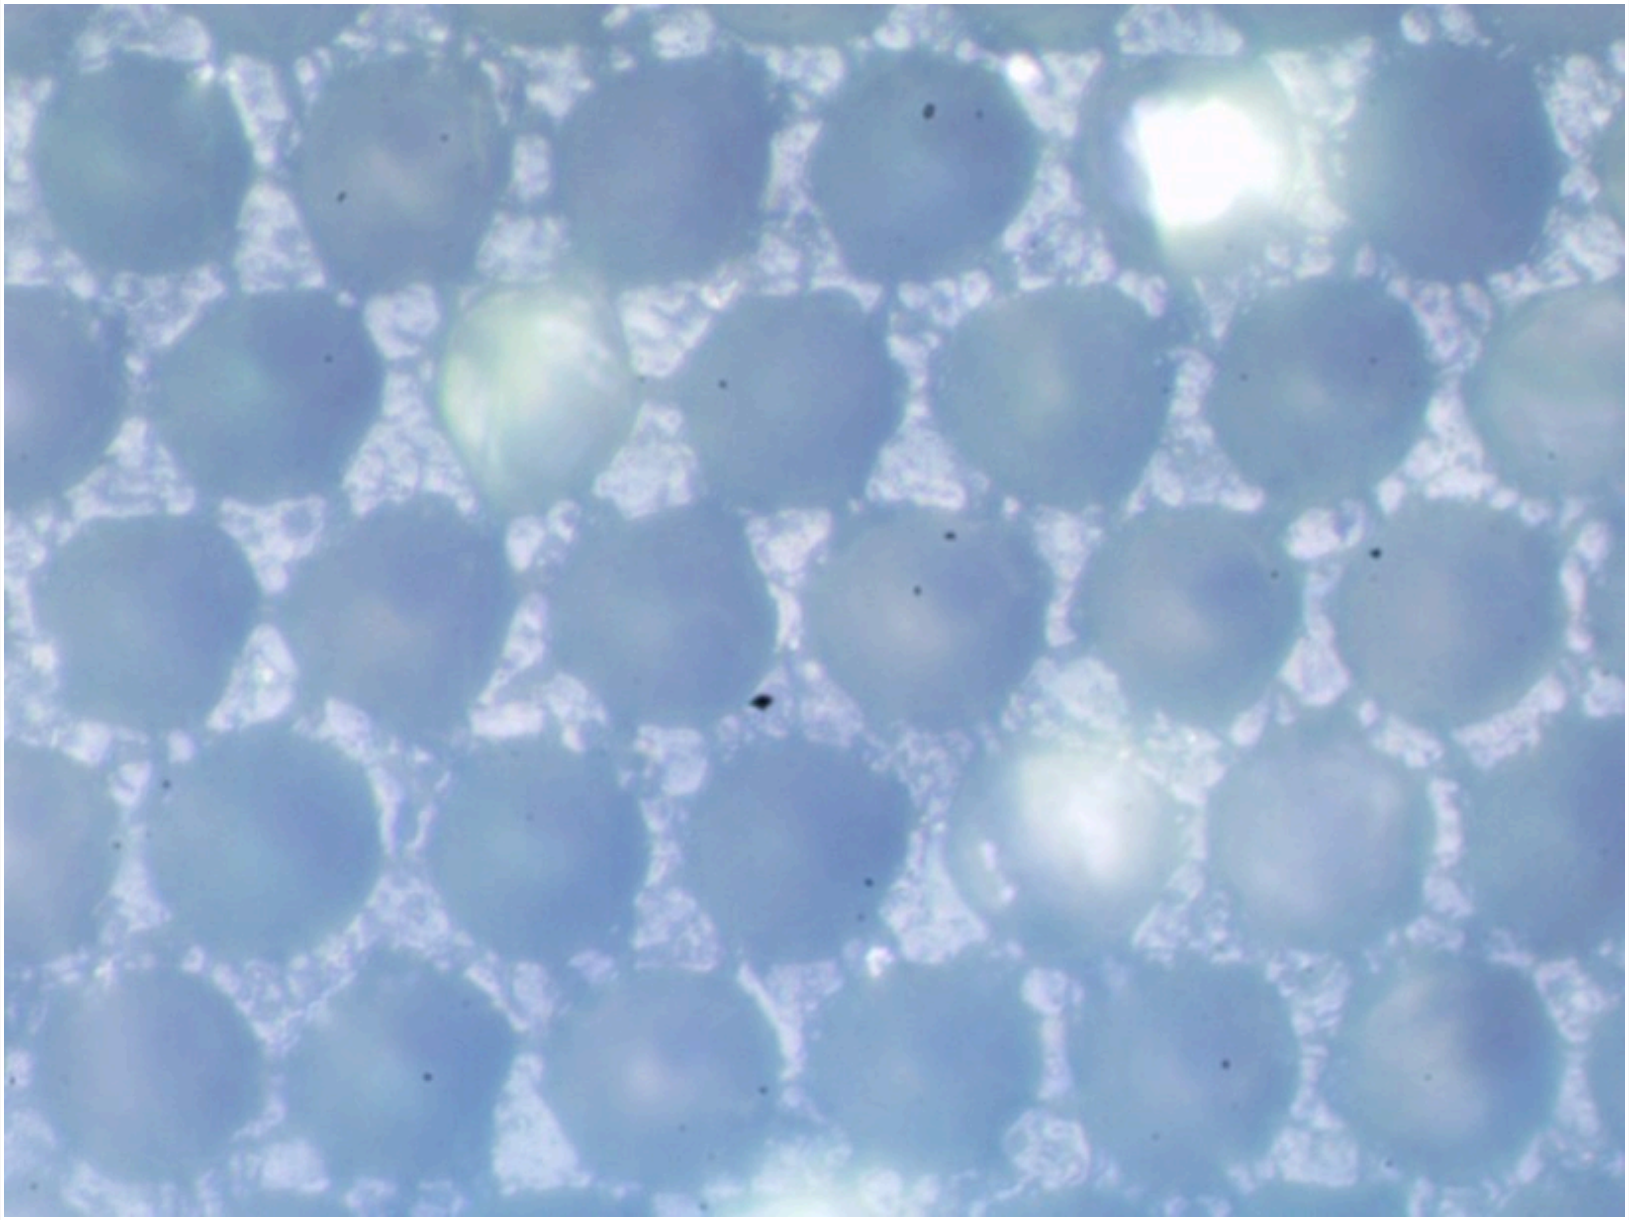
Page №88. Roll "046635". Length: 1300 mm. Photos with magnificaiton: x400. Cleaning passes: 1

Comment
scratch 1253.
Roll slightly ground off.

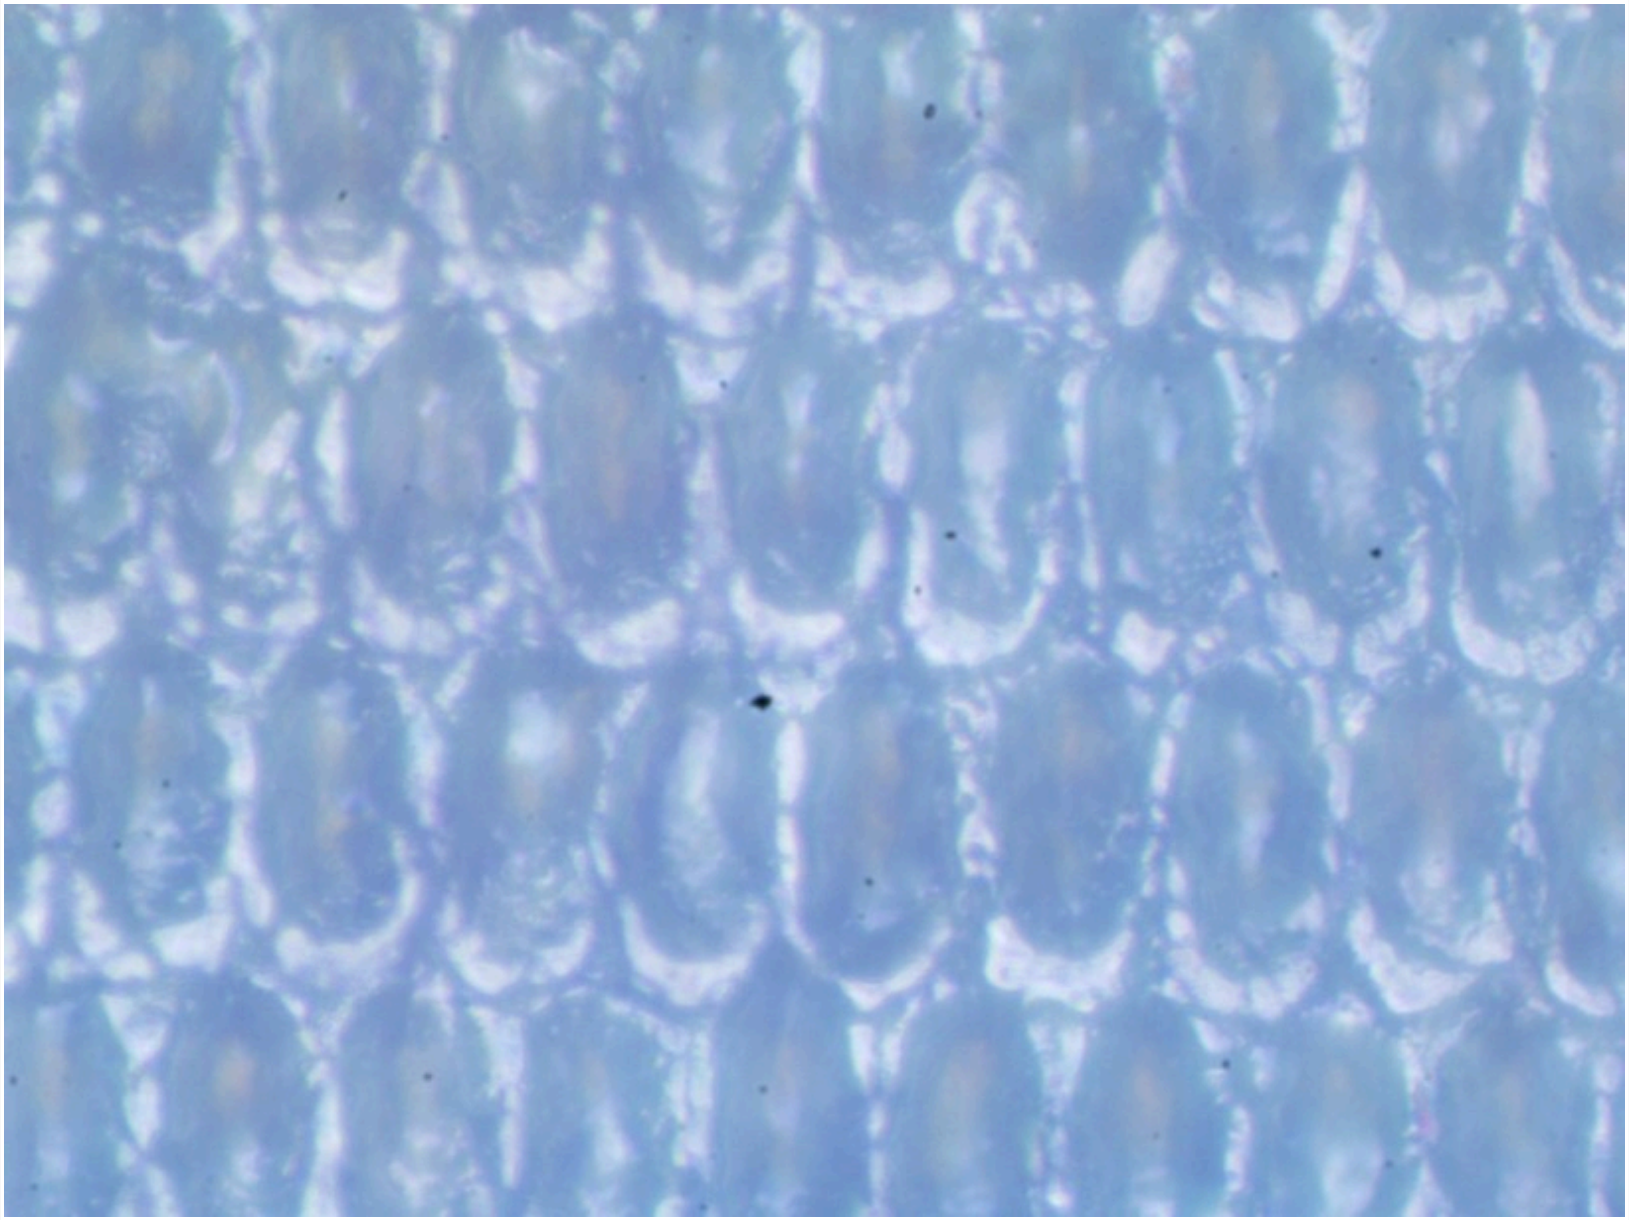
Page №89. Roll "z16007654". Length: 870 mm. Photos with magnificaiton: x400. Cleaning passes: 1

Comment
streak 120 409 689.
Roll ground off.
