RollerCheck360

Roll Inspection from 08.12.2025

Rolls: 178

We have analyzed for you 178 rolls.

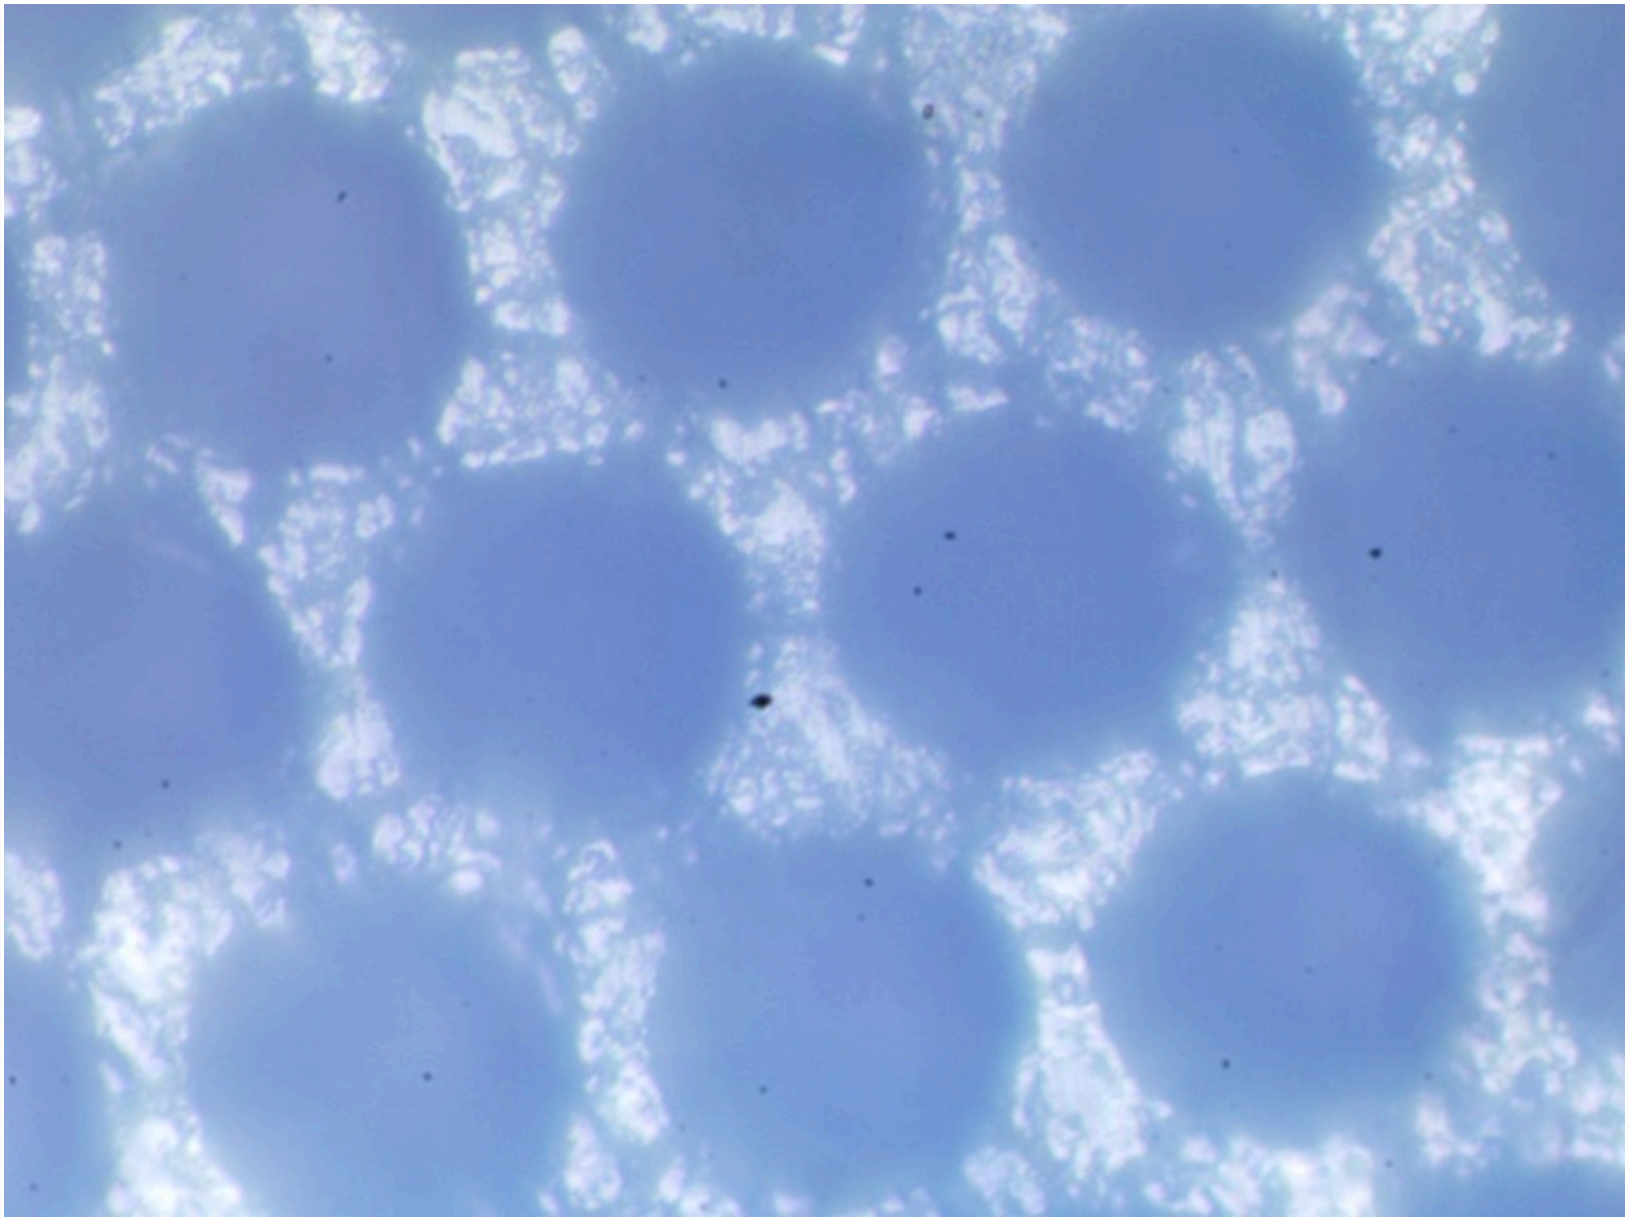
Page №90. Roll "3016198-2". Length: 870 mm. Photos with magnificaiton: x400. Cleaning passes: 1

Comment
streaks.
Roll slightly ground off.

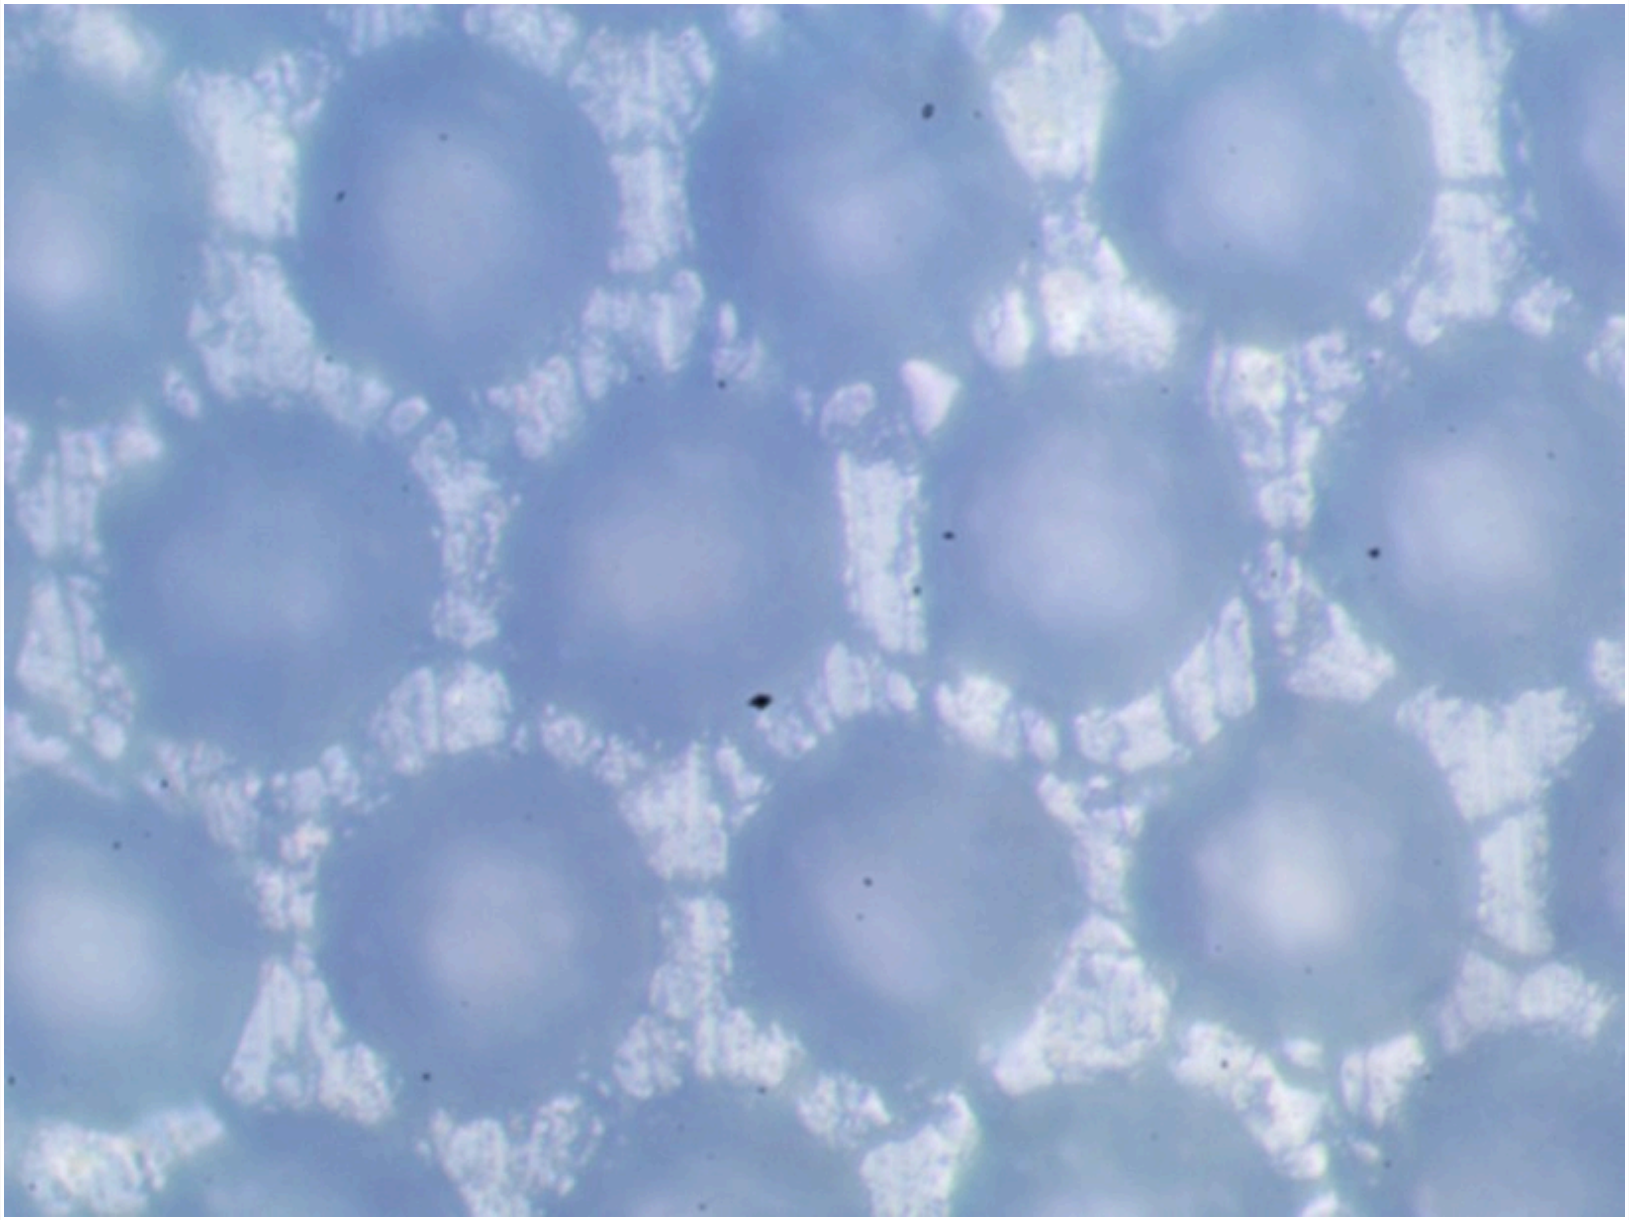
Page №91. Roll "z16007659". Length: 870 mm. Photos with magnificaiton: x400. Cleaning passes: 1

Comment
streak 860 streaks.
Roll ground off.

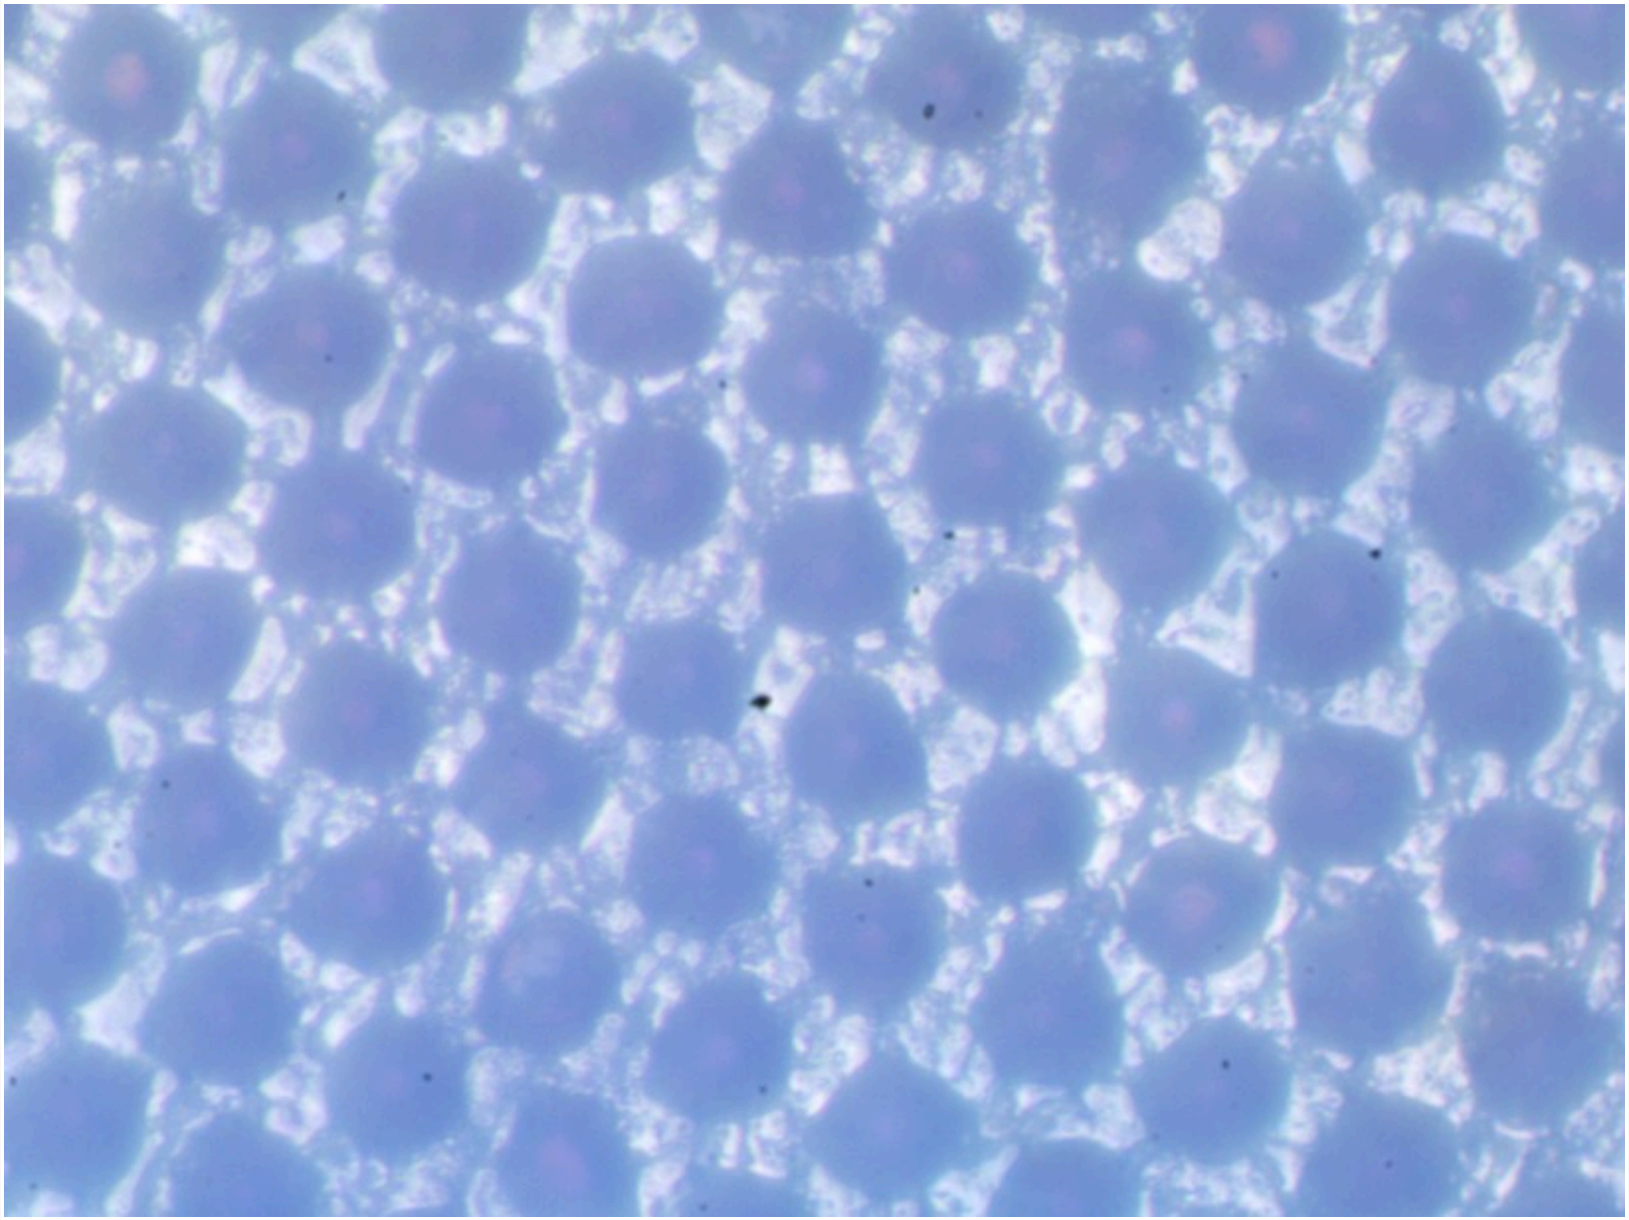
Page №92. Roll "z16007663". Length: 870 mm. Photos with magnificaiton: x400. Cleaning passes: 1

Comment
worn streak 739 748 streaks scratch 860.

Roll heavily ground off.

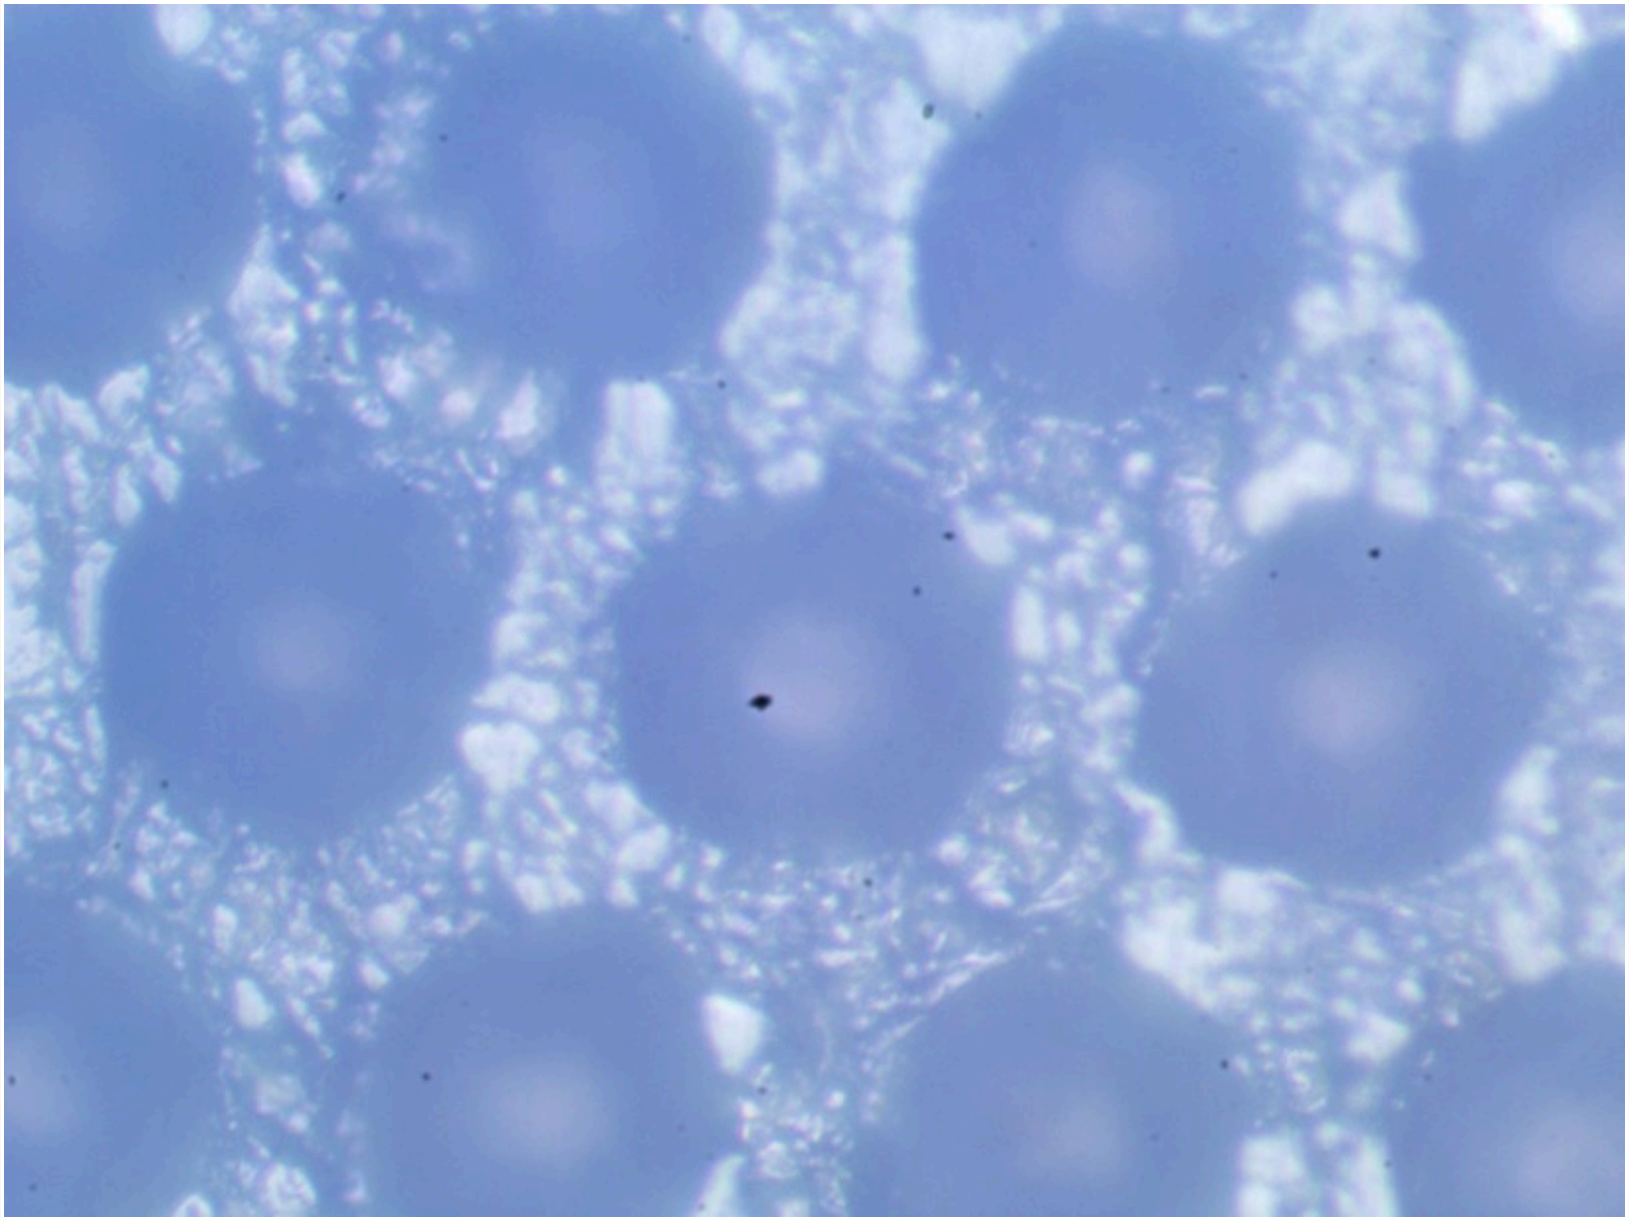
Page №93. Roll "z16007646". Length: 870 mm. Photos with magnificaiton: x400. Cleaning passes: 1

Comment
streak 112 254.
Roll ground off.

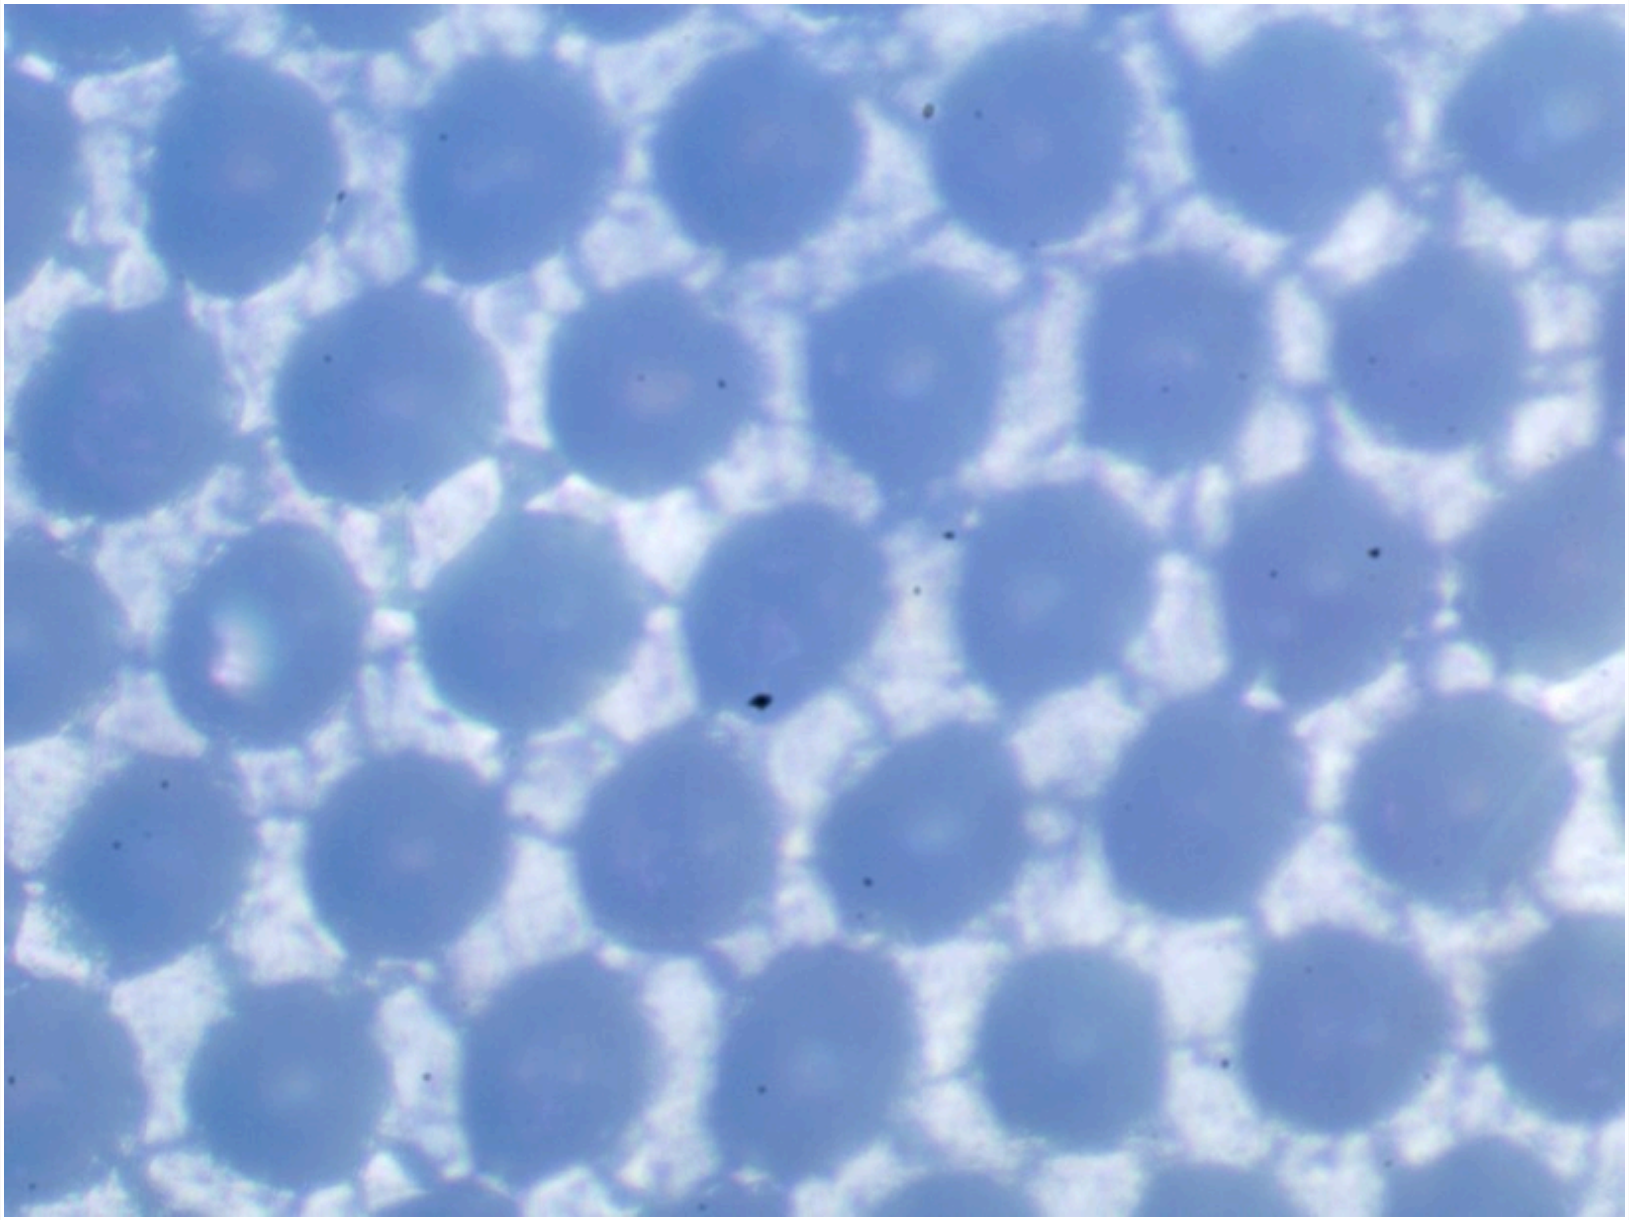
Page №94. Roll "sa008613". Length: 870 mm. Photos with magnificaiton: x400. Cleaning passes: 1

Comment
spots streak 129 151 158.
Roll ground off.

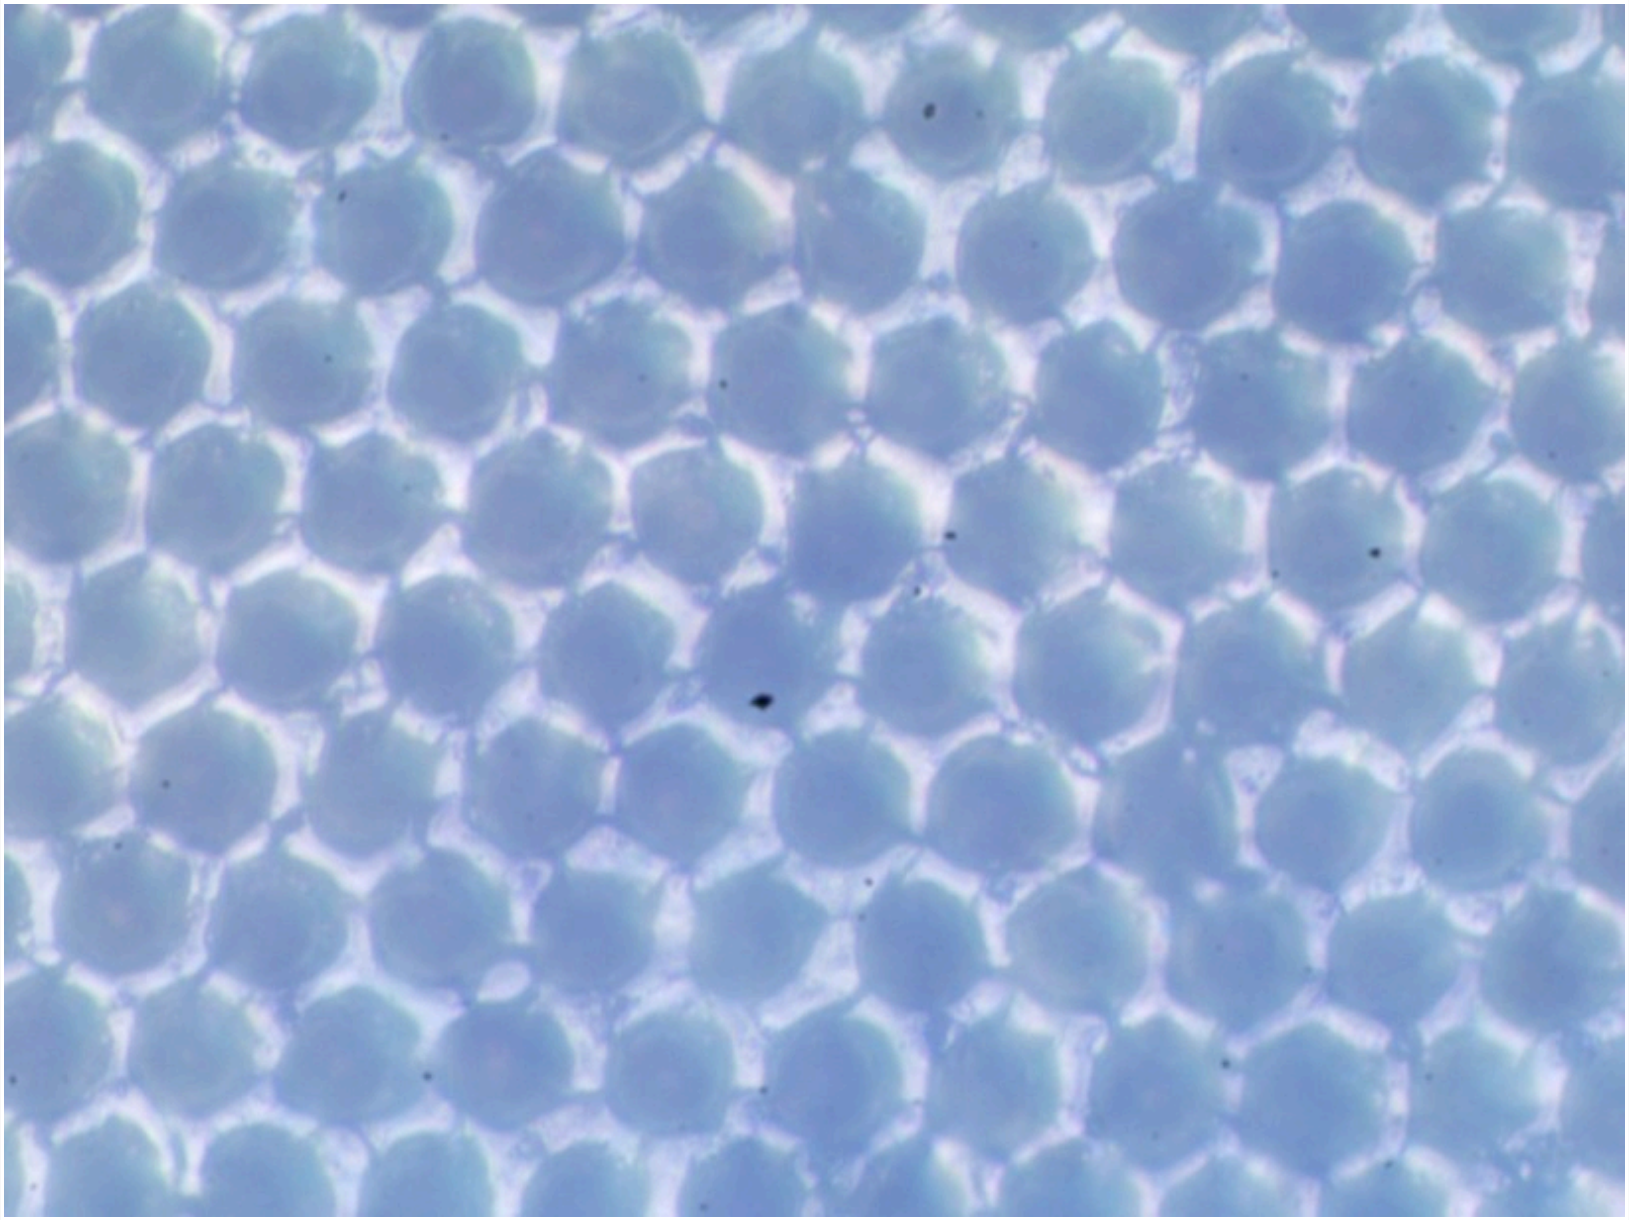
Page №95. Roll "alt17447". Length: 870 mm. Photos with magnificaiton: x400. Cleaning passes: 1

Bridge / Cell: 1 / 2
Depth before / after: 25 / 25 мкм
Depth decreased by: 0%

Comment
worn spots.
Roll heavily ground off.

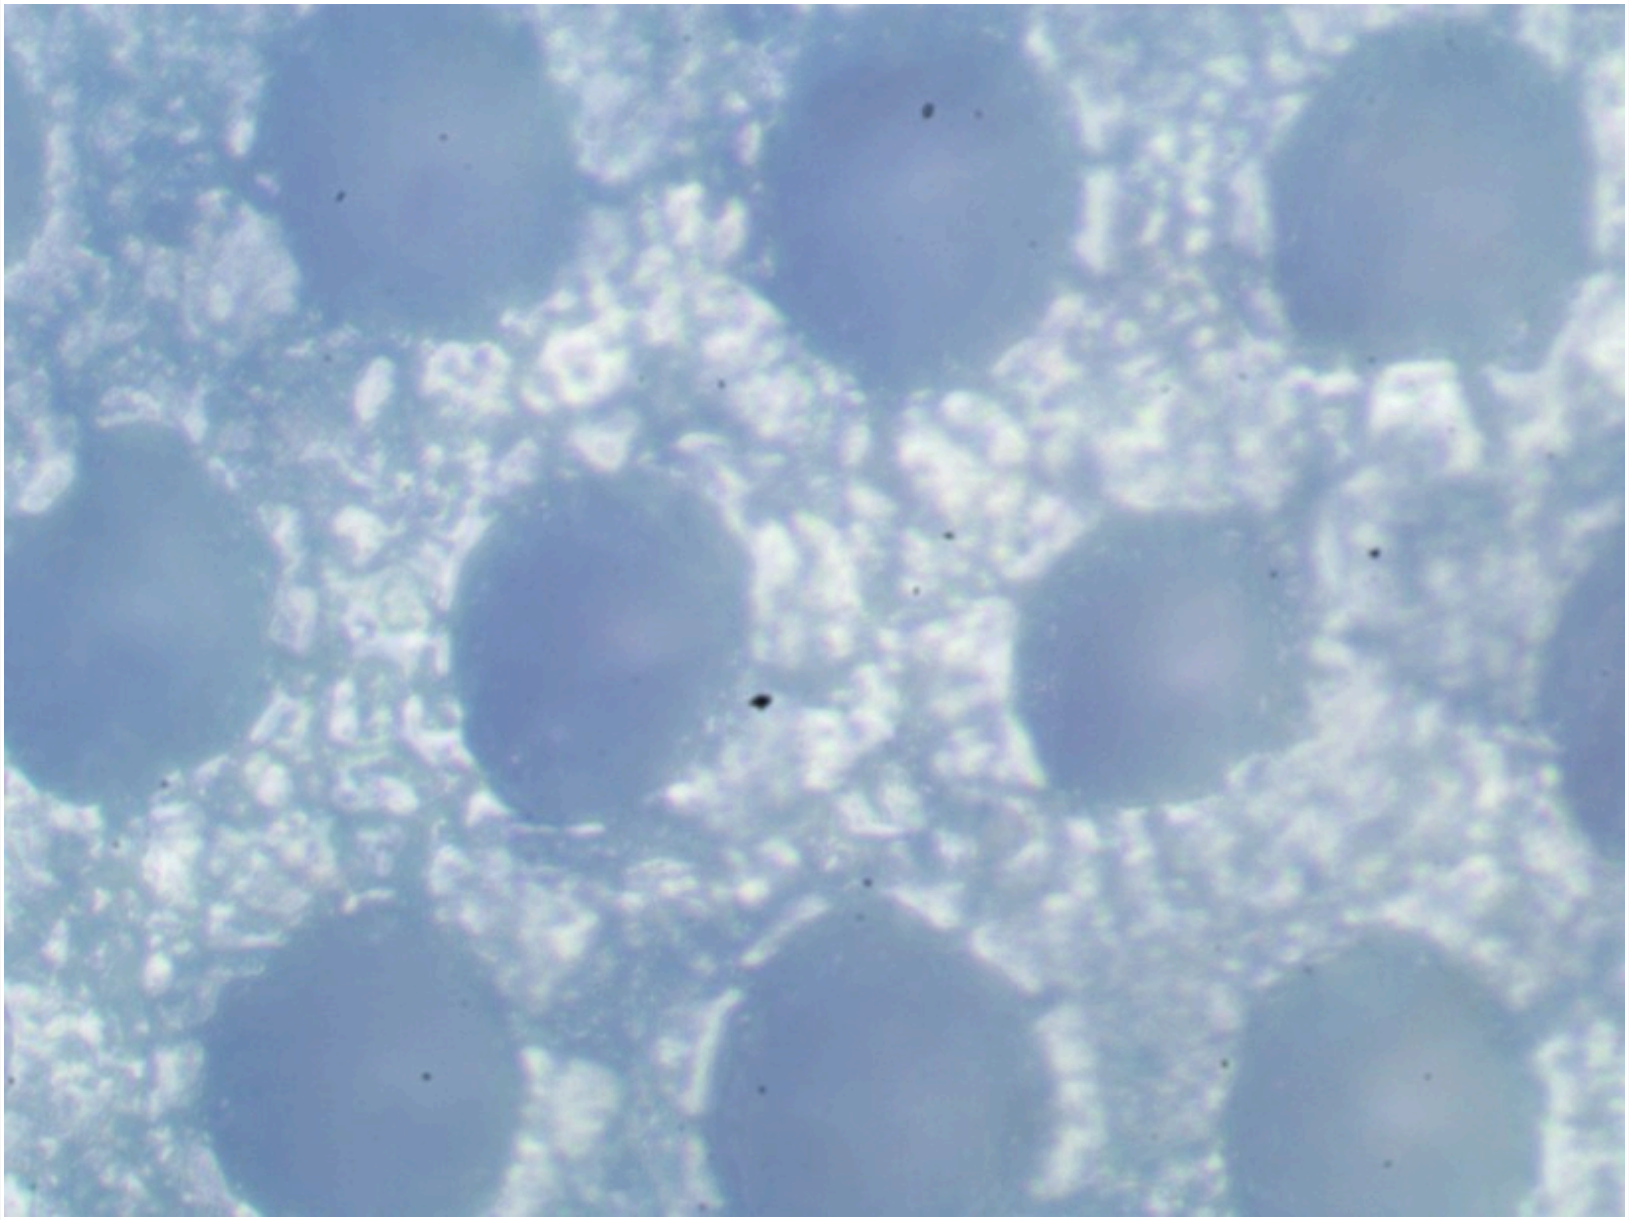
Page №96. Roll "aa2413650". Length: 1320 mm. Photos with magnificaiton: x400. Cleaning passes: 1

Ink transfer volume decrease from the passport value: 15.79%

Comment
streaks.
Roll ground off.

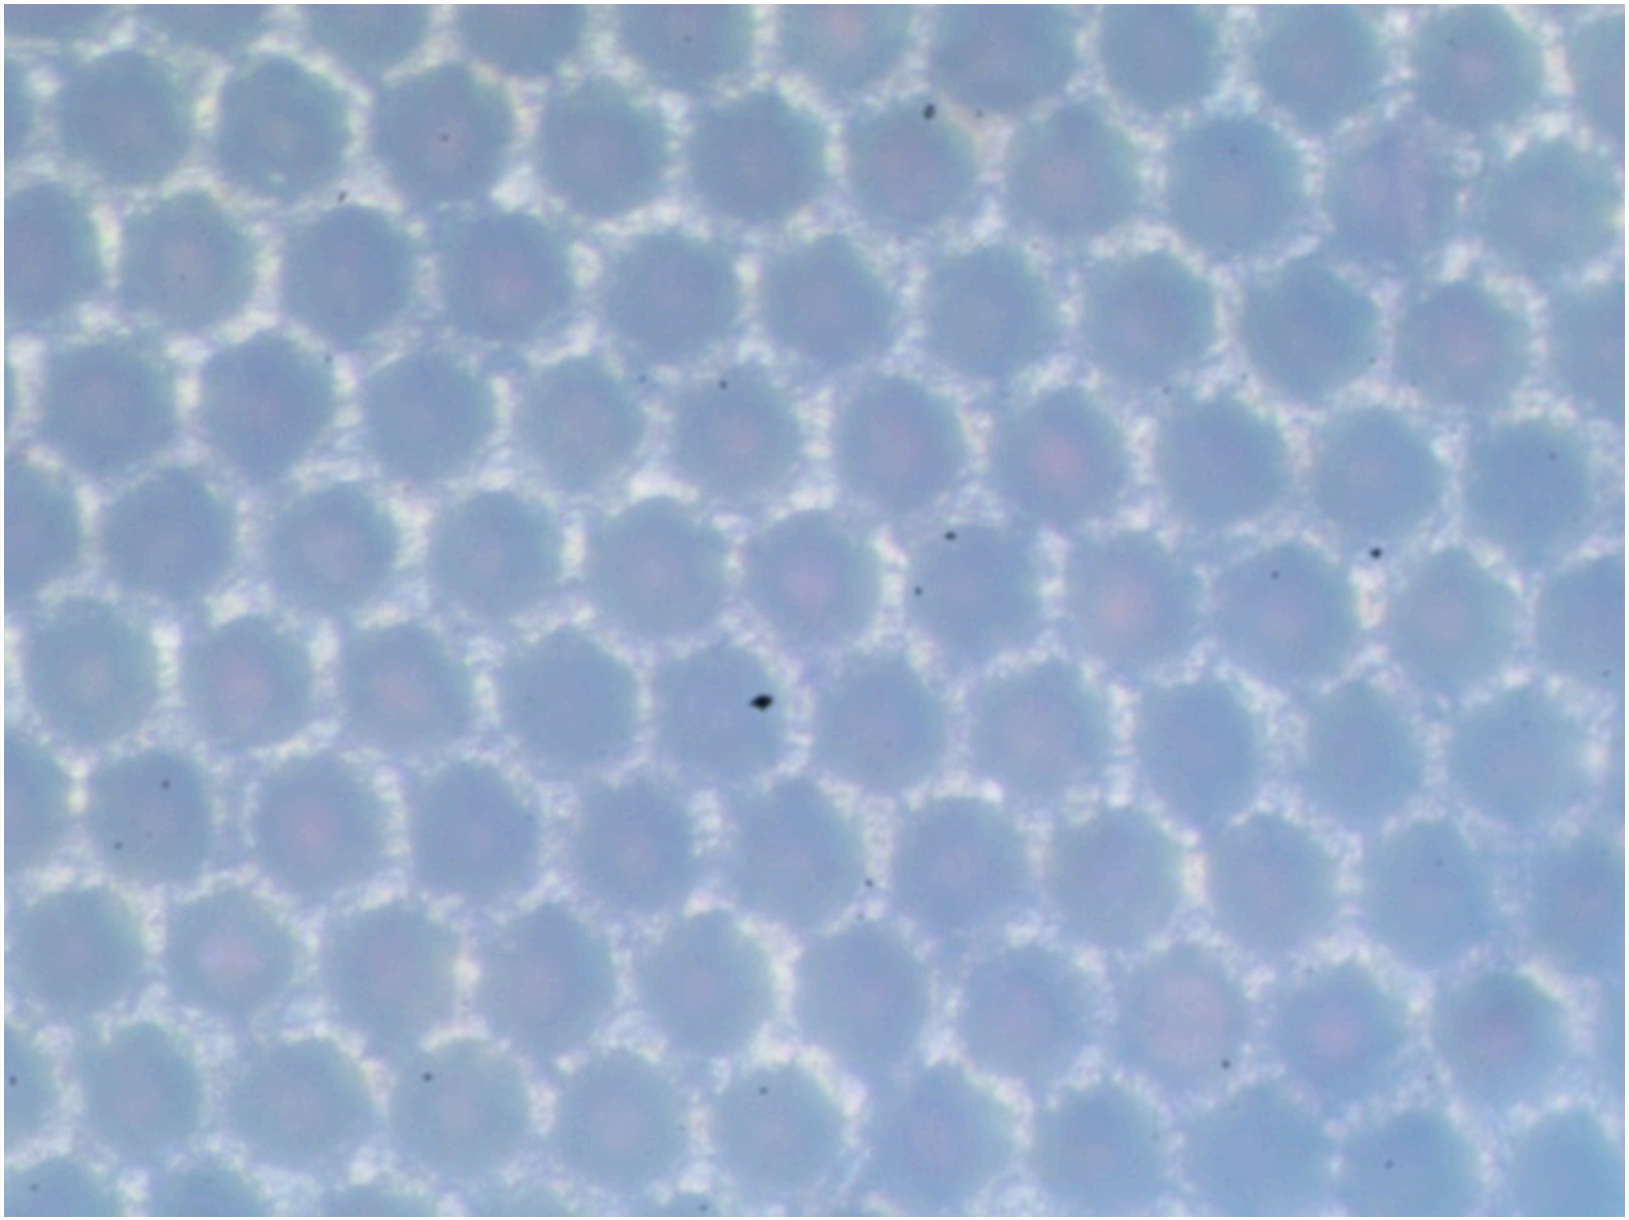
Page №97. Roll "aa2413653". Length: 1320 mm. Photos with magnificaiton: x400. Cleaning passes: 1

Comment
streaks.
Roll ground off.

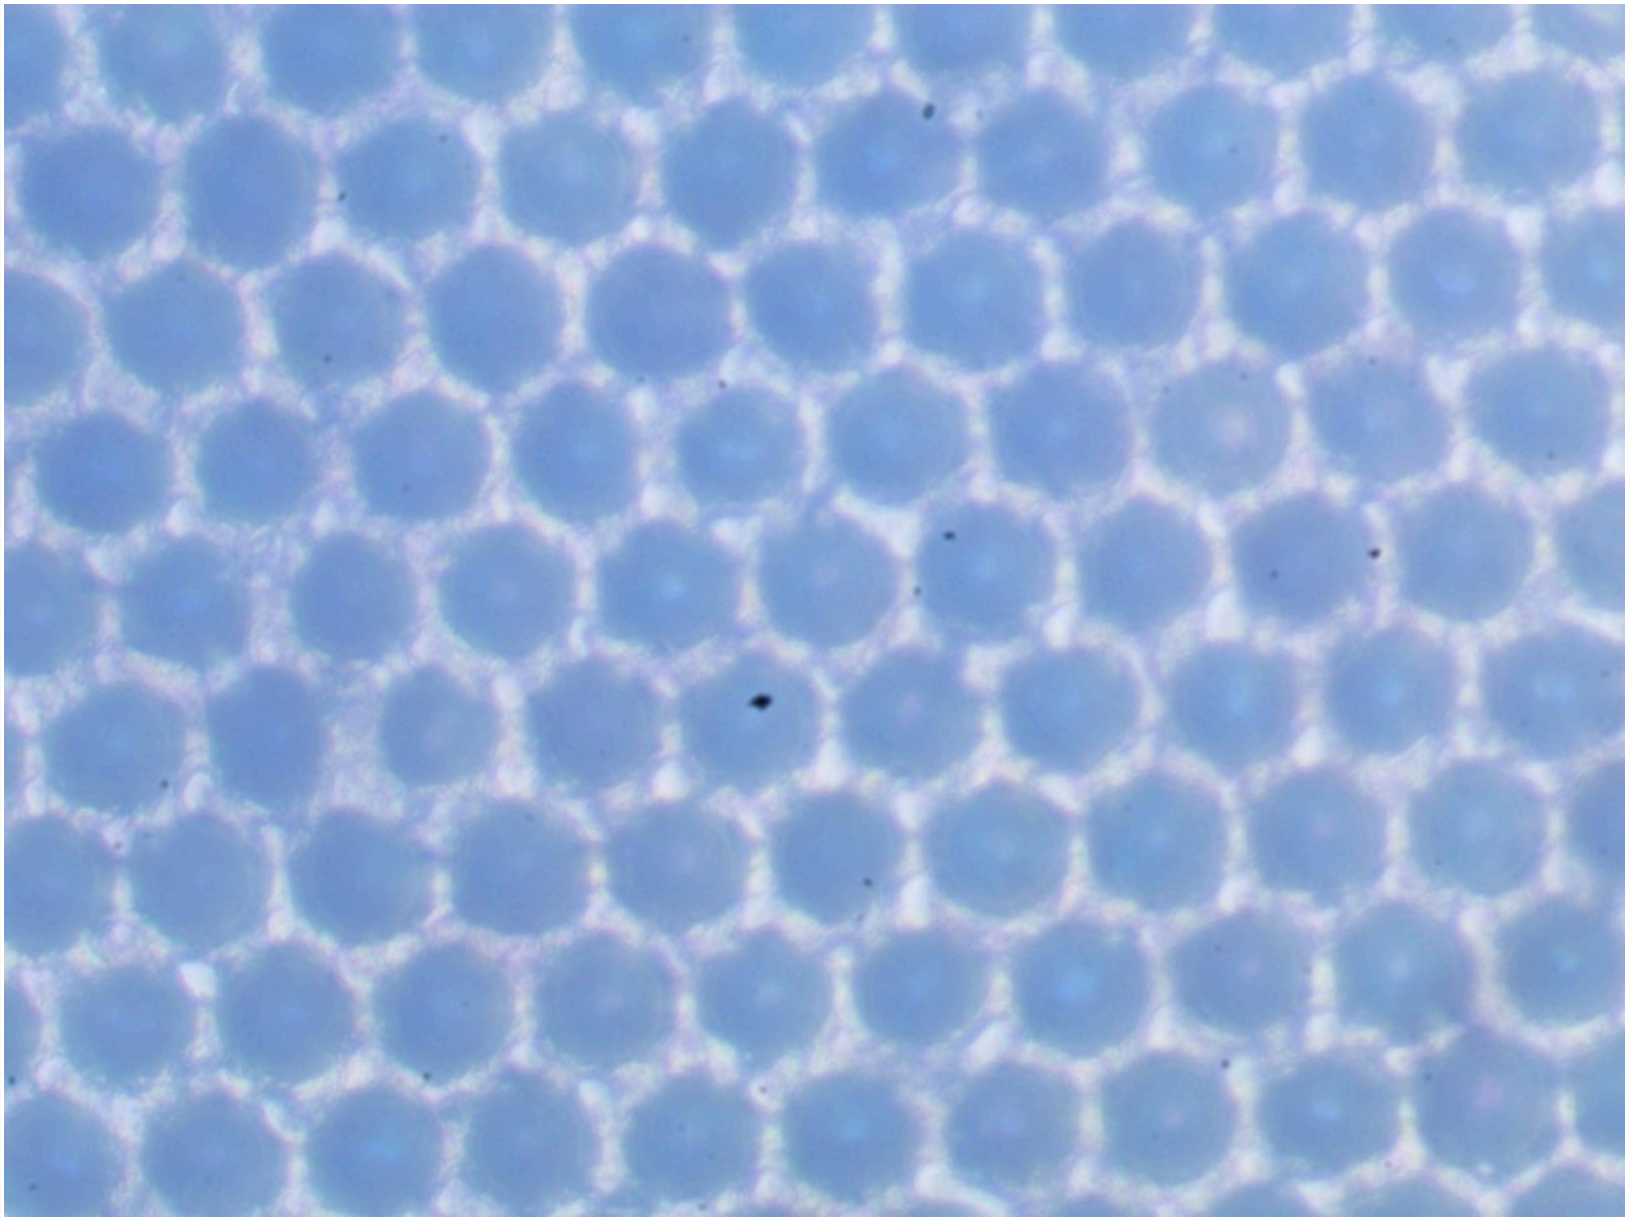
Page №98. Roll "z18008079". Length: 1320 mm. Photos with magnificaiton: x400. Cleaning passes: 1

Comment
streak 134.
Roll ground off.

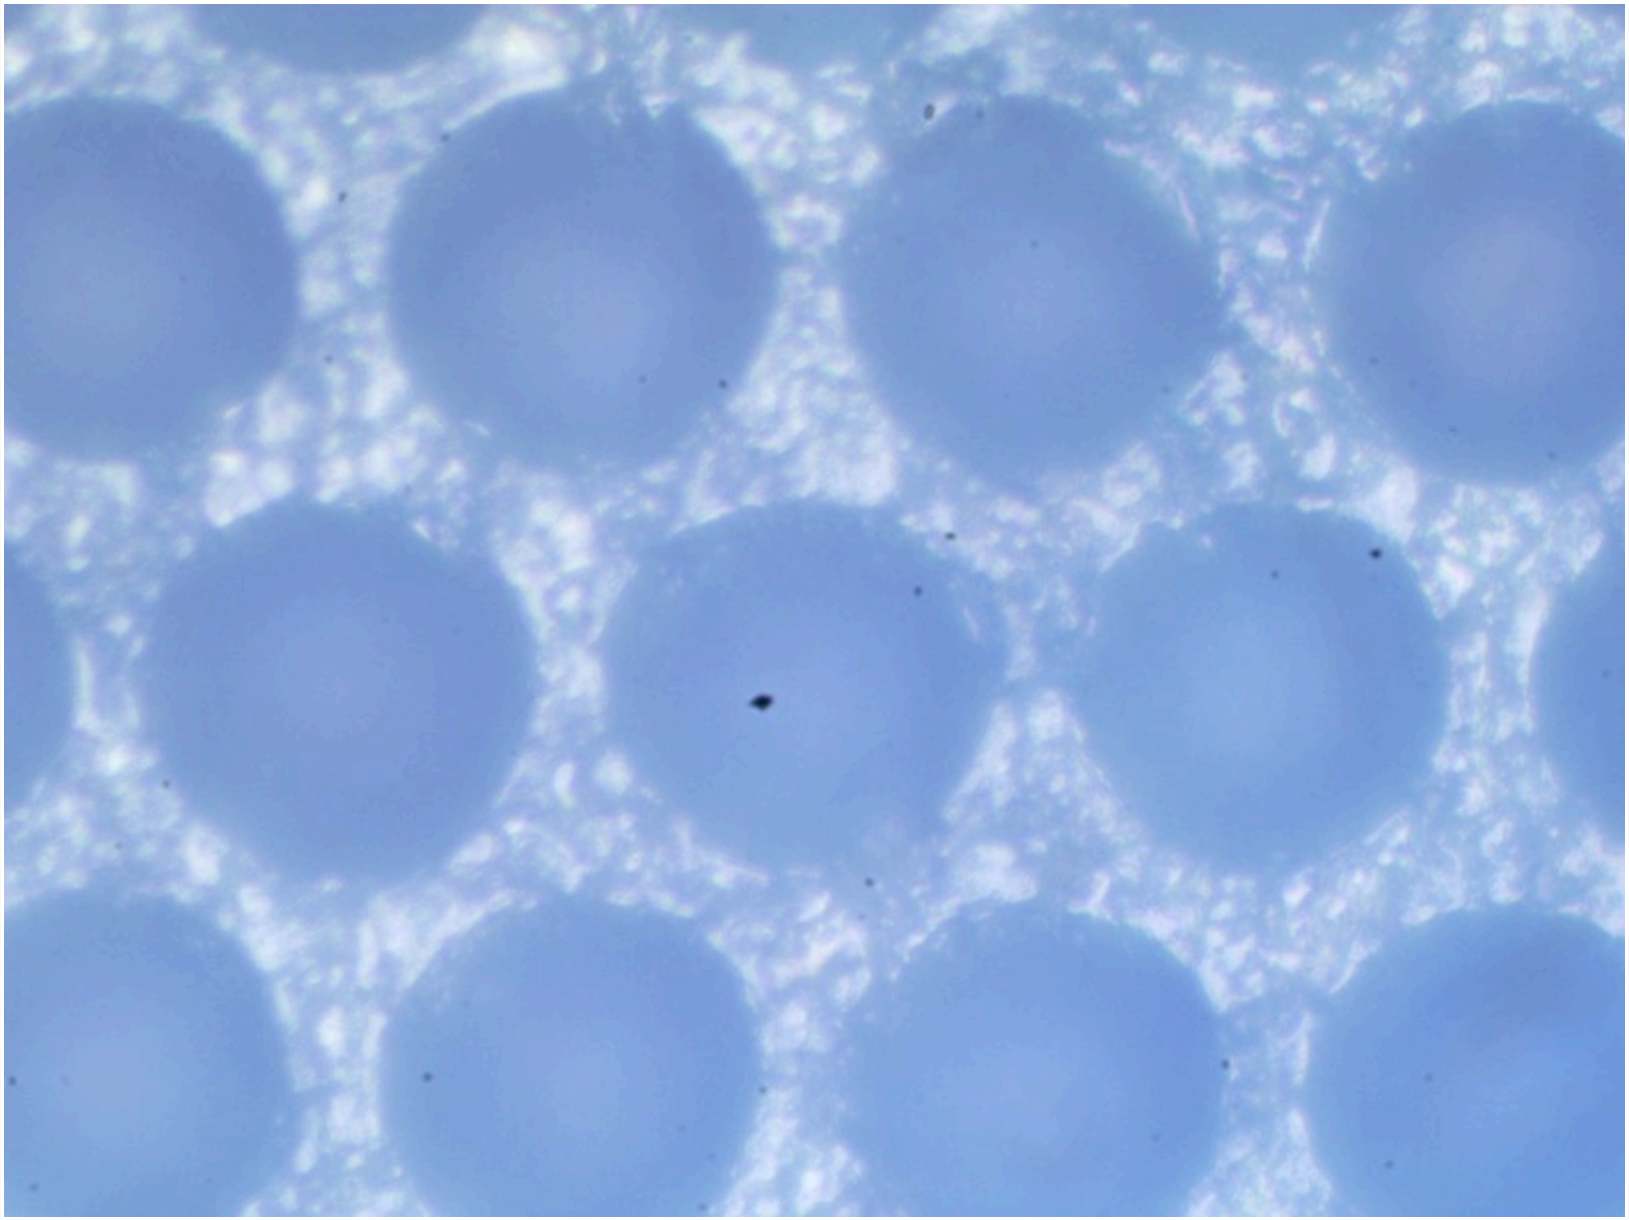
Page №99. Roll "aa2409897". Length: 1320 mm. Photos with magnificaiton: x400. Cleaning passes: 1

Comment
streak 900.

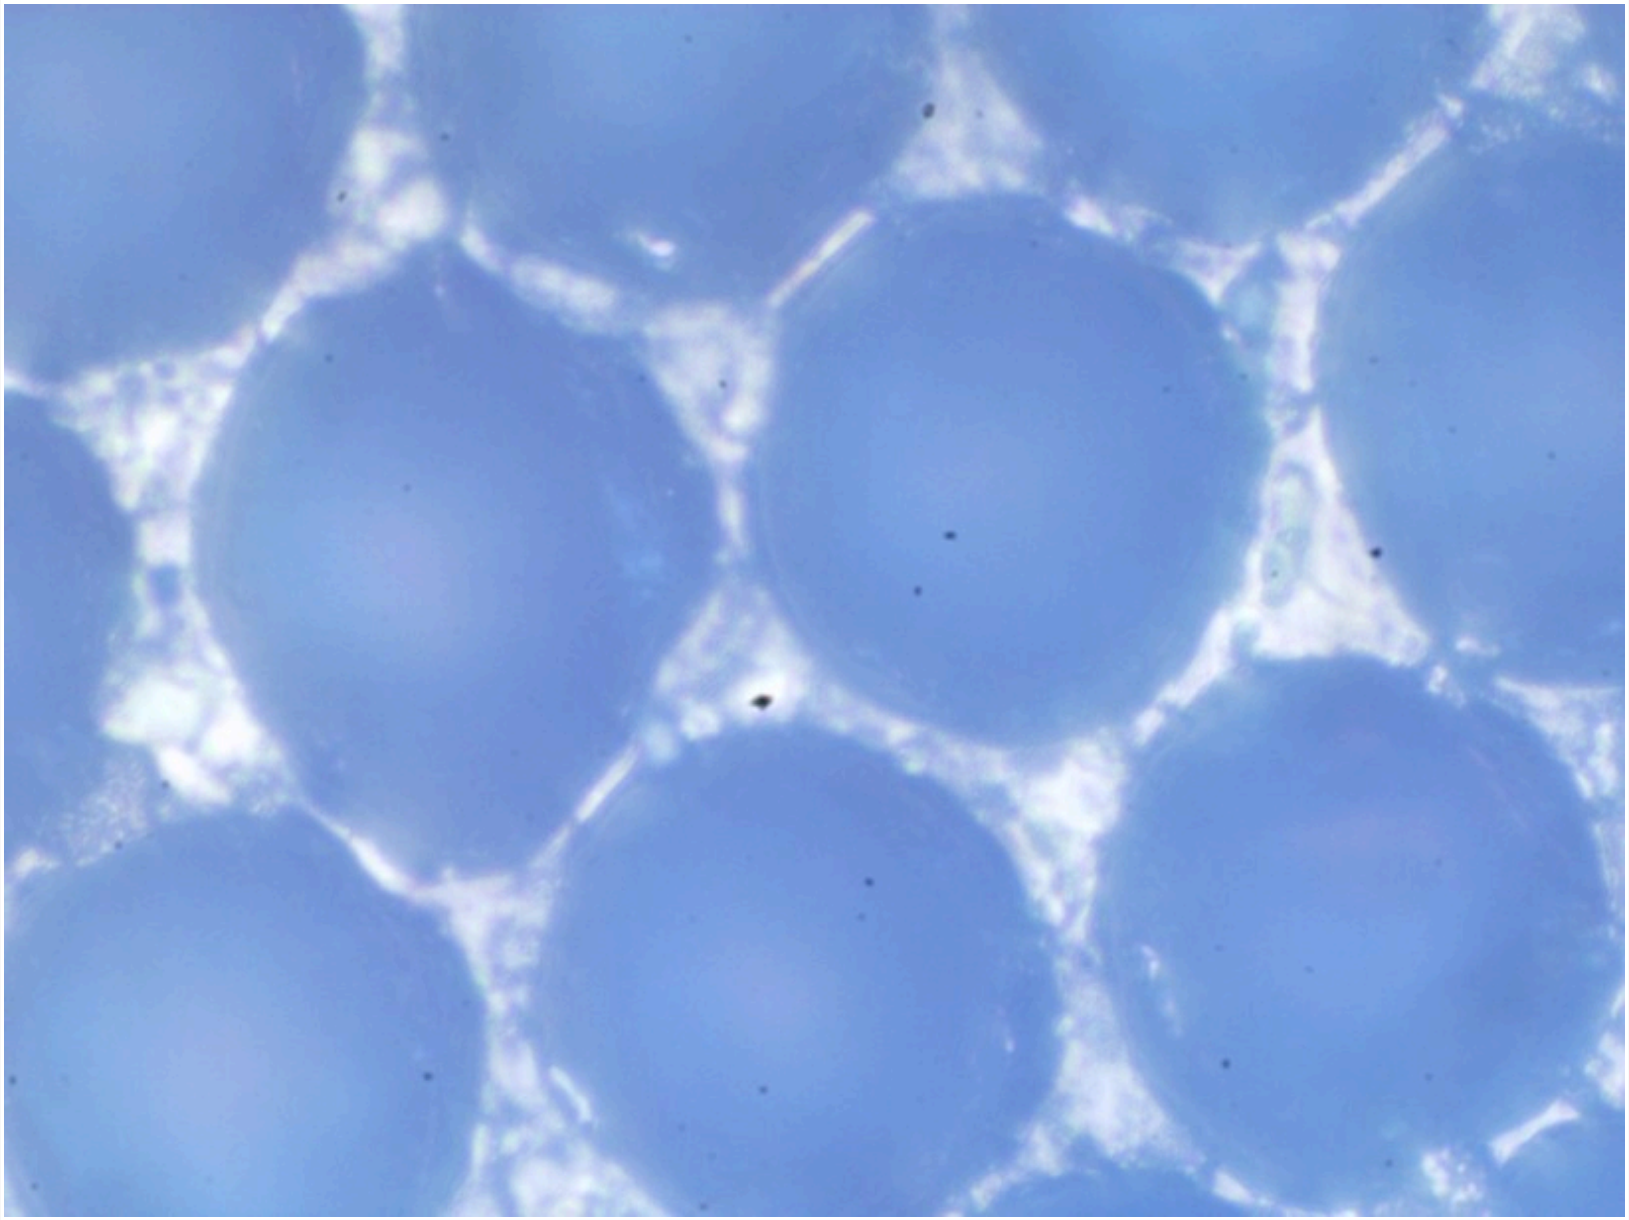
Page №100. Roll "ad007096". Length: 1320 mm. Photos with magnificaiton: x400. Cleaning passes: 1

Comment
streak 759.
Roll ground off.
