RollerCheck360

Roll Inspection from 08.12.2025

Rolls: 178

We have analyzed for you 178 rolls.

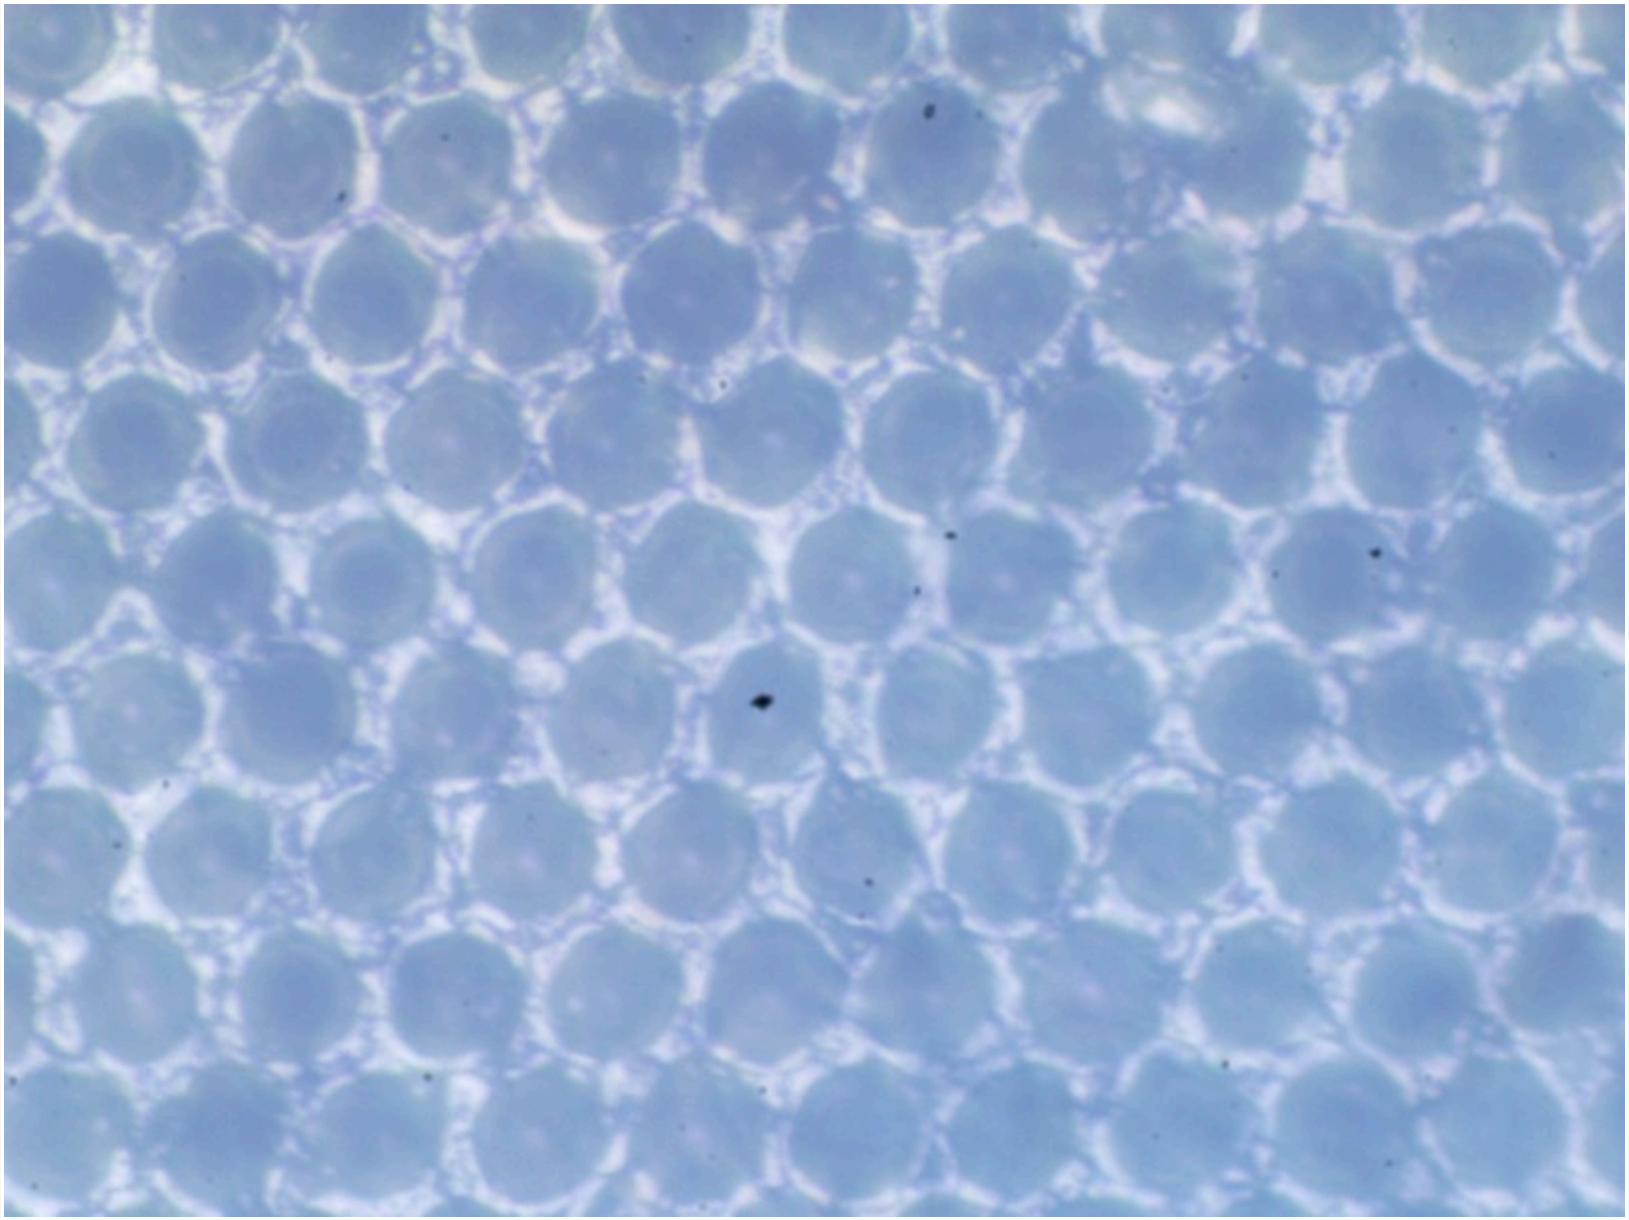
Page №101. Roll "z45229". Length: 1300 mm. Photos with magnificaiton: x400. Cleaning passes: 1

Comment
worn streak 78 875 100 65 50 1255
dent 213 234 1243 1265.

Roll heavily ground off.

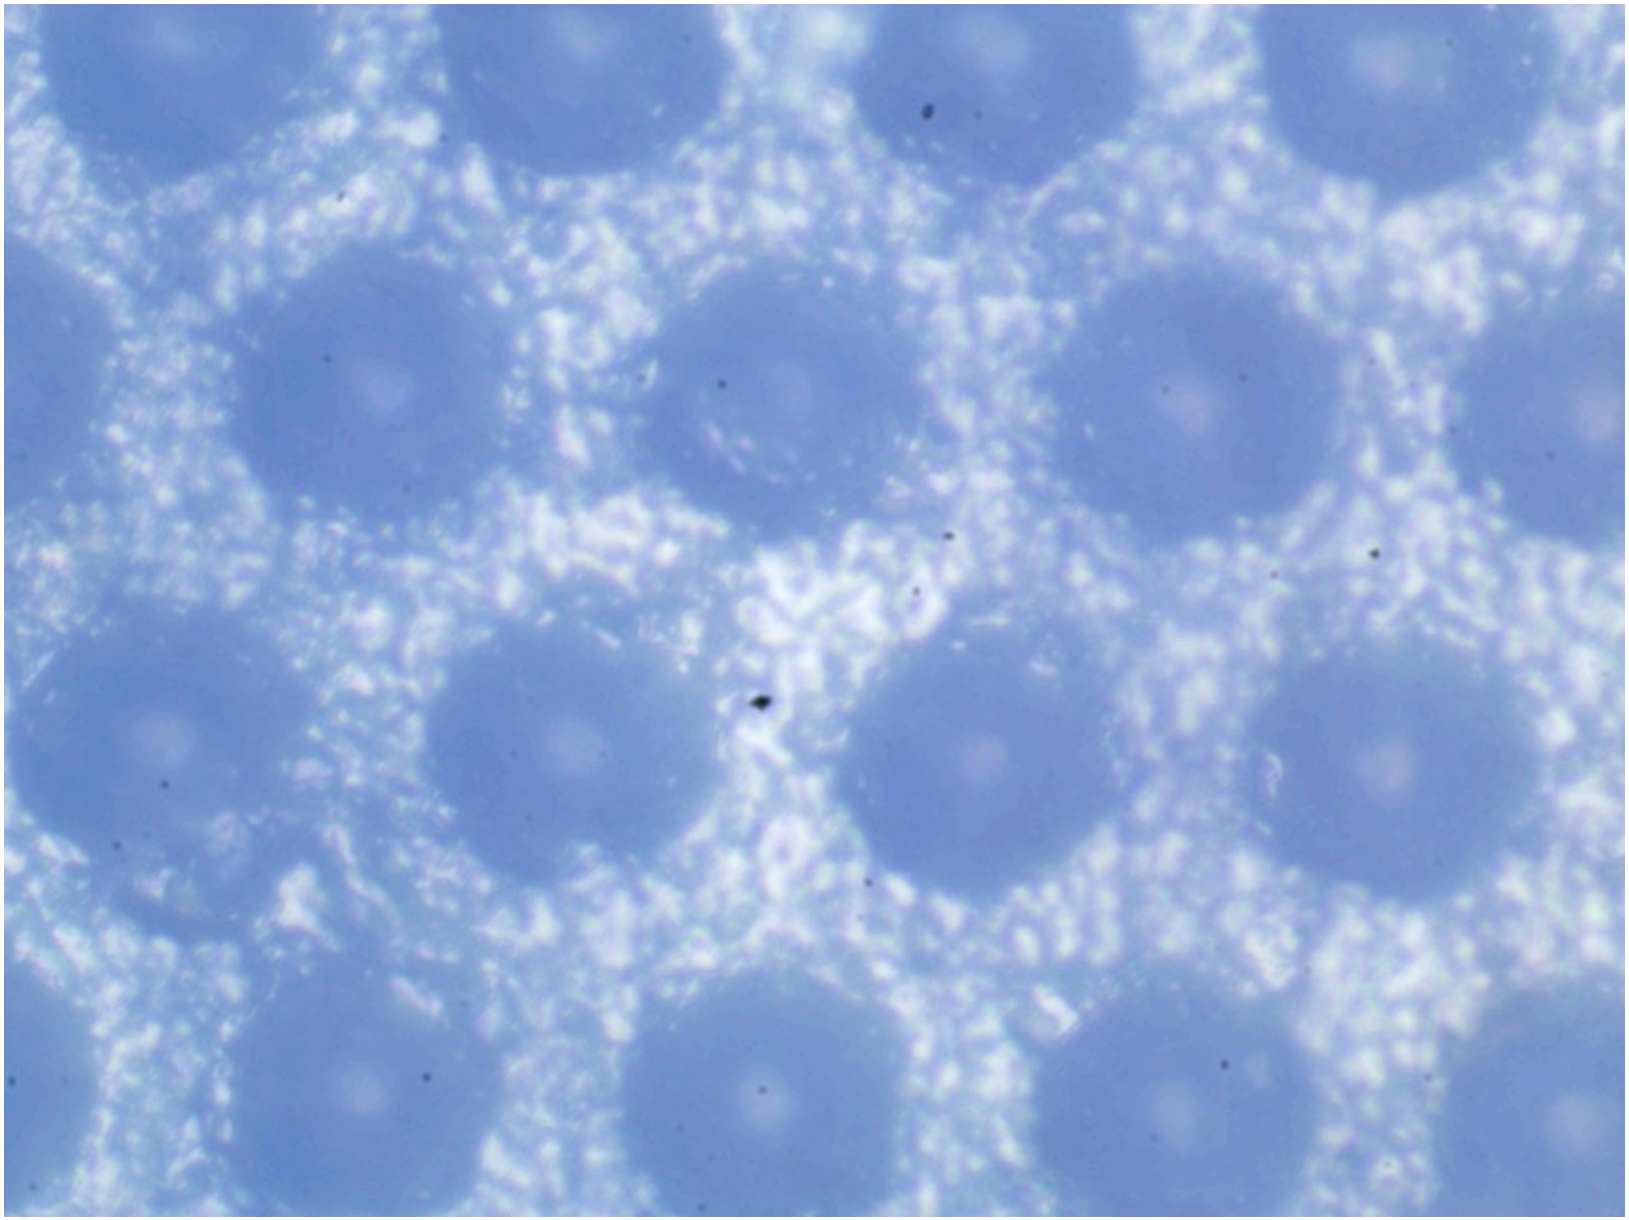
Page №102. Roll "sa008592". Length: 1300 mm. Photos with magnificaiton: x400. Cleaning passes: 1

Comment
worn streak 110 scratch dent 1185.
390 400 414 510 523 535 555

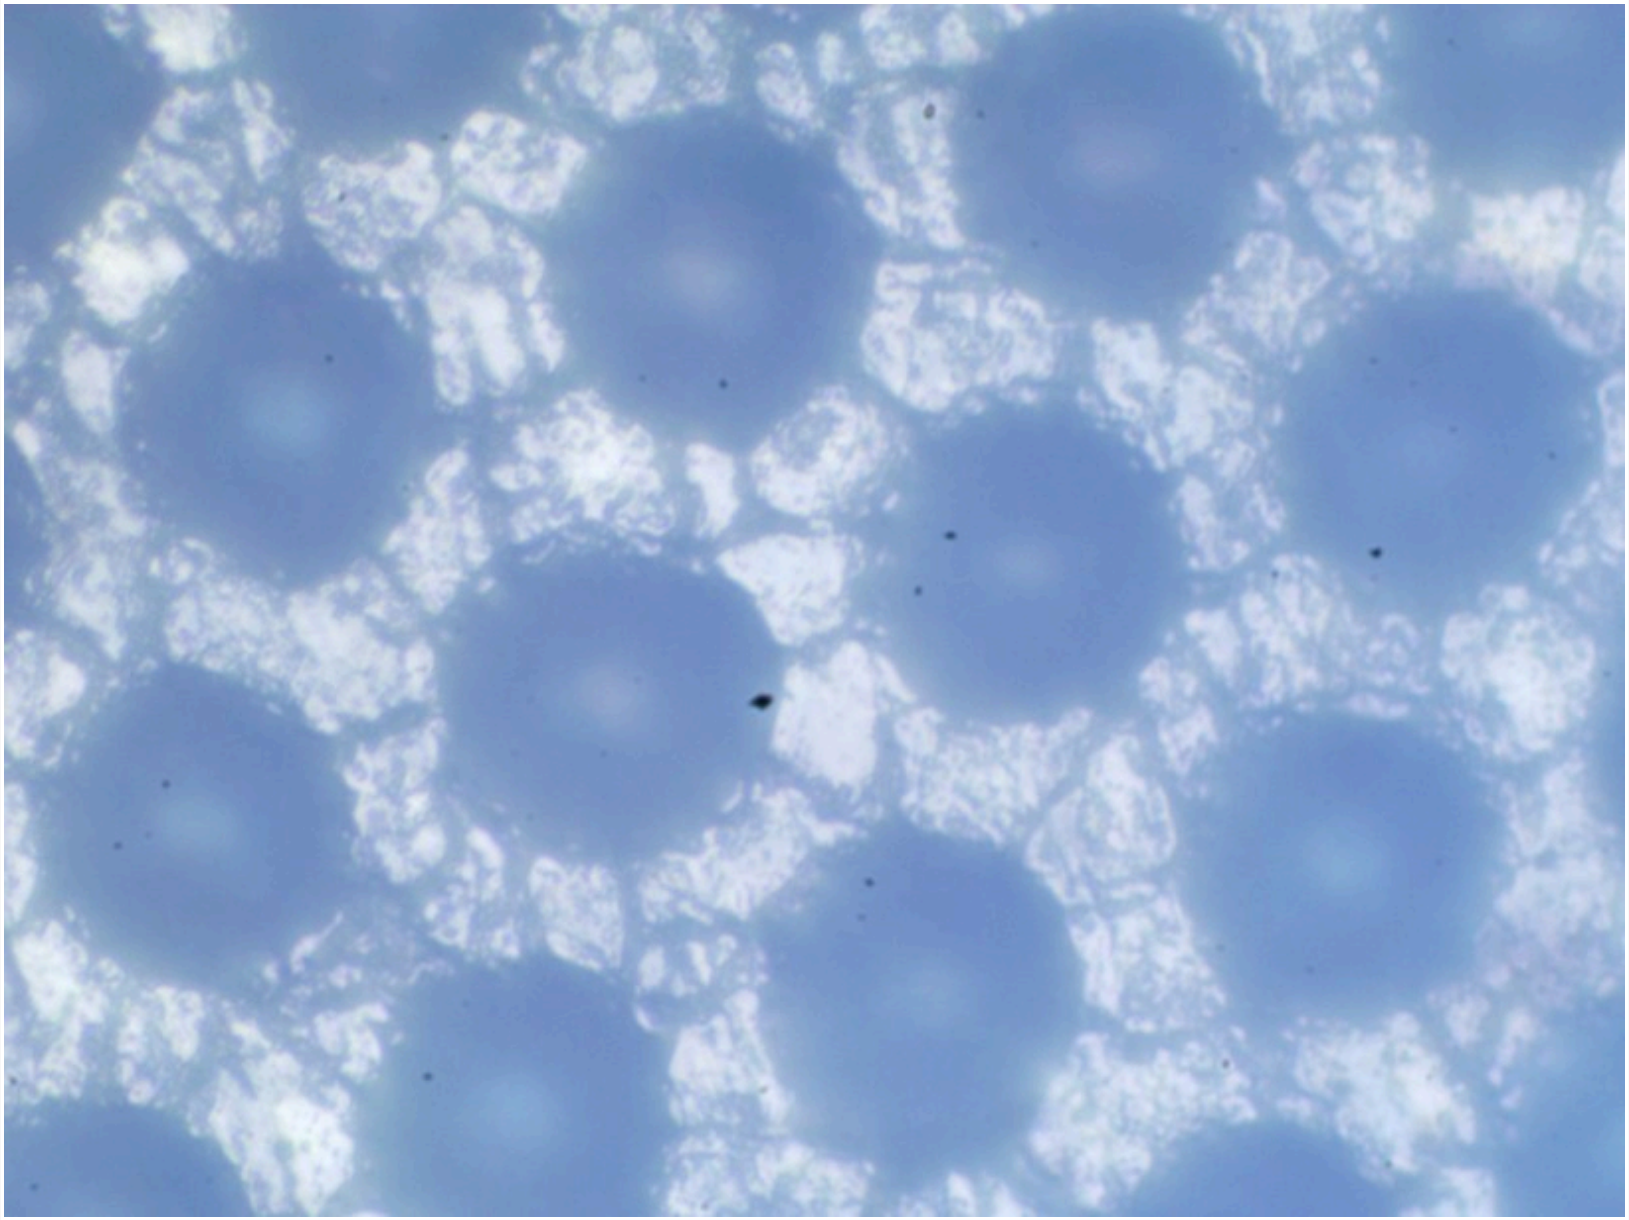
Roll ground off.

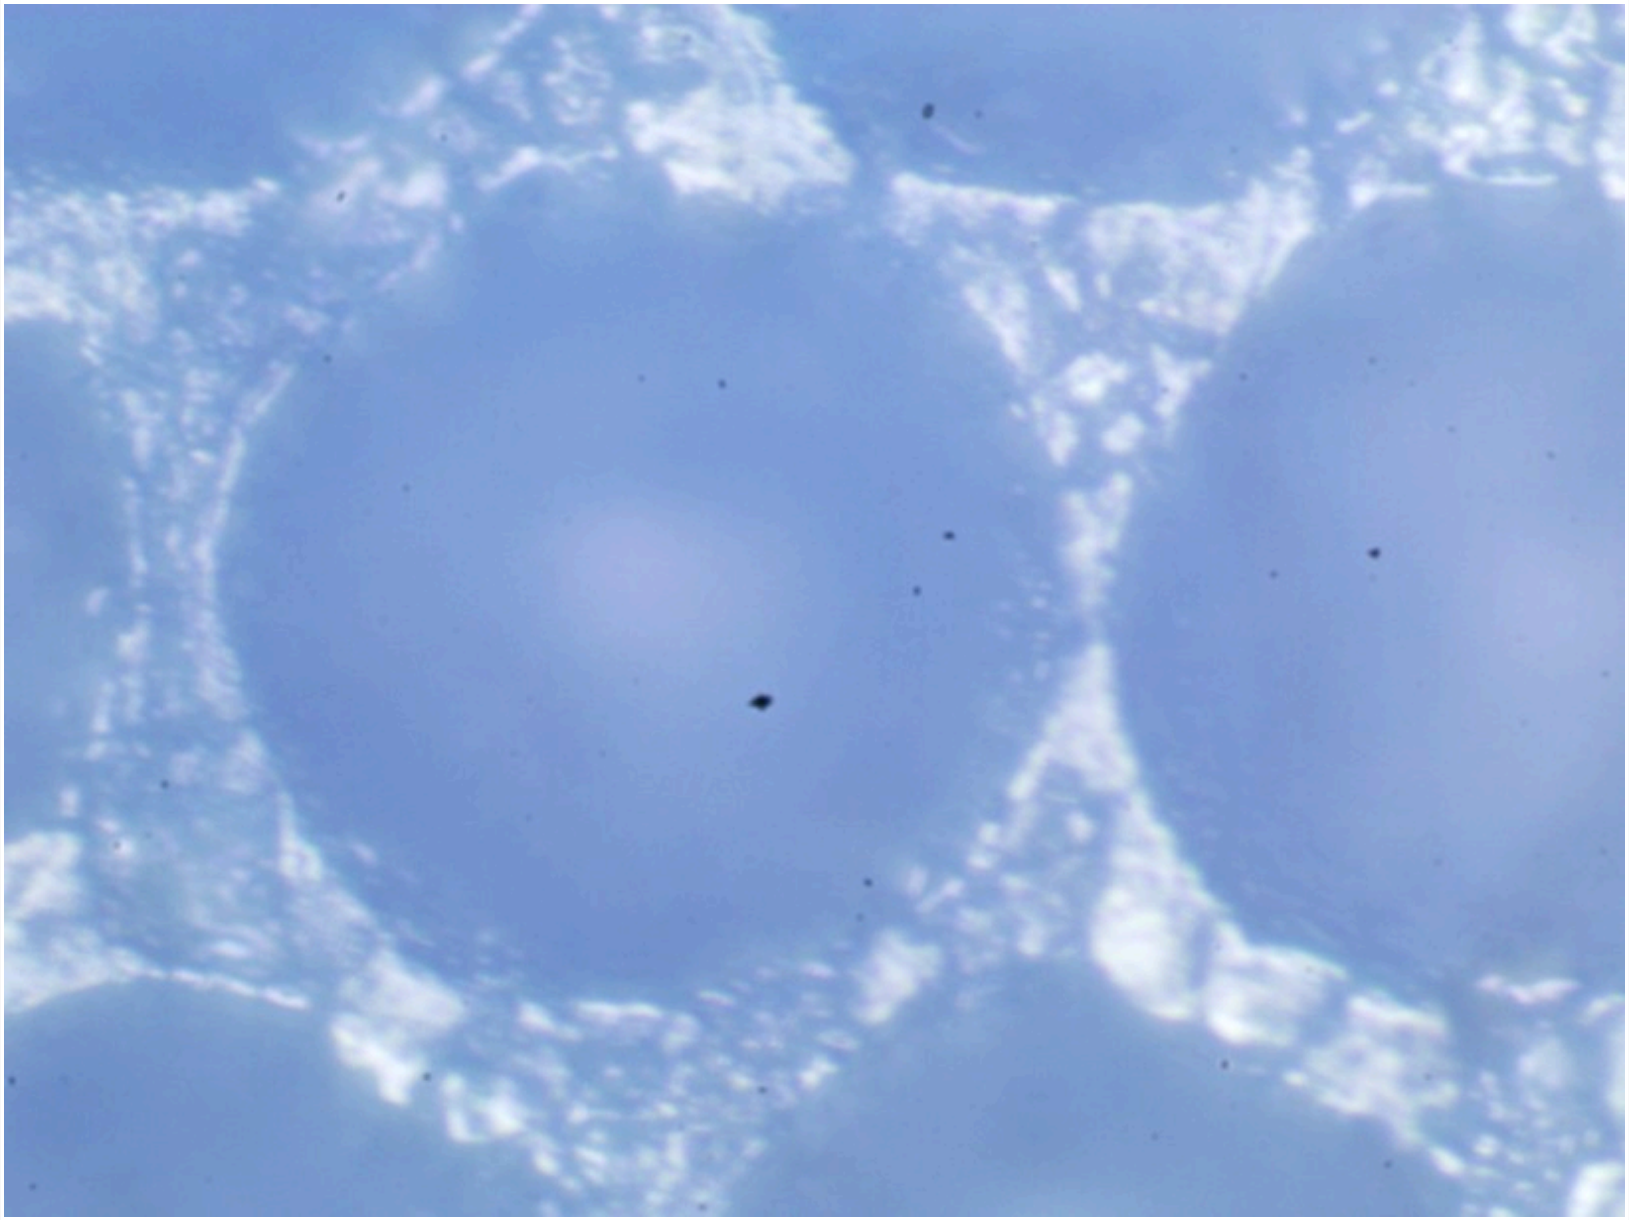
Page №103. Roll "alt17454". Length: 1300 mm. Photos with magnificaiton: x400. Cleaning passes: 1

Comment
dent 450 467 493 530 580 streak 780.

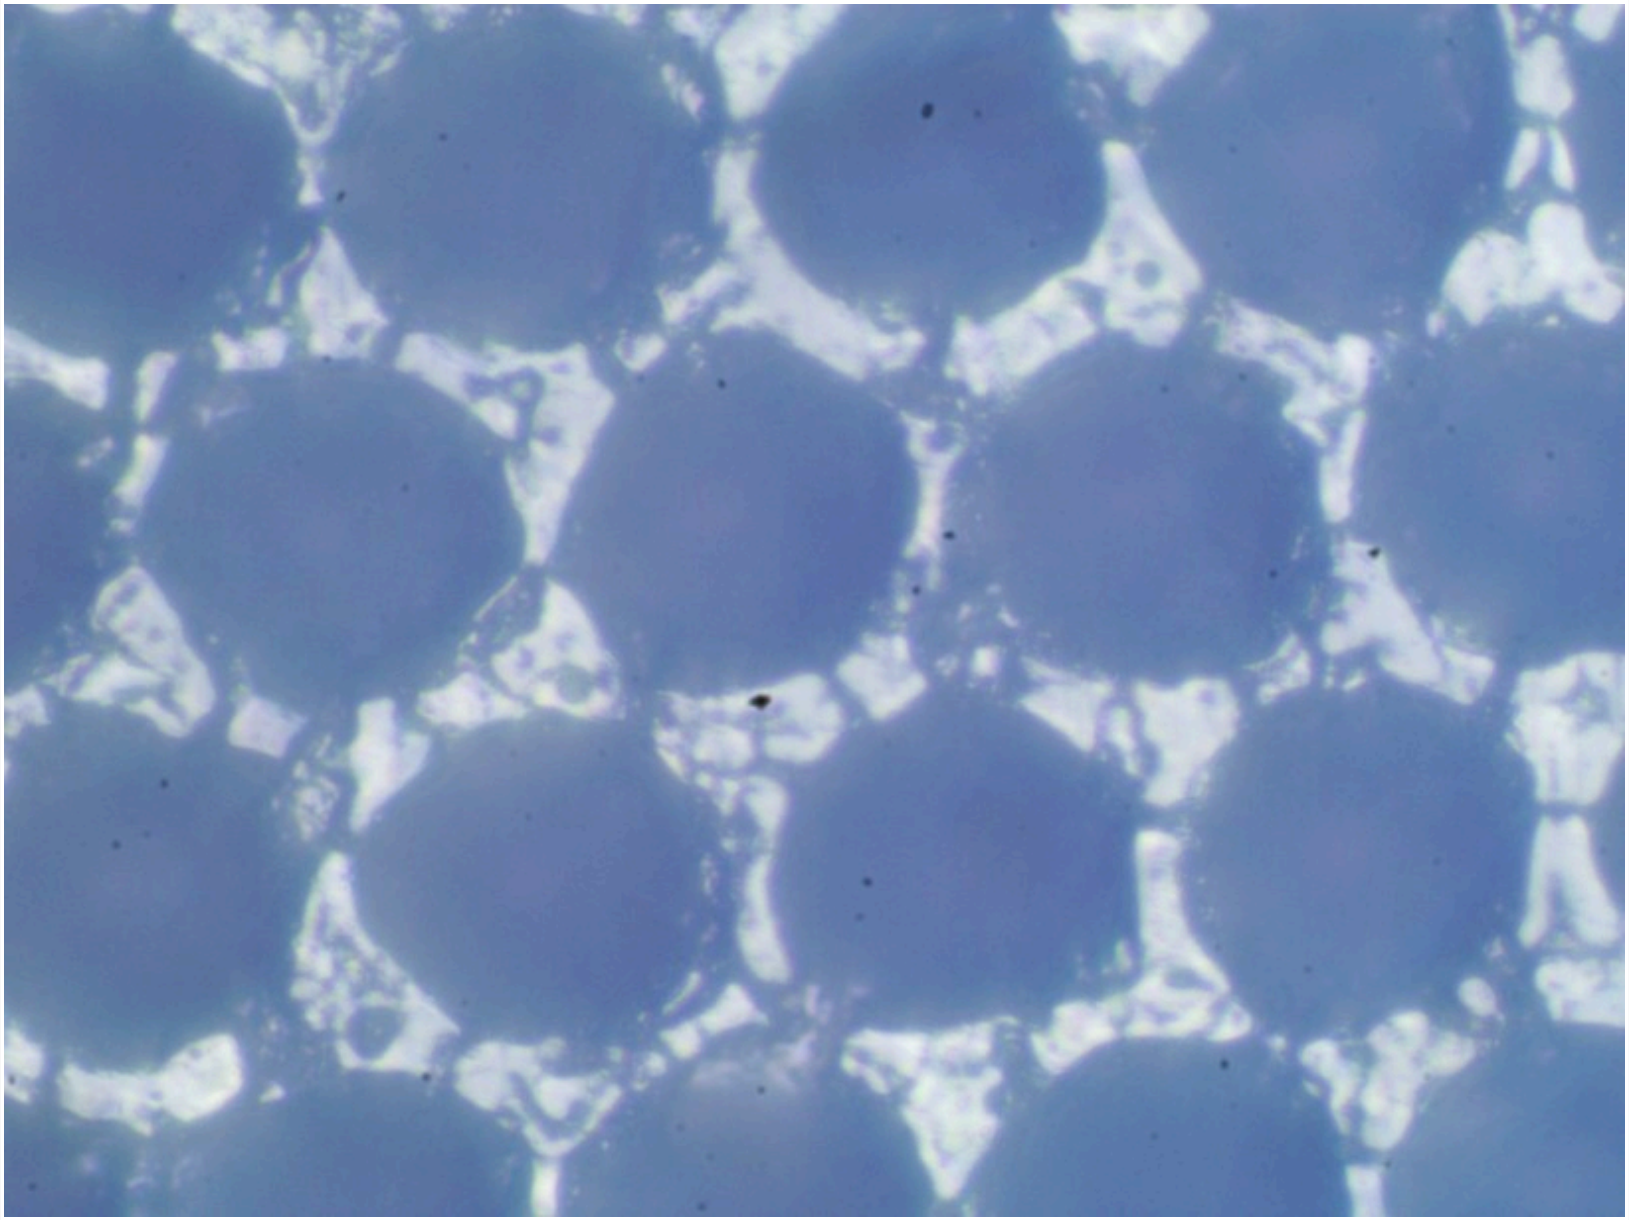
Page №104. Roll "sg49046-9". Length: 1360 mm. Photos with magnificaiton: x400. Cleaning passes: 1

Comment
streaks scratch 205 chips at edges.

Roll slightly ground off.

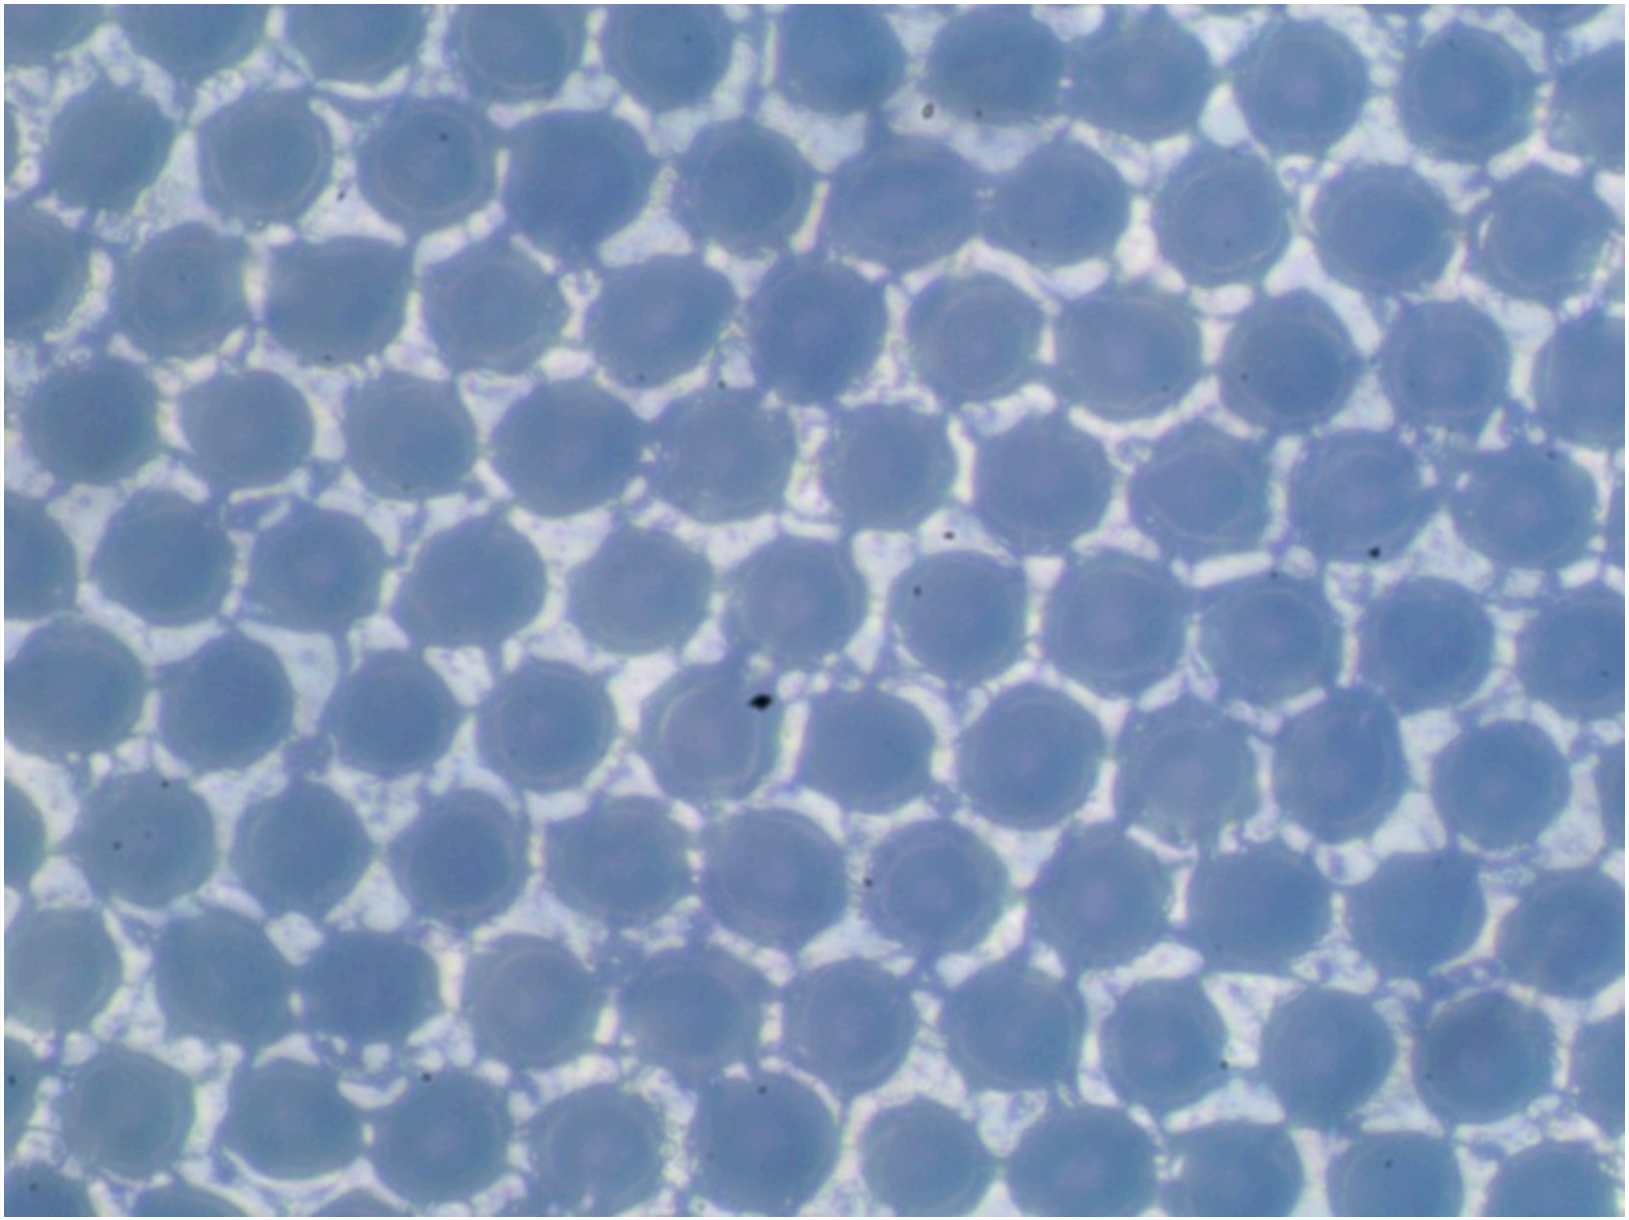
Page №105. Roll "sg49046-31". Length: 1360 mm. Photos with magnificaiton: x400. Cleaning passes: 1

Comment
streak 40.
Roll ground off.

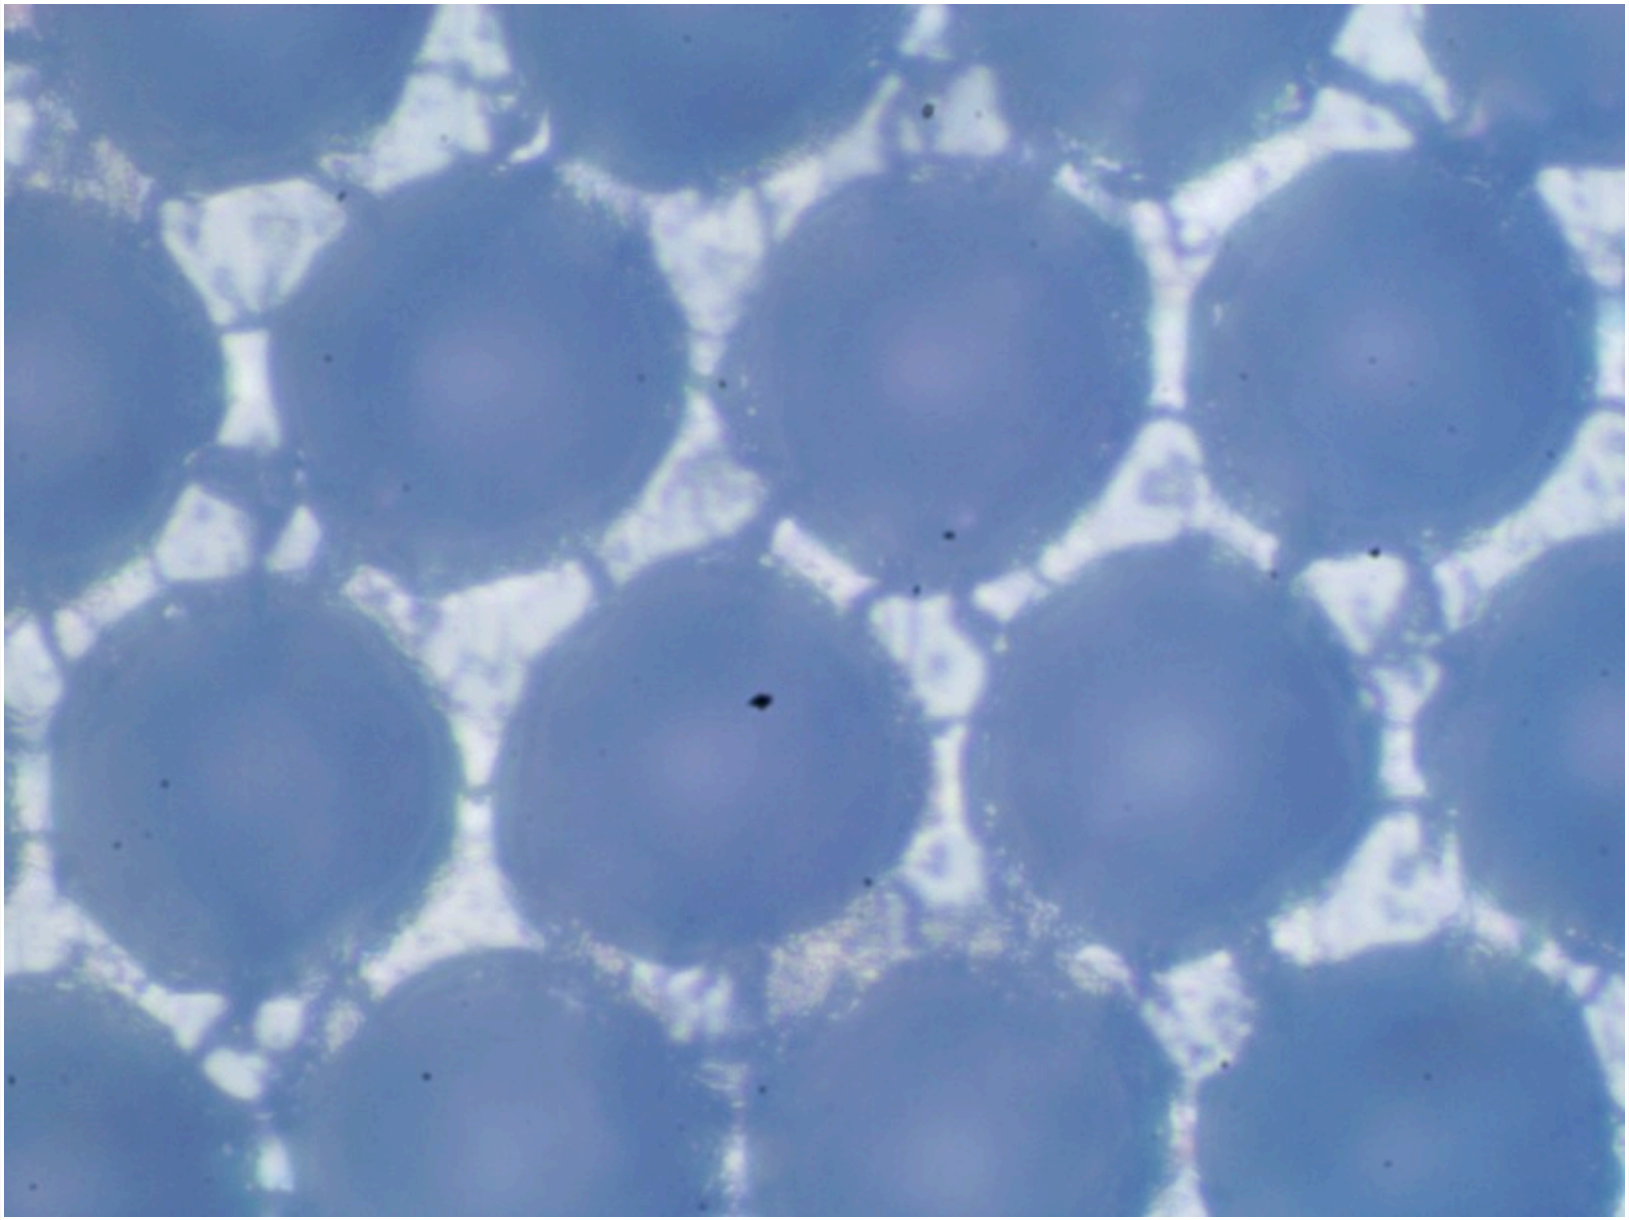
Page №106. Roll "sg49046-5". Length: 1360 mm. Photos with magnificaiton: x400. Cleaning passes: 1

Comment
streak 480 430.
Roll slightly ground off.

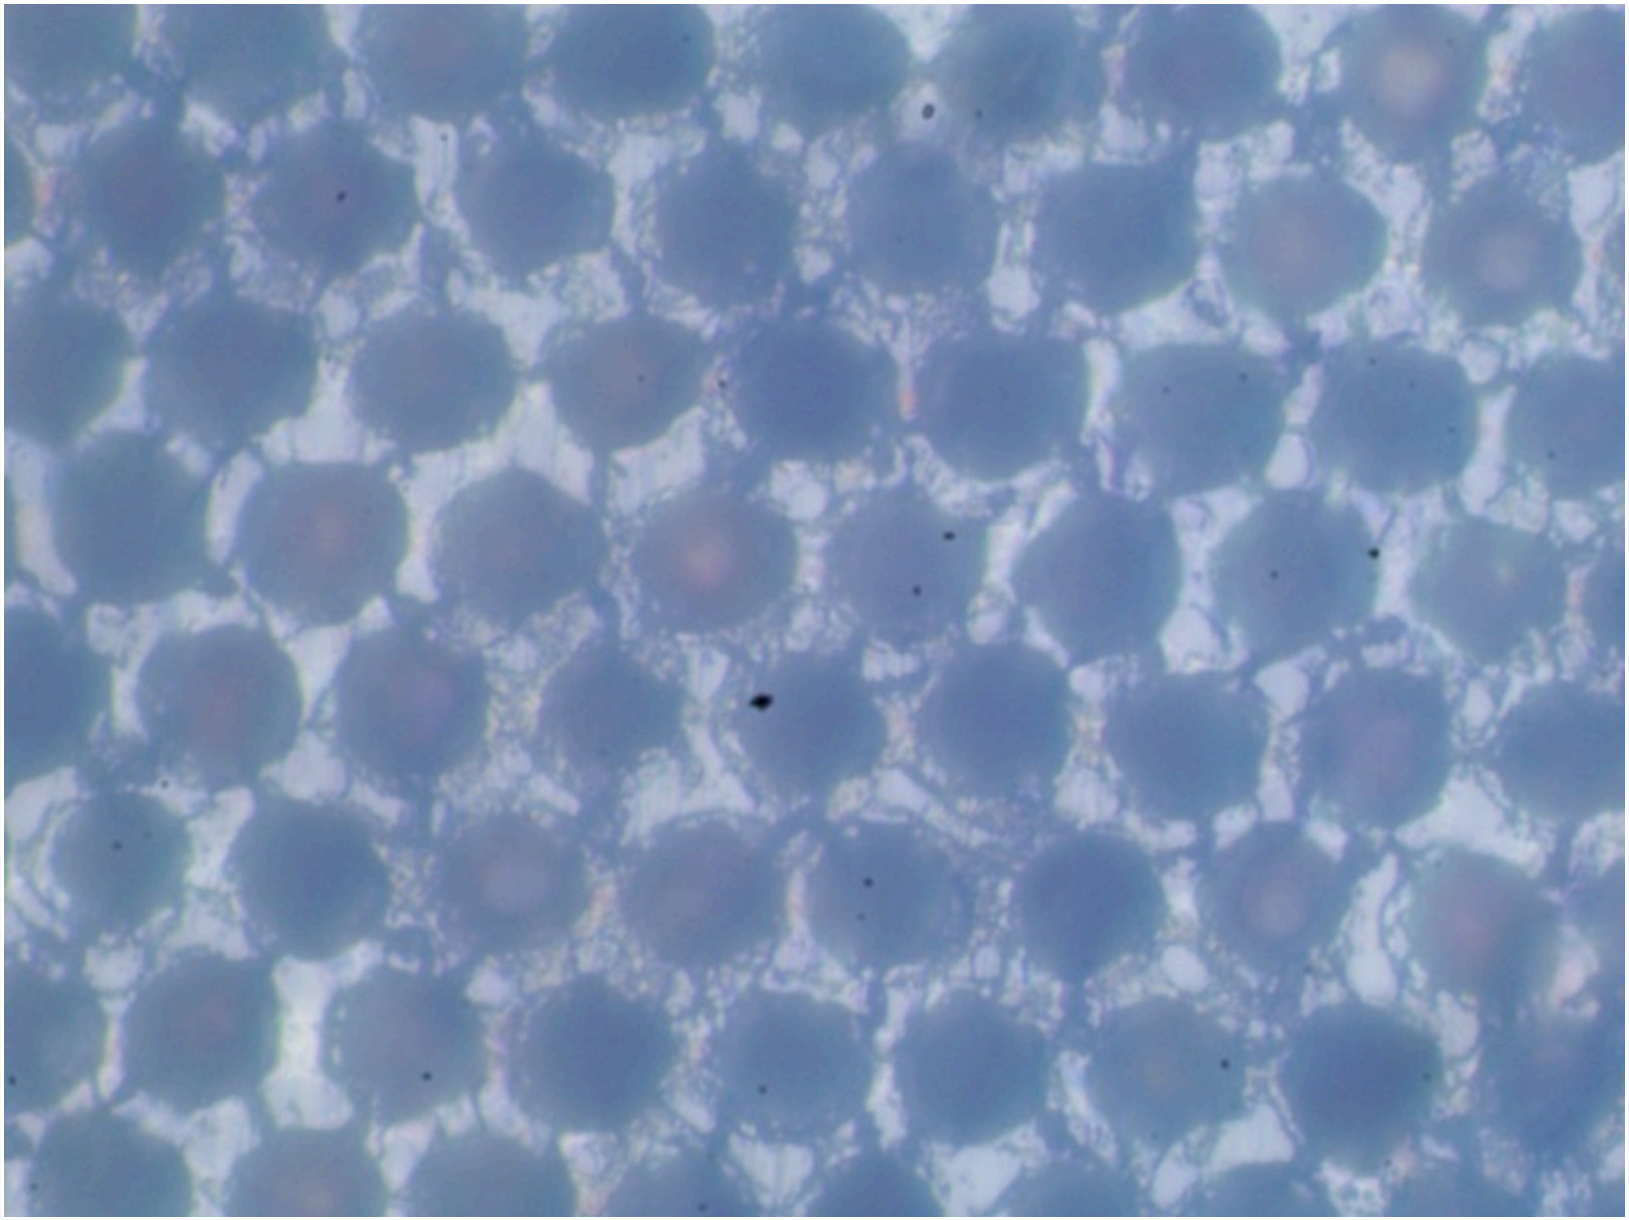
Page №107. Roll "sg49046-20". Length: 1360 mm. Photos with magnificaiton: x400. Cleaning passes: 1

Comment
spot 1335 streak 877 scratch
80.
Roll heavily ground off.

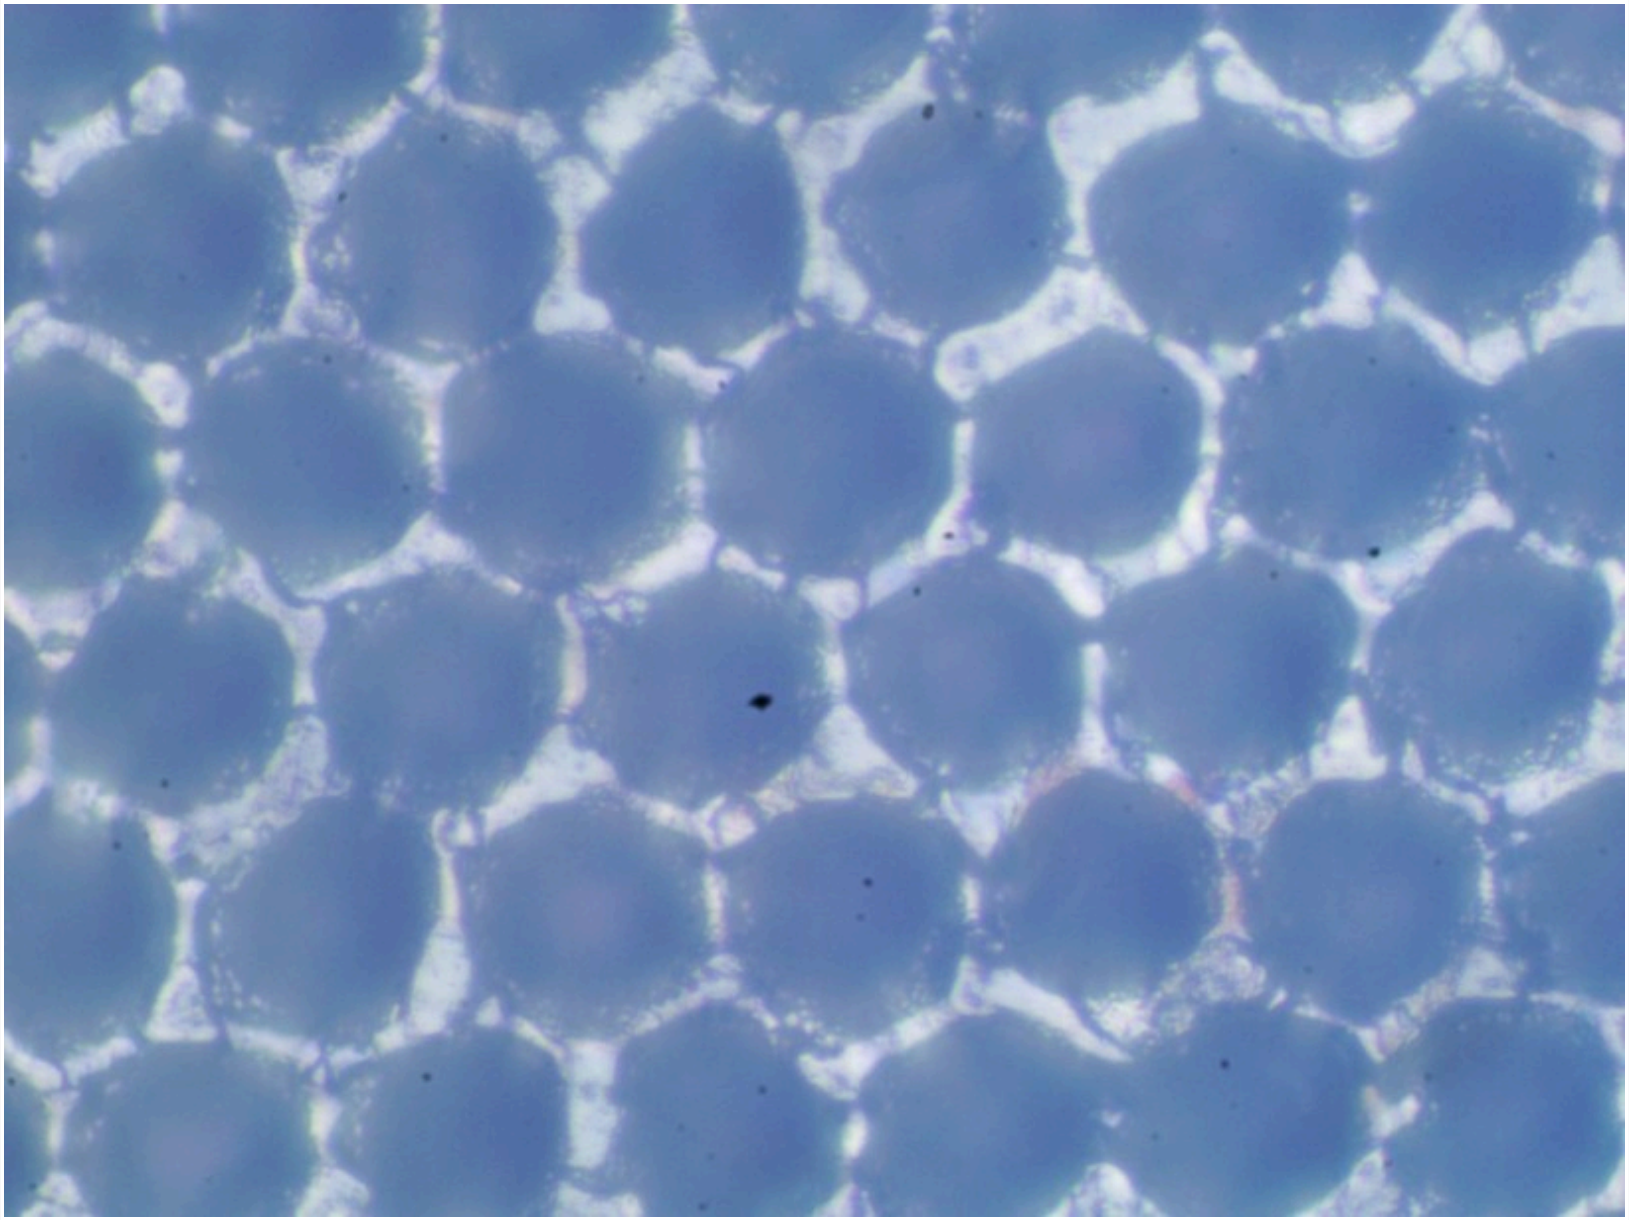
Page №108. Roll "sg49046-14". Length: 1360 mm. Photos with magnificaiton: x400. Cleaning passes: 1

Comment
scratch 1270.
Roll slightly ground off.

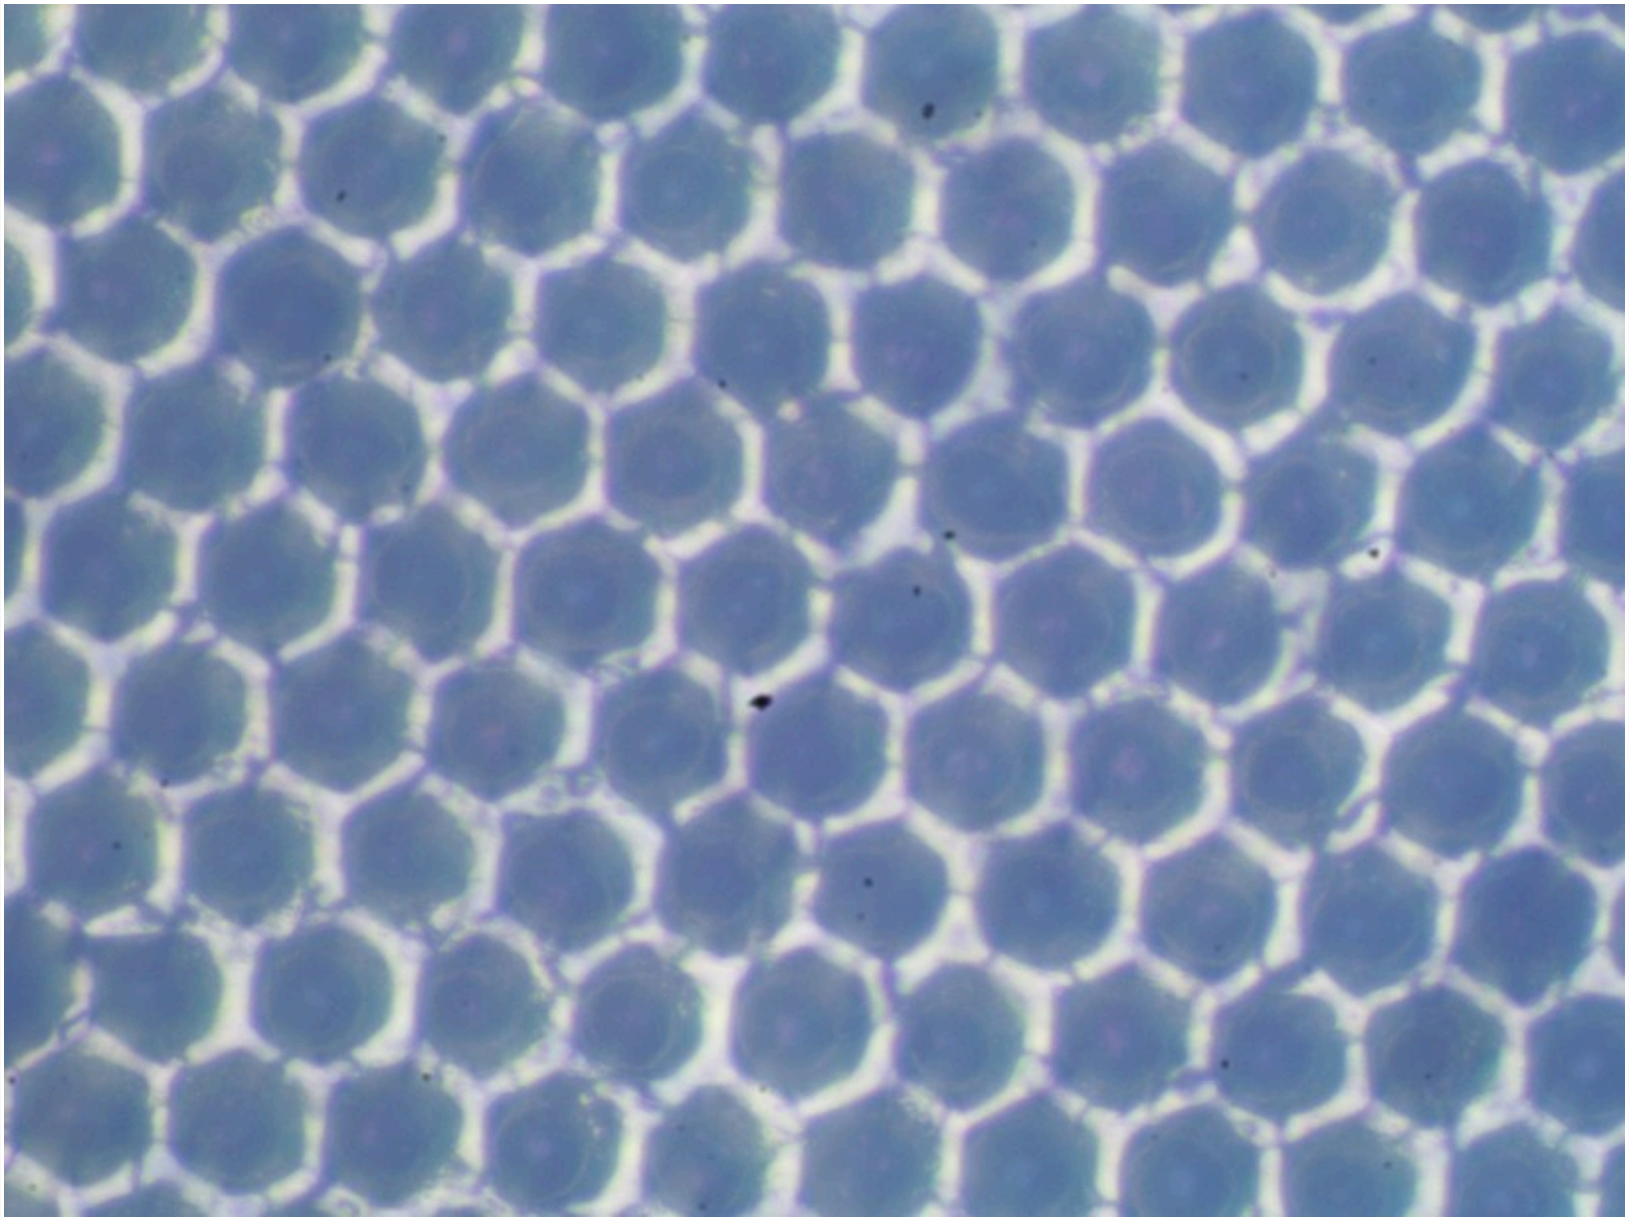
Page №109. Roll "sa008602". Length: 1300 mm. Photos with magnificaiton: x400. Cleaning passes: 1

Comment
scratch 40 130 1120 90 spots many.

Roll ground off.

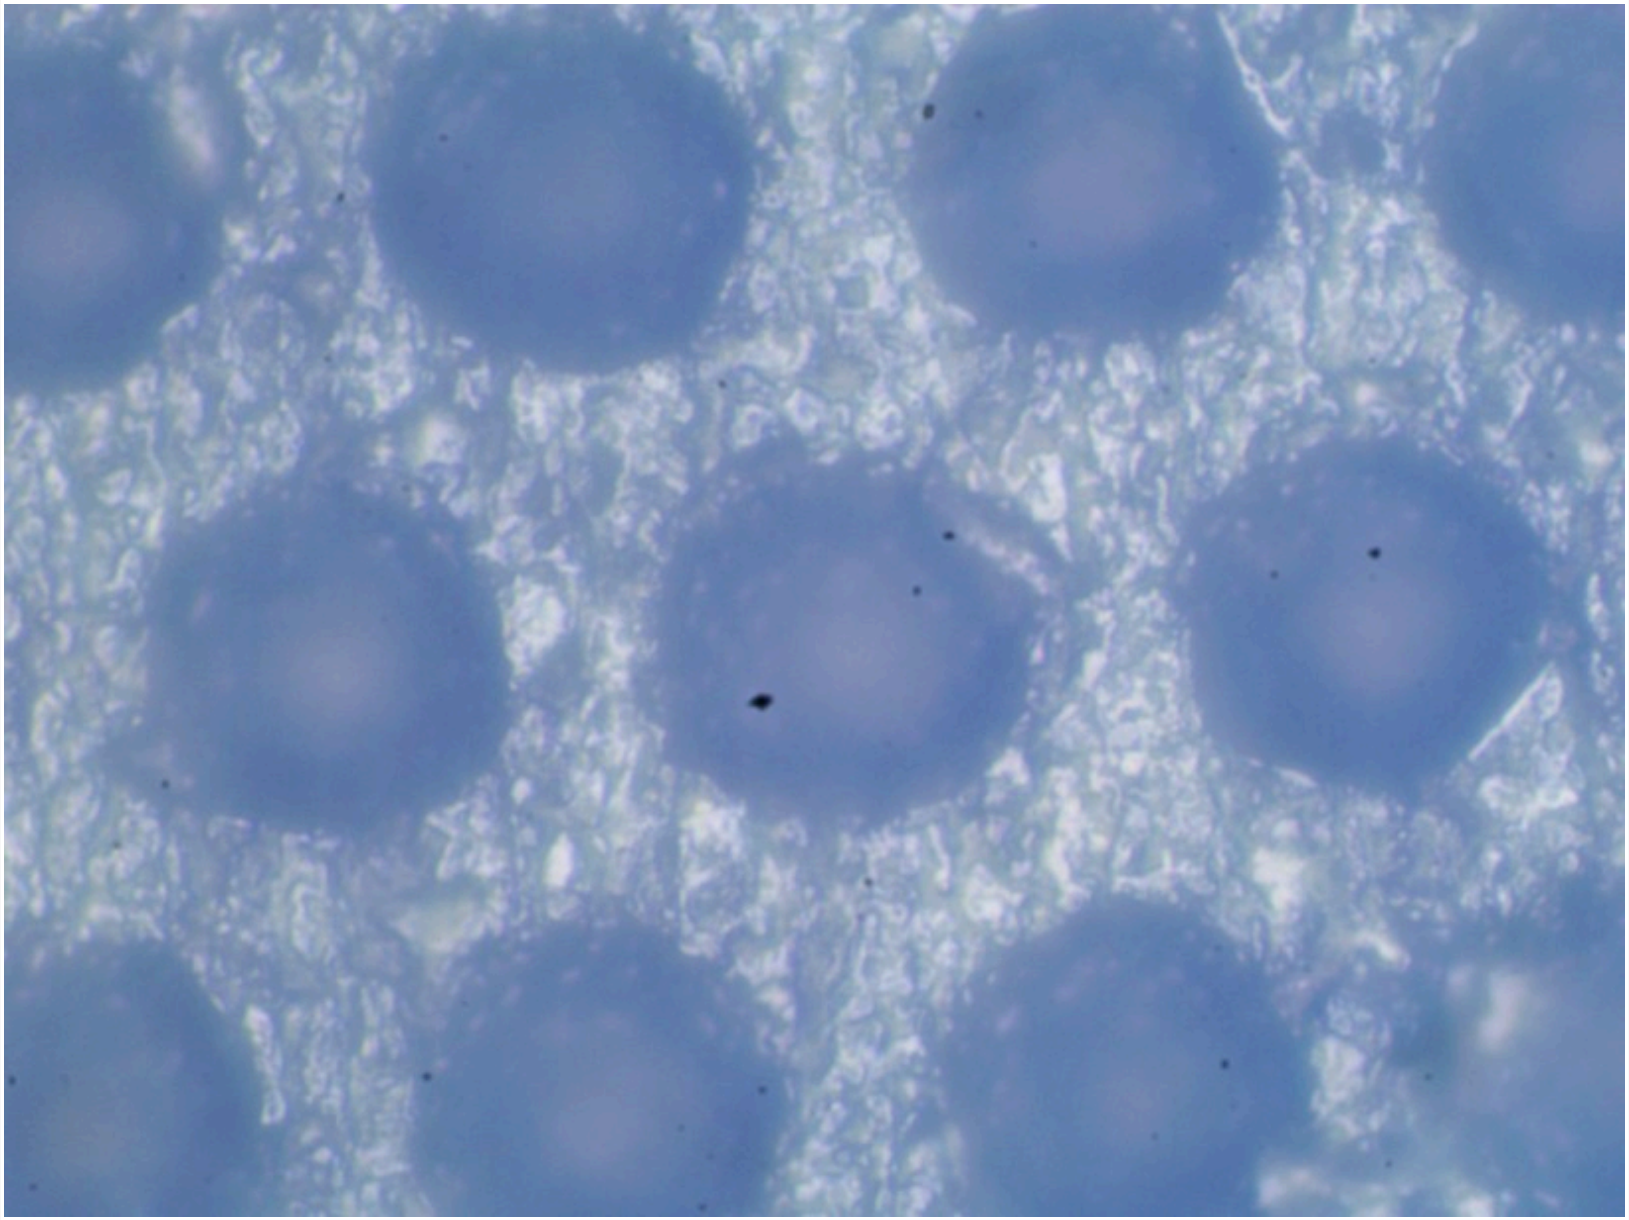
Page №110. Roll "z17011016". Length: 1300 mm. Photos with magnificaiton: x400. Cleaning passes: 1

Comment
worn.
Roll heavily ground off.
