RollerCheck360

Roll Inspection from 08.12.2025

Rolls: 178

We have analyzed for you 178 rolls.

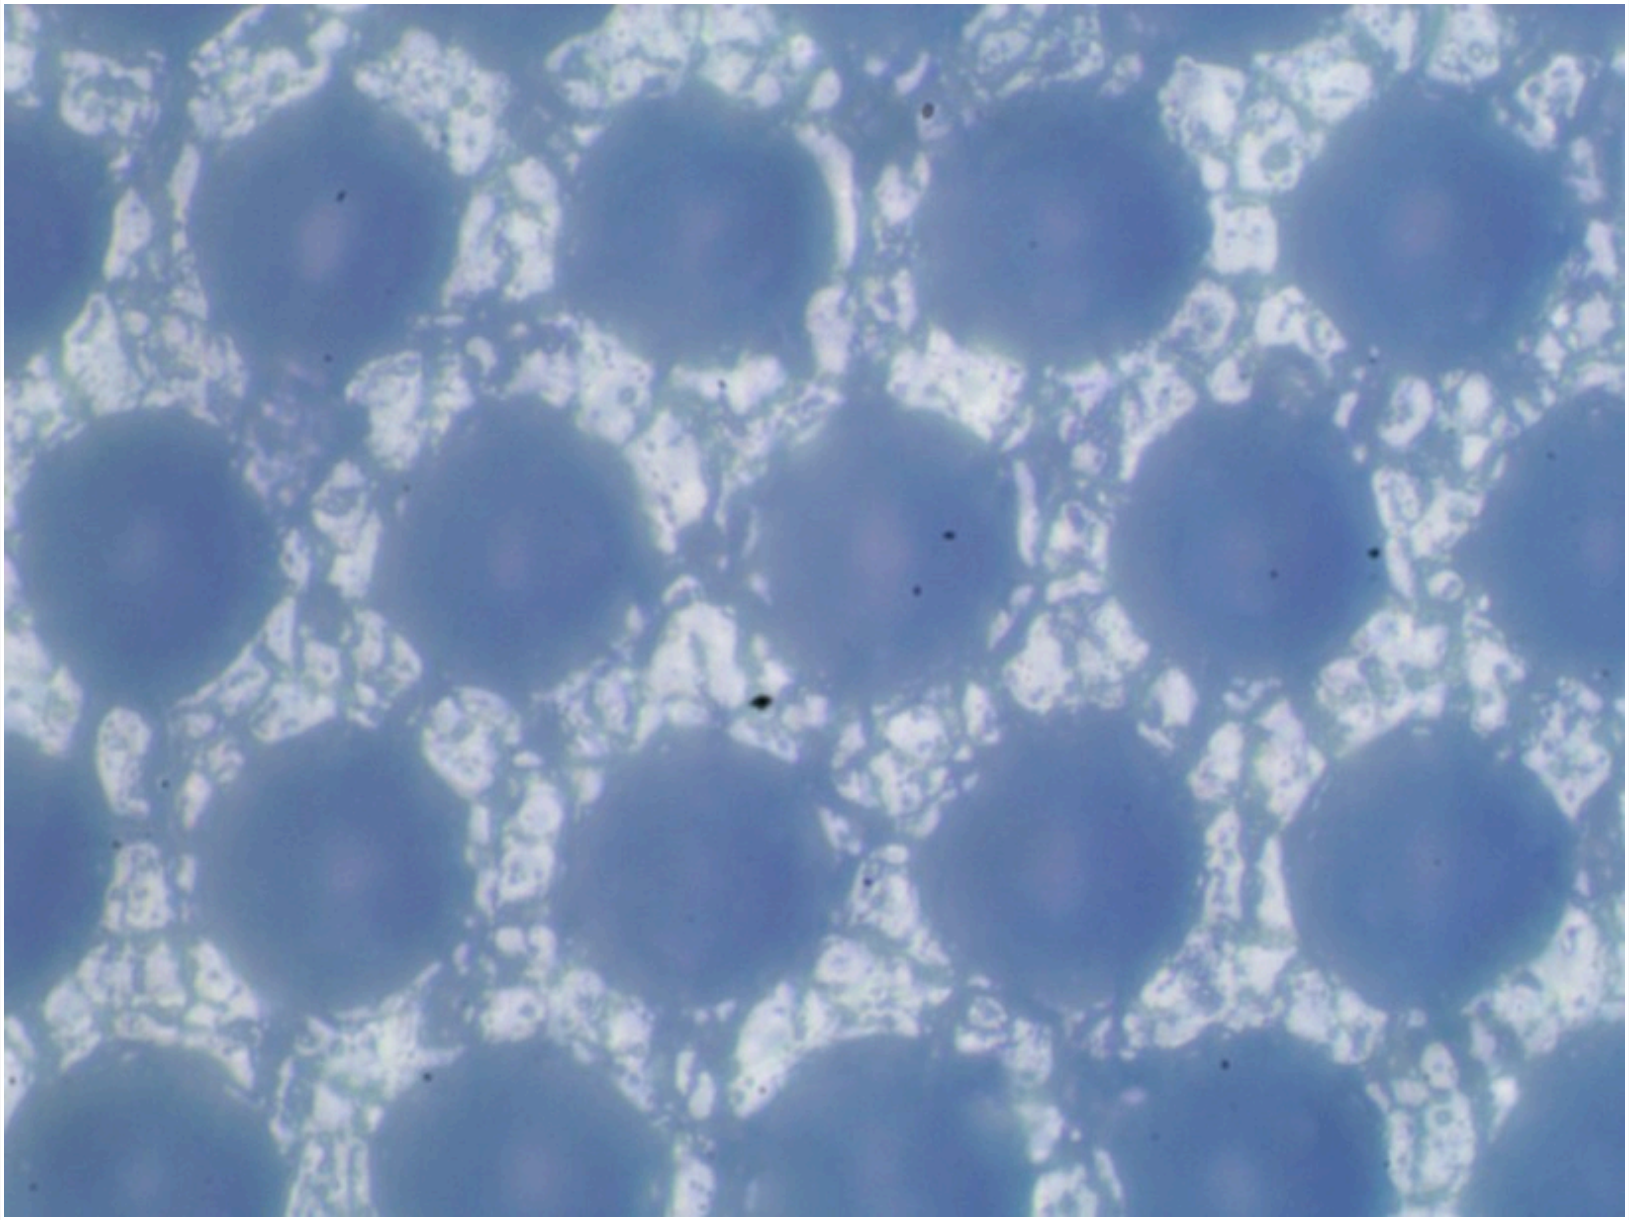
Page №111. Roll "sa008593". Length: 1300 mm. Photos with magnificaiton: x400. Cleaning passes: 1

Comment
streaks many dent 55 worn scratches 55 spots 260

210 180.
Roll ground off.

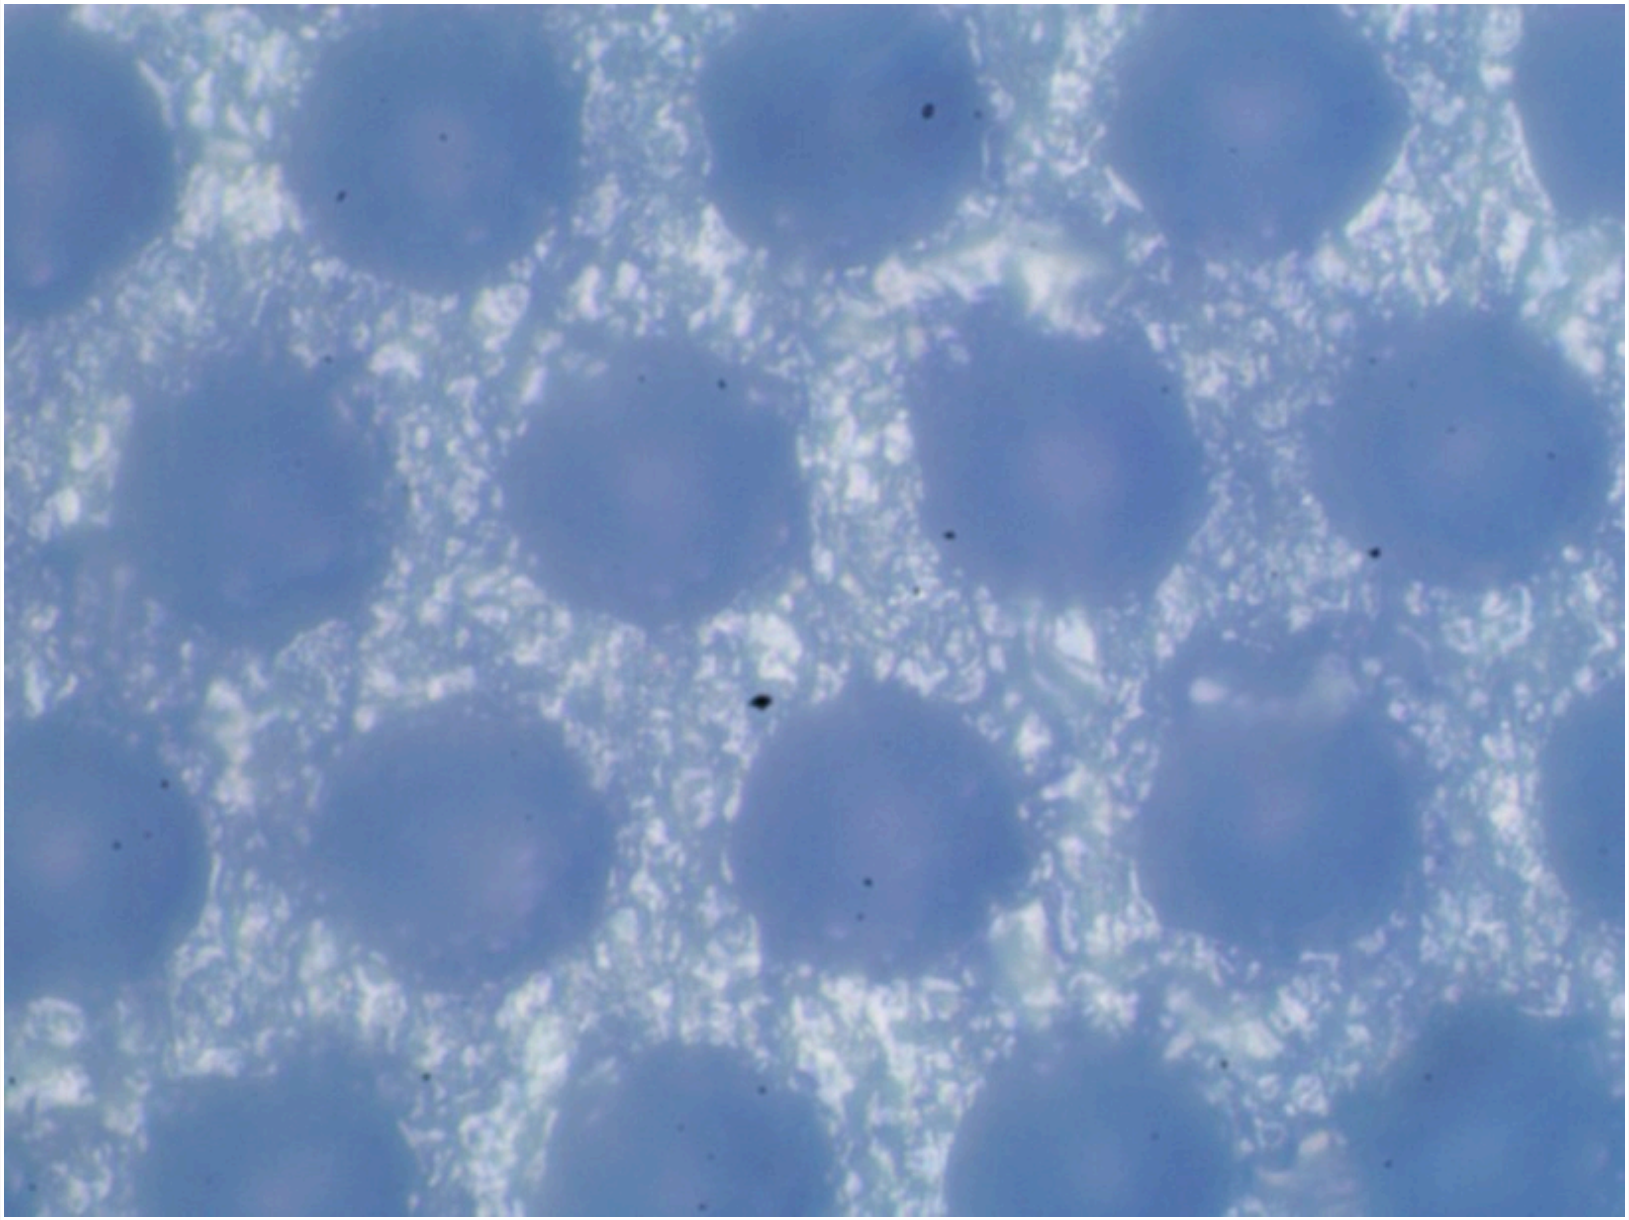
Page №112. Roll "z48062". Length: 1300 mm. Photos with magnificaiton: x400. Cleaning passes: 1

Comment
scratch 80 streaks.
Roll heavily ground off.

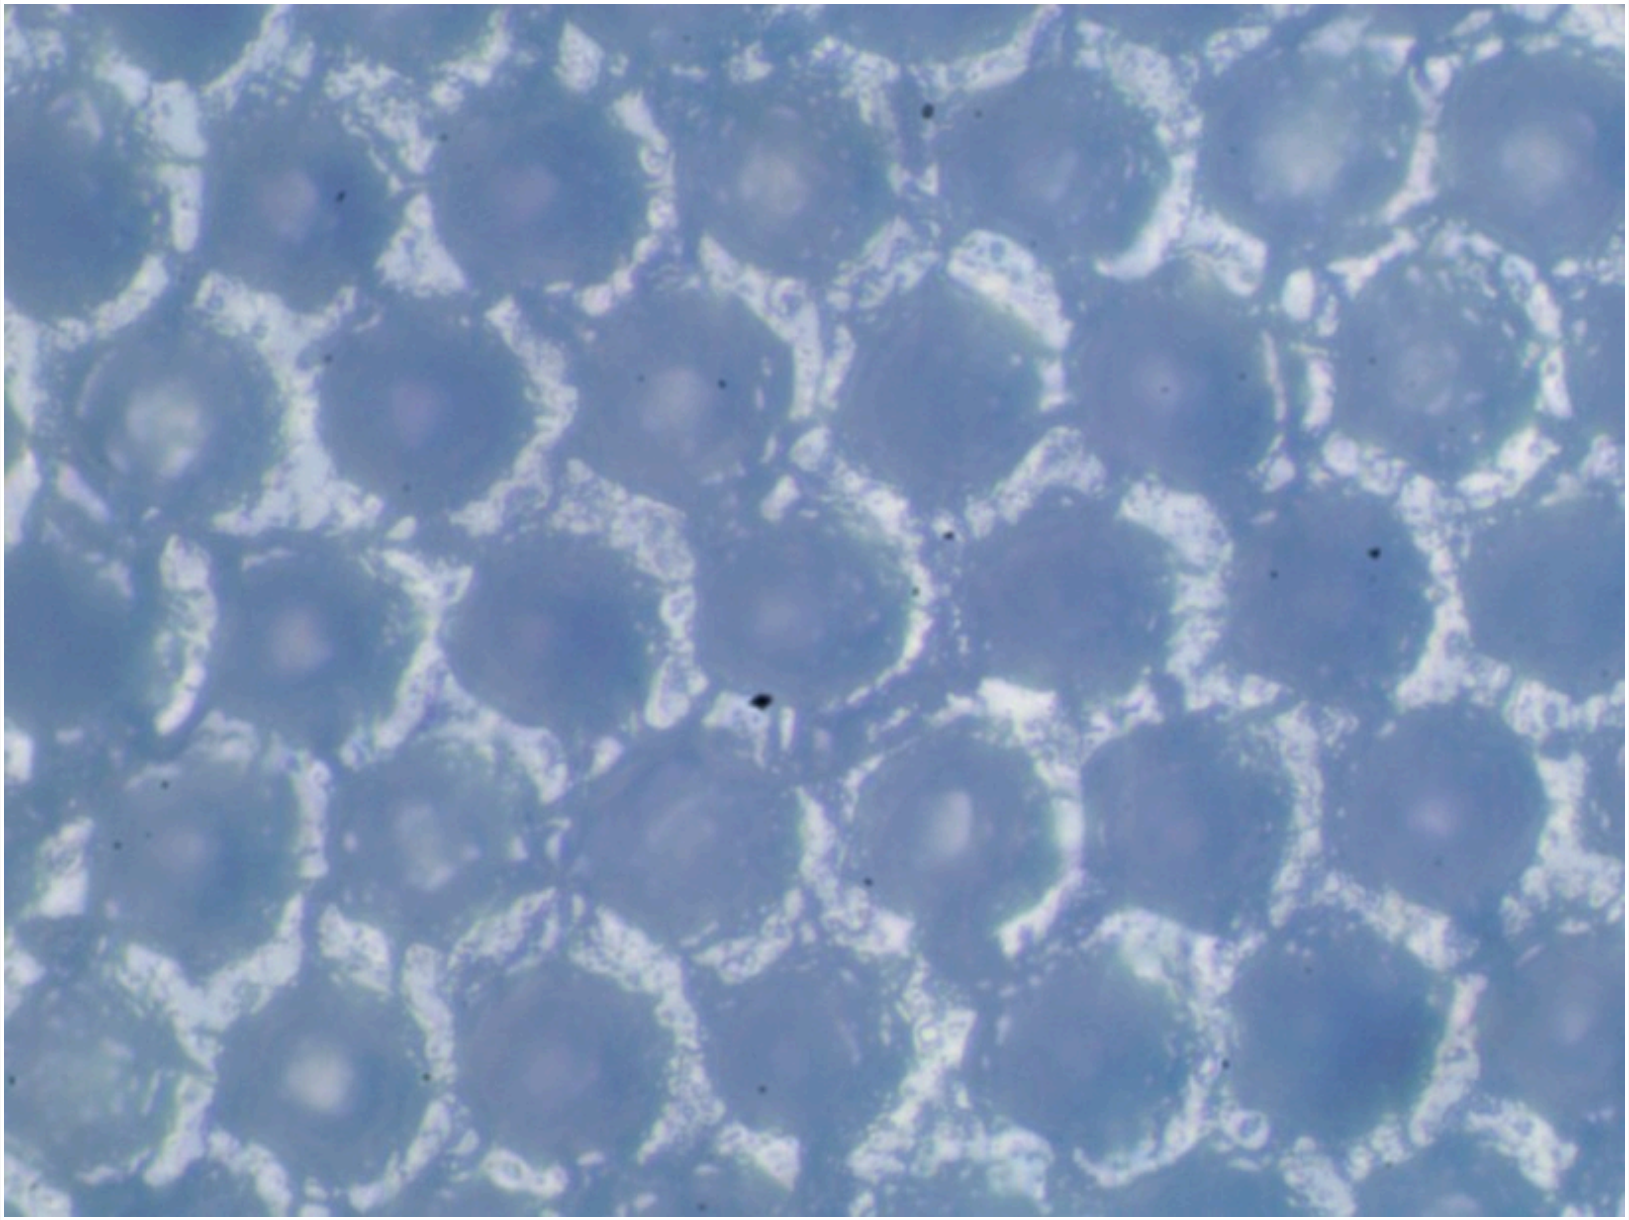
Page №114. Roll "kk74444". Length: 1300 mm. Photos with magnificaiton: x400. Cleaning passes: 1

Comment
chips at edges scratch 140 dent 1200 spot 1165 335

260.
Roll ground off.

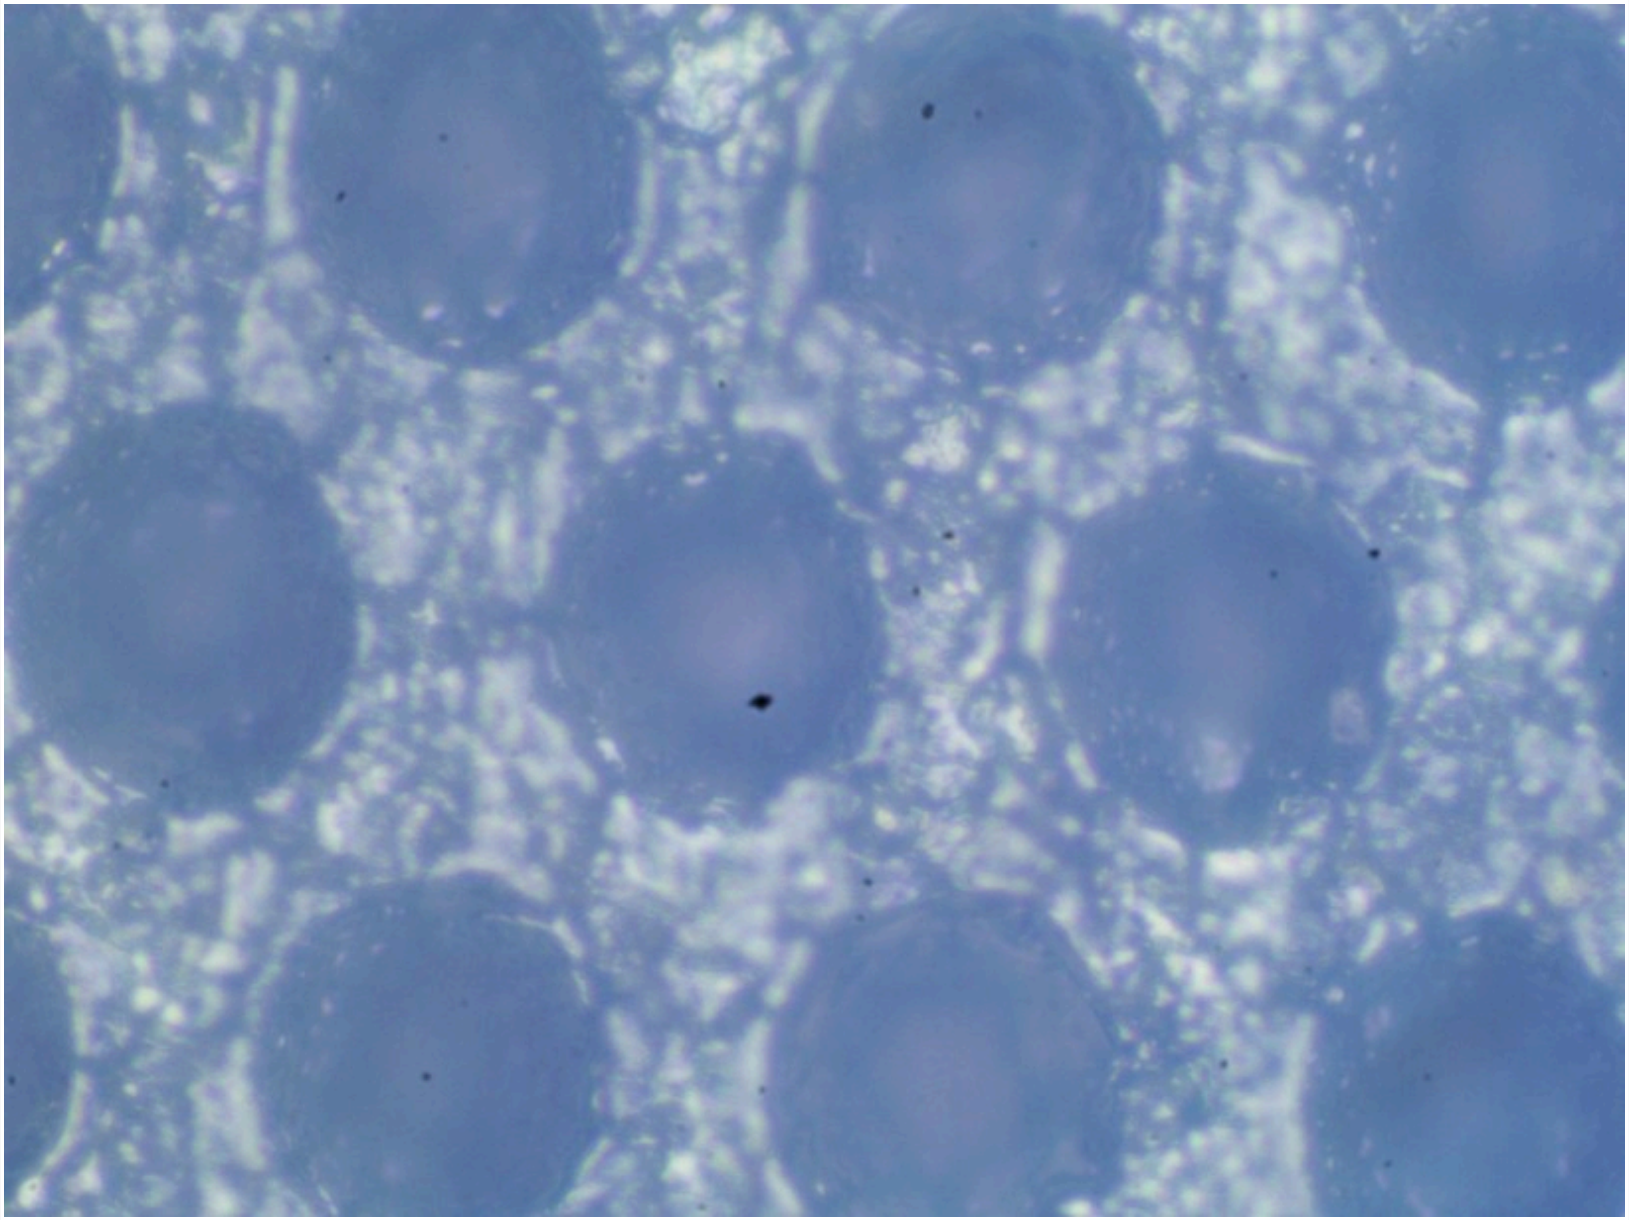
Page №115. Roll "z45224". Length: 1300 mm. Photos with magnificaiton: x400. Cleaning passes: 1

Comment
worn chips at edges scratch 250 dent 45.

Roll heavily ground off.

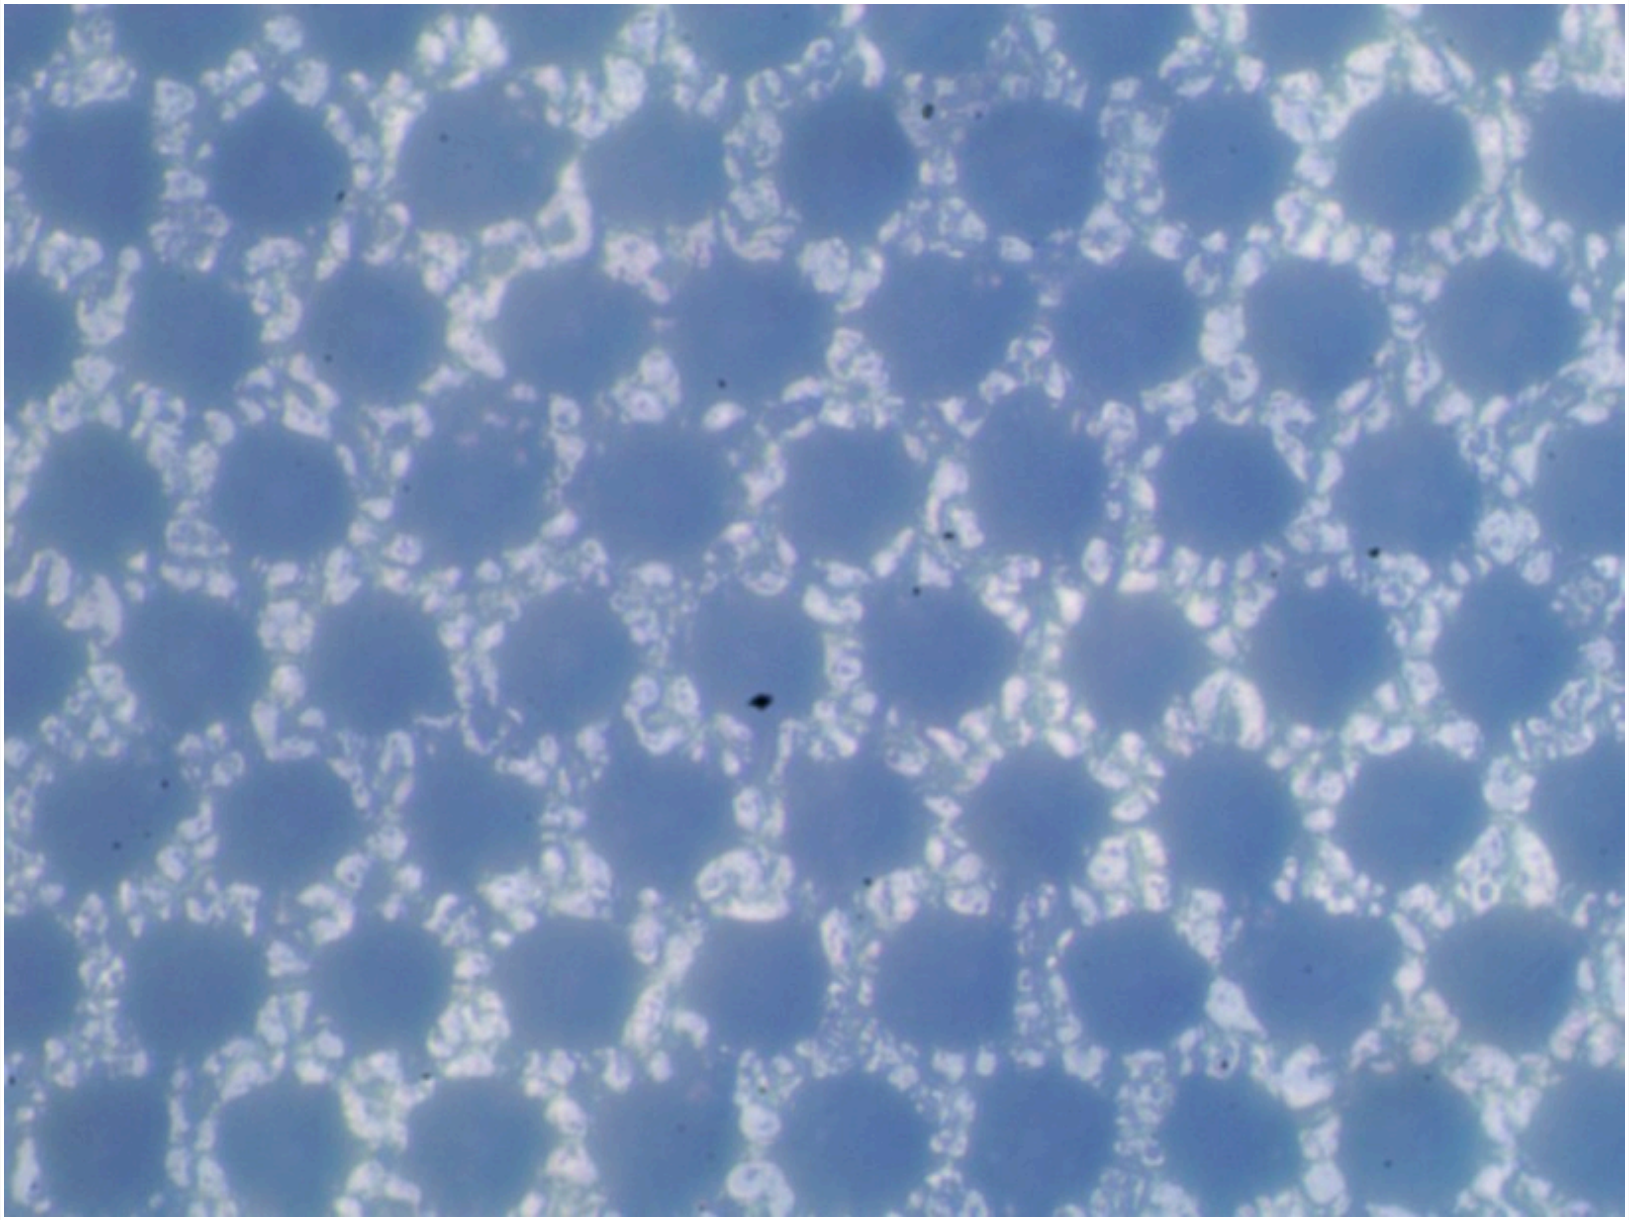
Page №116. Roll "z17011024". Length: 1300 mm. Photos with magnificaiton: x400. Cleaning passes: 1

Comment
wear spot 1190 1150 590 570 550
streaks scratch 25 dent
1240.
Roll heavily ground off.

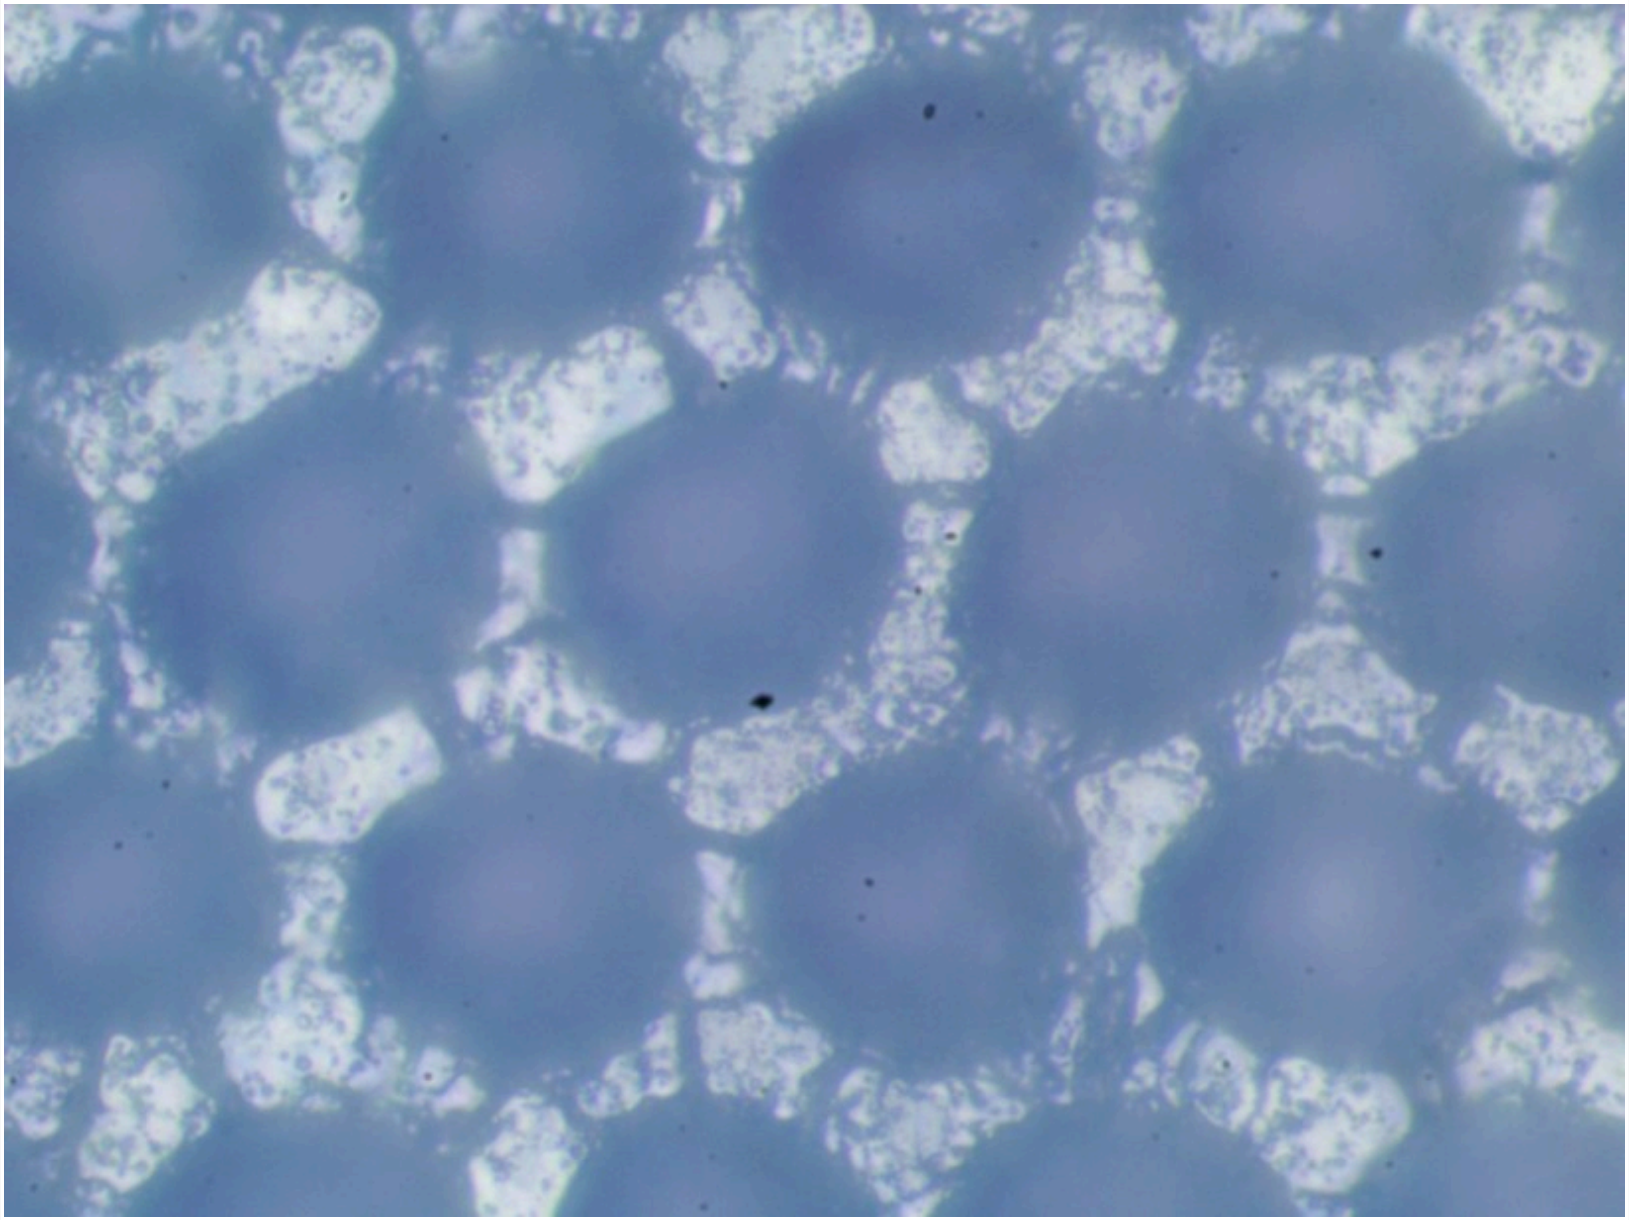
Page №117. Roll "h100749-3". Length: 1320 mm. Photos with magnificaiton: x400. Cleaning passes: 1

Comment
spot many across the entire roll chips 1220 1270.
Roll ground off.

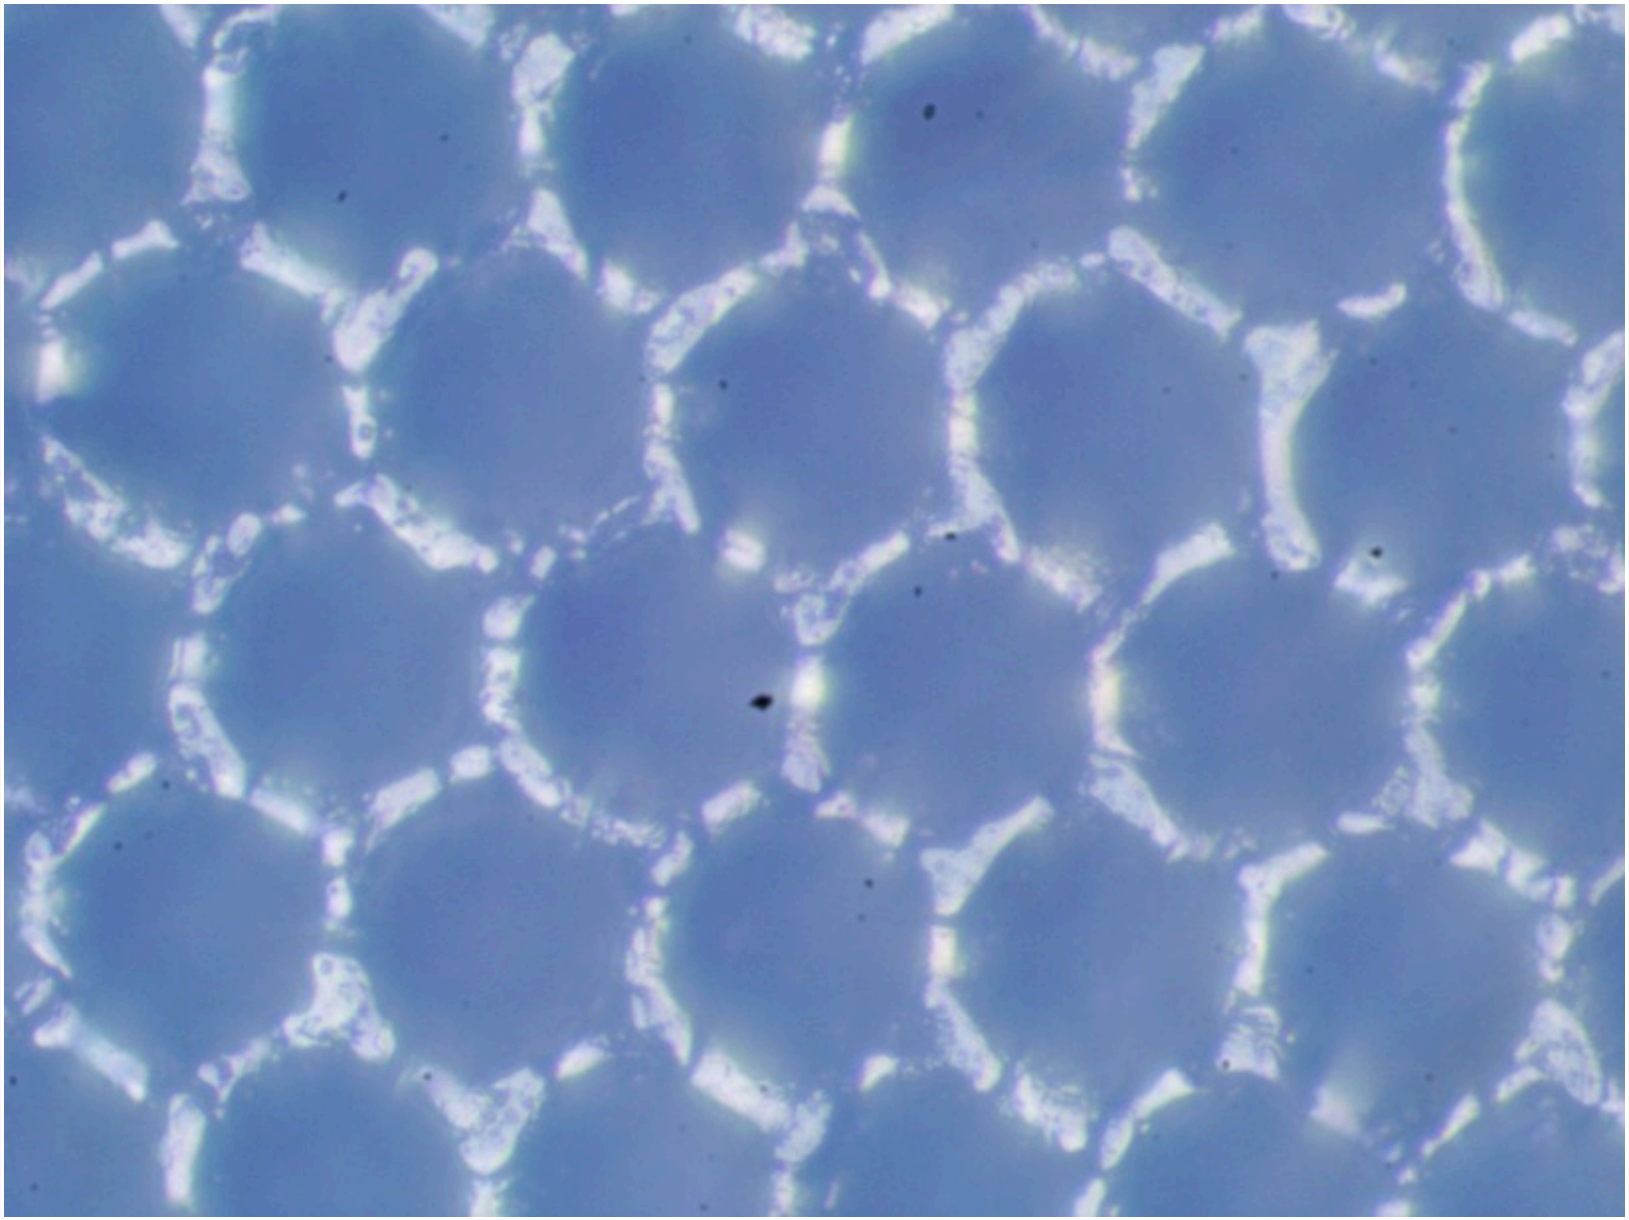
Page №118. Roll "sg4904611". Length: 1360 mm. Photos with magnificaiton: x400. Cleaning passes: 1

Comment
chip 278 streak 814.

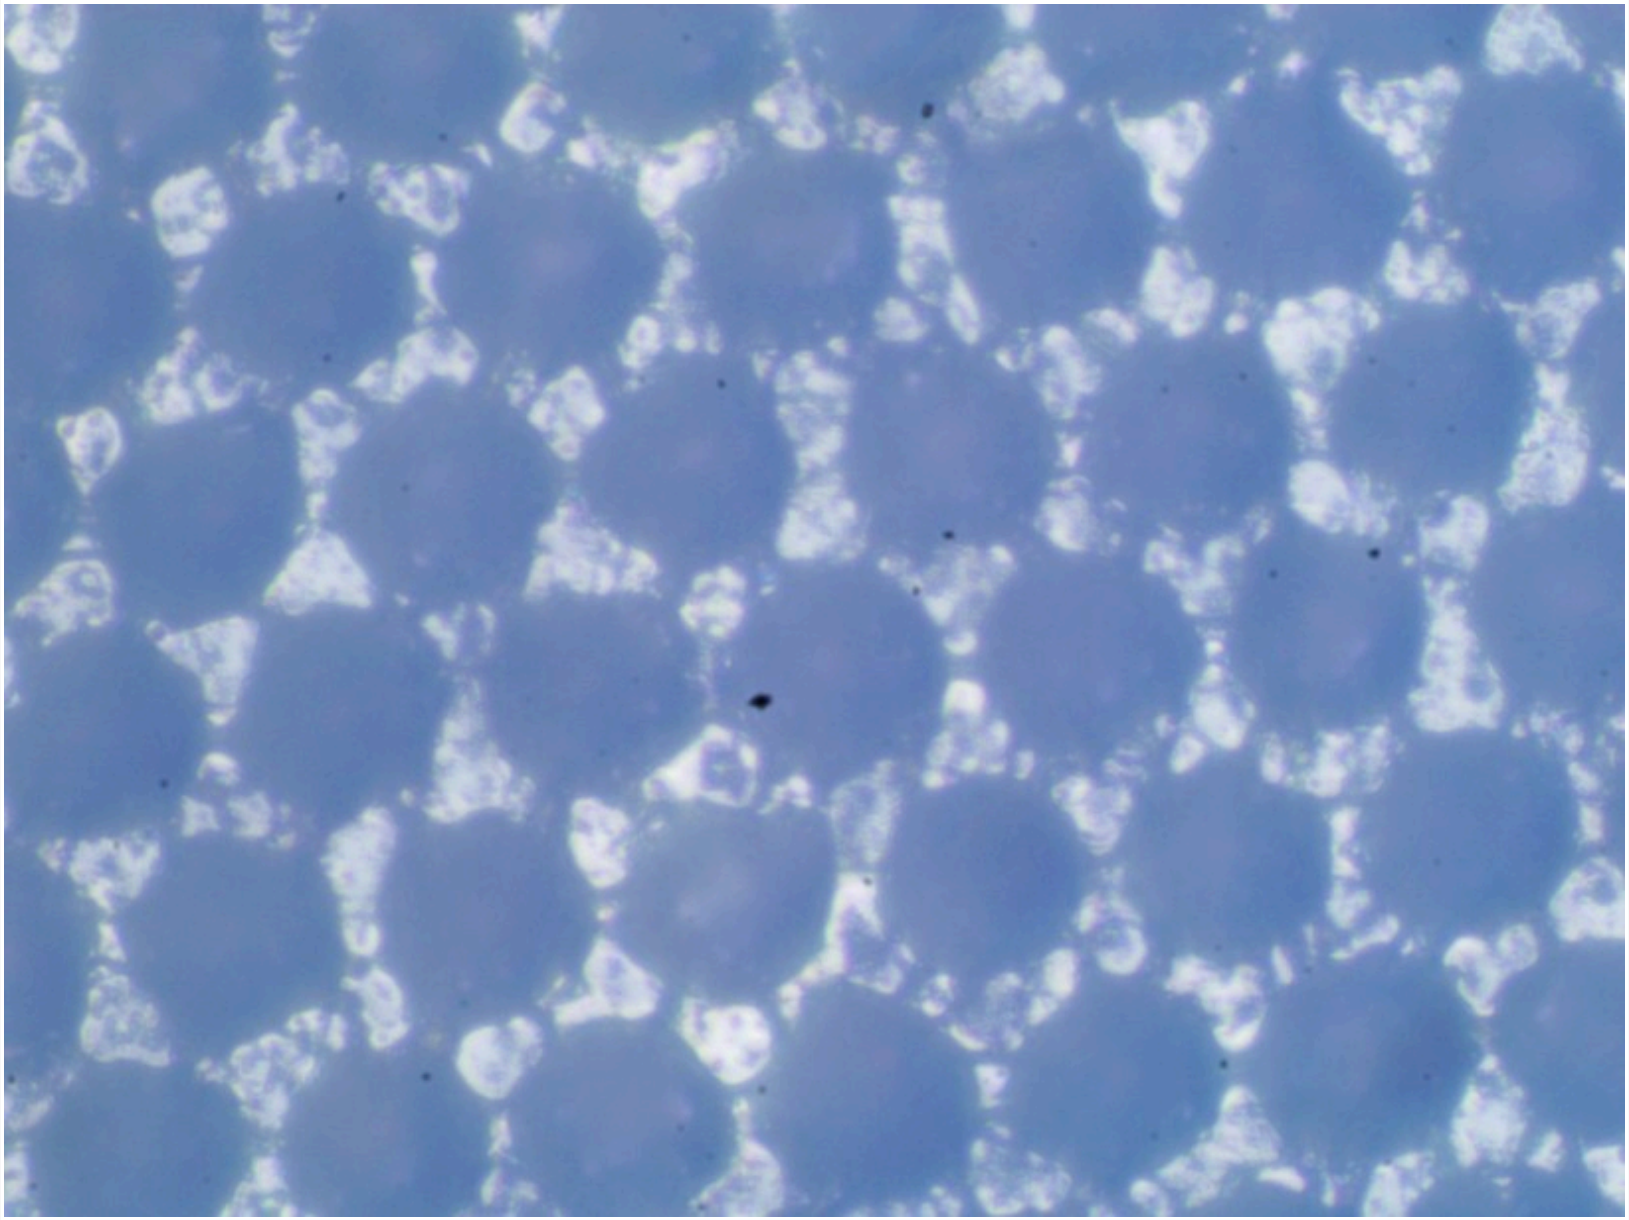
Page №120. Roll "h100748-2". Length: 870 mm. Photos with magnificaiton: x400. Cleaning passes: 1

Comment
spot 500 635 streaks at edges.
Roll slightly ground off.

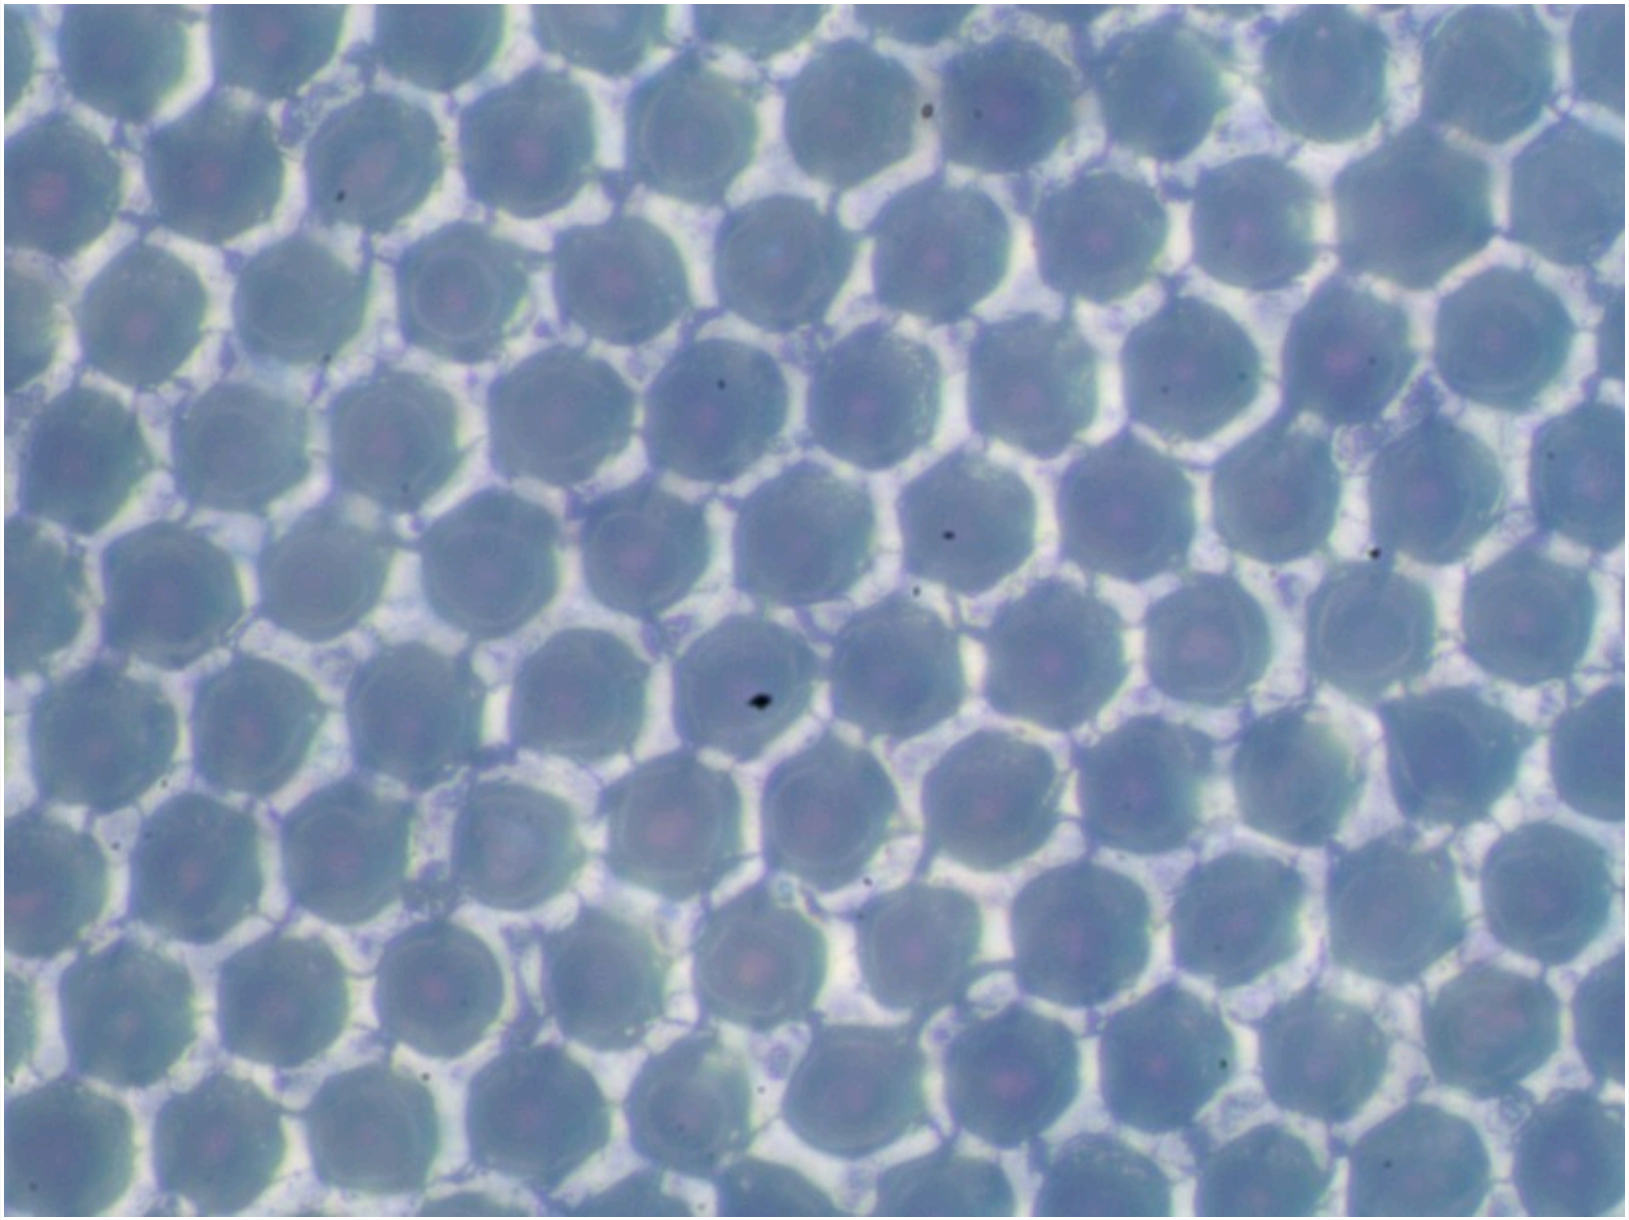
Page №121. Roll "sa008609". Length: 870 mm. Photos with magnificaiton: x400. Cleaning passes: 1

Comment
spot 380.

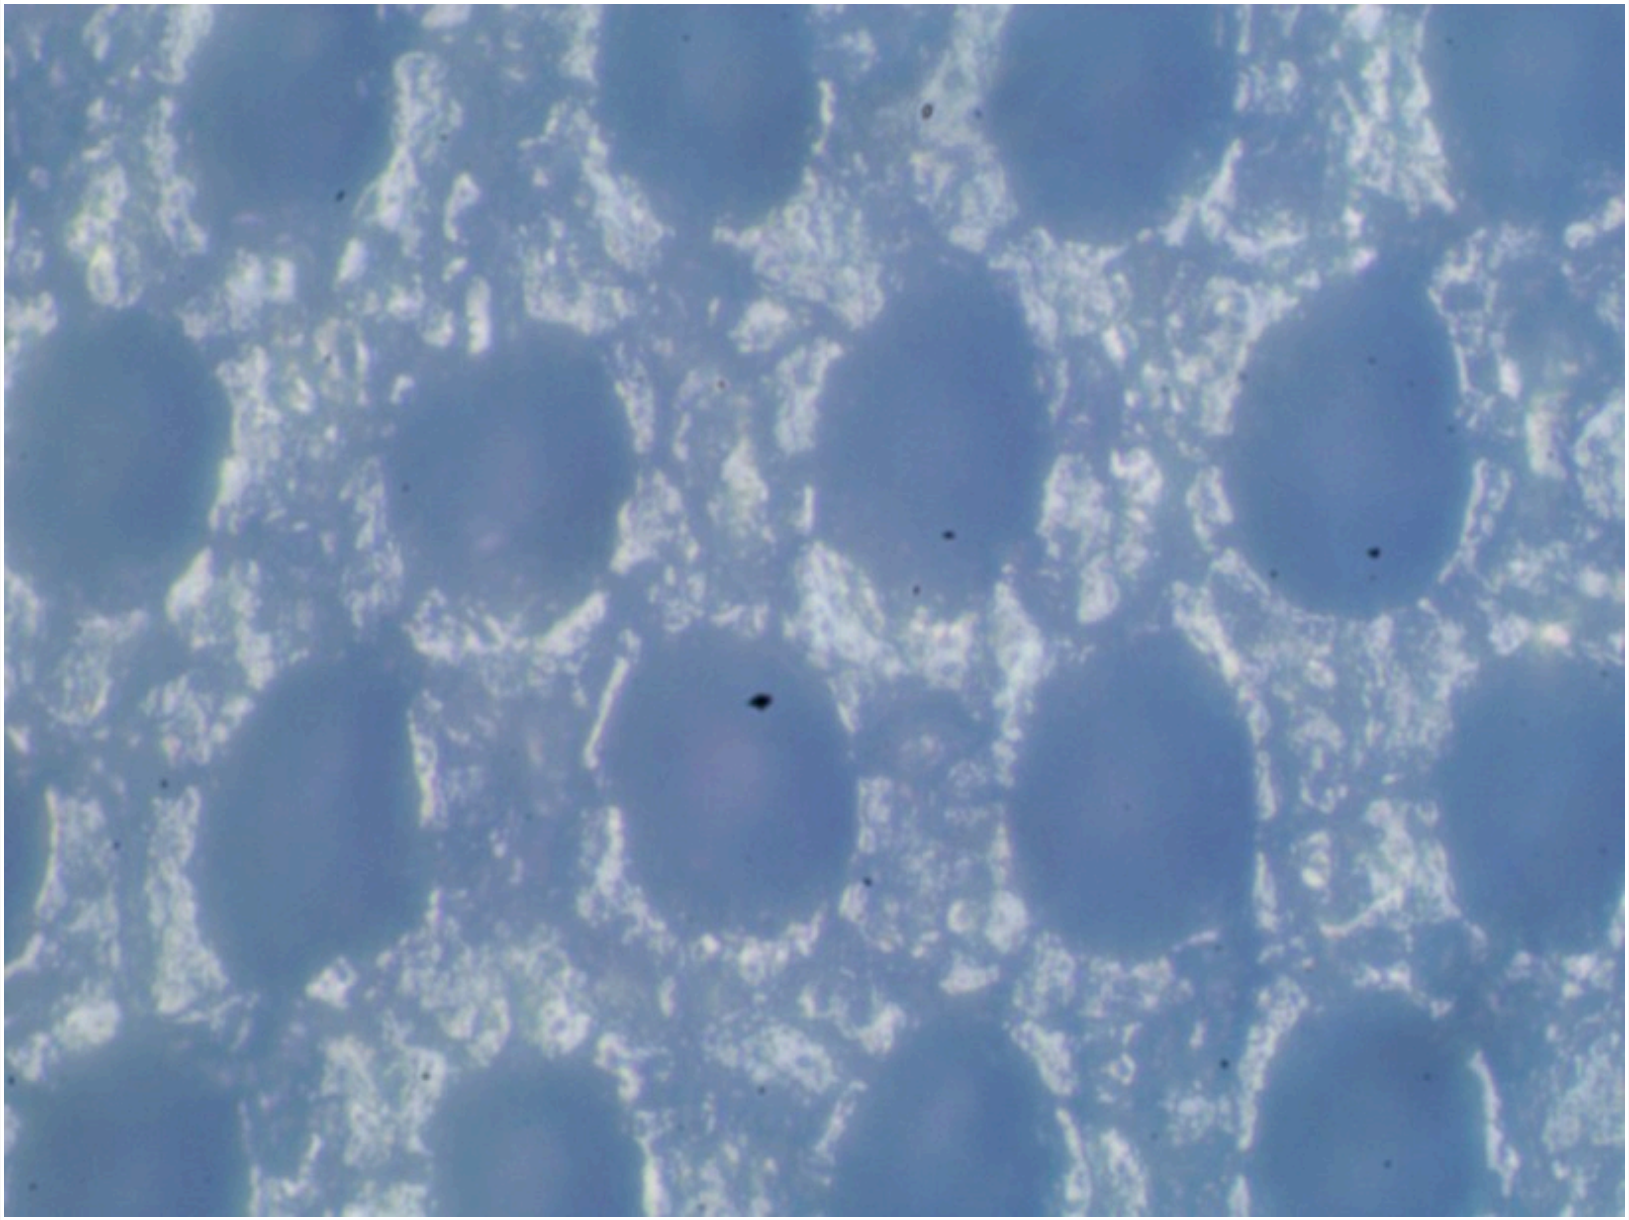
Page №122. Roll "z16007651". Length: 870 mm. Photos with magnificaiton: x400. Cleaning passes: 1

Comment
worn.
Roll heavily ground off.

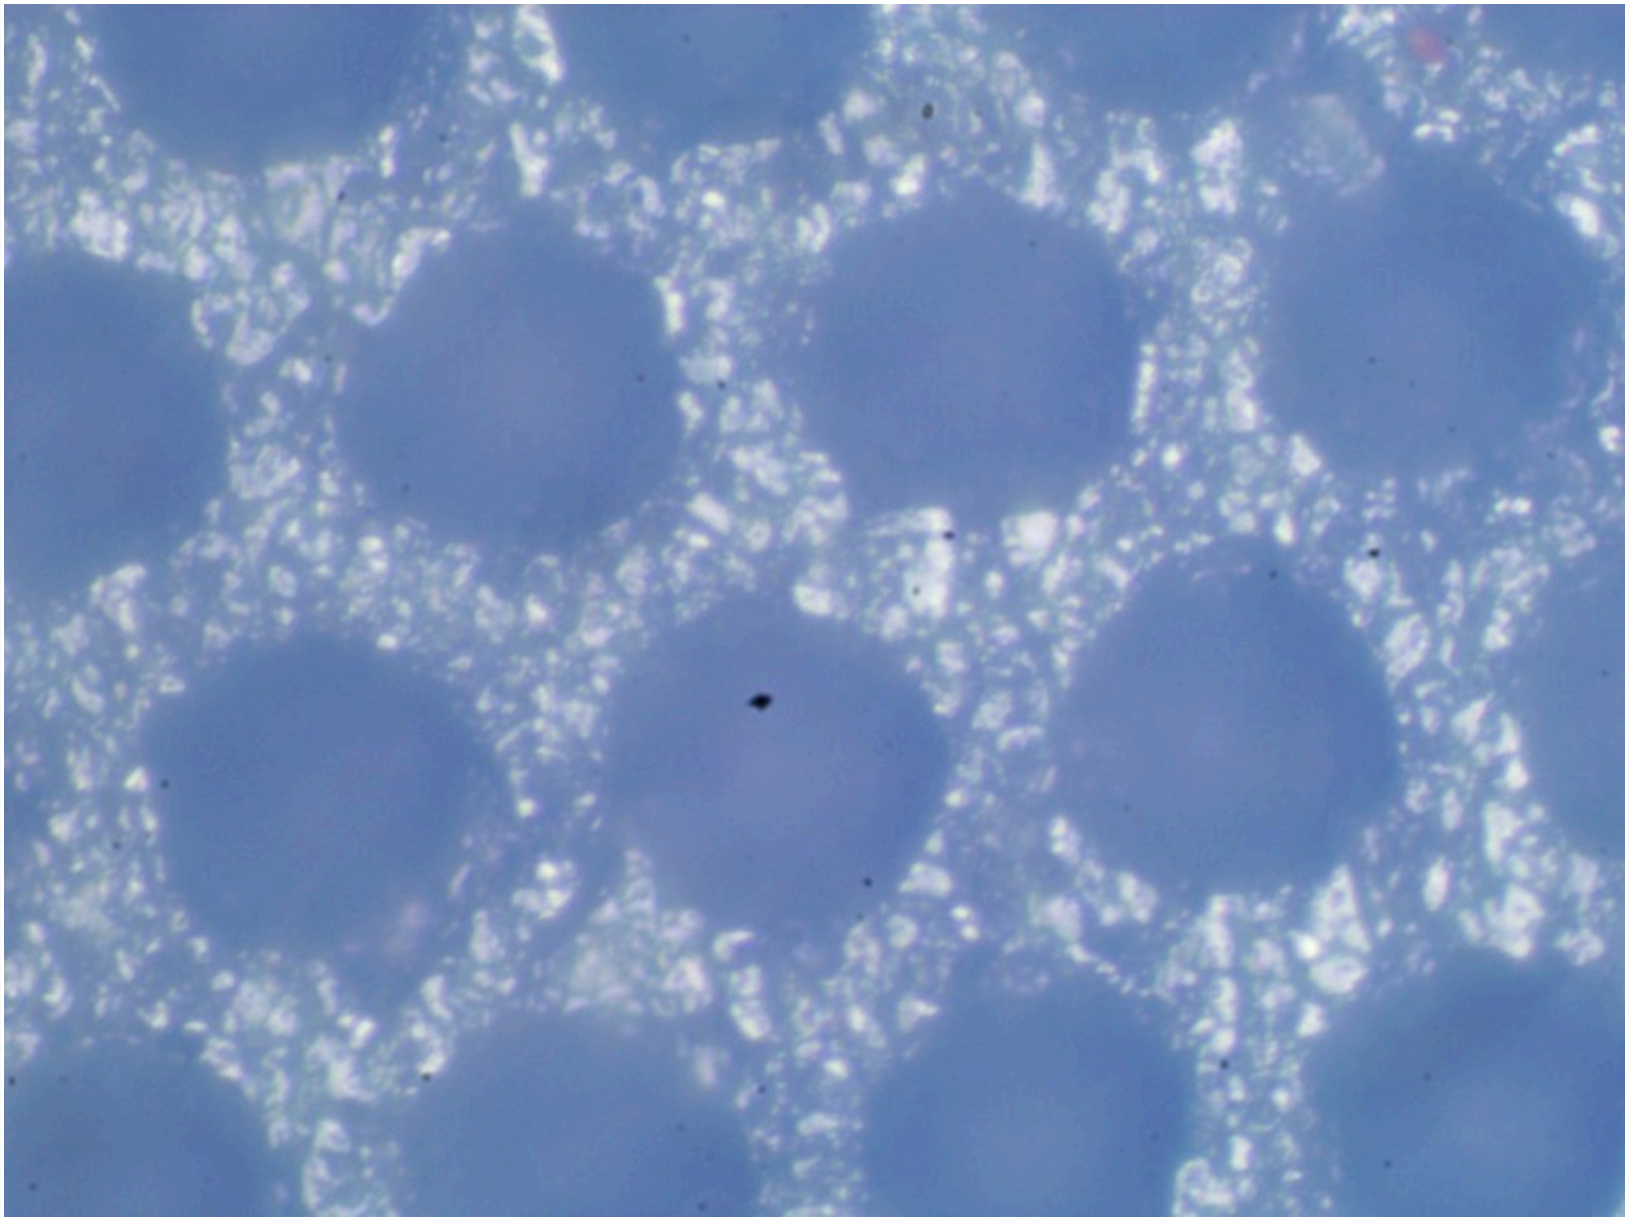
Page №123. Roll "z16007652". Length: 870 mm. Photos with magnificaiton: x400. Cleaning passes: 1

Comment
streaks at edges , 640.
Roll heavily ground off.
