RollerCheck360

Roll Inspection from 08.12.2025

Rolls: 178

We have analyzed for you 178 rolls.

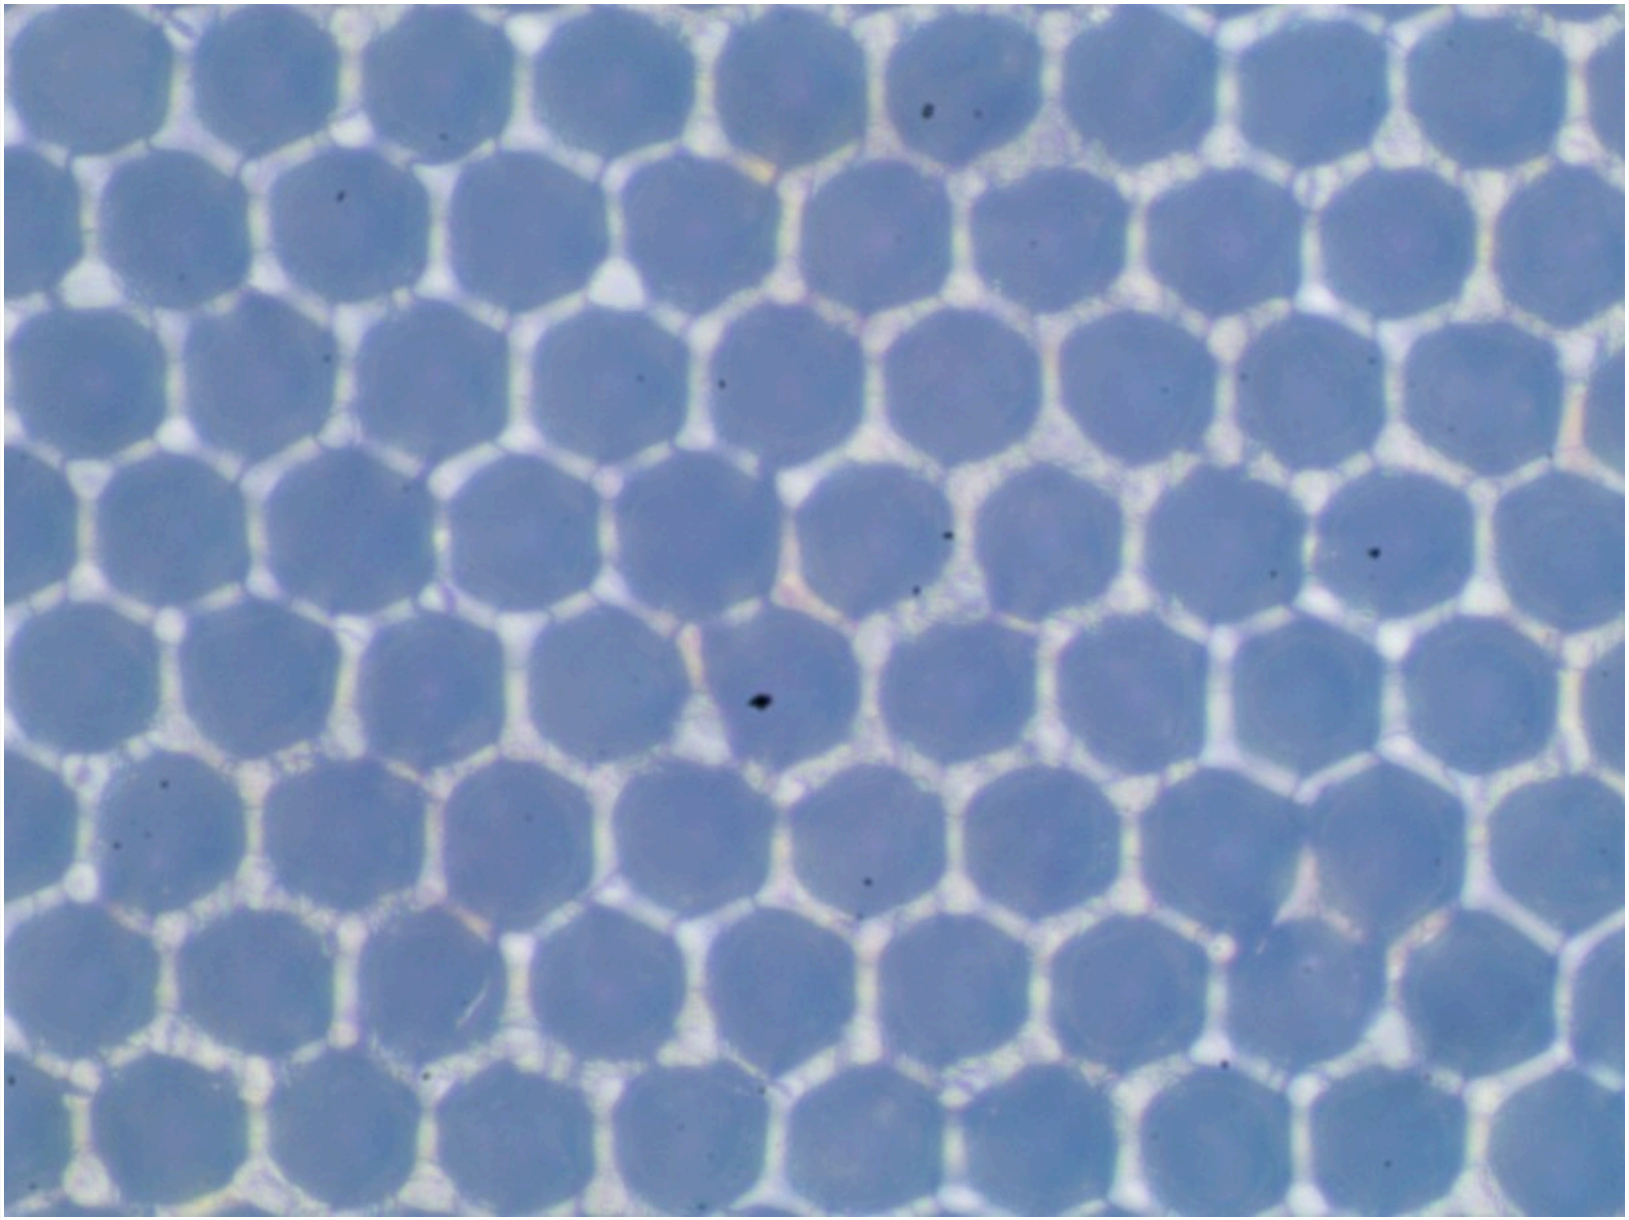
Page №125. Roll "aa2413872". Length: 870 mm. Photos with magnificaiton: x400. Cleaning passes: 1

Comment
streak at edge.
Roll slightly ground off.

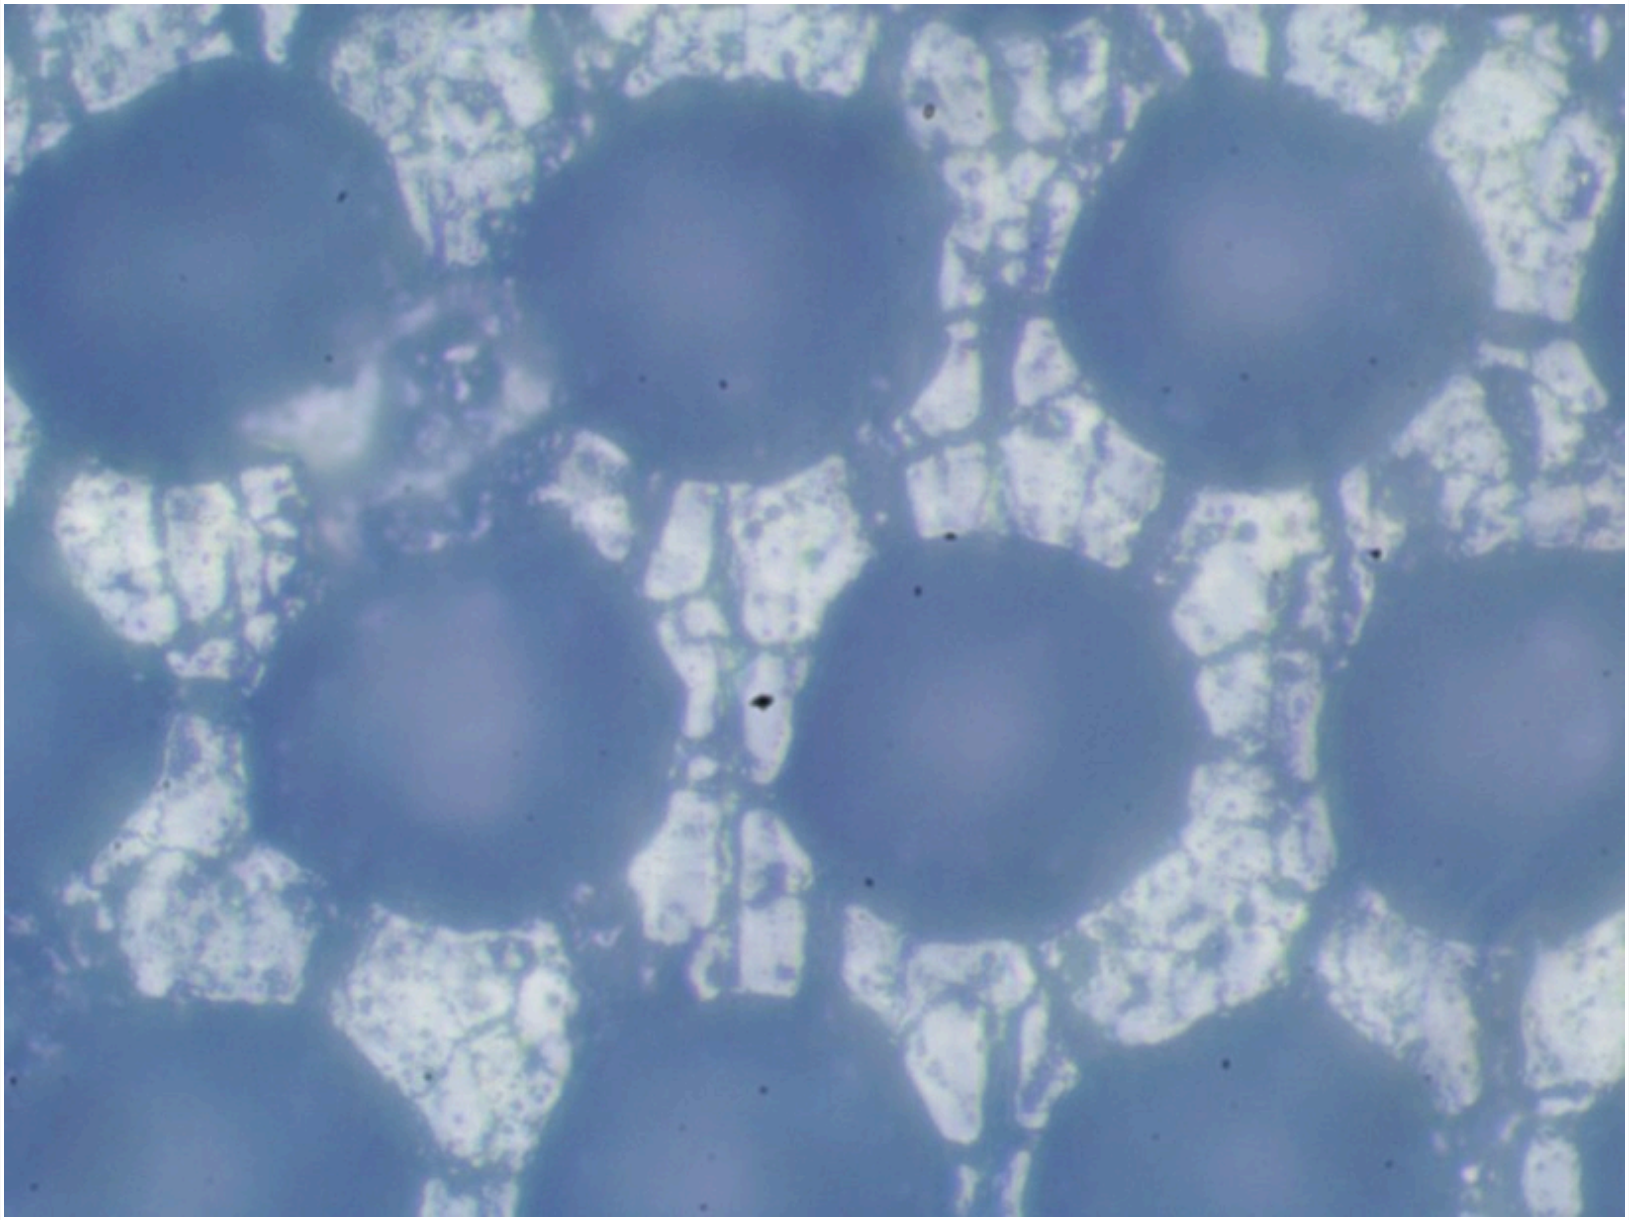
Page №126. Roll "h100748-3". Length: 870 mm. Photos with magnificaiton: x400. Cleaning passes: 1

Comment
streak 610.
Roll ground off.

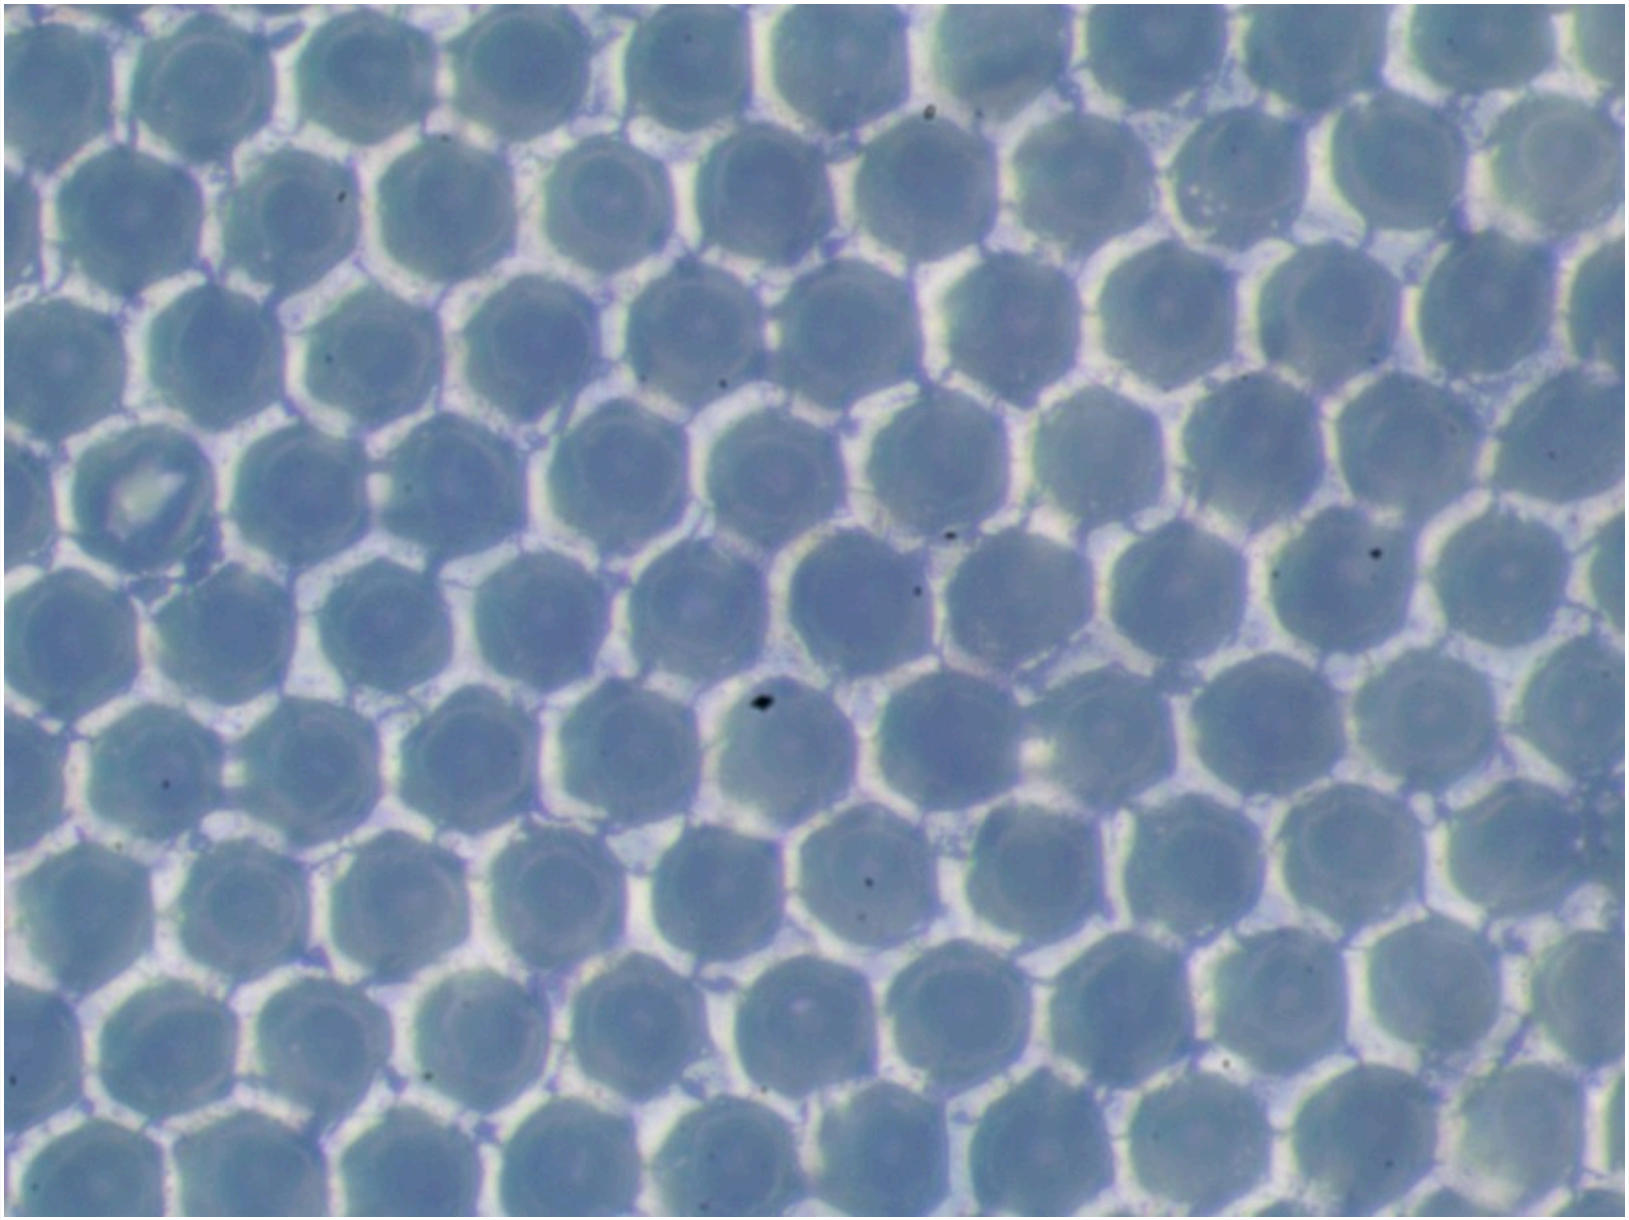
Page №127. Roll "sa008608". Length: 870 mm. Photos with magnificaiton: x400. Cleaning passes: 1

Comment
spots.
Roll ground off.

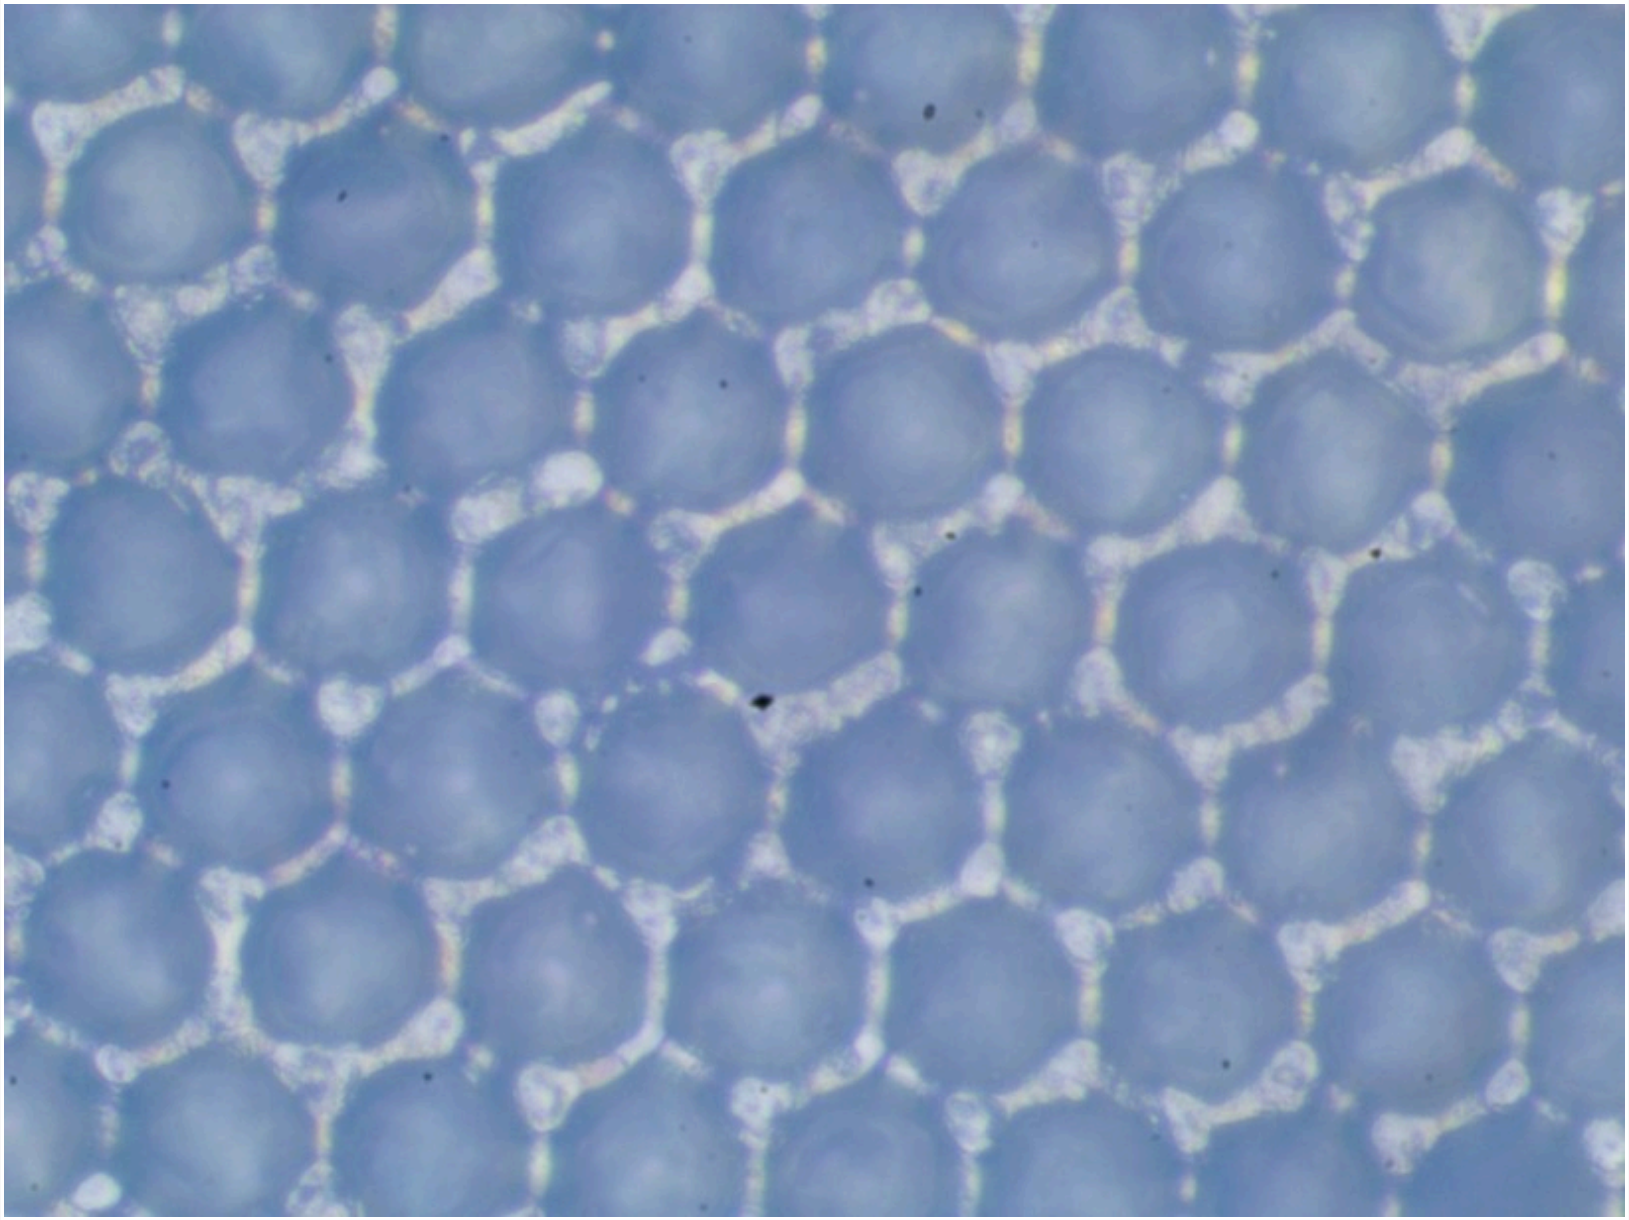
Page №128. Roll "aa2413869". Length: 870 mm. Photos with magnificaiton: x400. Cleaning passes: 1

Comment
streak at edge.

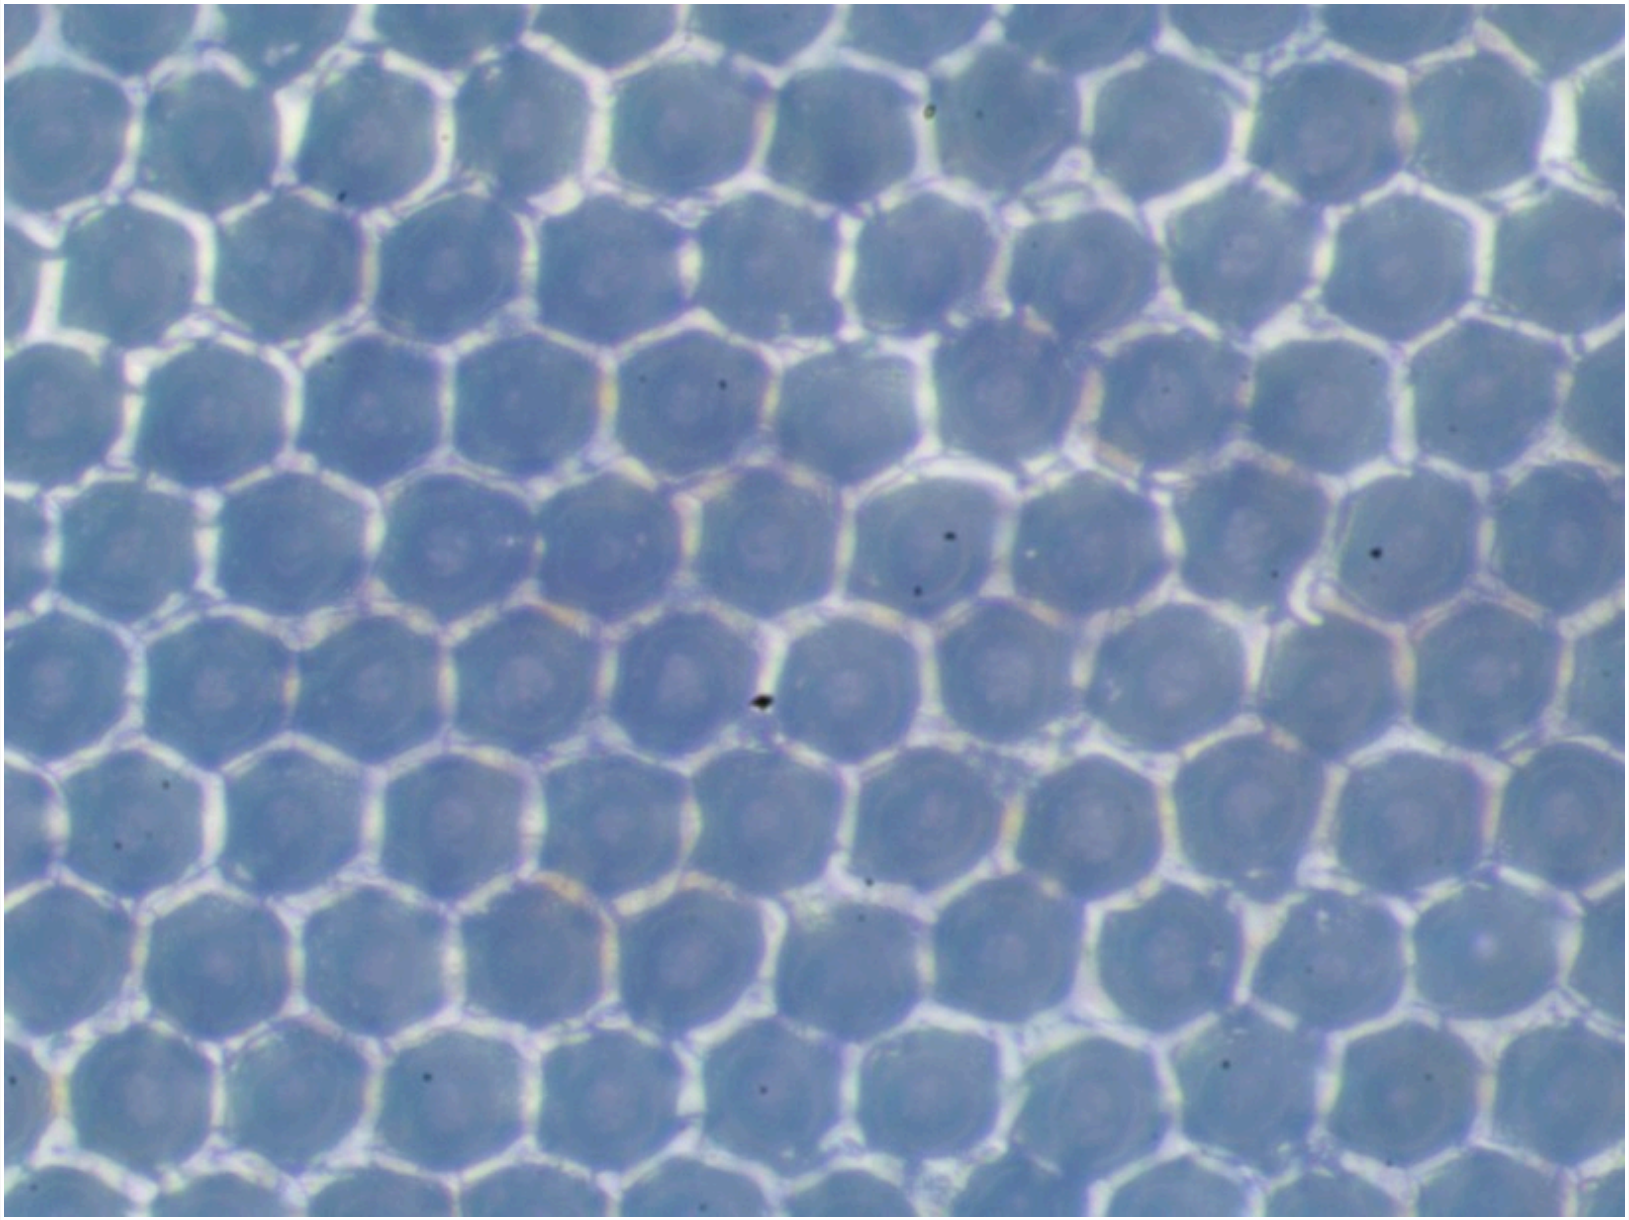
Page №129. Roll "s2401658". Length: 1320 mm. Photos with magnificaiton: x400. Cleaning passes: 1

Comment
streaks.
Roll ground off.

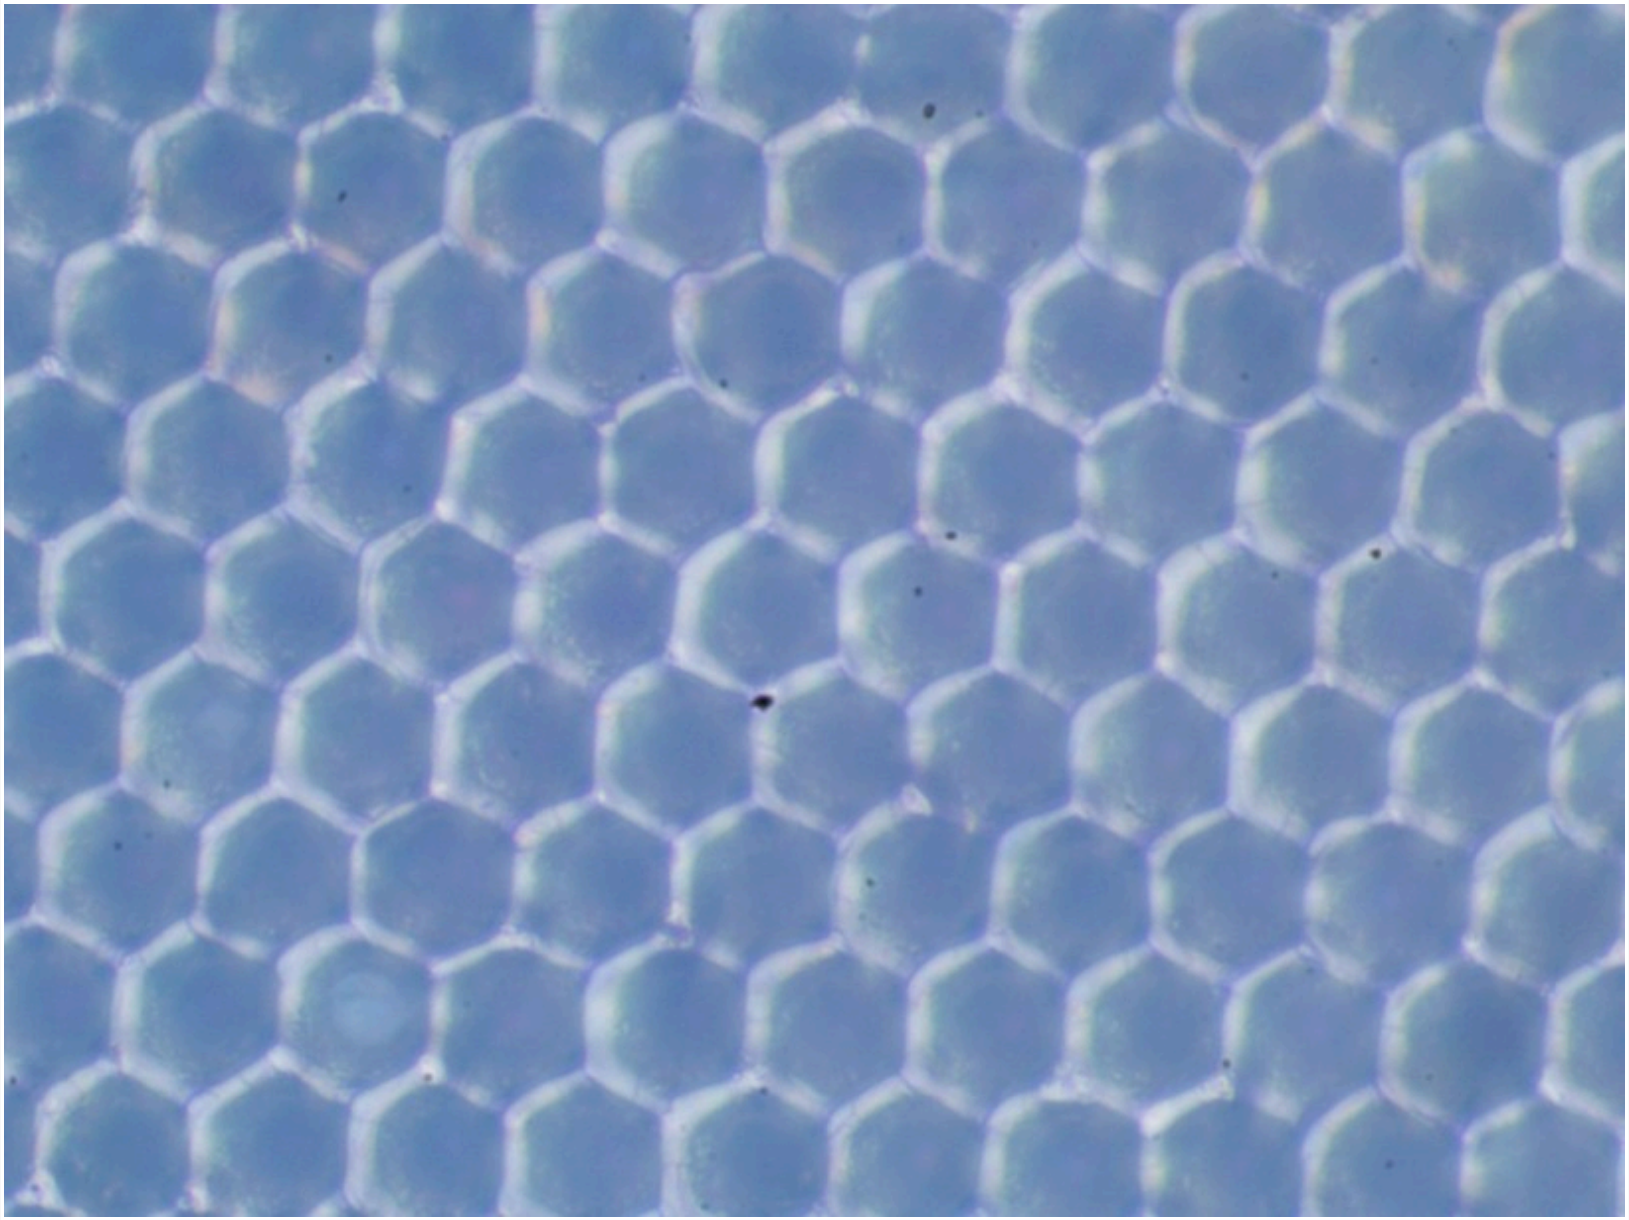
Page №130. Roll "sa008612". Length: 870 mm. Photos with magnificaiton: x400. Cleaning passes: 1

Comment
Roll ground off.

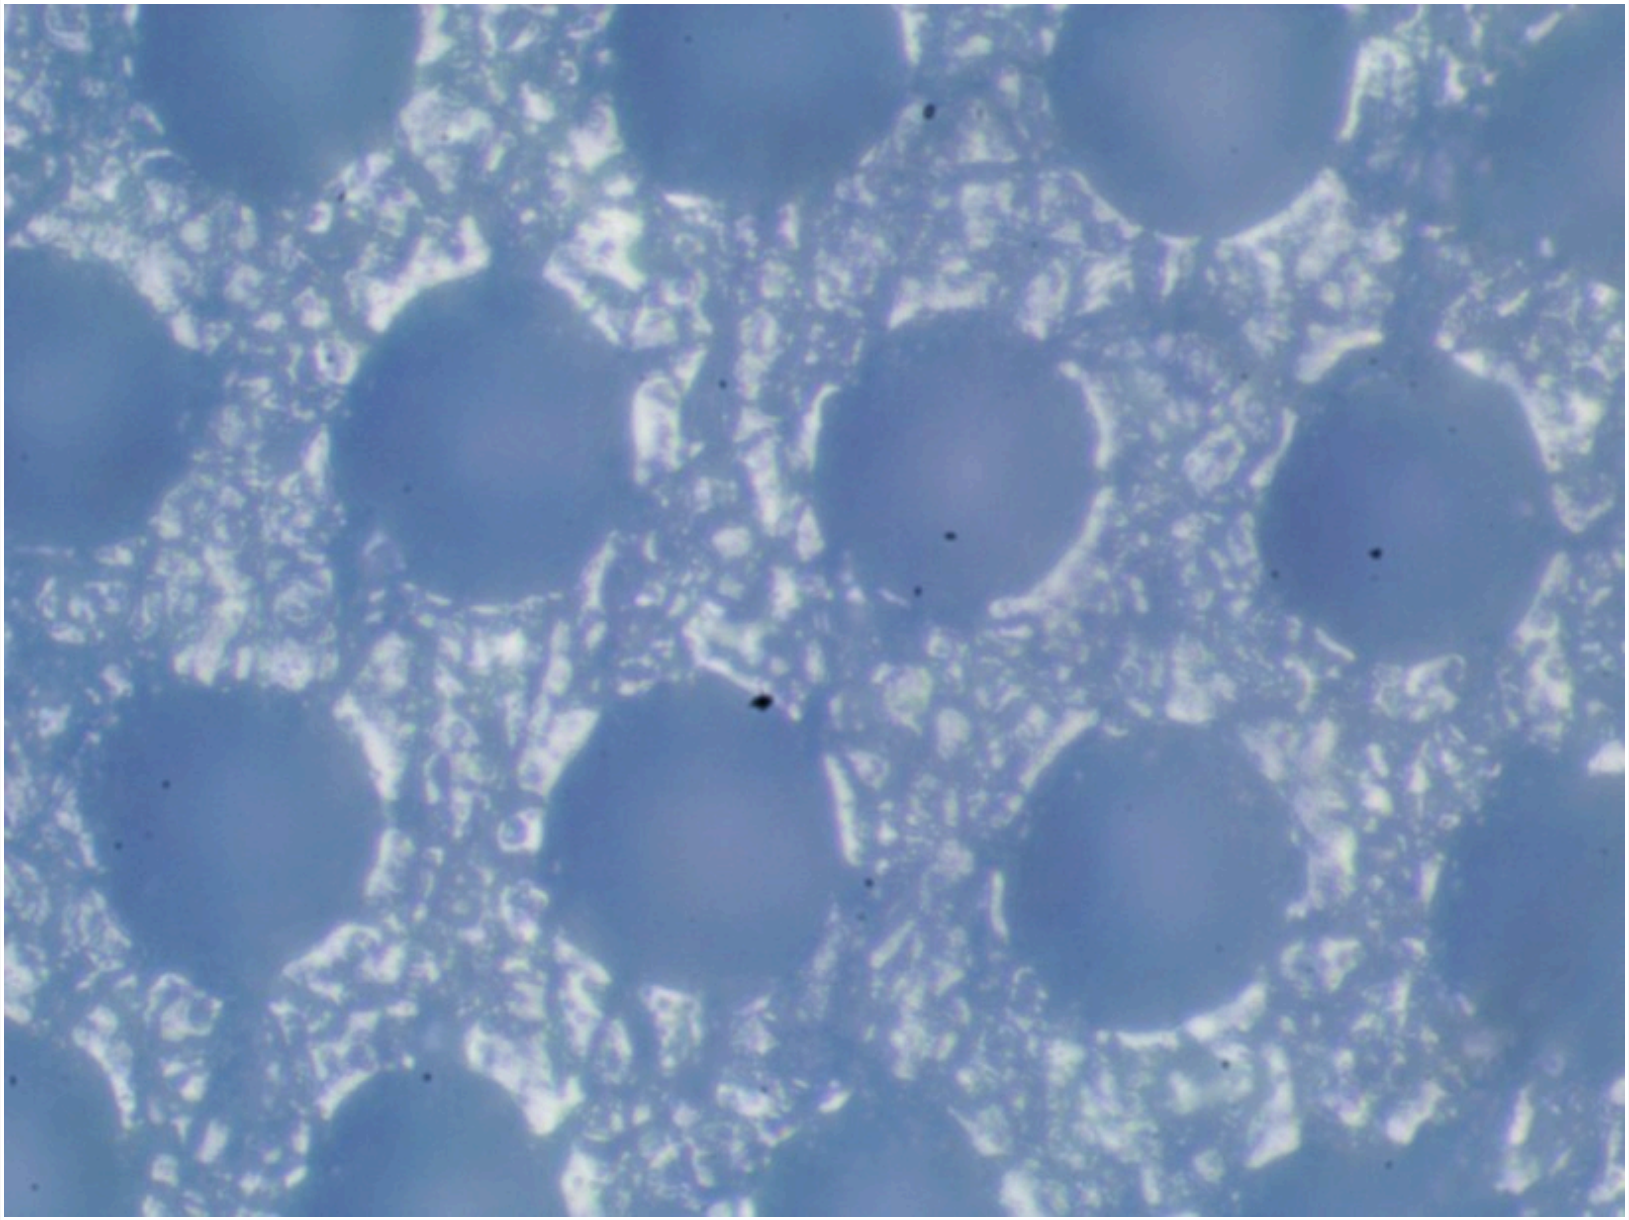
Page №131. Roll "z16007667". Length: 870 mm. Photos with magnificaiton: x400. Cleaning passes: 1

Comment
worn.
Roll heavily ground off.

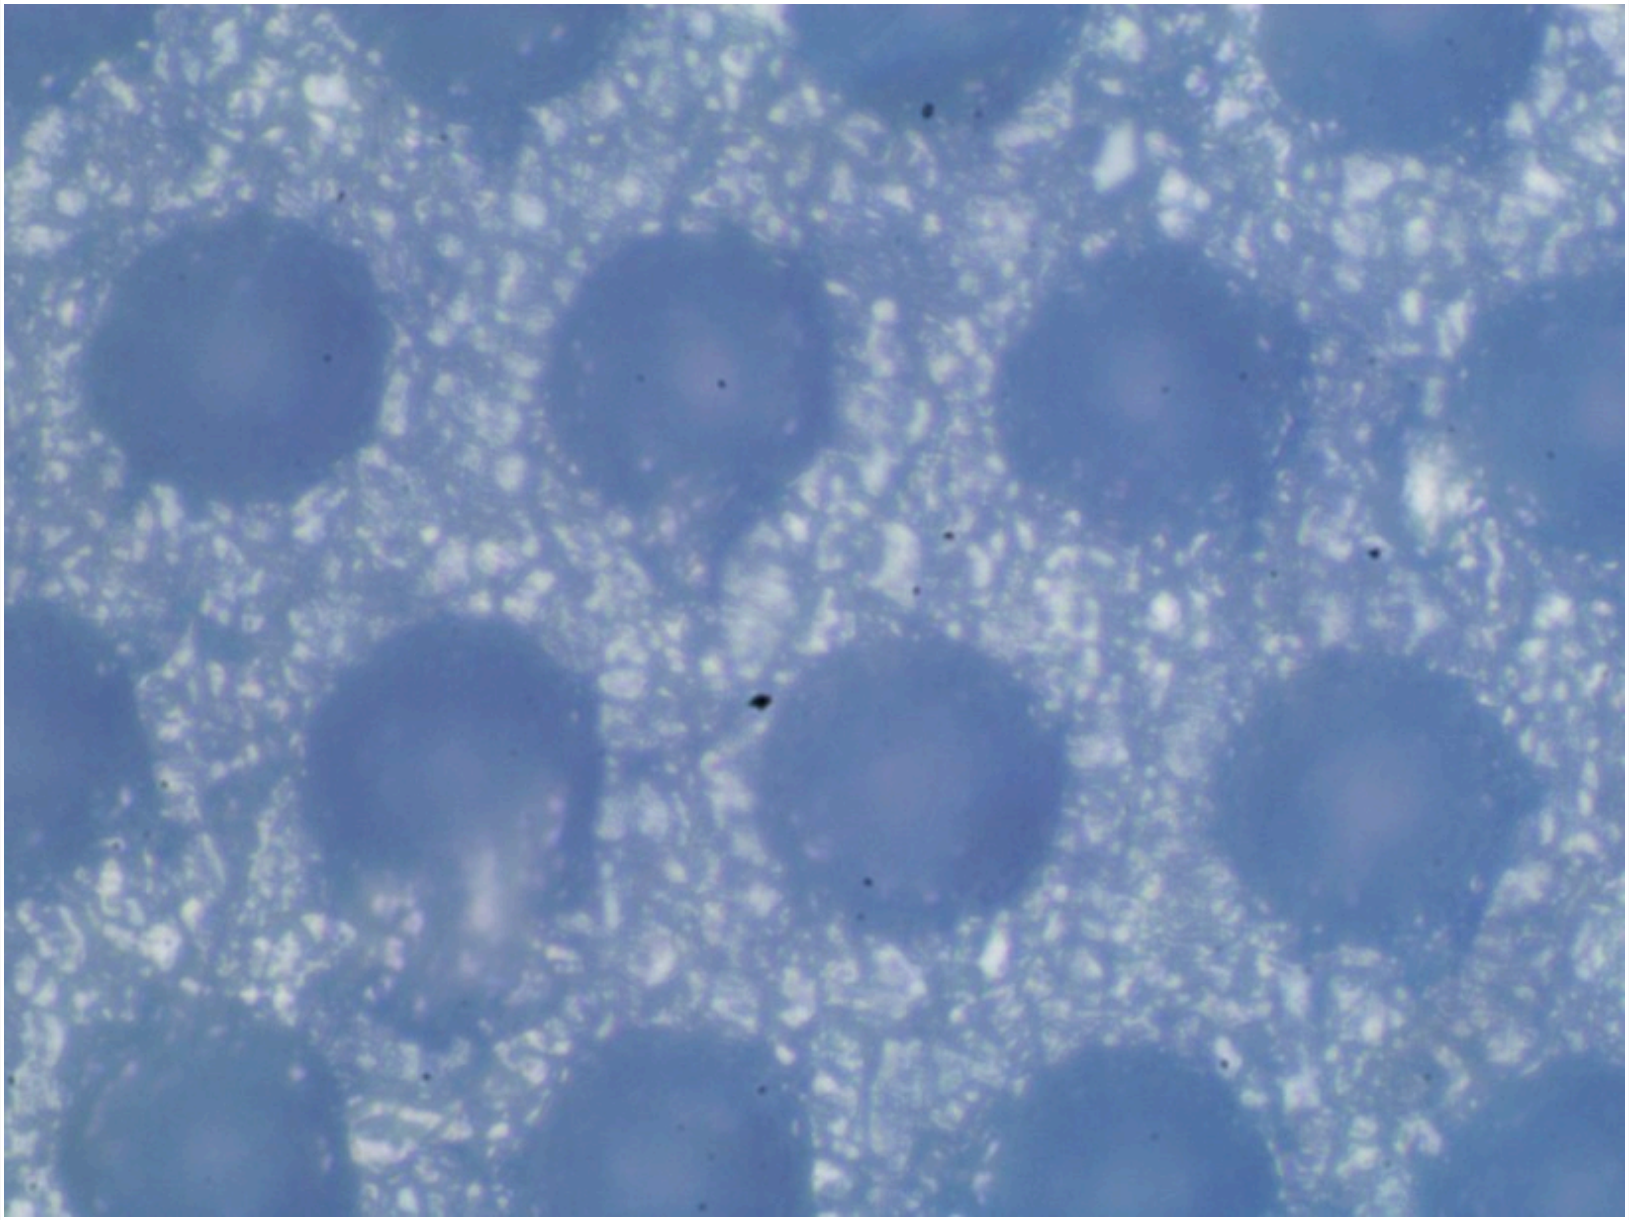
Page №132. Roll "z16007650". Length: 870 mm. Photos with magnificaiton: x400. Cleaning passes: 1

Bridge / Cell: 1 / 2
Depth before / after: 17 / 17 мкм
Depth decreased by: 0%

Comment
worn streaks.
Roll heavily ground off.

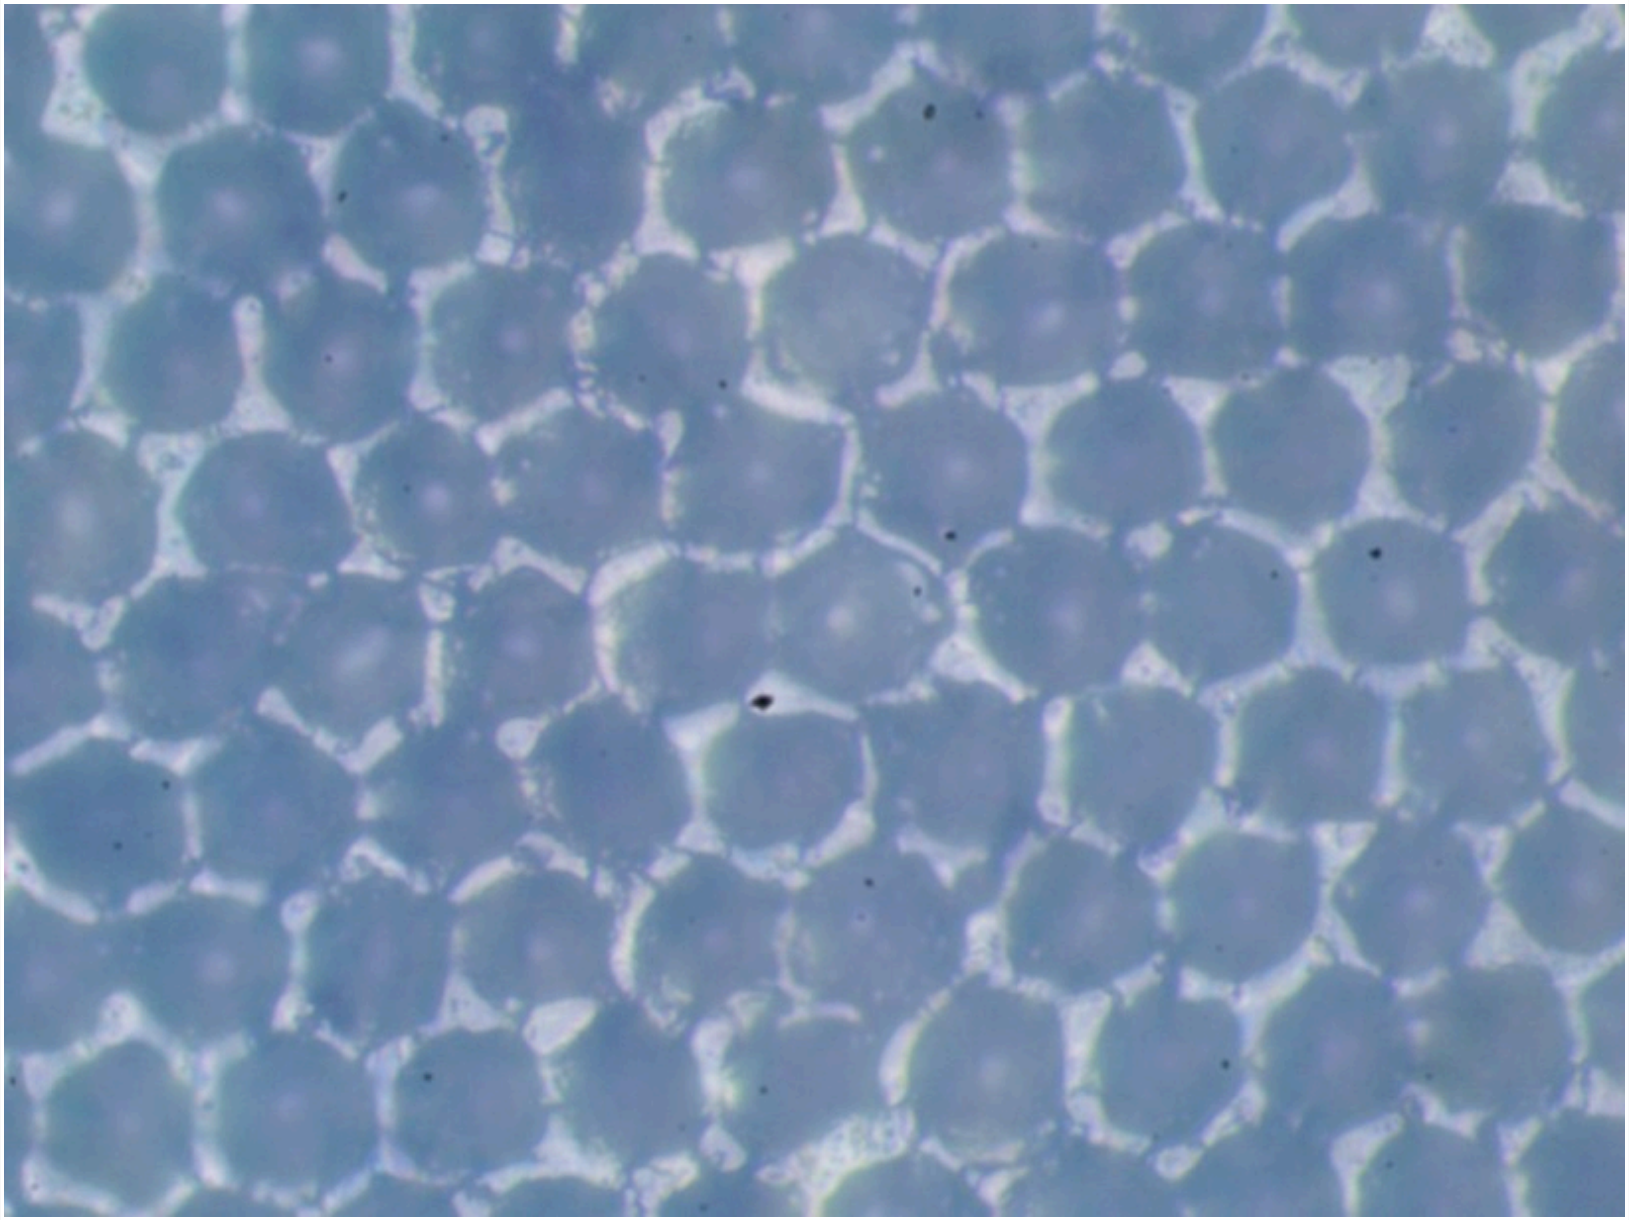
Page №134. Roll "sg49046-25". Length: 1360 mm. Photos with magnificaiton: x400. Cleaning passes: 1

.
Roll slightly ground off.

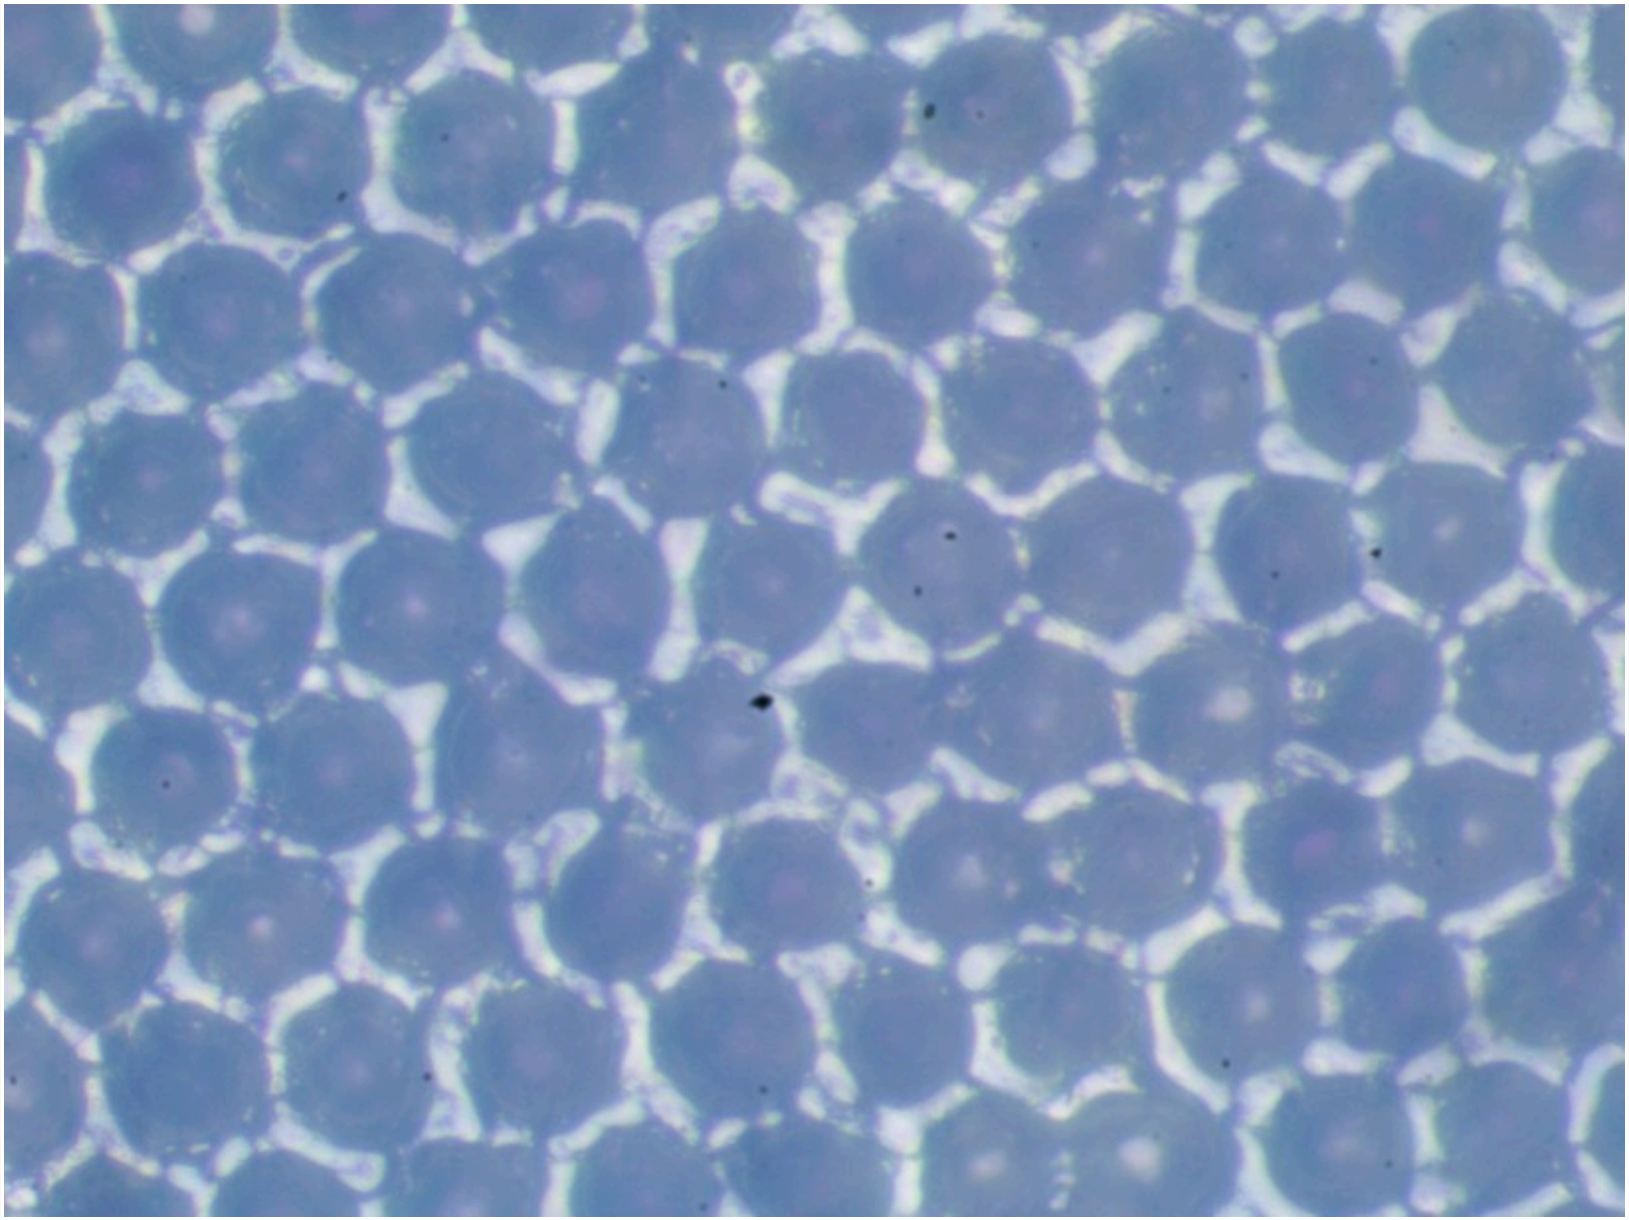
Page №135. Roll "sg49046-27". Length: 1360 mm. Photos with magnificaiton: x400. Cleaning passes: 1

Comment
chips at edges.
Roll slightly ground off.

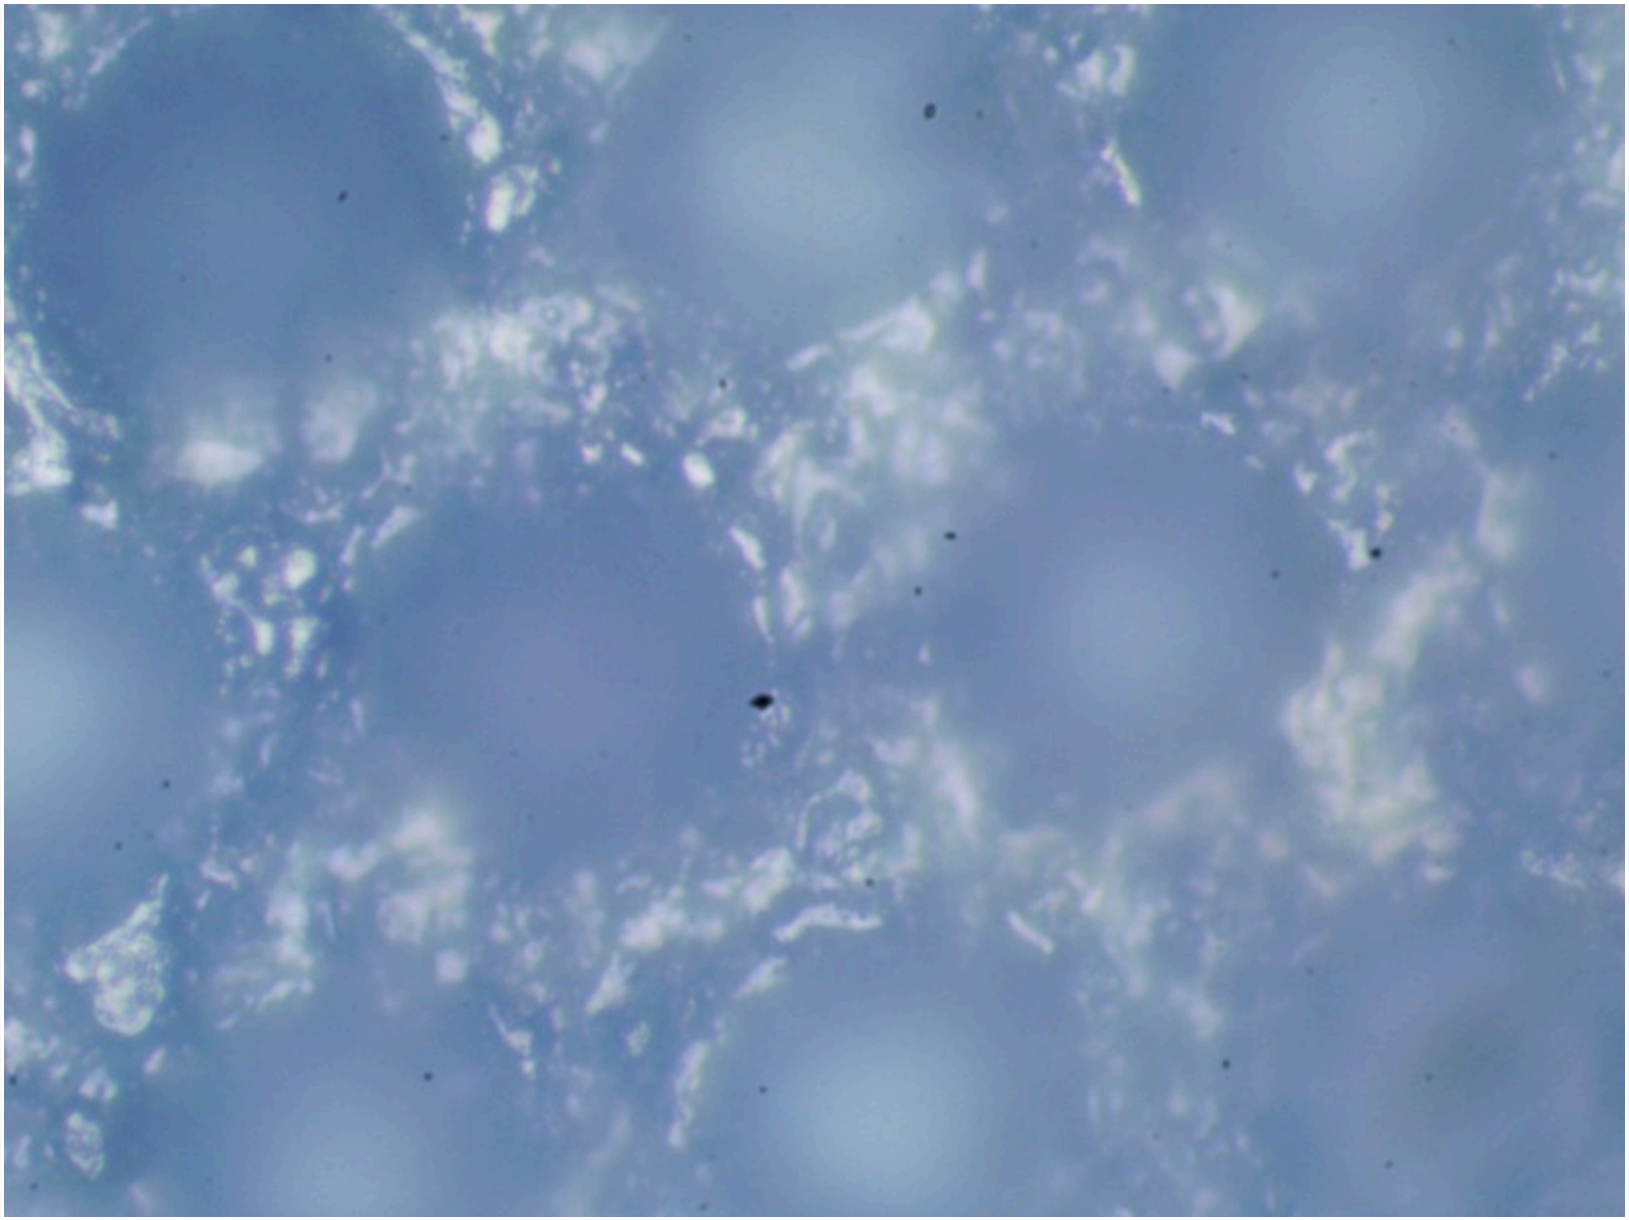
Page №136. Roll "sg49046-3". Length: 1360 mm. Photos with magnificaiton: x400. Cleaning passes: 1

Comment
cell walls are damaged streaks.
Roll heavily ground off.
