RollerCheck360

Roll Inspection from 08.12.2025

Rolls: 178

We have analyzed for you 178 rolls.

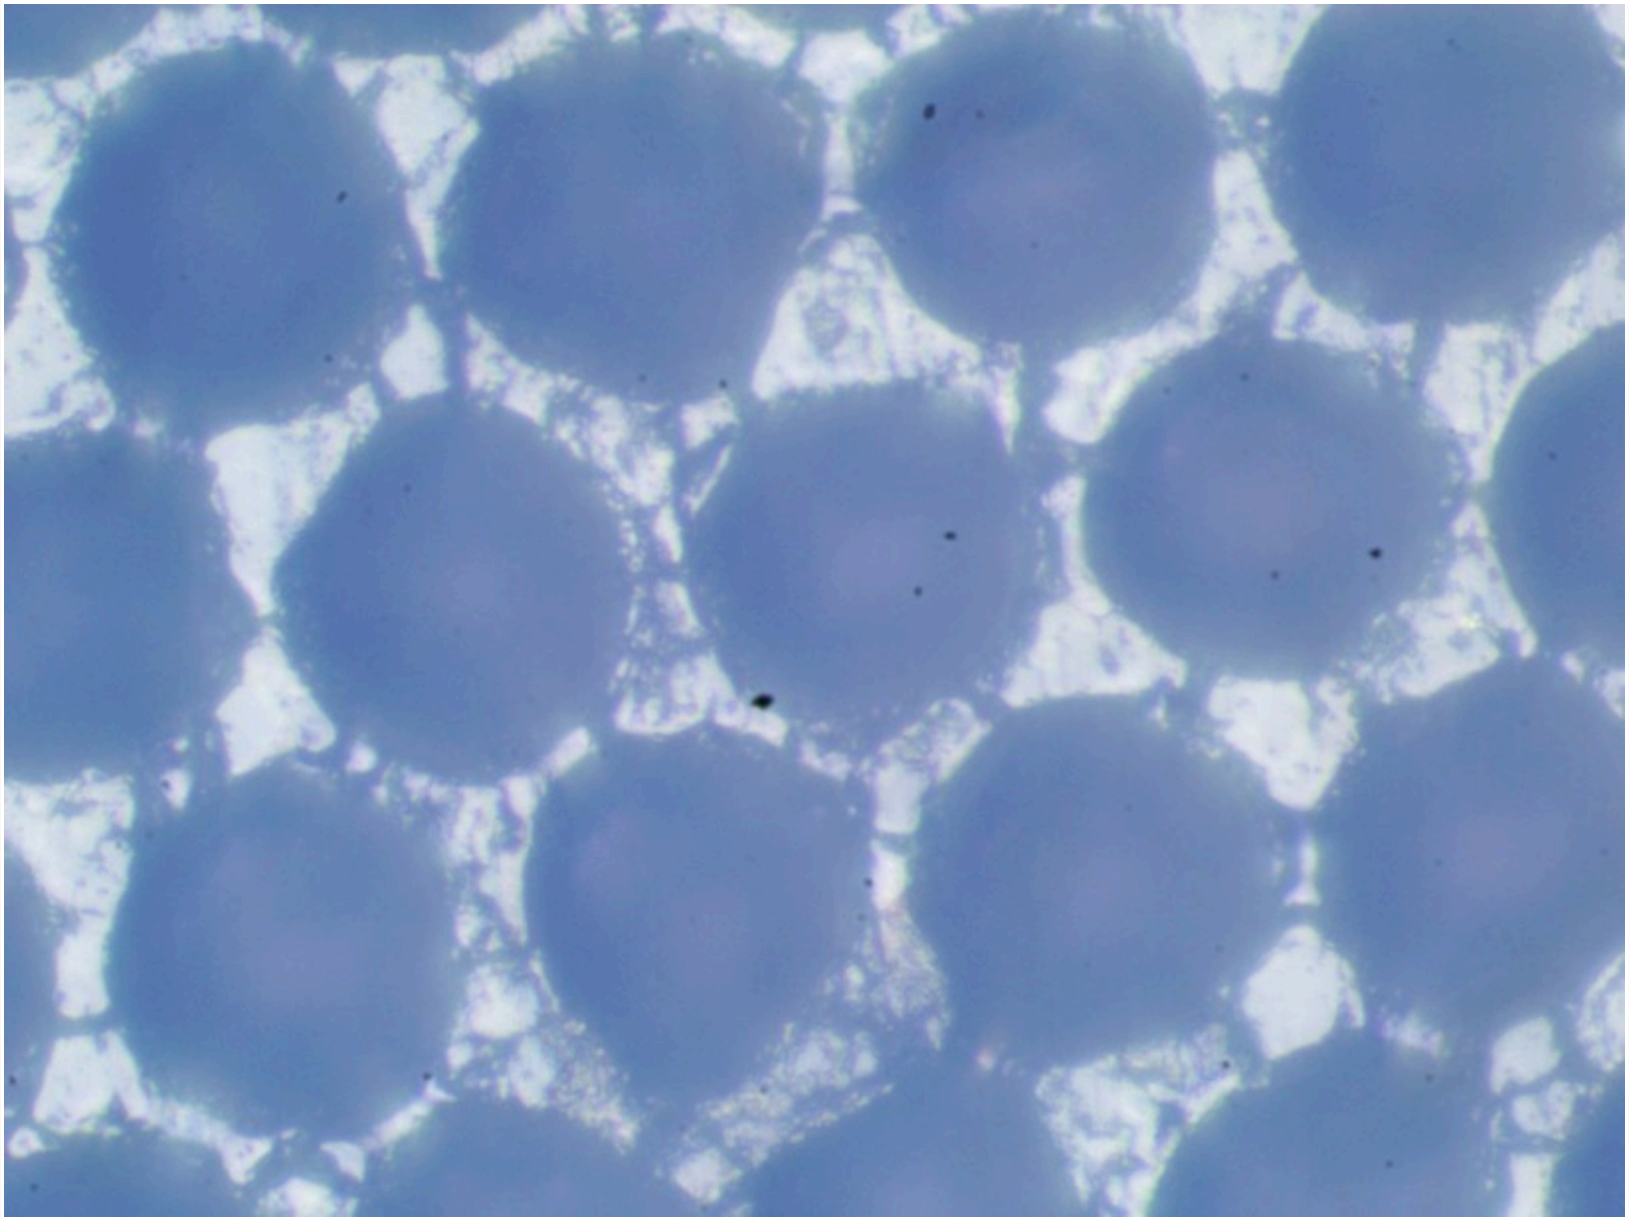
Page №137. Roll "sg49046-6". Length: 1360 mm. Photos with magnificaiton: x400. Cleaning passes: 1

Comment
dents 34 scratch 460 chips at edges.

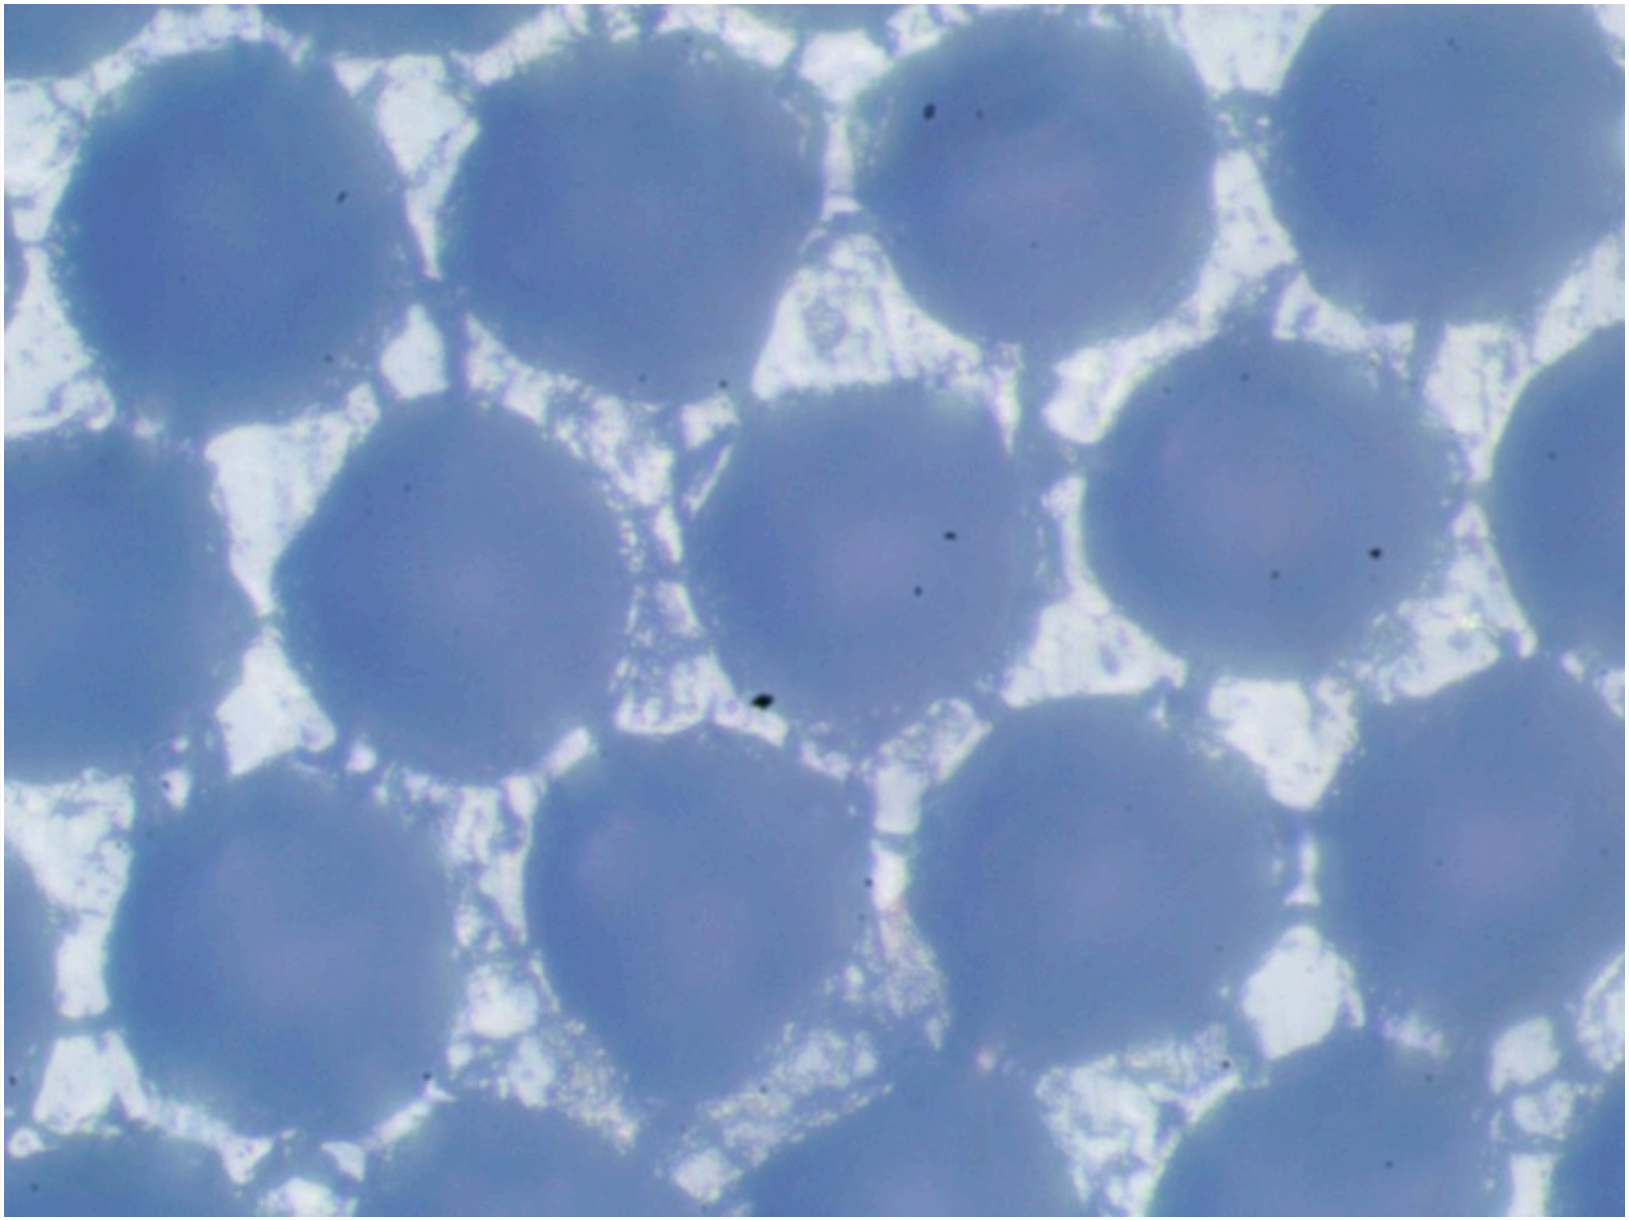
Page №138. Roll "sg49046-4". Length: 1360 mm. Photos with magnificaiton: x400. Cleaning passes: 1

Comment
streaks 295 564 spot 1180 scratch 28.

Roll slightly ground off.

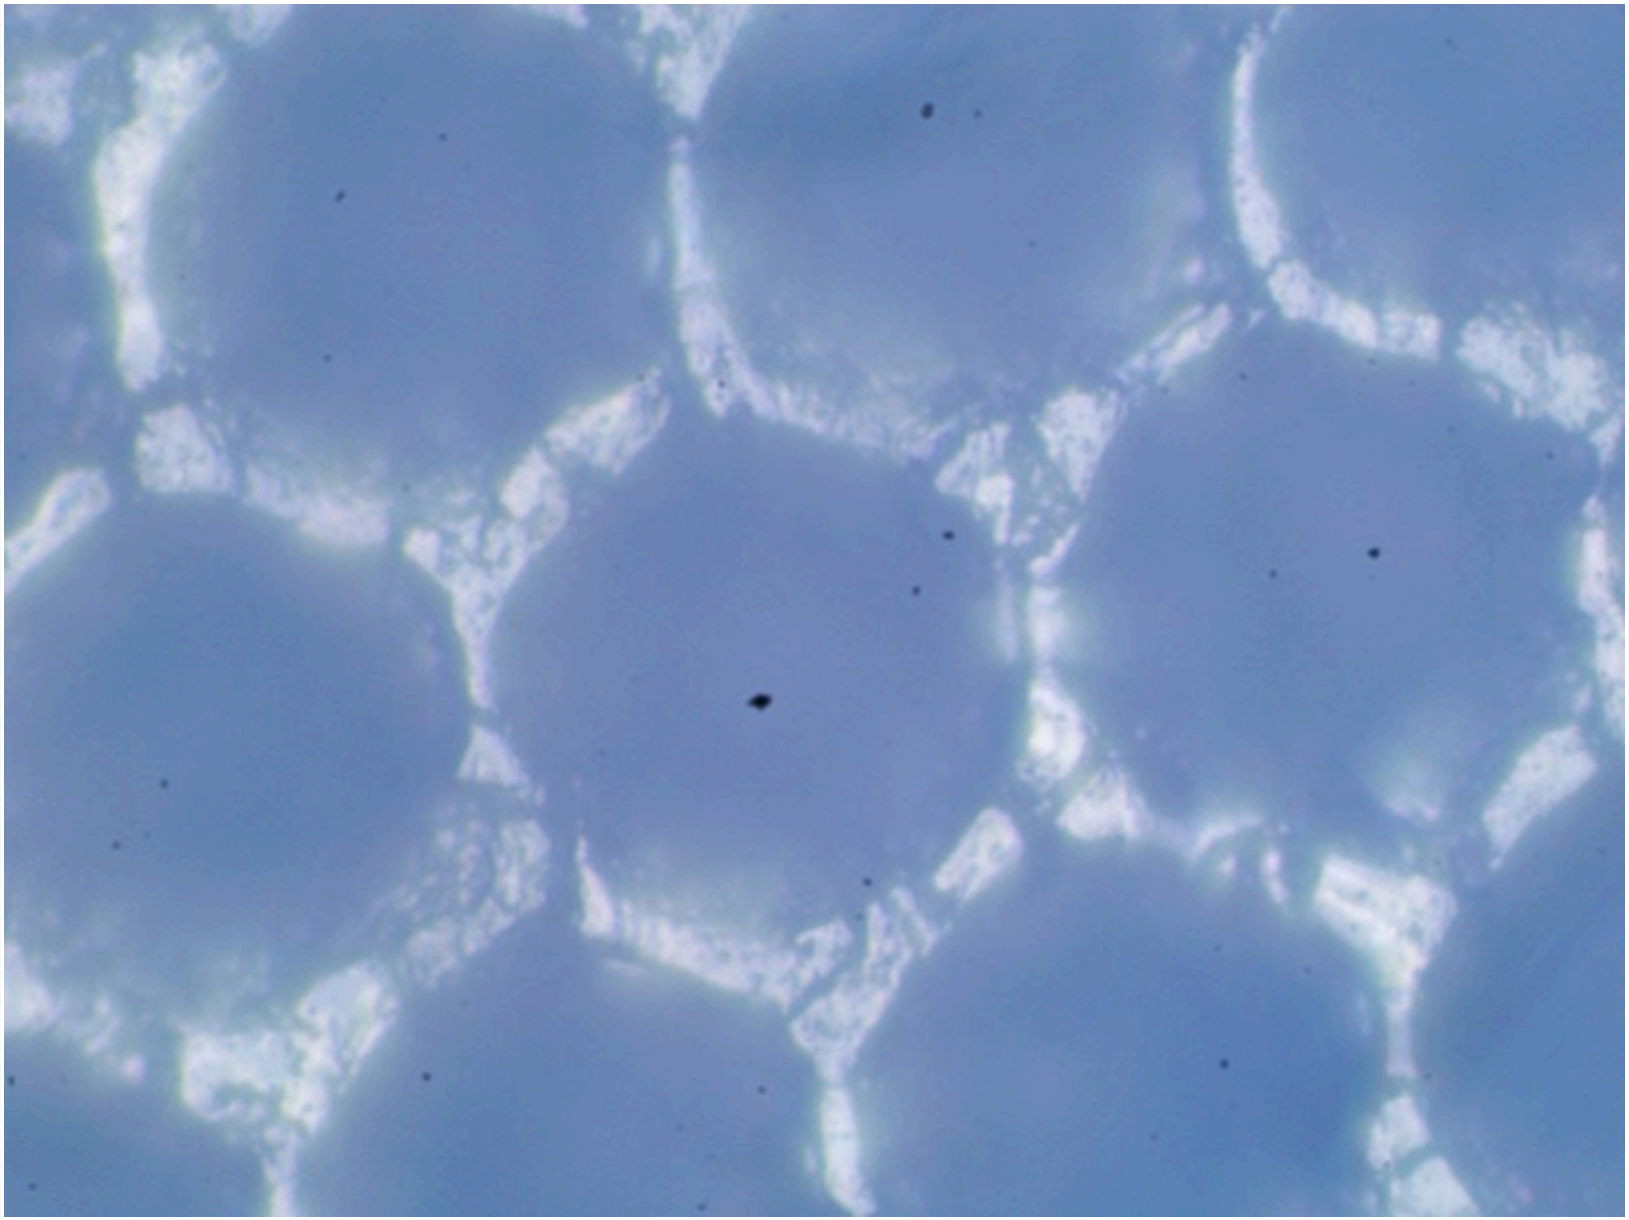
Page №139. Roll "sg49046-1". Length: 1360 mm. Photos with magnificaiton: x400. Cleaning passes: 1

Comment
not worn, no visible damage.

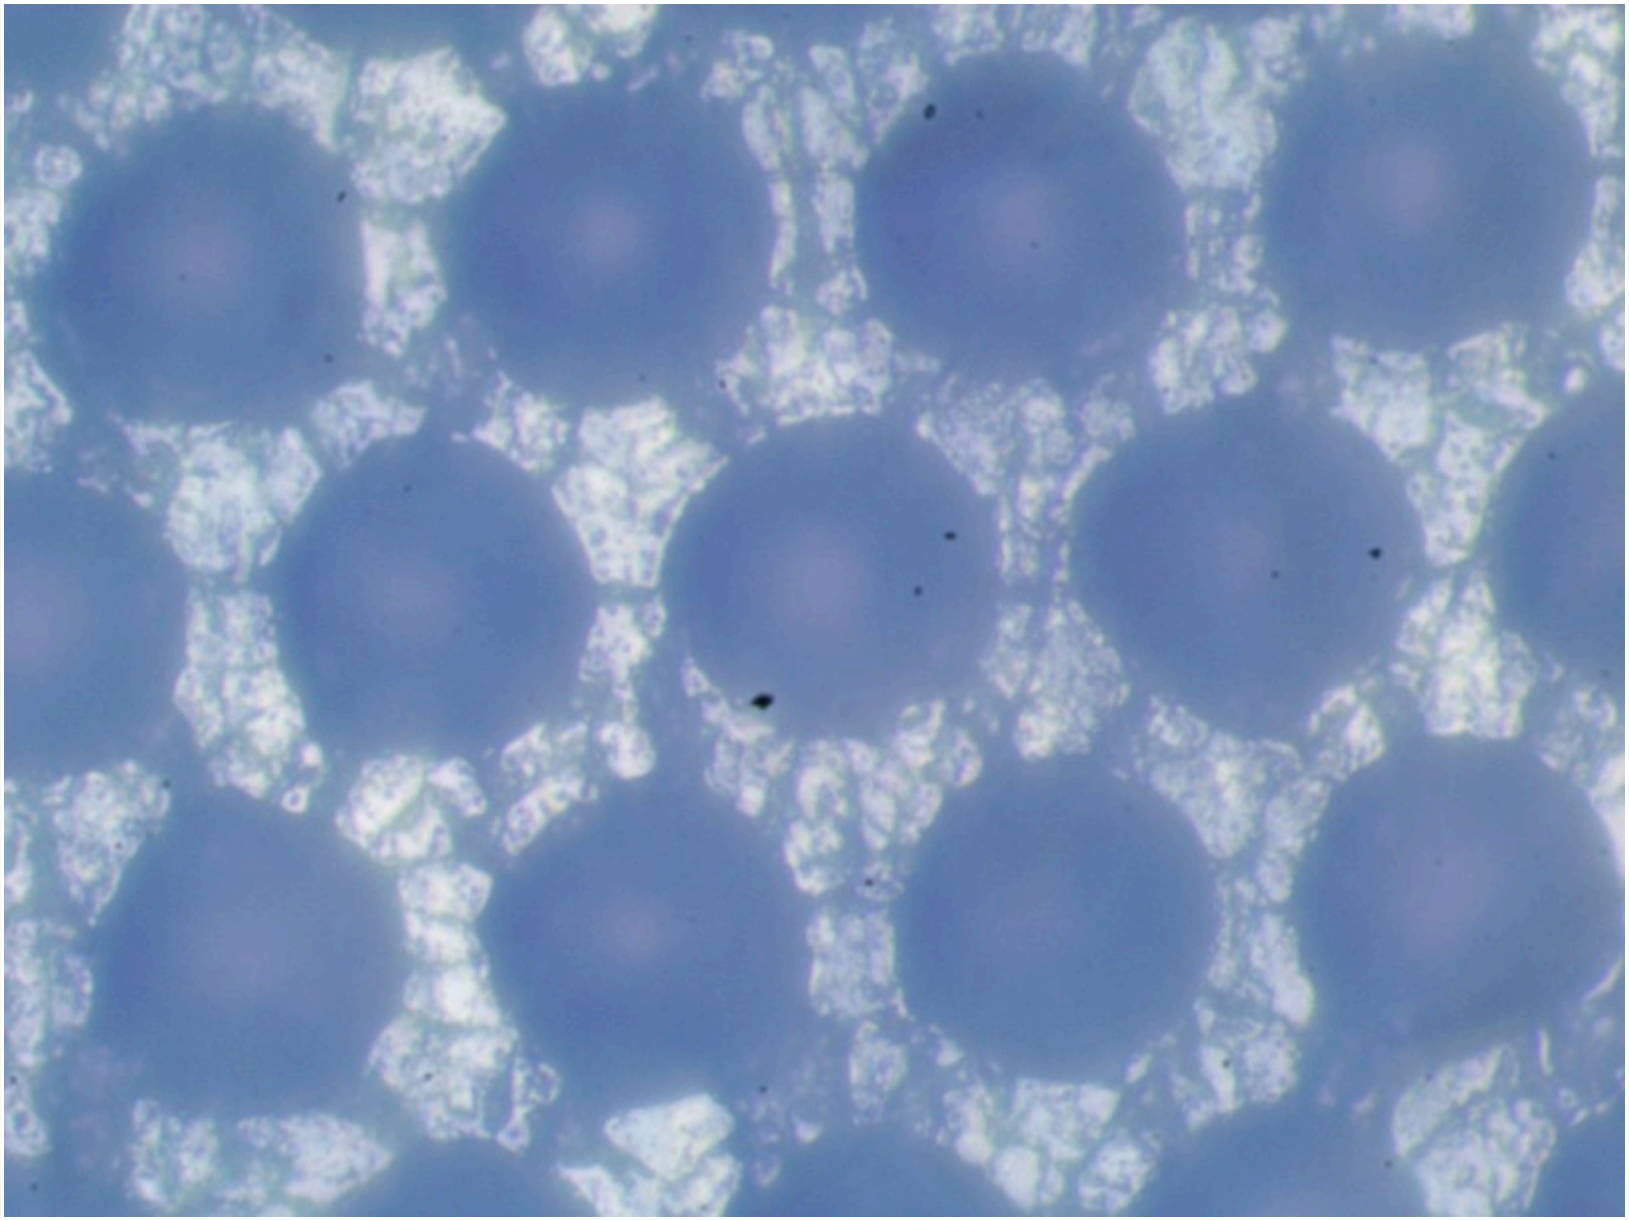
Page №140. Roll "z48064". Length: 1300 mm. Photos with magnificaiton: x400. Cleaning passes: 1

Comment
edge chips worn dent 190
248.
Roll ground off.

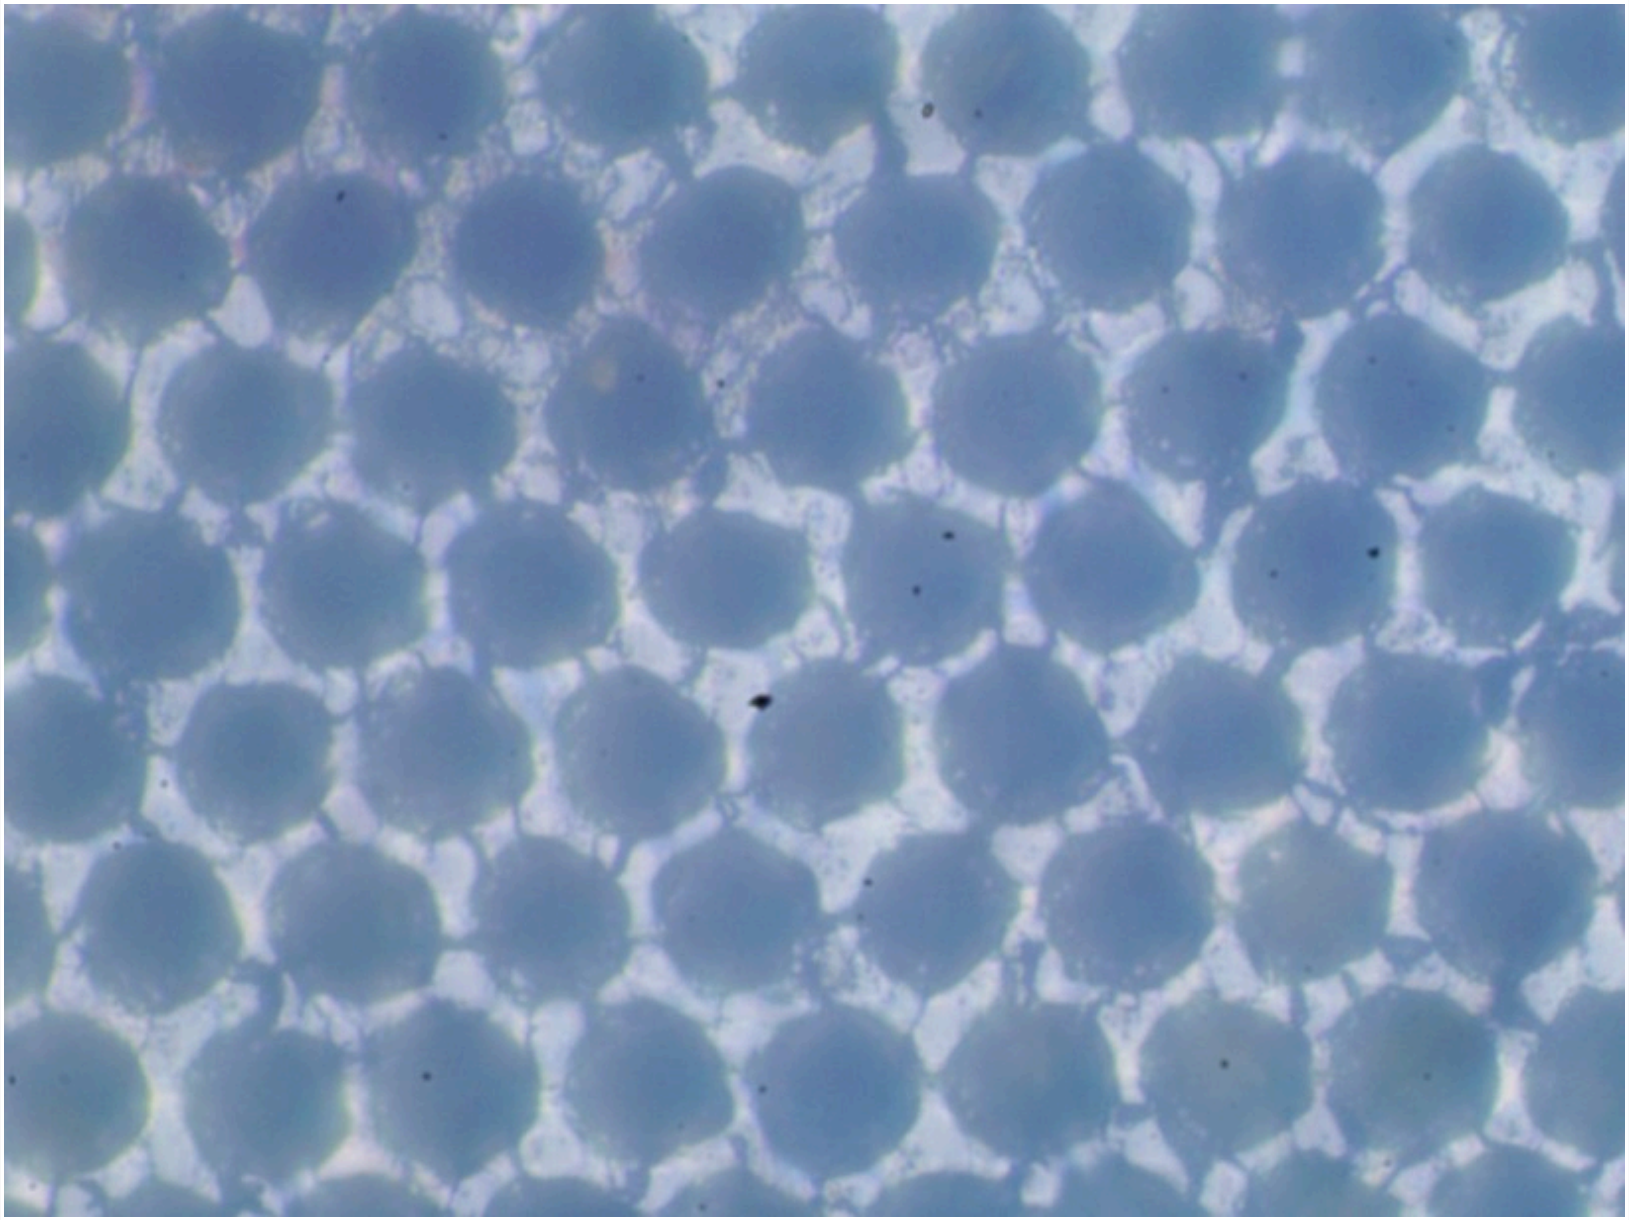
Page №141. Roll "sg49046-19". Length: 1360 mm. Photos with magnificaiton: x400. Cleaning passes: 1

Comment
streak 1135 64.

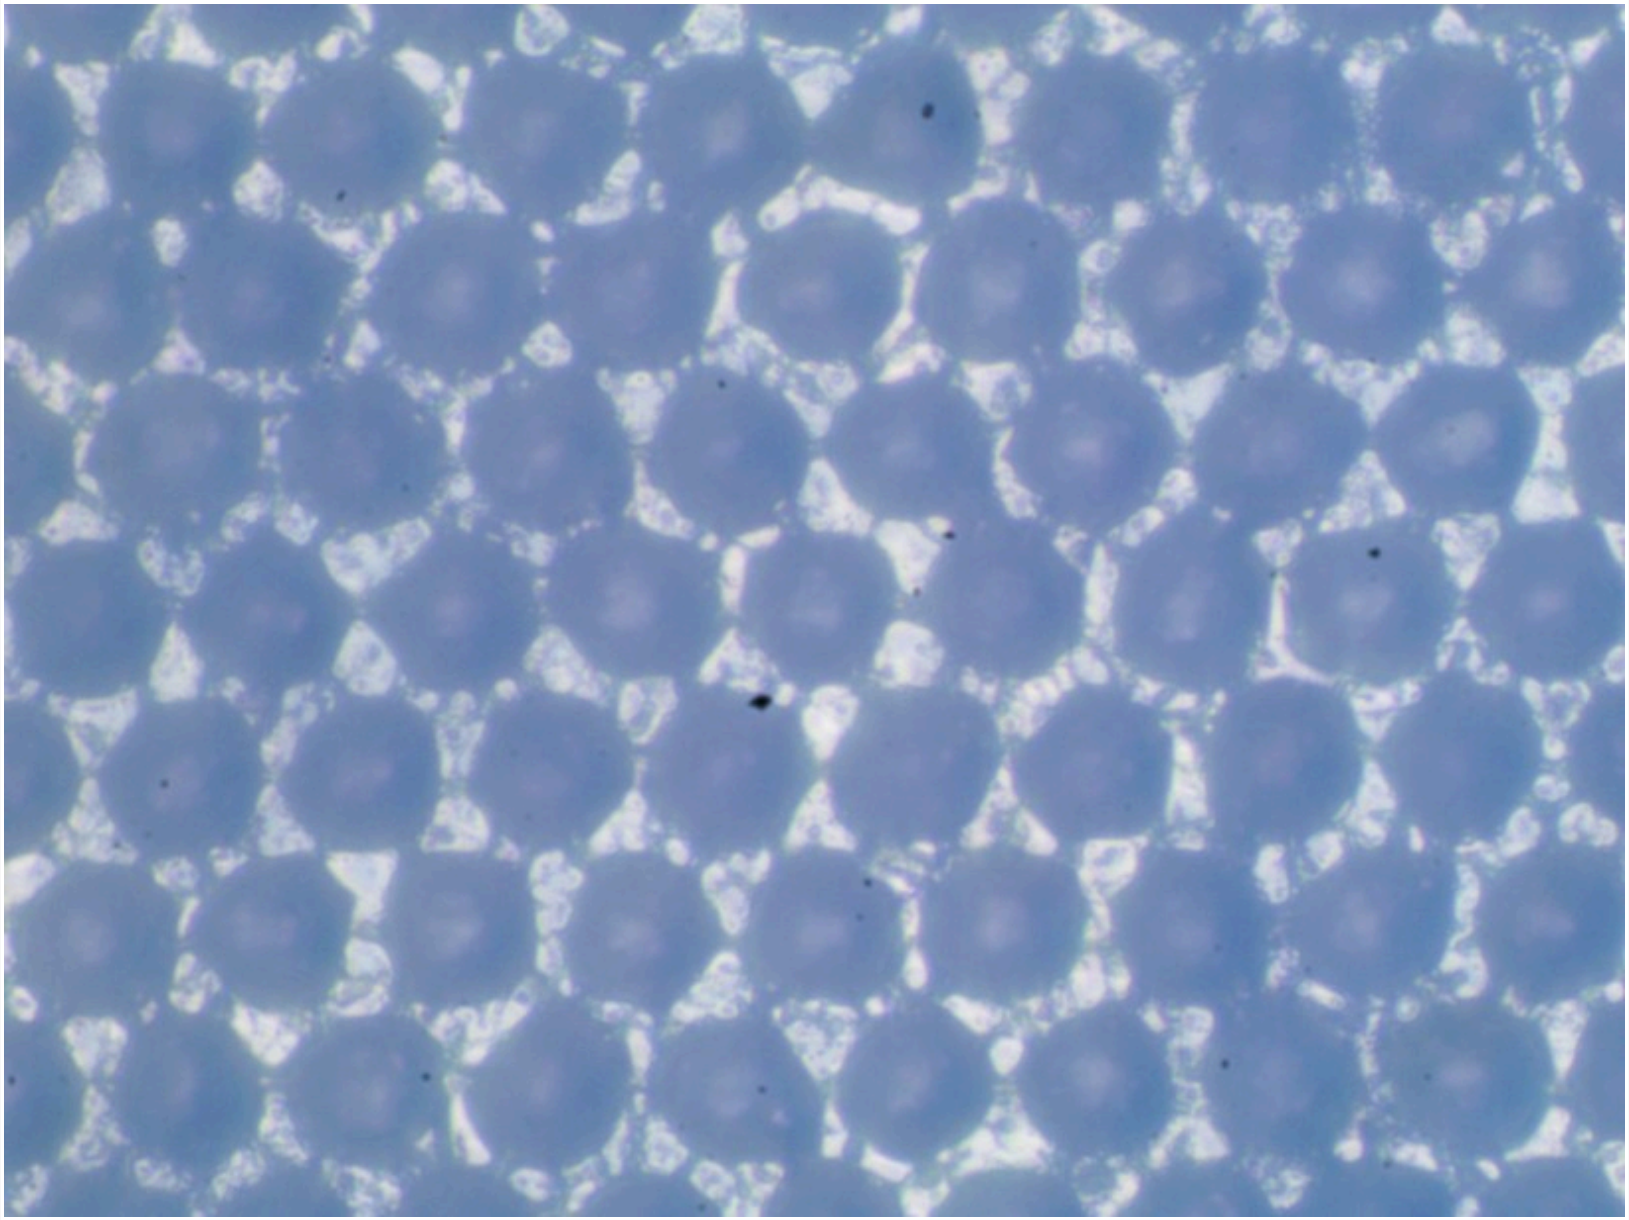
Page №142. Roll "z56917". Length: 1300 mm. Photos with magnificaiton: x400. Cleaning passes: 1

Comment
chips at edges streaks streak 345 795 spot 85.

Roll ground off.

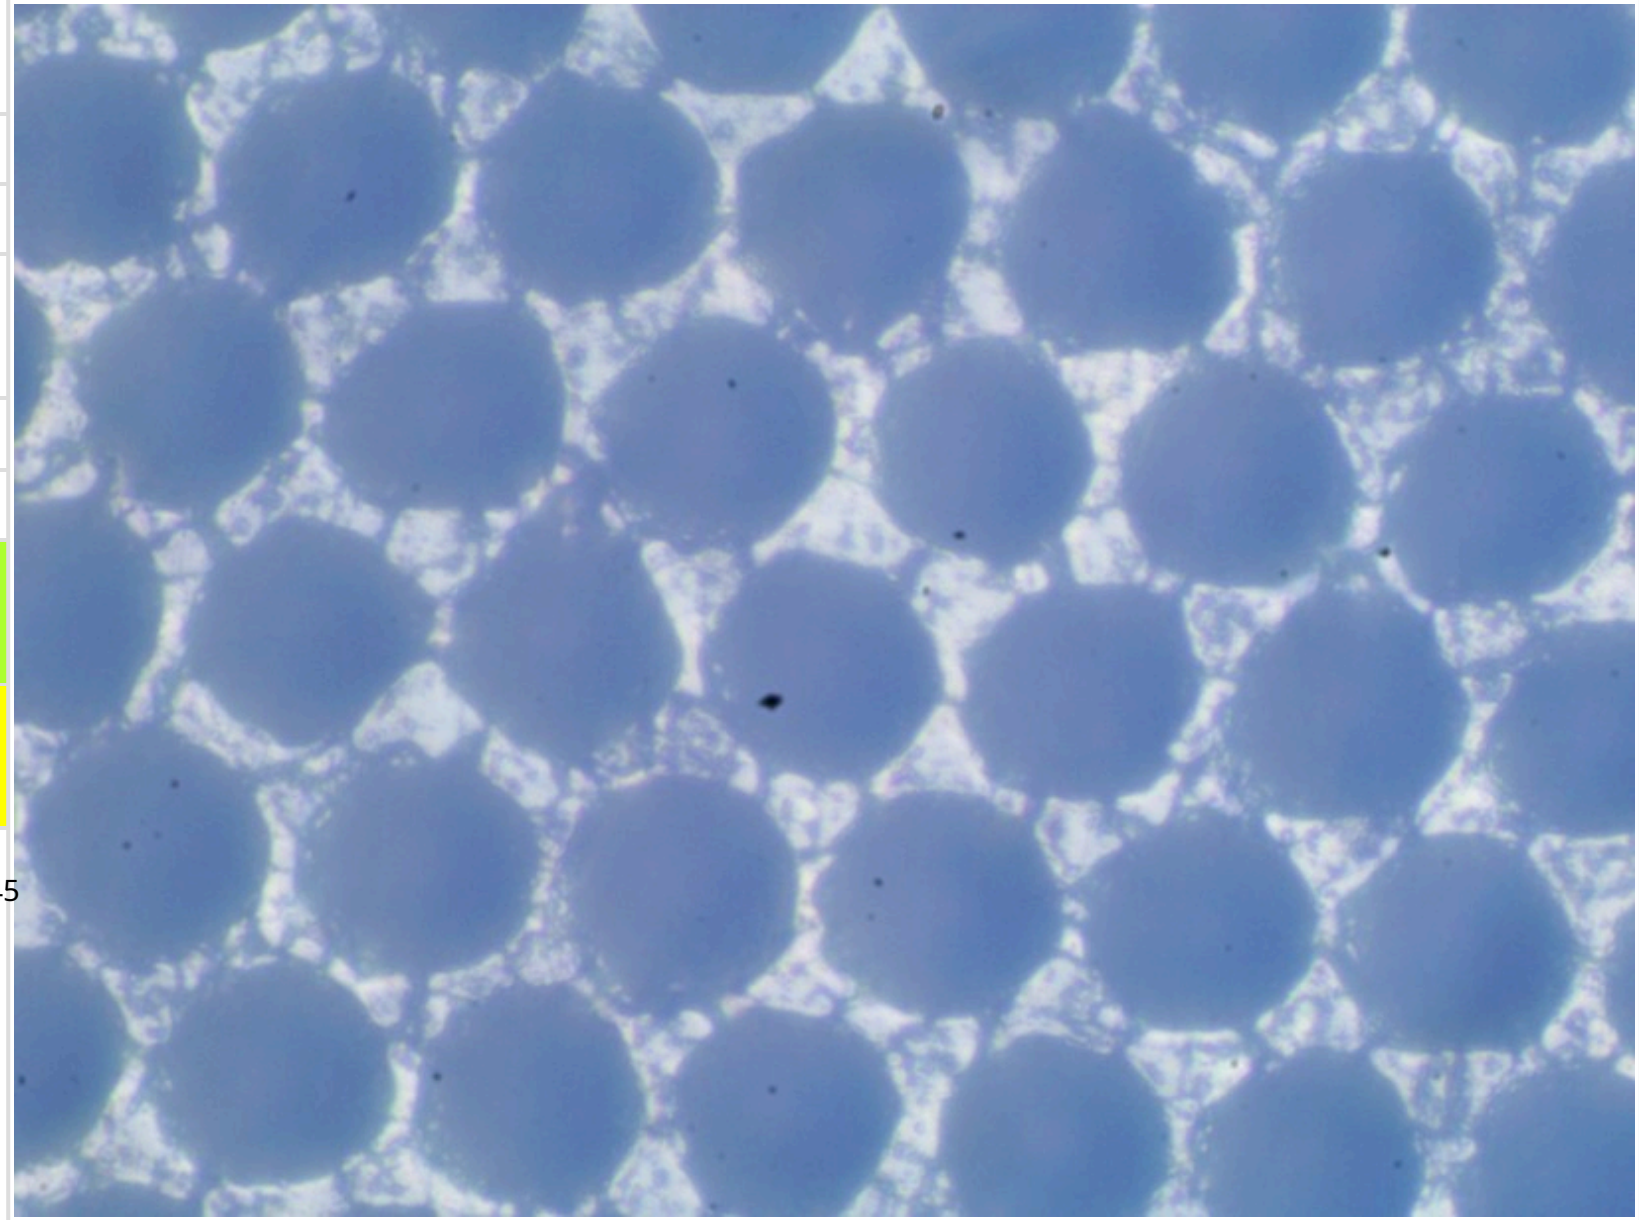
Page №144. Roll "17011018". Length: 1300 mm. Photos with magnificaiton: x400. Cleaning passes: 1

Ink transfer volume decrease from the passport value: 55.29%

Bridge / Cell: 1 / 3
Depth before / after: 17 / 17 мкм
Depth decreased by: 0%

Comment
worn scratch 1240 spots
1280.
Roll heavily ground off.

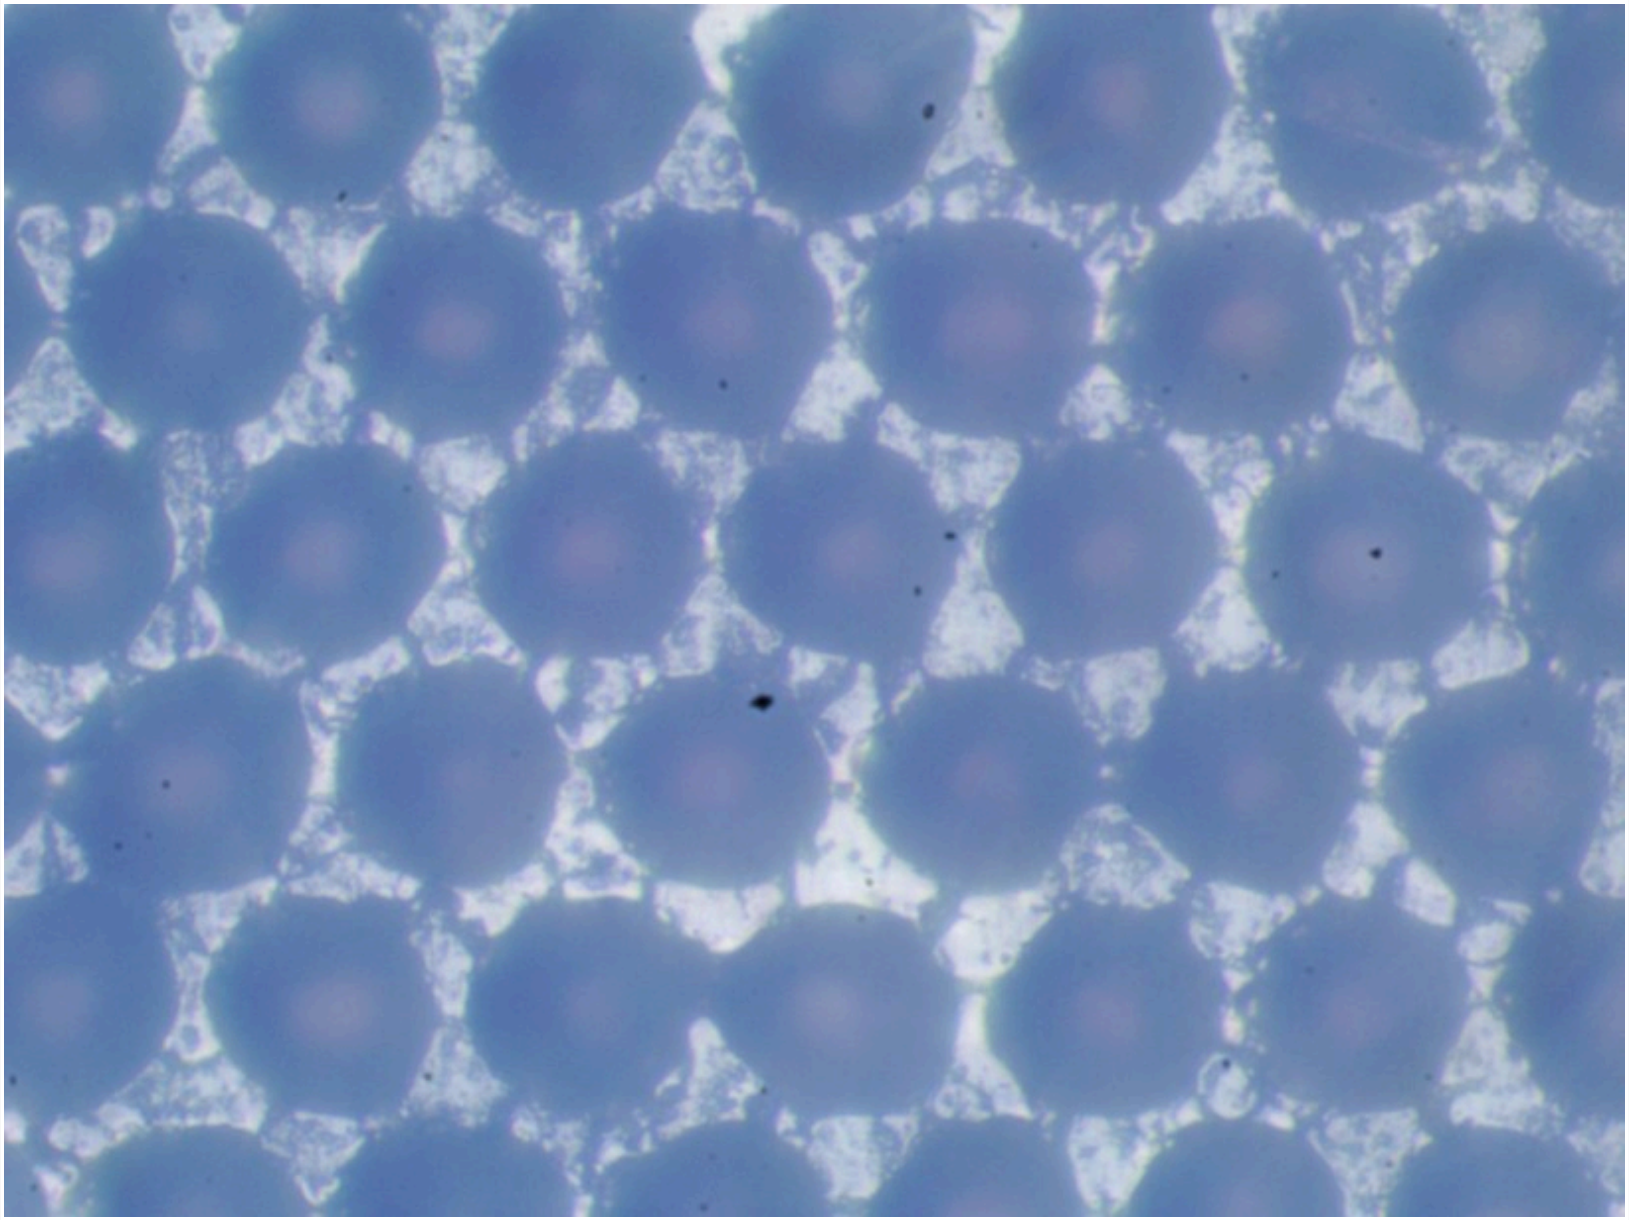
Page №146. Roll "z17011013". Length: 1300 mm. Photos with magnificaiton: x400. Cleaning passes: 1

Comment
dents 370 340 scratch 45 spots.

Roll ground off.

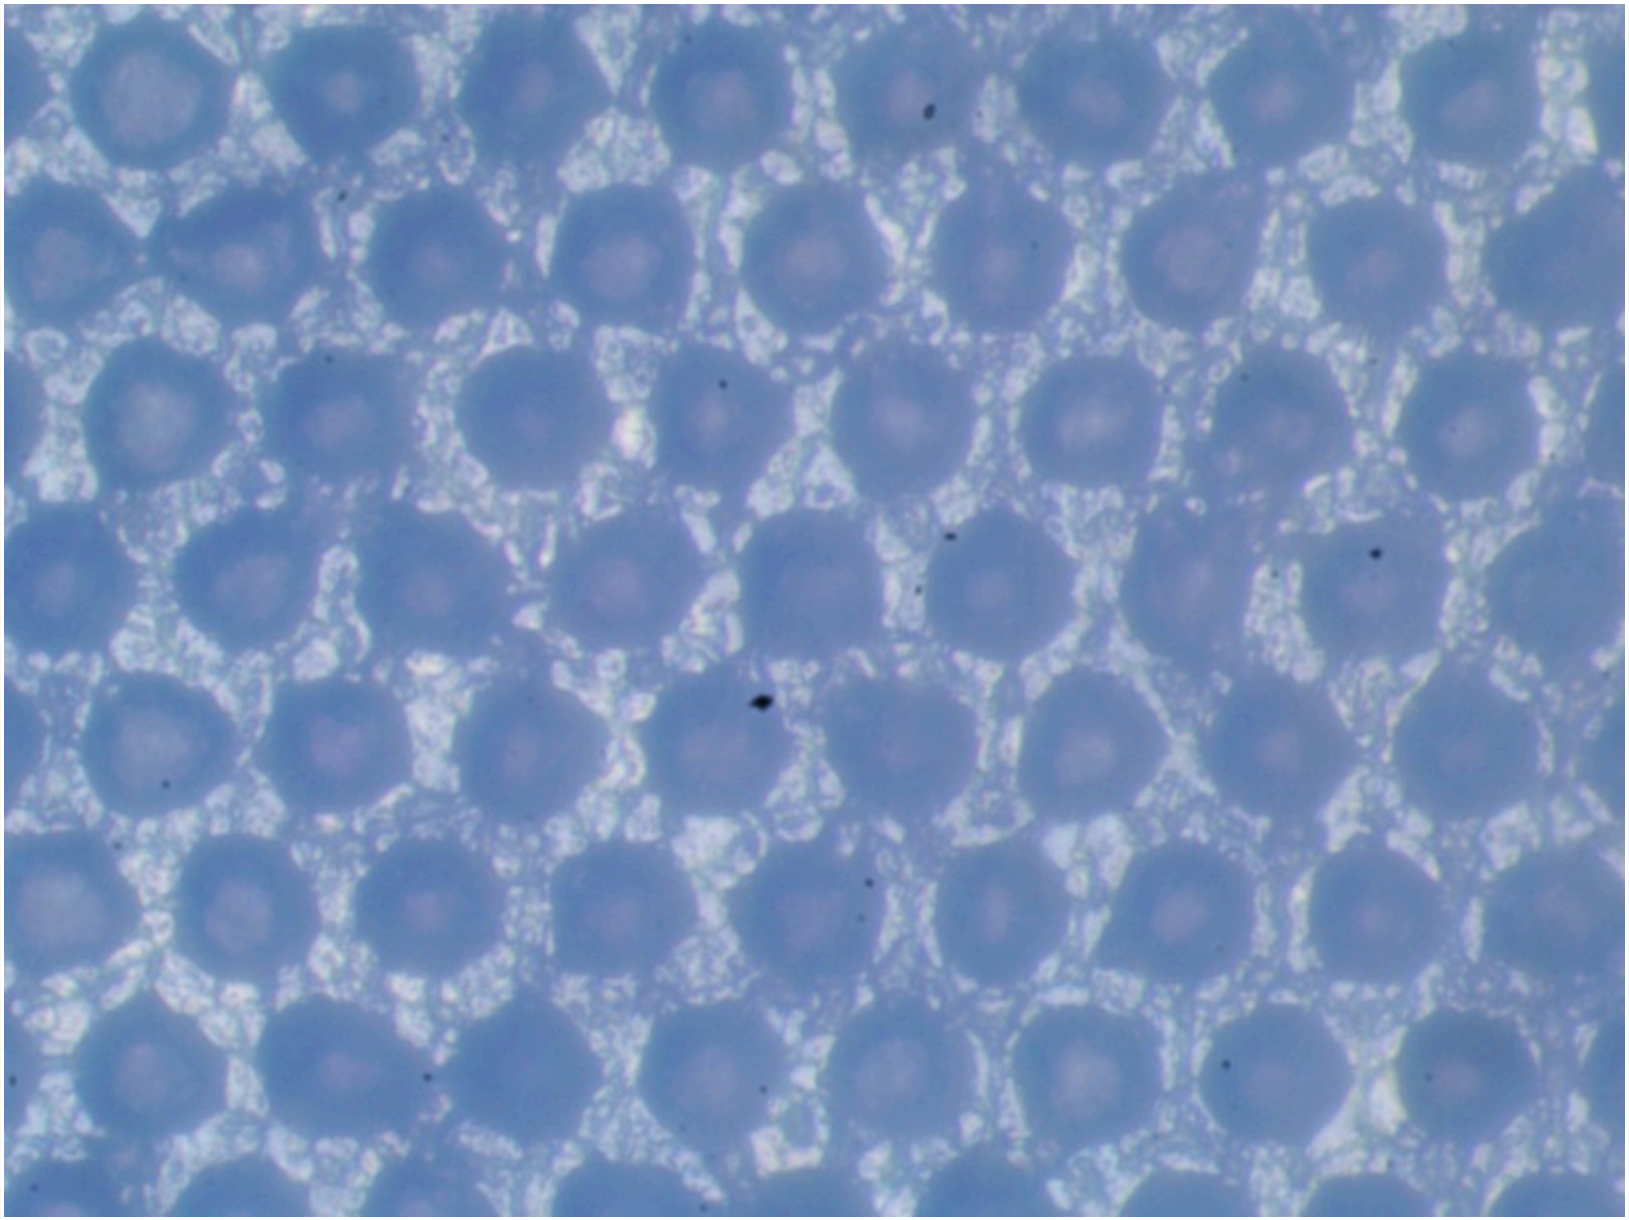
Page №147. Roll "z48065". Length: 1300 mm. Photos with magnificaiton: x400. Cleaning passes: 1

Ink transfer volume decrease from the passport value: 73.86%

Bridge / Cell: 1 / 3
Depth before / after: 11 / 11 мкм
Depth decreased by: 0%

Comment
scratch 72 spots.
Roll heavily ground off.

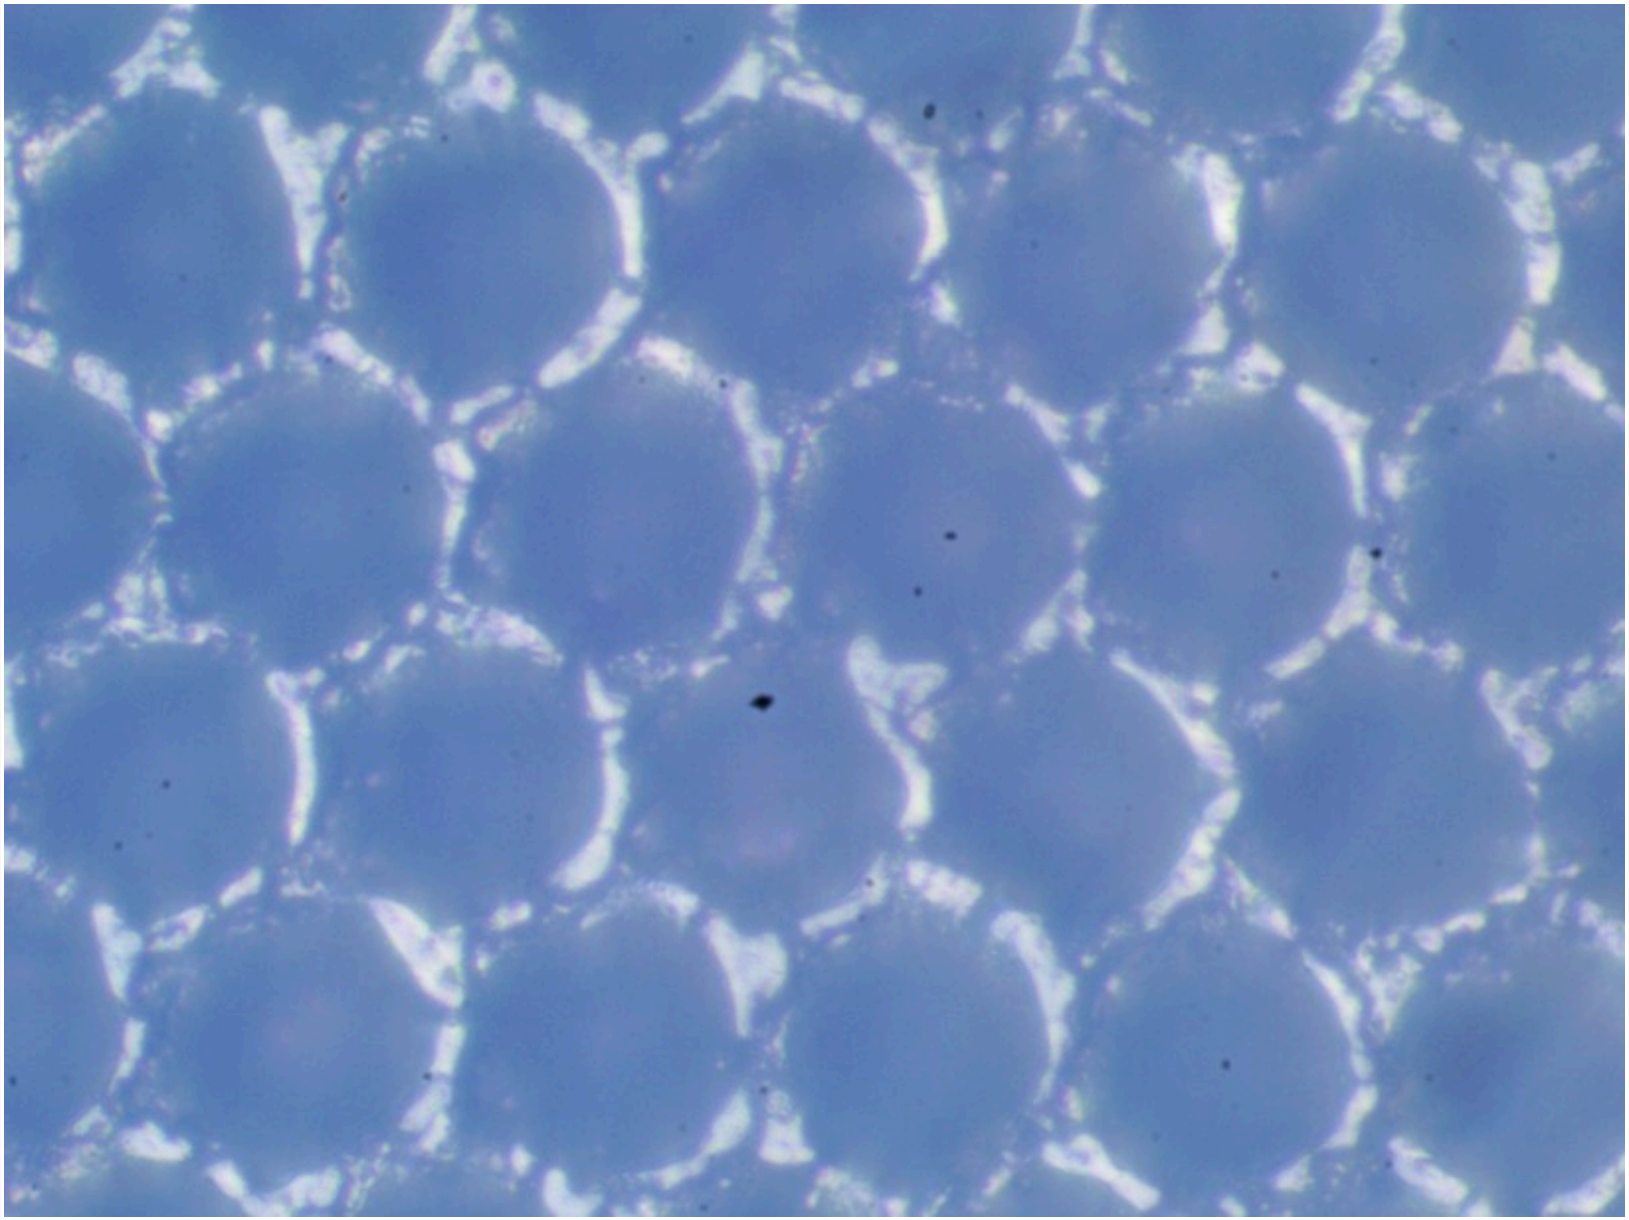
Page №149. Roll "h100748-6". Length: 870 mm. Photos with magnificaiton: x400. Cleaning passes: 1

Ink transfer volume decrease from the passport value: 65.26%

Bridge / Cell: 1 / 3
Depth before / after: 16 / 16 мкм
Depth decreased by: 0%

Comment
worn streaks.
Roll heavily ground off.

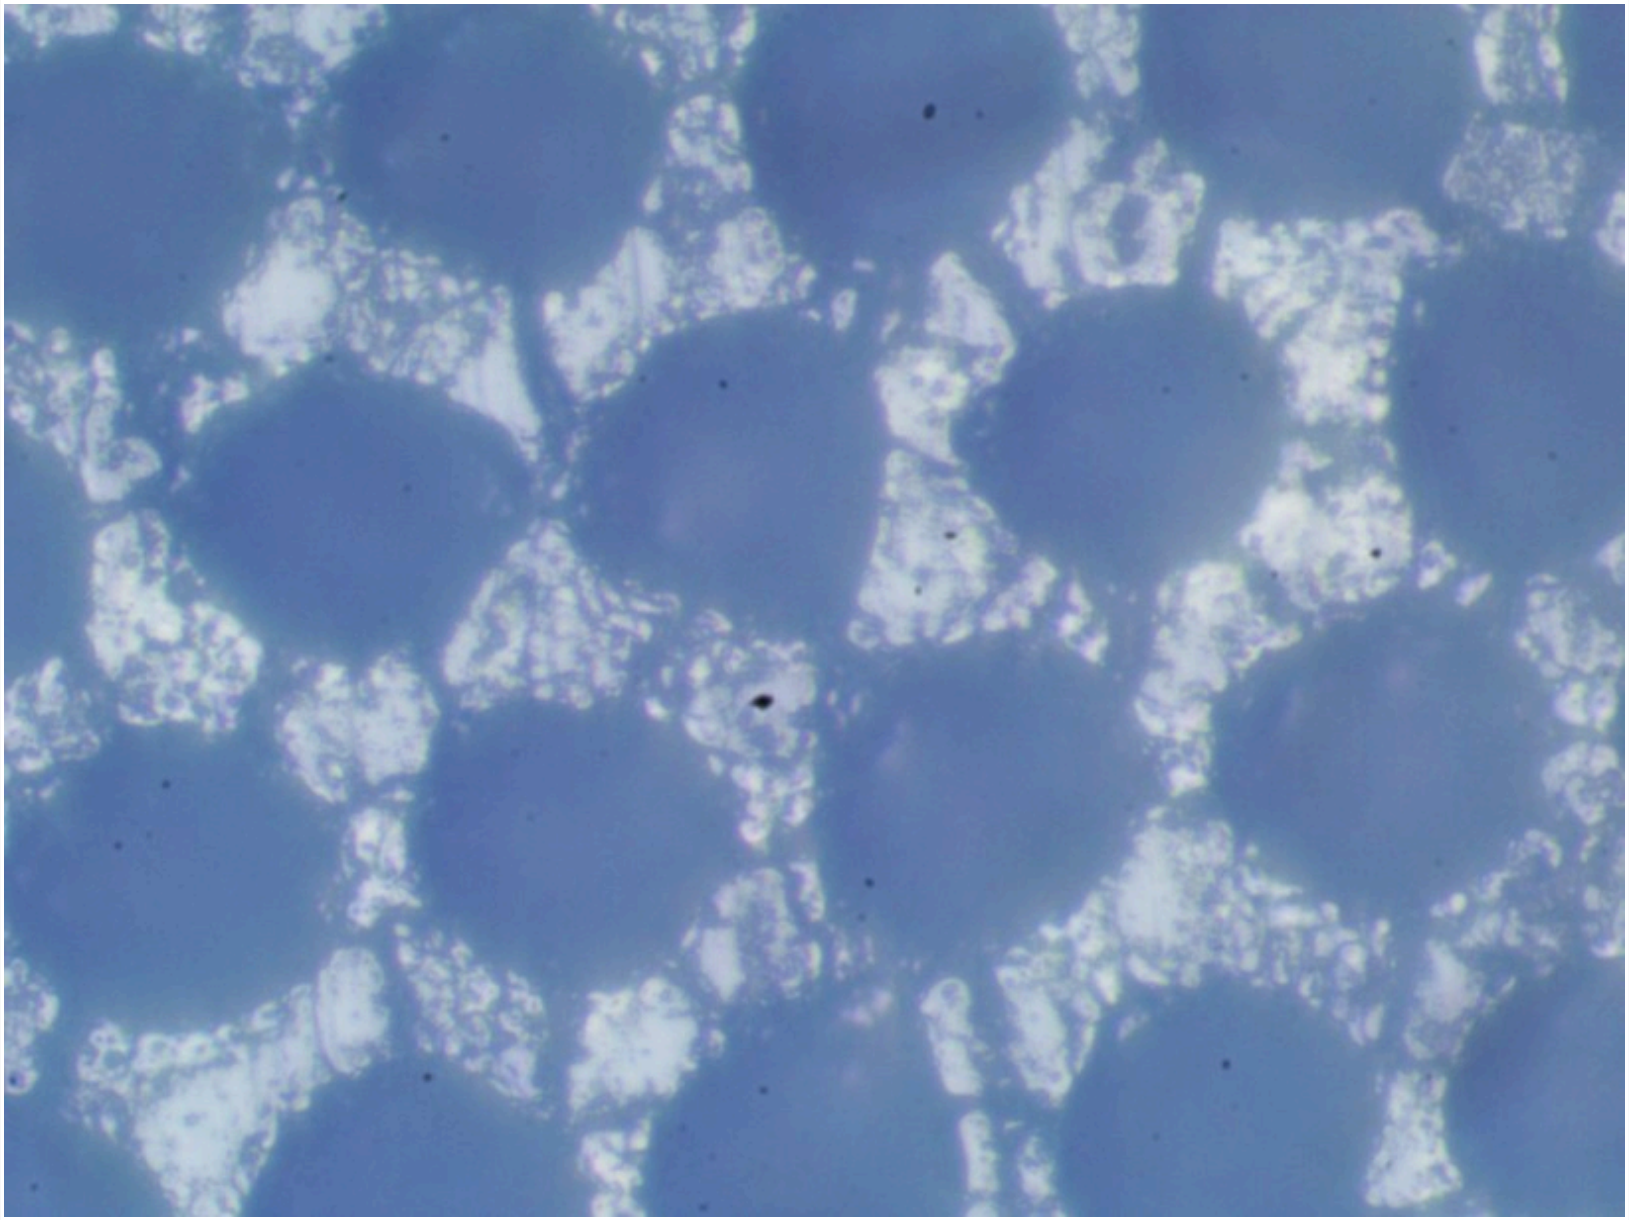
Page №150. Roll "z17011040". Length: 870 mm. Photos with magnificaiton: x400. Cleaning passes: 1

Bridge / Cell: 1 / 3
Depth before / after: 10 / 10 мкм
Depth decreased by: 0%

Comment
wear streaks 65 130.
Roll heavily ground off.
