RollerCheck360

Roll Inspection from 08.12.2025

Rolls: 178

We have analyzed for you 178 rolls.

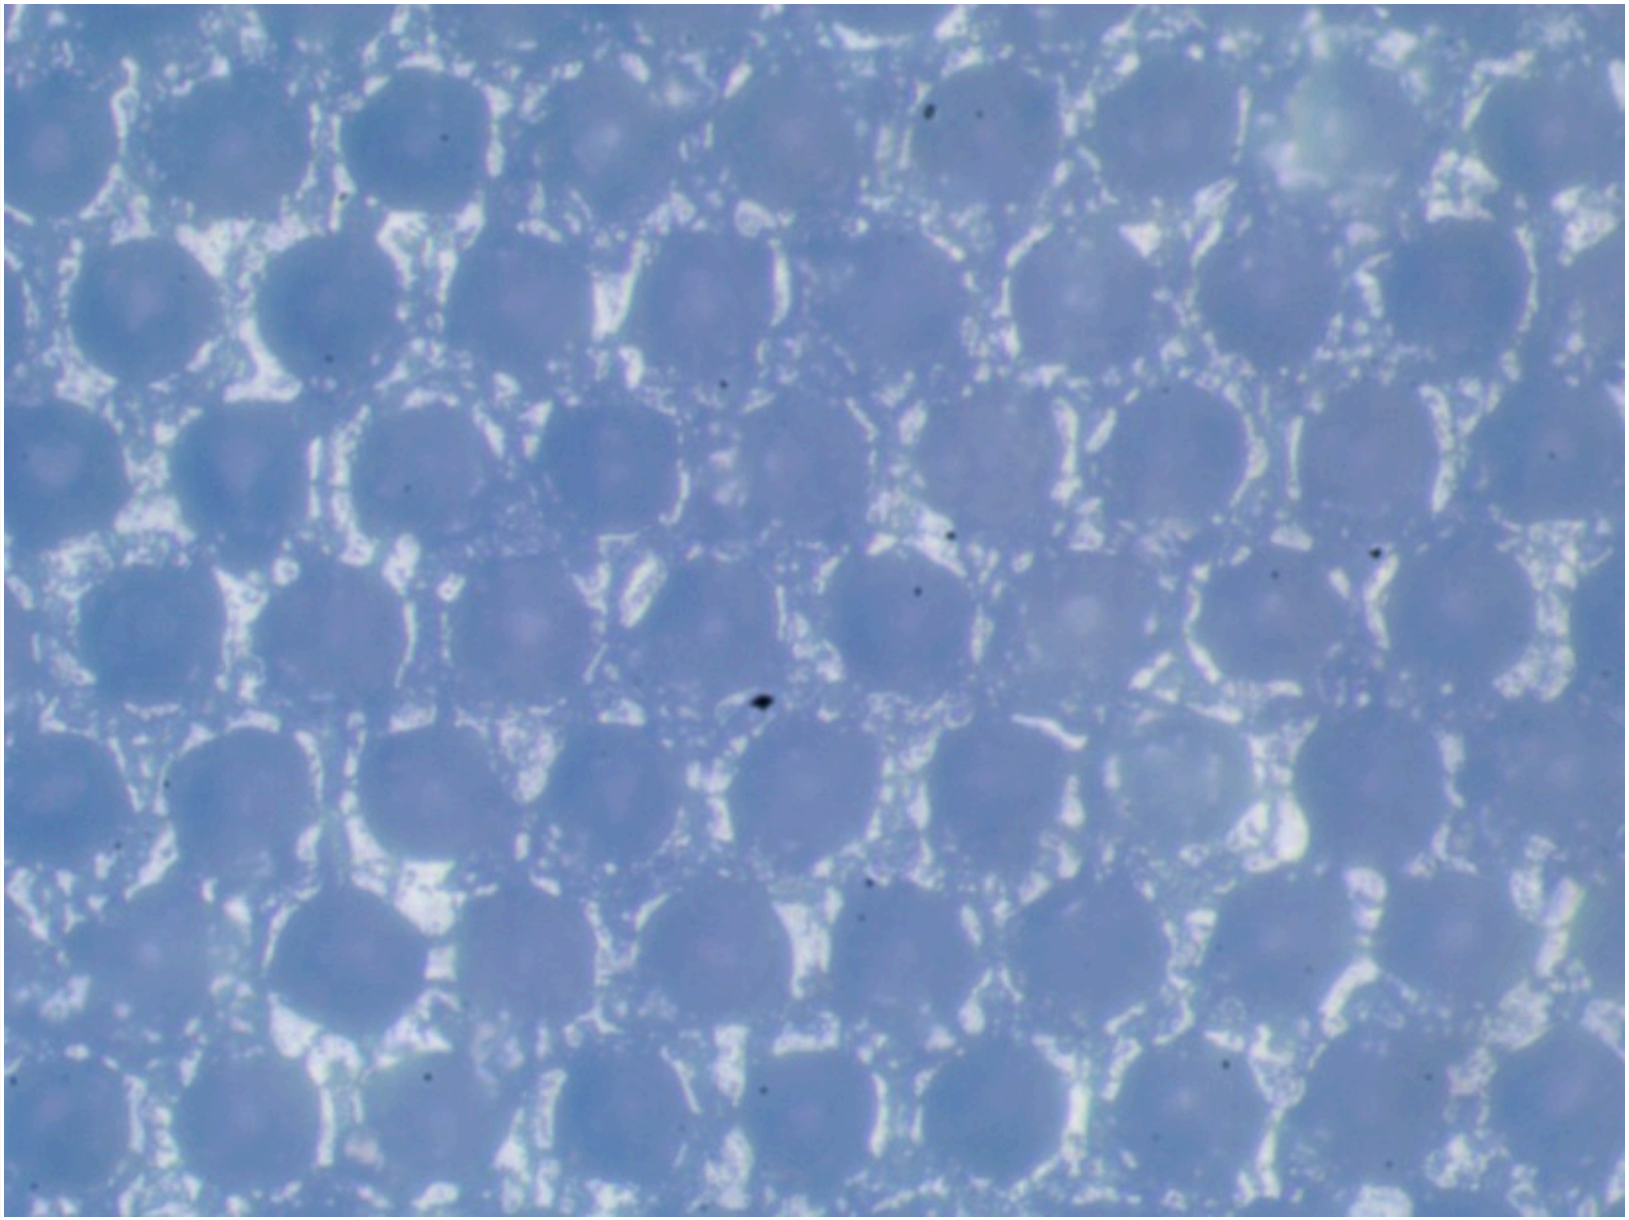
Page №151. Roll "aa2413870". Length: 870 mm. Photos with magnificaiton: x400. Cleaning passes: 1

Comment
streak 855.
Roll slightly ground off.

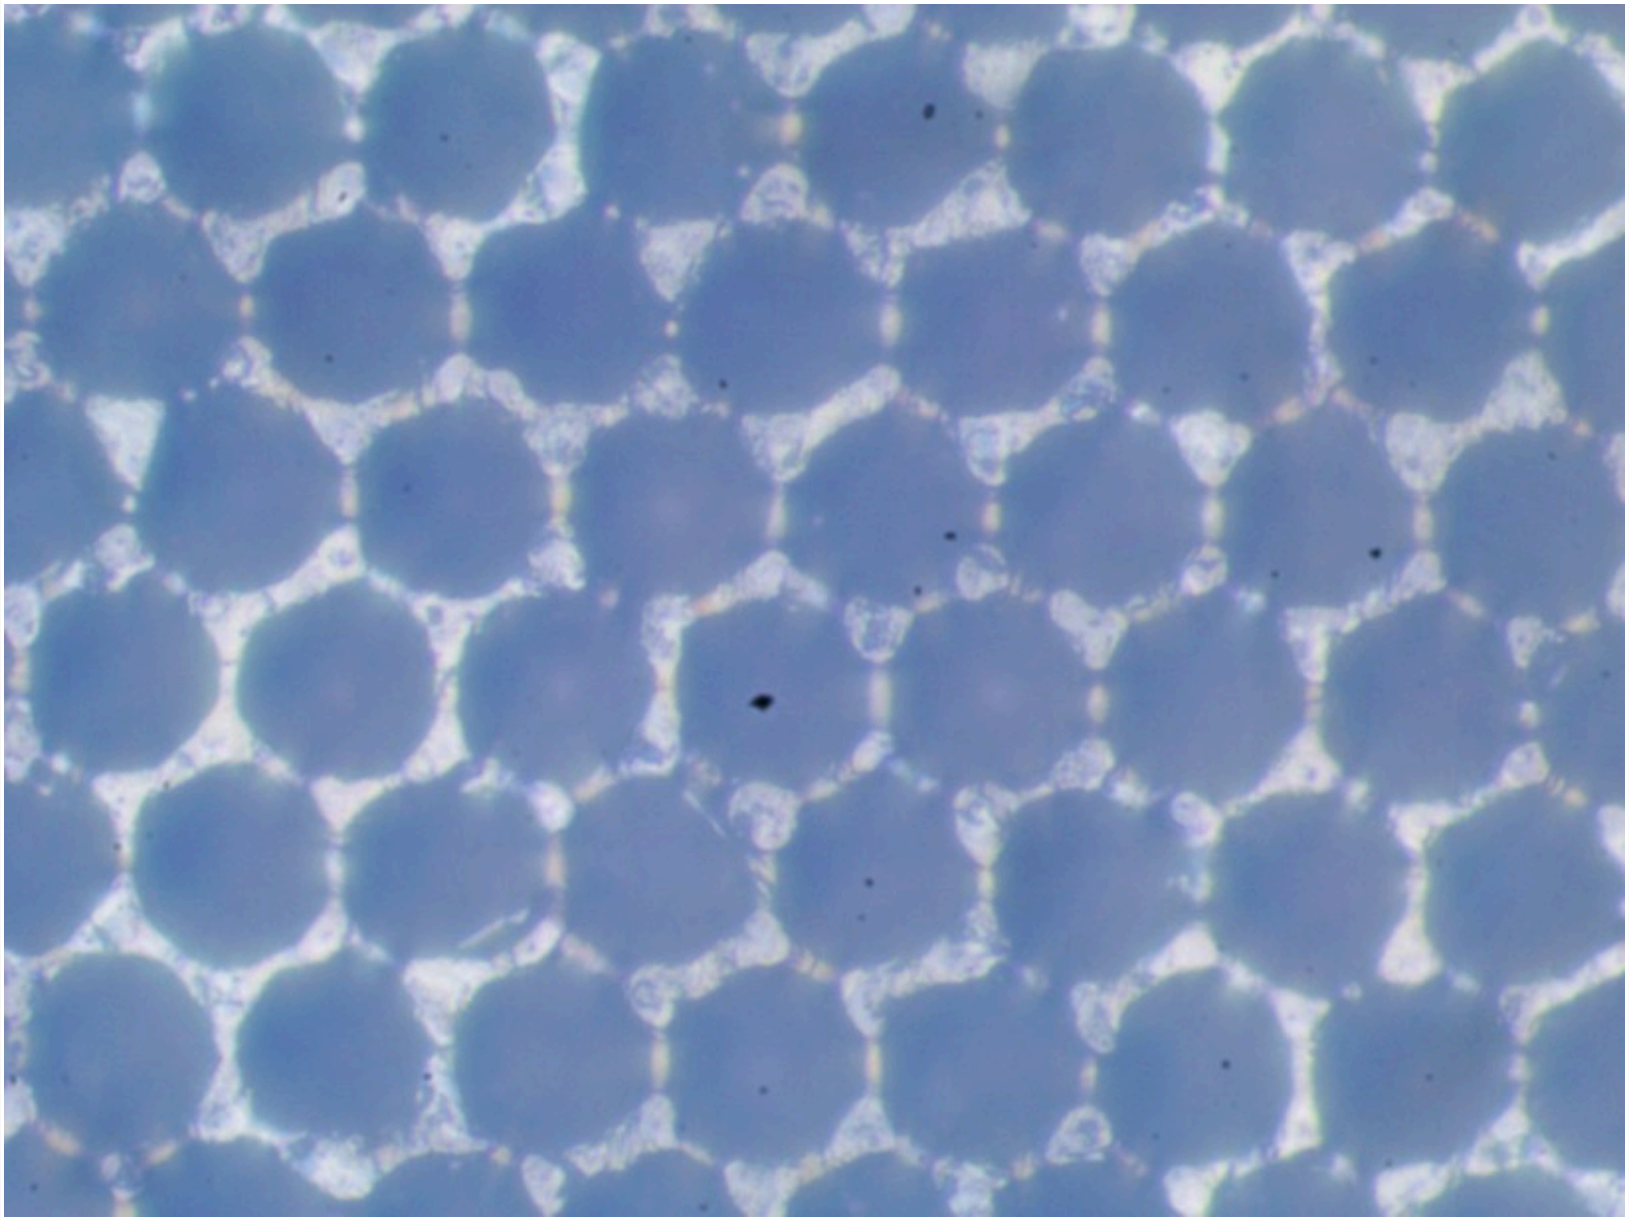
Page №152. Roll "z16007664". Length: 870 mm. Photos with magnificaiton: x400. Cleaning passes: 1

Comment
wear streak 300.
Roll heavily ground off.

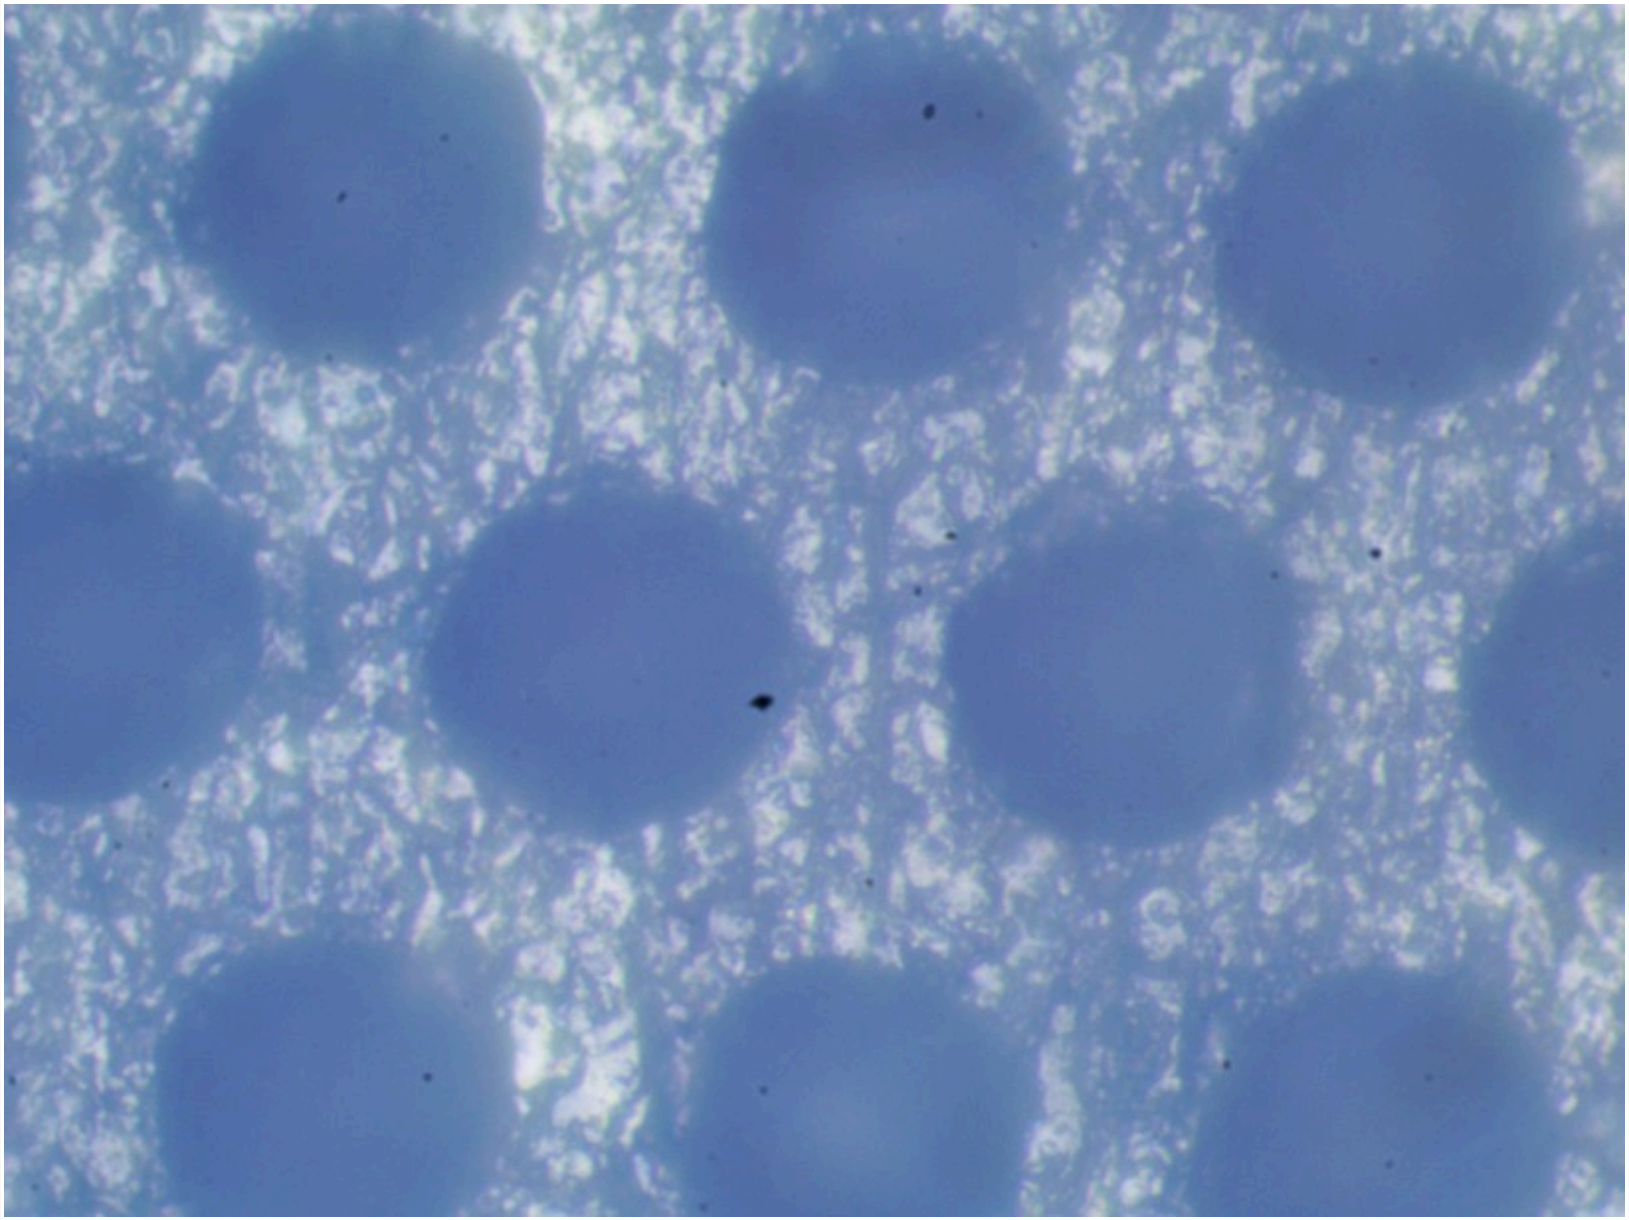
Page №153. Roll "3016198-3". Length: 870 mm. Photos with magnificaiton: x400. Cleaning passes: 1

Comment
streak 95.

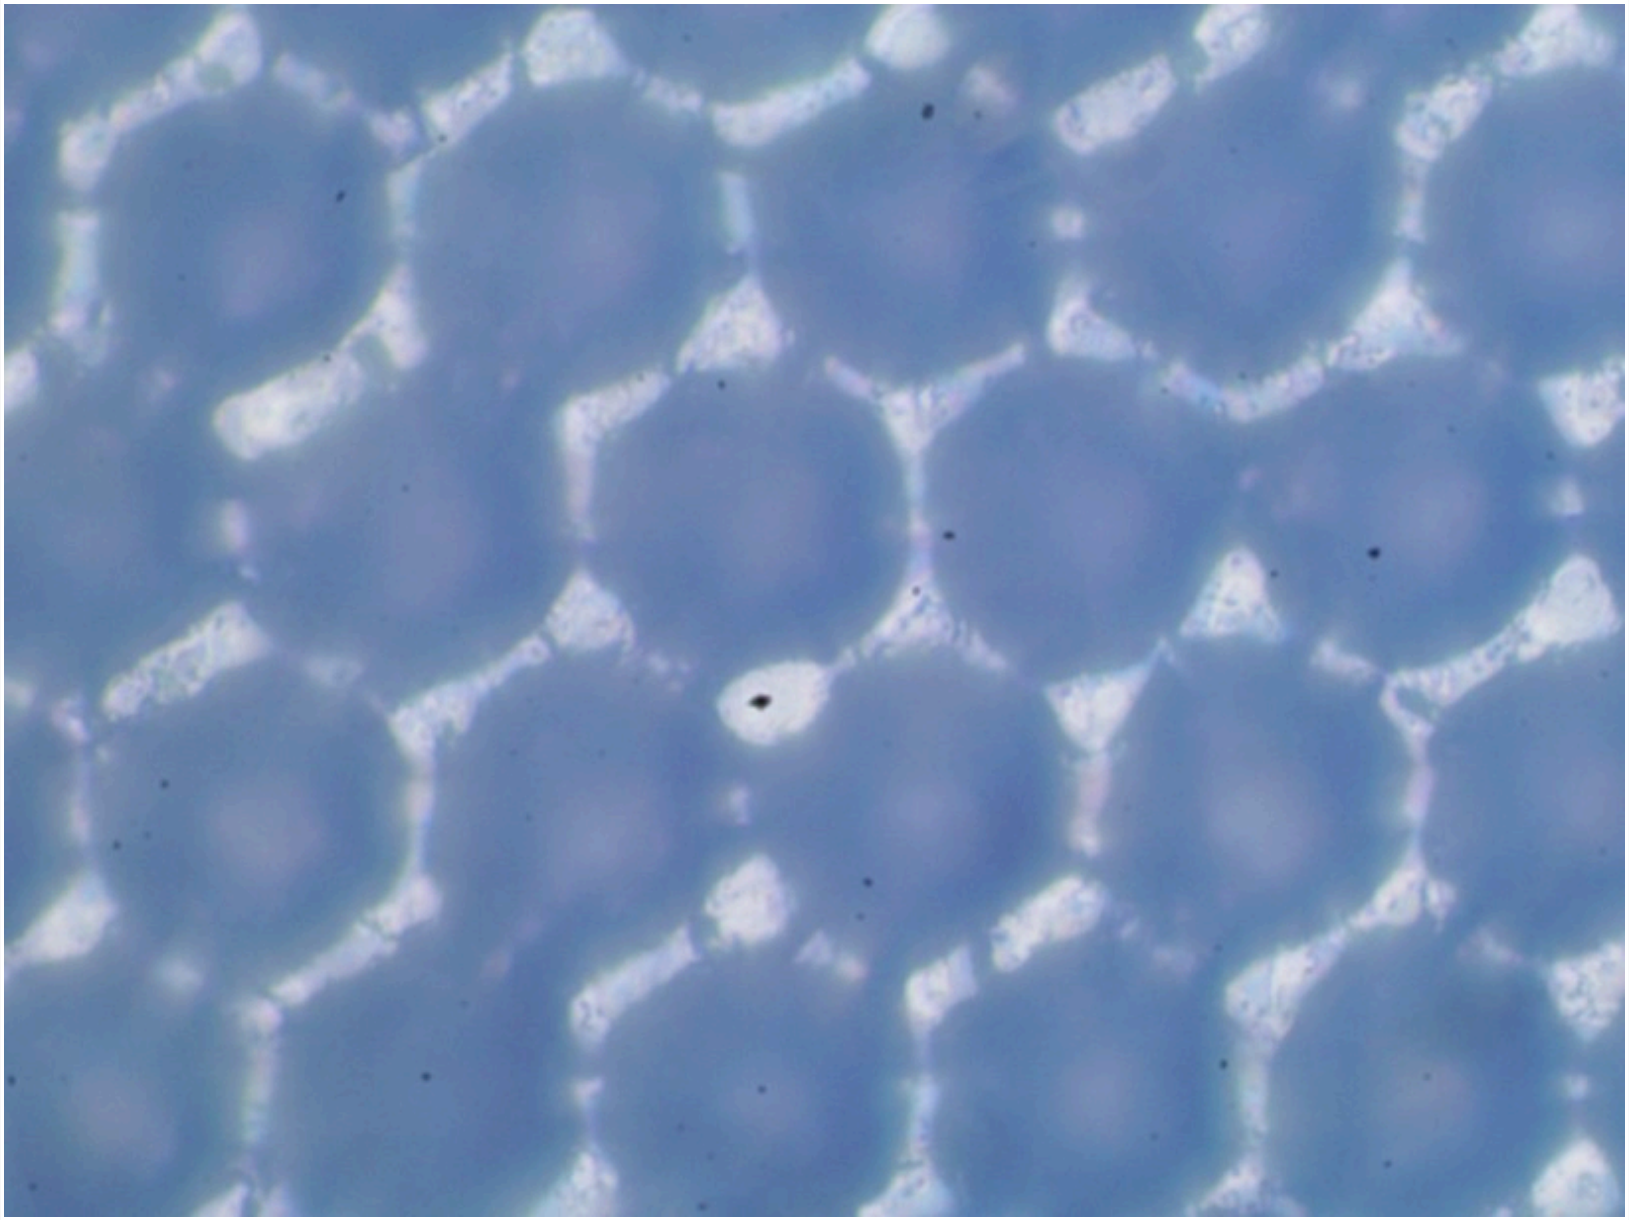
Page №154. Roll "sg49046-18". Length: 1360 mm. Photos with magnificaiton: x400. Cleaning passes: 1

Comment
Roll ground off.

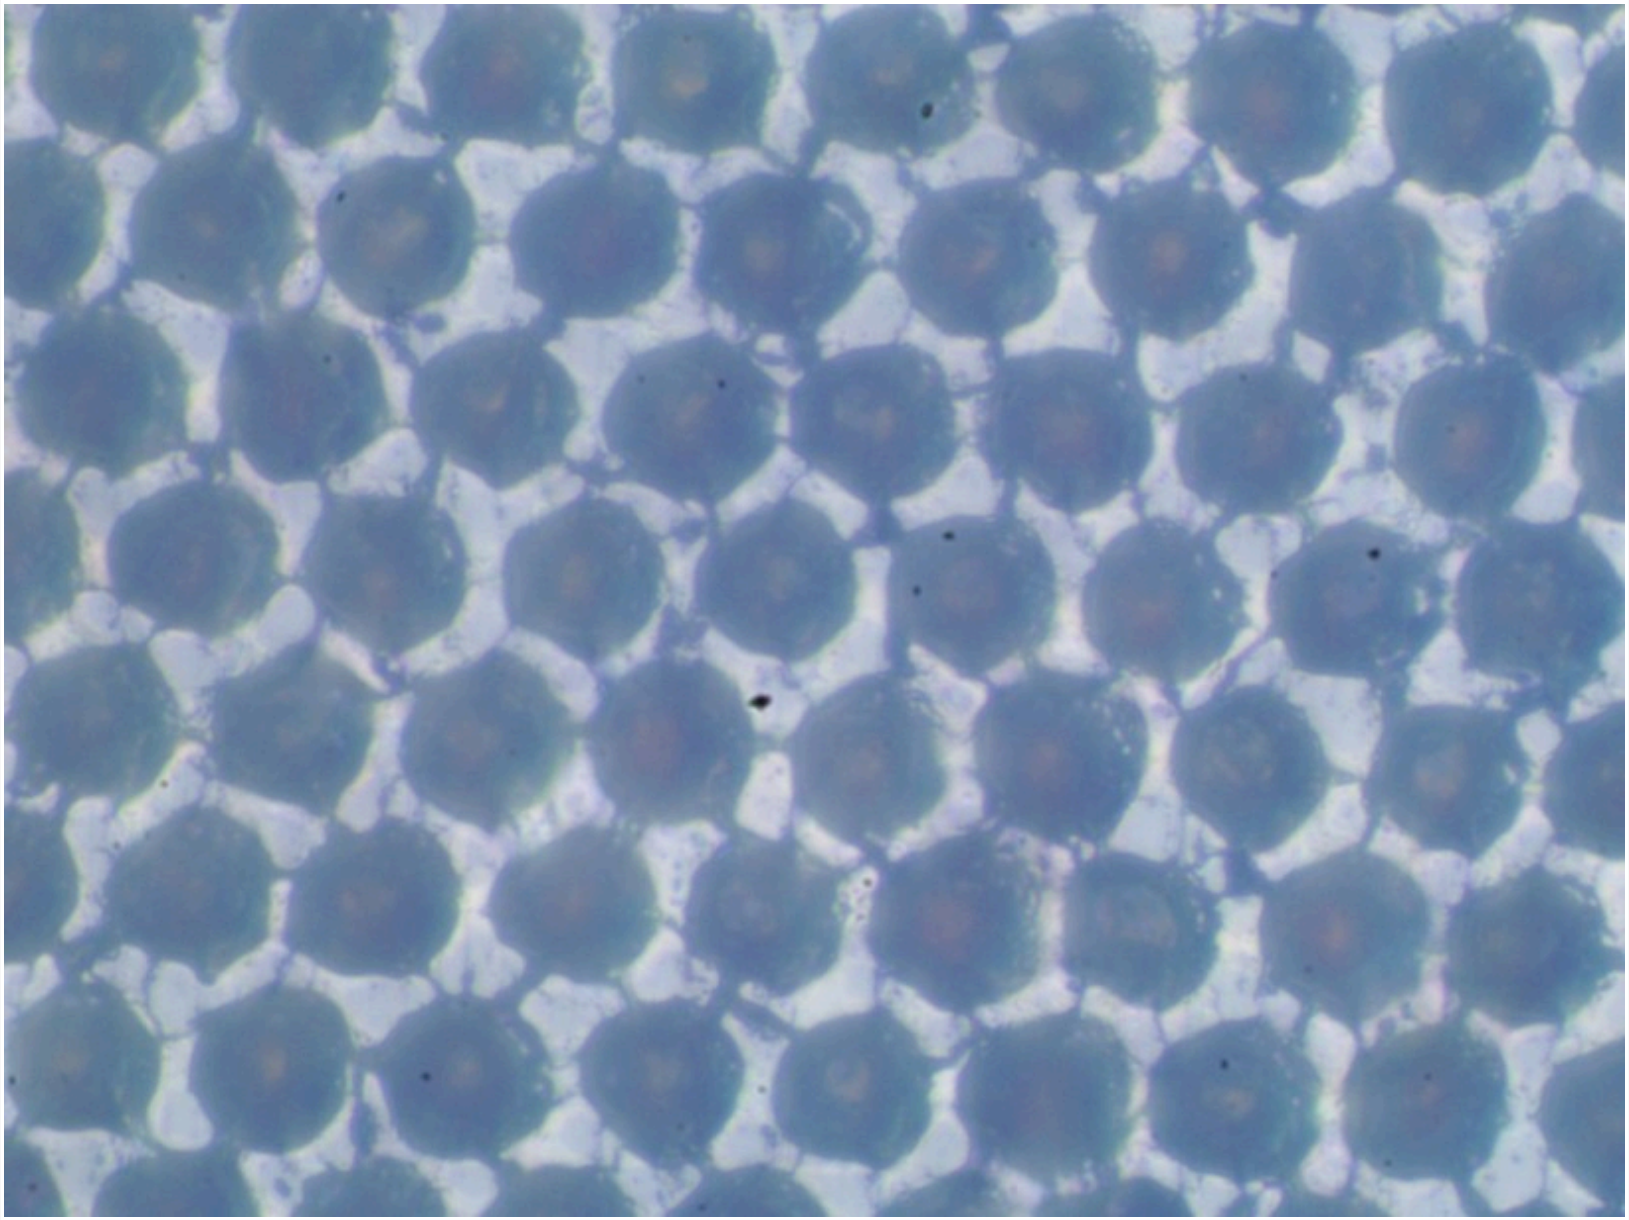
Page №155. Roll "sg49046-23". Length: 1360 mm. Photos with magnificaiton: x400. Cleaning passes: 1

Comment
streaks streak 50 1335 chips at edges.

Roll slightly ground off.

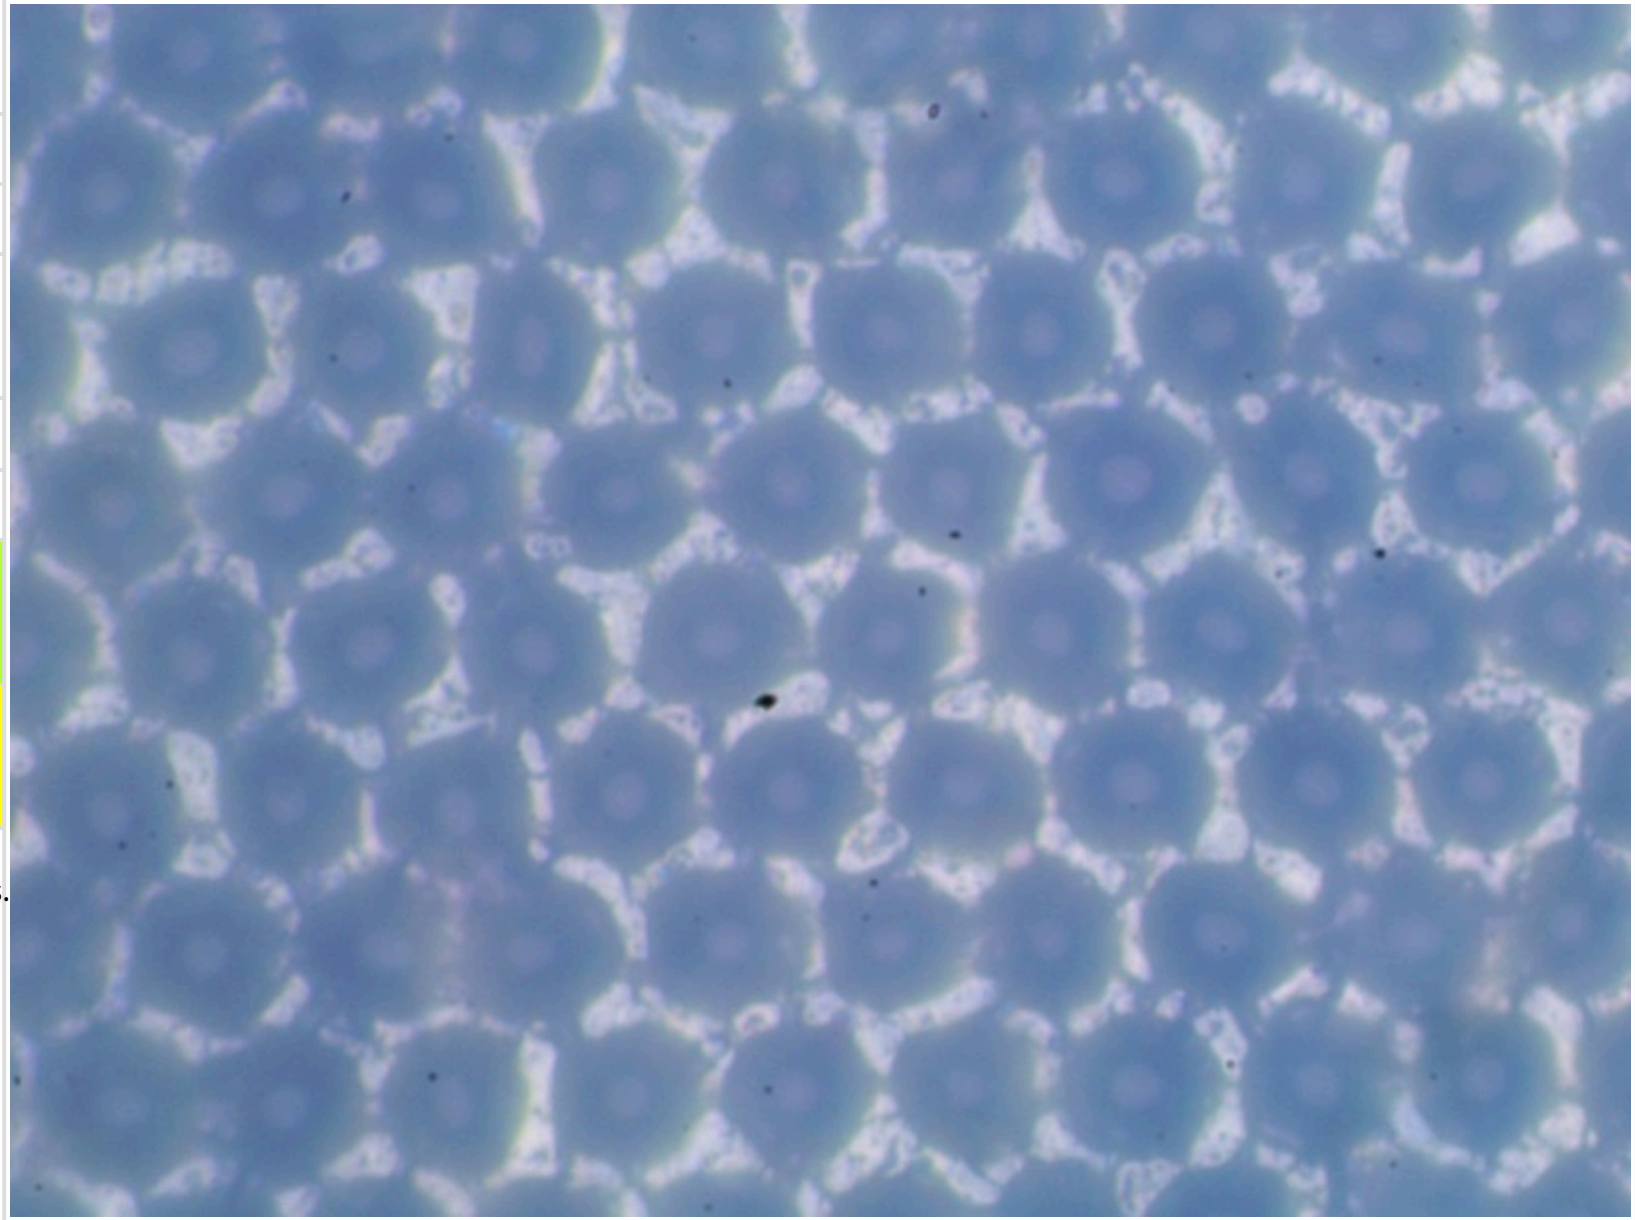
Page №156. Roll "sg49046-17". Length: 1360 mm. Photos with magnificaiton: x400. Cleaning passes: 1

Comment
streak 1260 chips at edges.
Roll ground off.

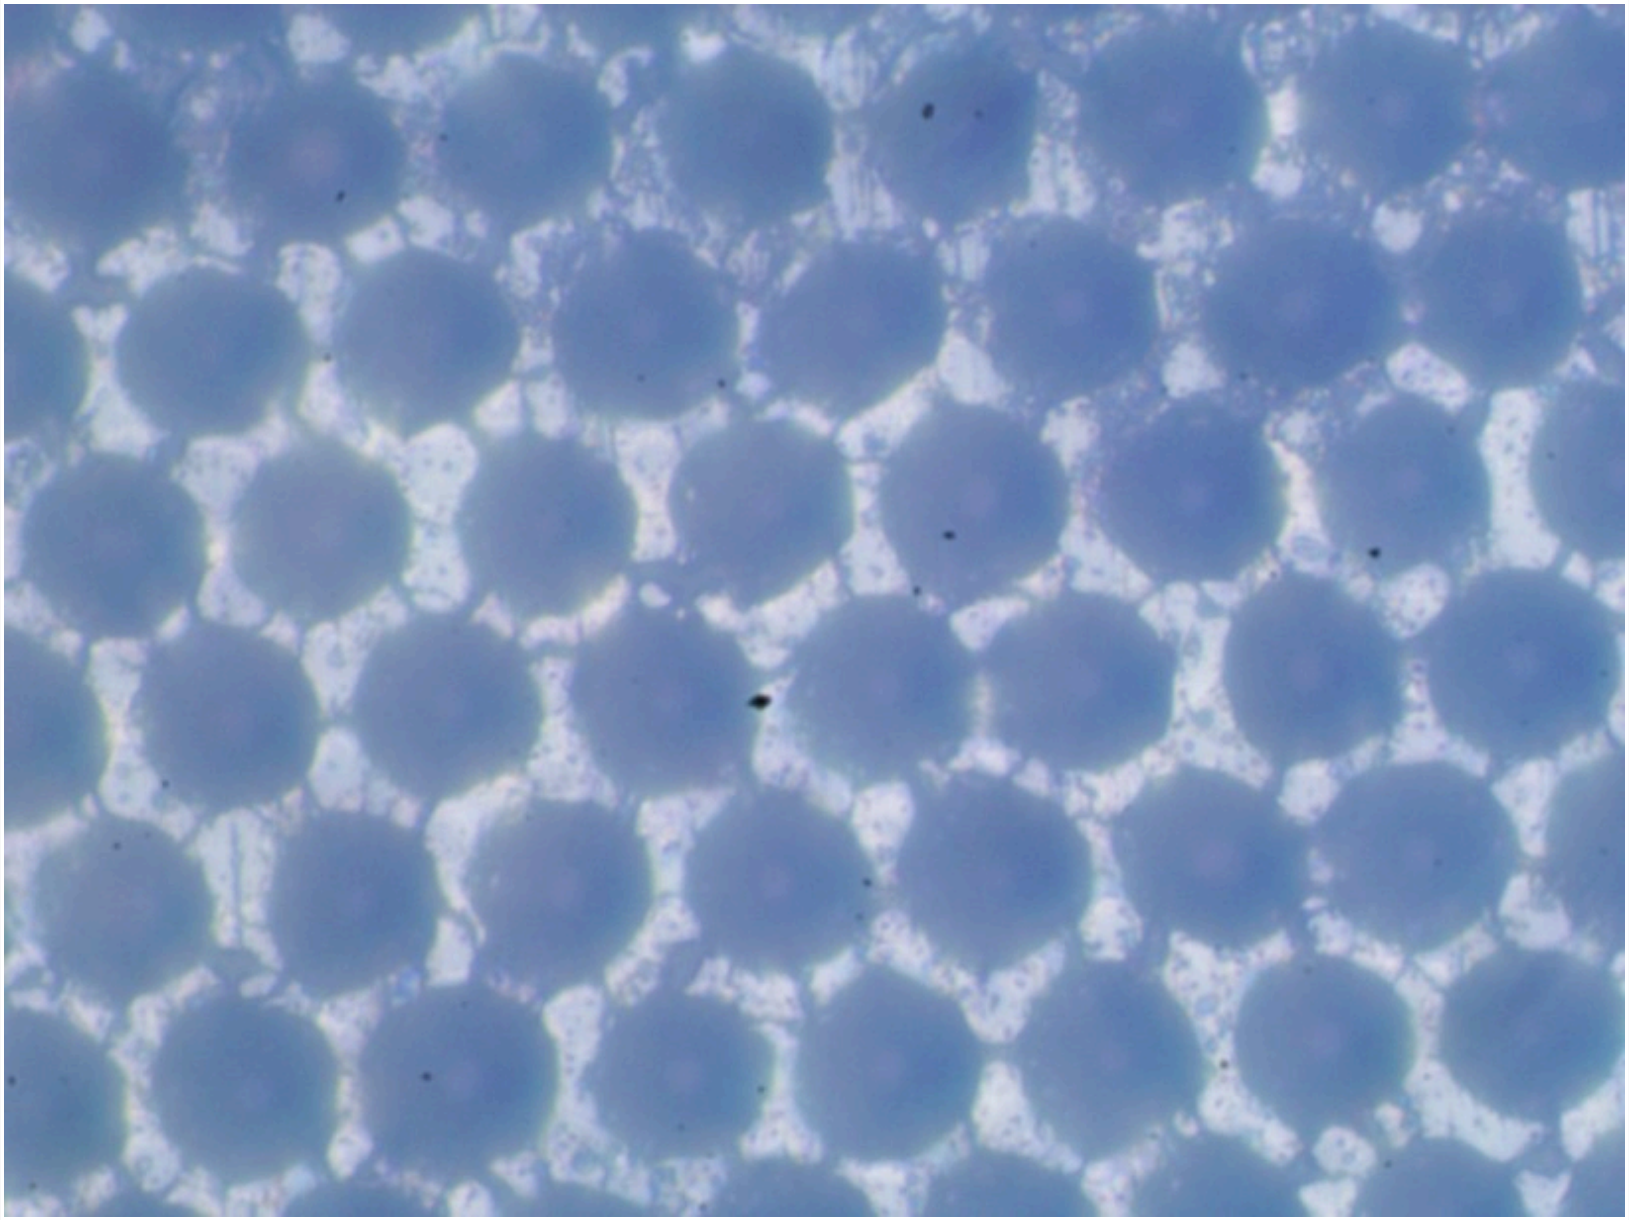
Page №157. Roll "z17011022". Length: 1300 mm. Photos with magnificaiton: x400. Cleaning passes: 1

Ink transfer volume decrease from the passport value: 51.35%

Bridge / Cell: 1 / 3
Depth before / after: 8 / 8 мкм
Depth decreased by: 0%

Comment
streaks cell walls are missing.
Roll heavily ground off.

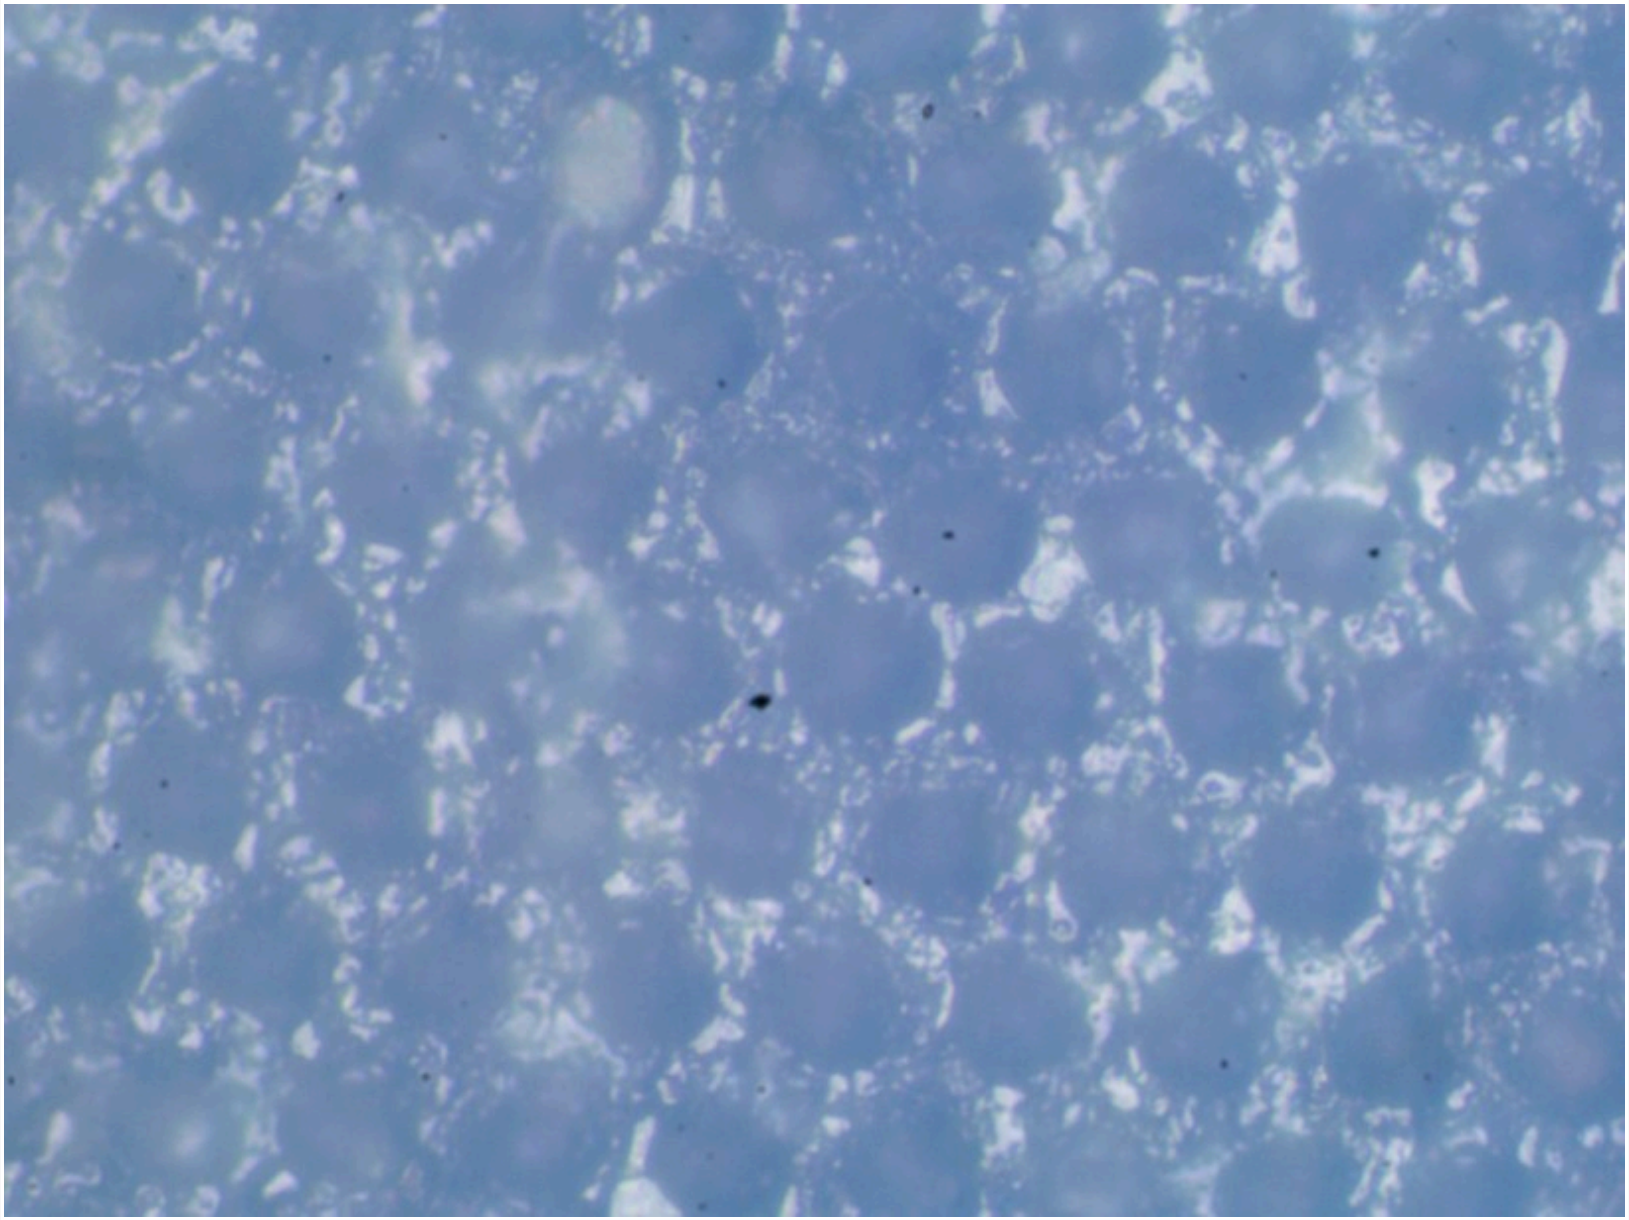
Page №158. Roll "sa008599". Length: 1300 mm. Photos with magnificaiton: x400. Cleaning passes: 1

Comment
spot 1335 chips at edges.
Roll ground off.

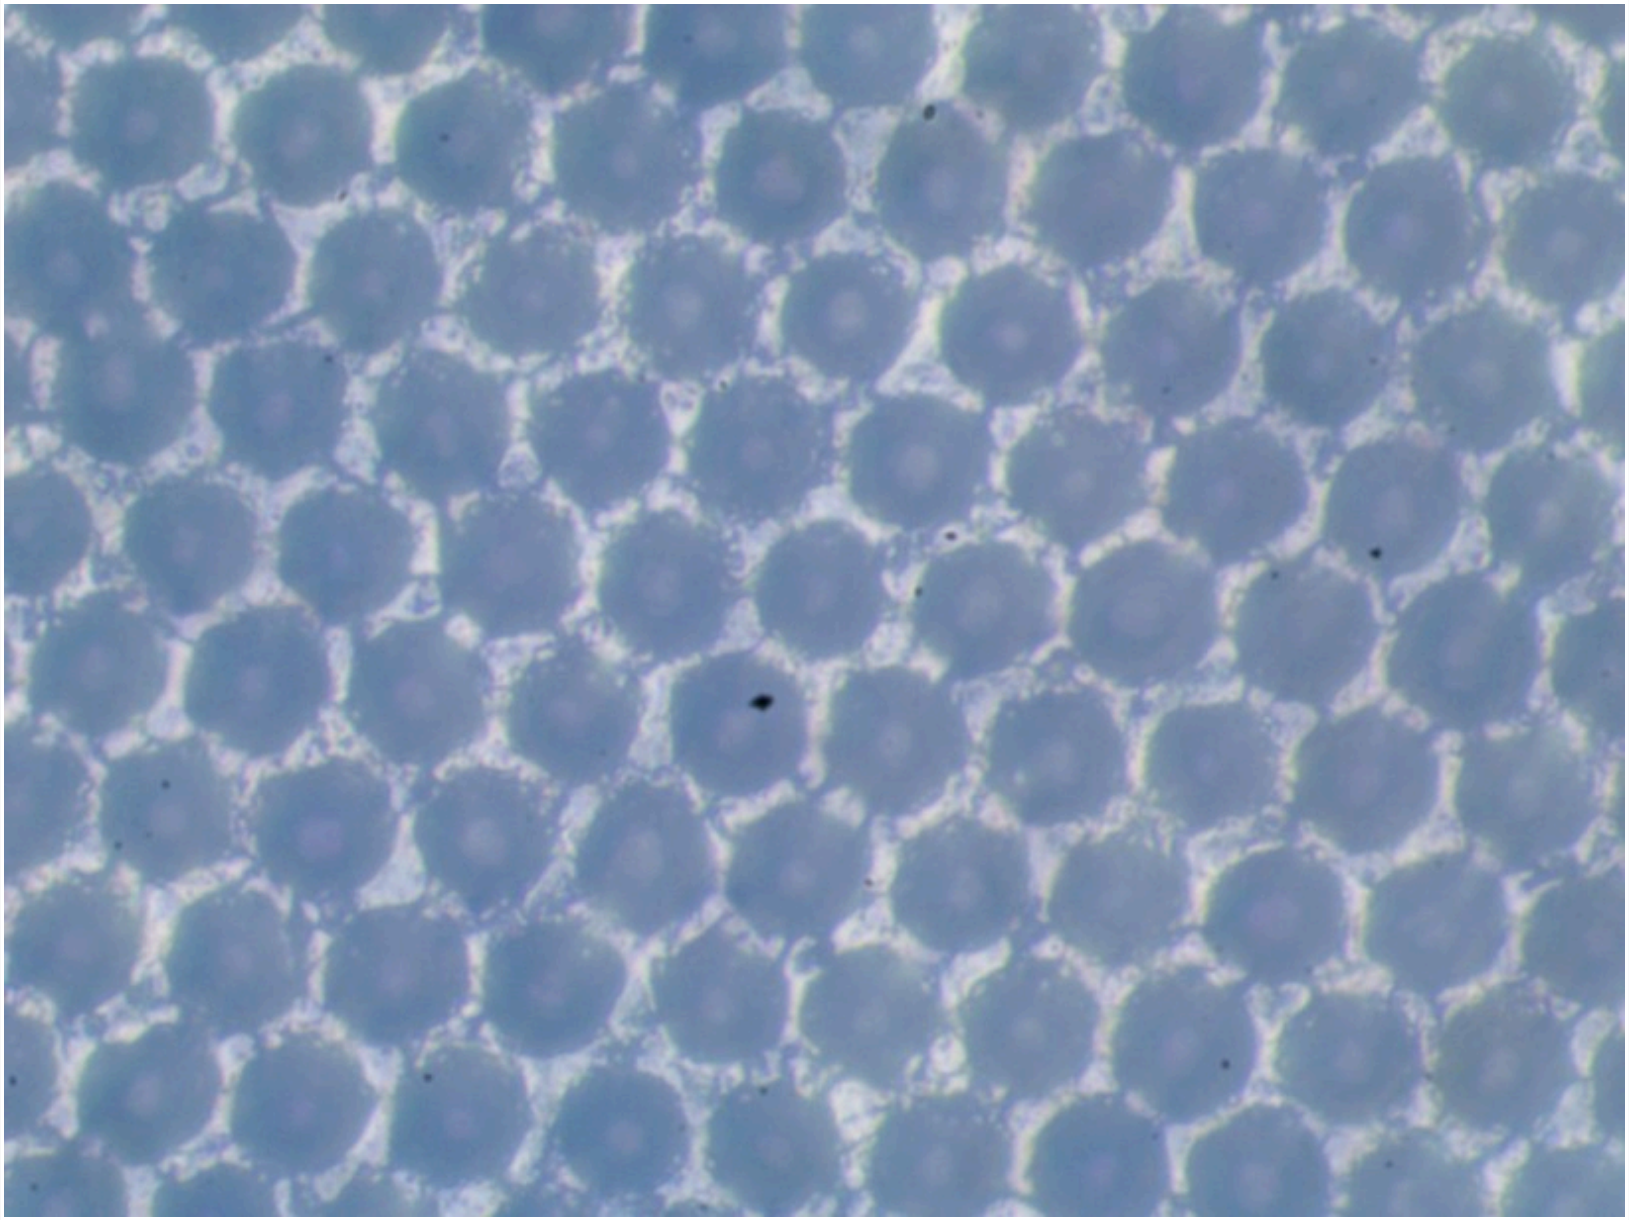
Page №159. Roll "h100750-6". Length: 1300 mm. Photos with magnificaiton: x400. Cleaning passes: 1

Comment
streaks wear cell walls are missing.

Roll heavily ground off.

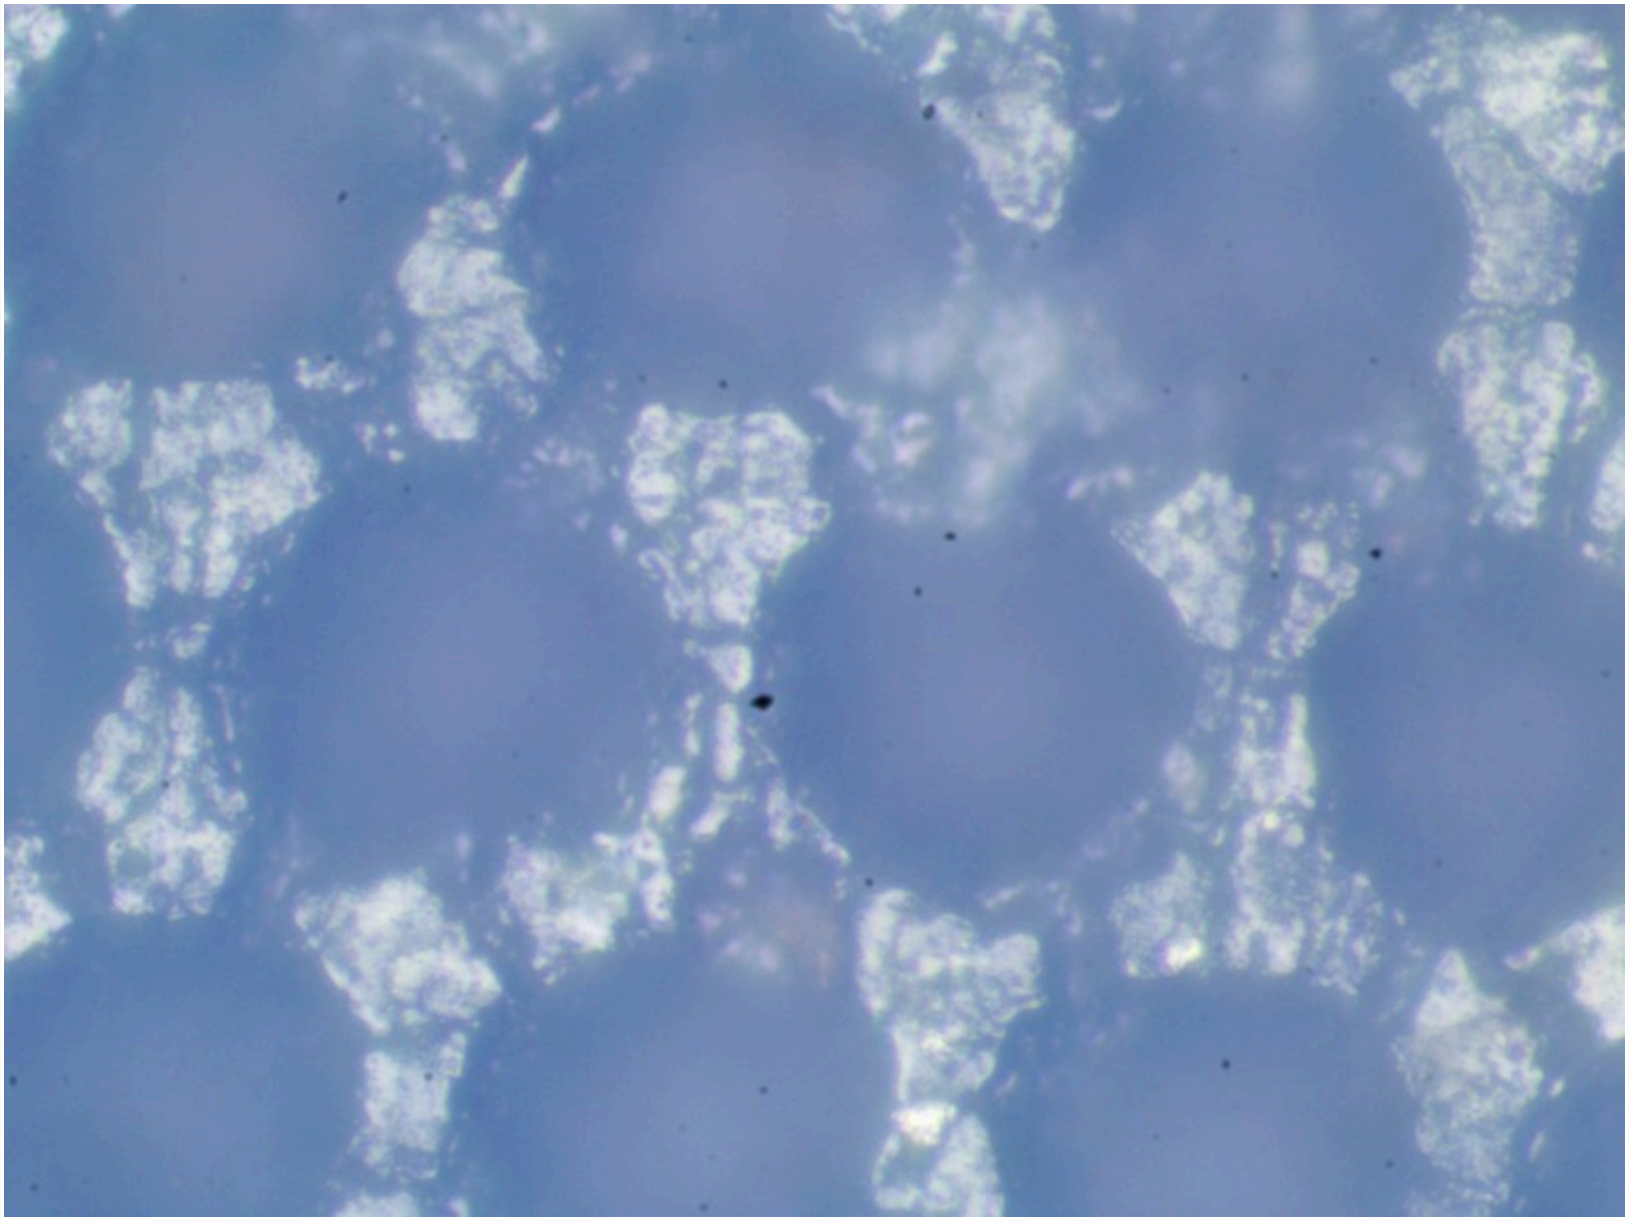
Page №160. Roll "046639". Length: 1300 mm. Photos with magnificaiton: x400. Cleaning passes: 1

Ink transfer volume decrease from the passport value: 55.56%

Comment
dent 250 290 scratch 1020
470.
Roll heavily ground off.

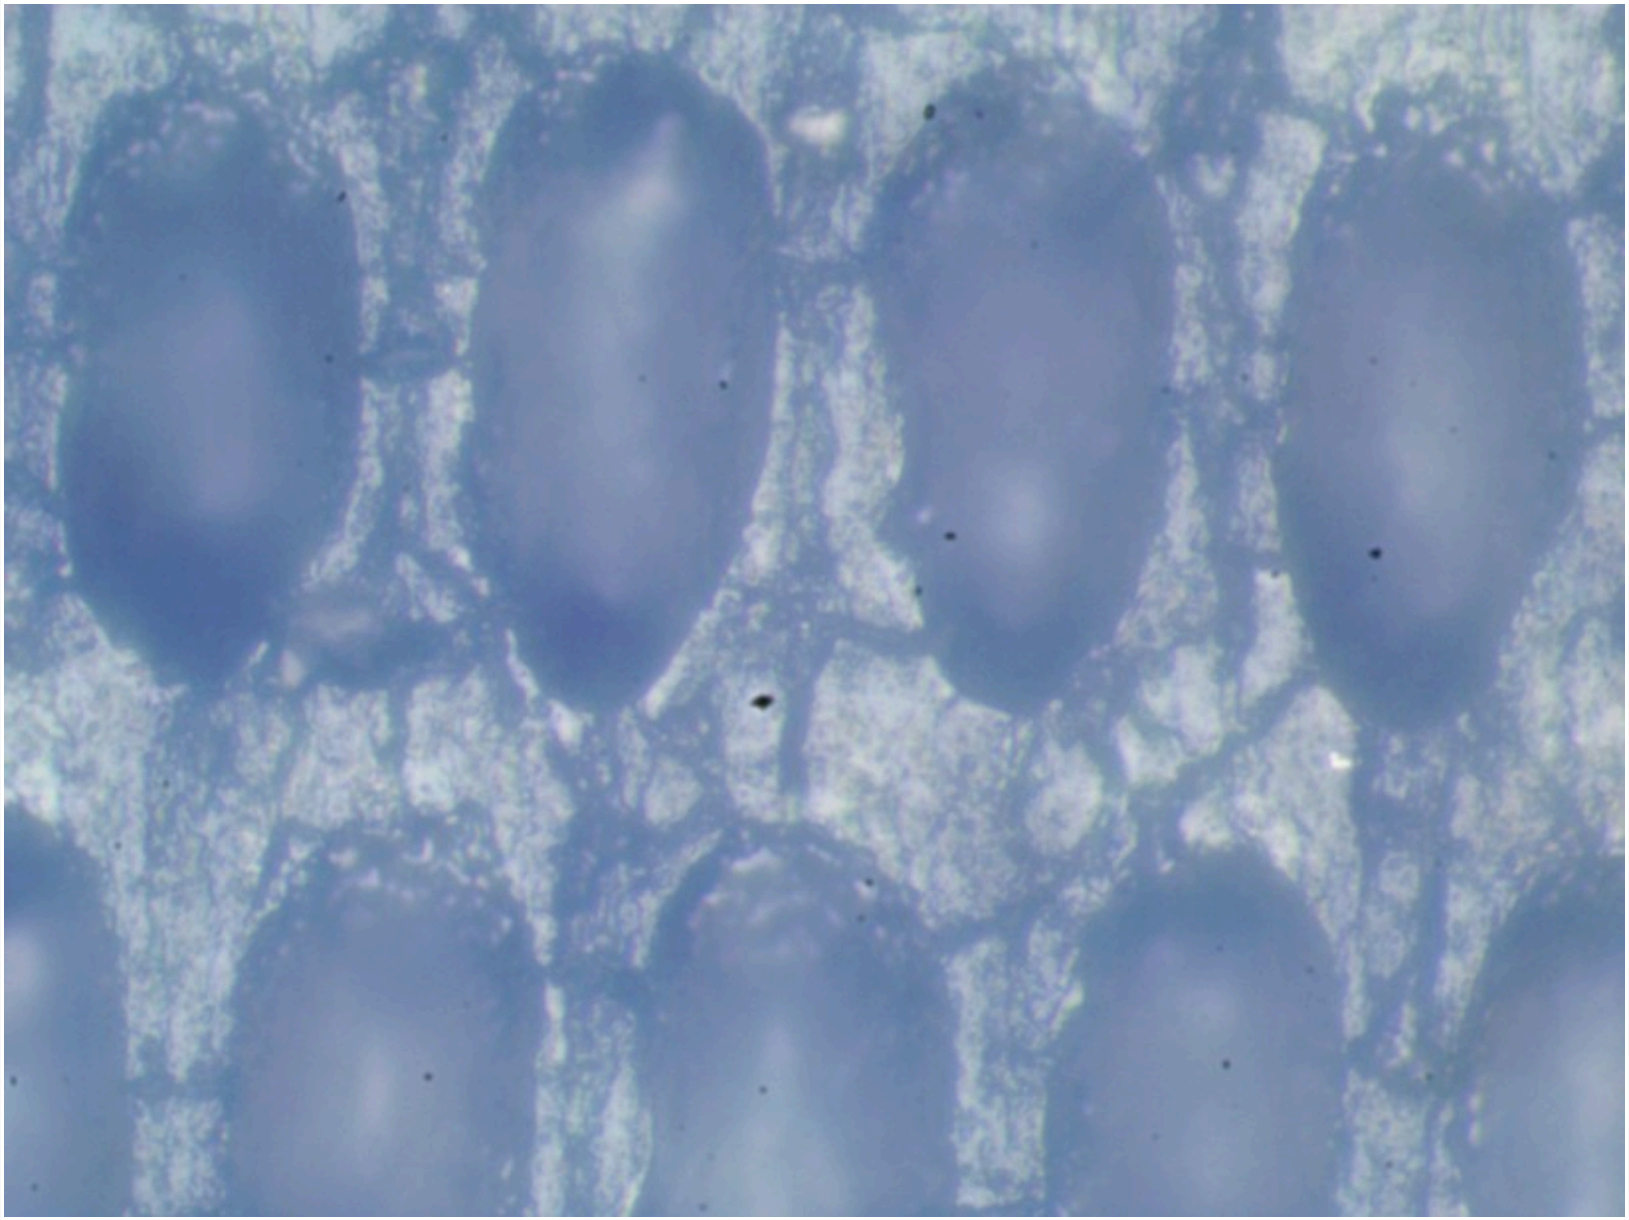
Page №161. Roll "sa008590". Length: 1300 mm. Photos with magnificaiton: x400. Cleaning passes: 1

Comment
streak 1070 bumps 300 scrap.
Roll heavily ground off.
