RollerCheck360

Roll Inspection from 08.12.2025

Rolls: 178

We have analyzed for you 178 rolls.

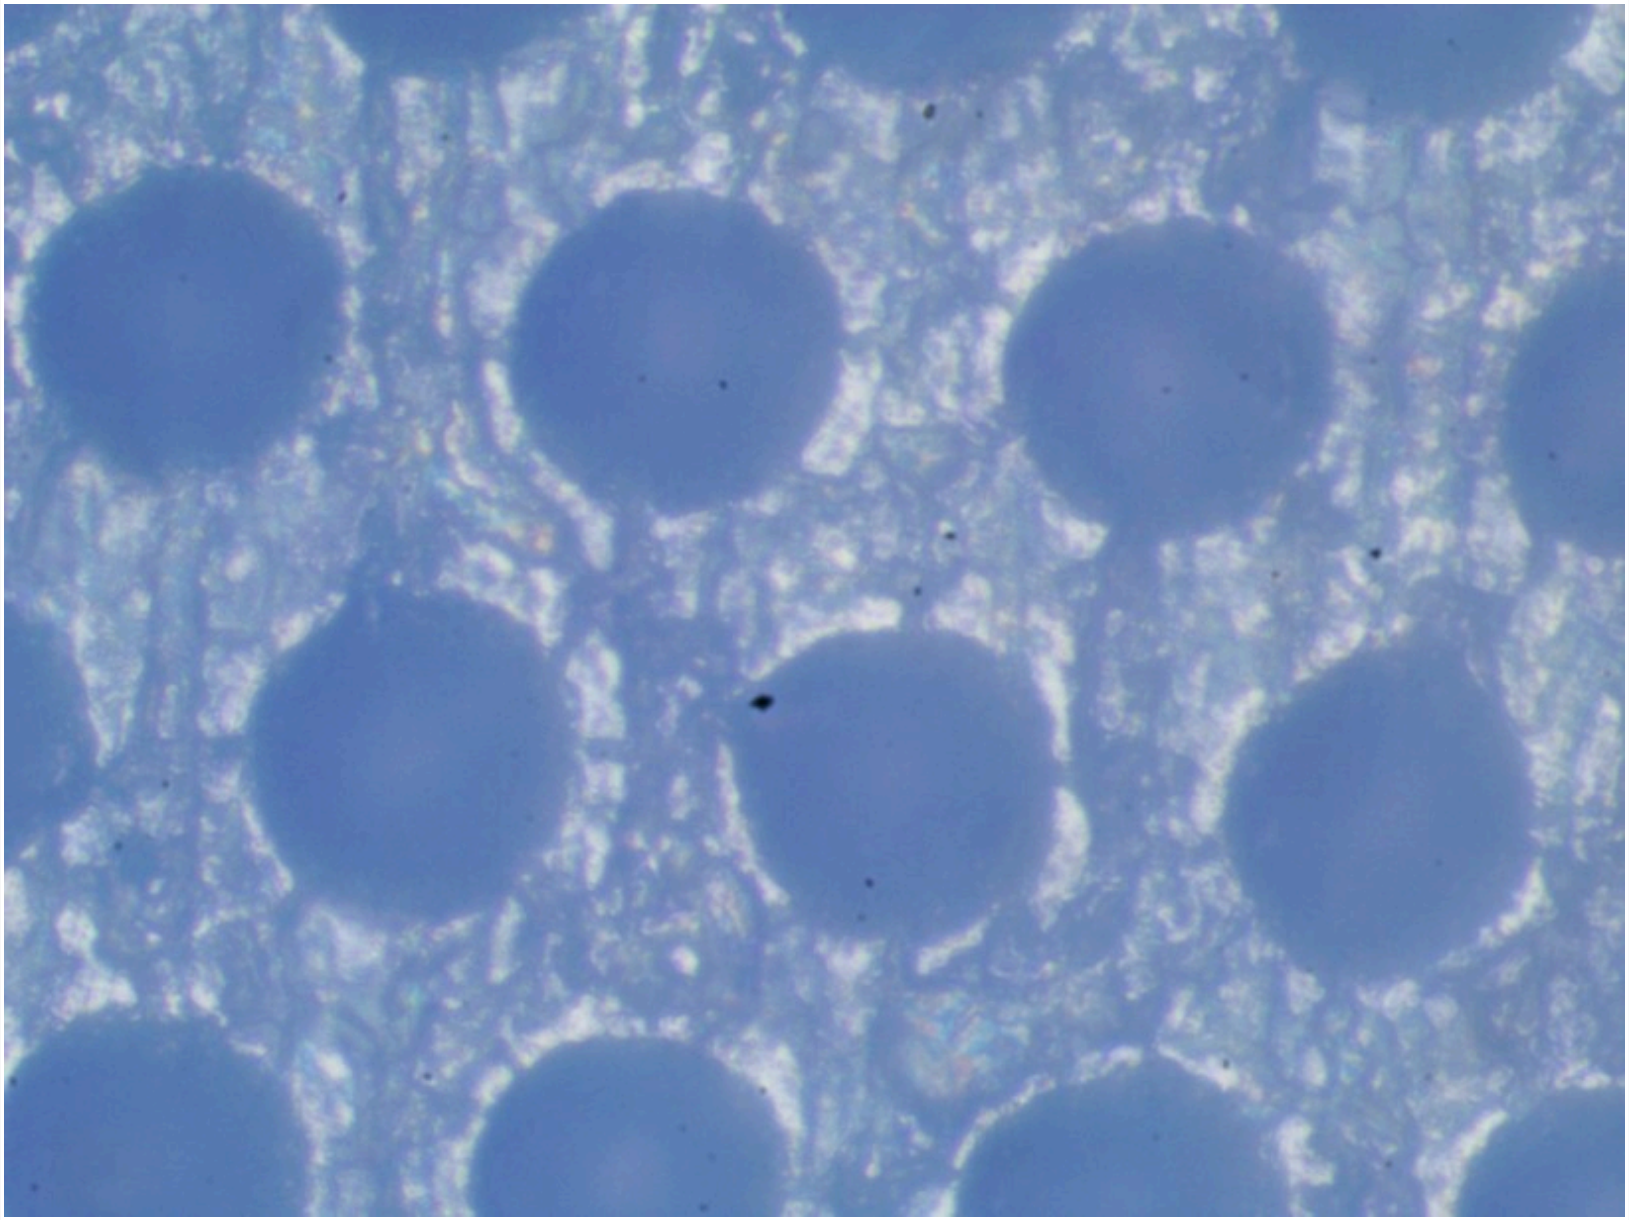
Page №162. Roll "z17011032". Length: 1300 mm. Photos with magnificaiton: x400. Cleaning passes: 1

Comment
spot 1260 streaks.
Roll ground off.

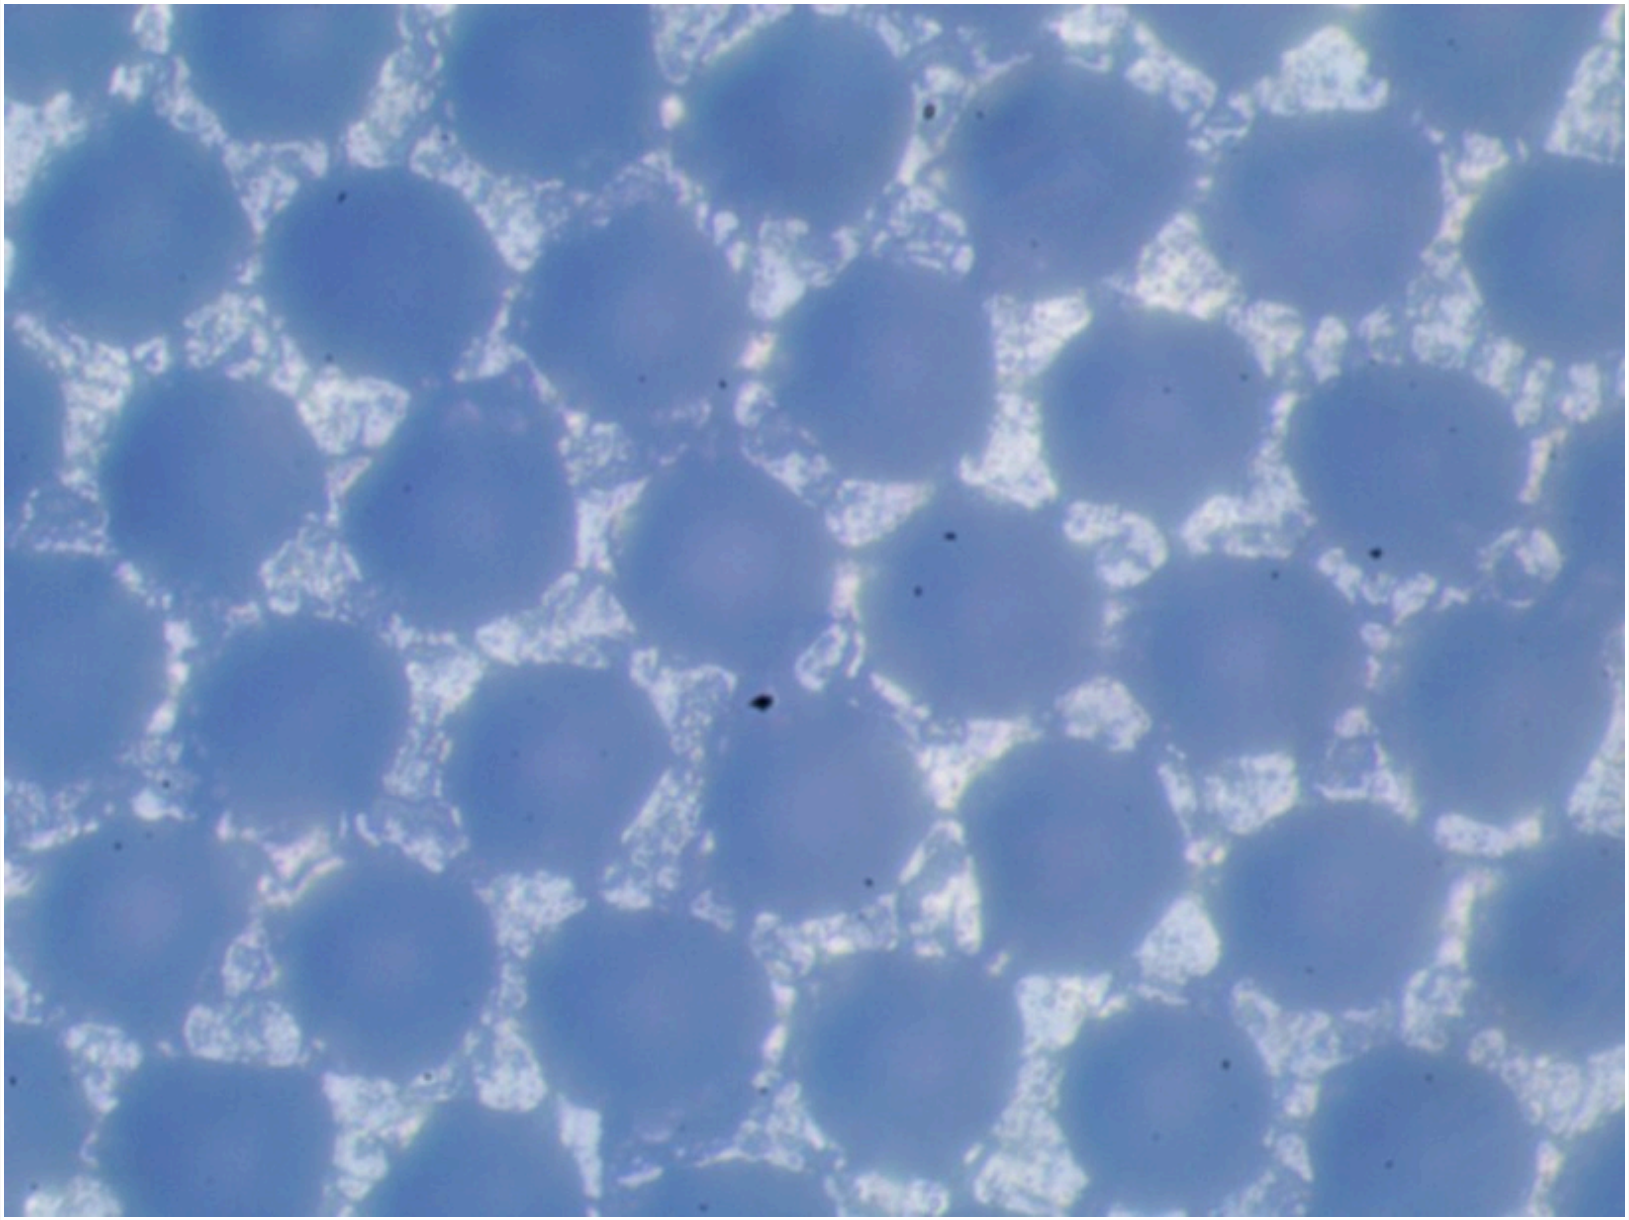
Page №163. Roll "z17011020". Length: 1300 mm. Photos with magnificaiton: x400. Cleaning passes: 1

Comment
dents 95 114 305 360.
Roll ground off.

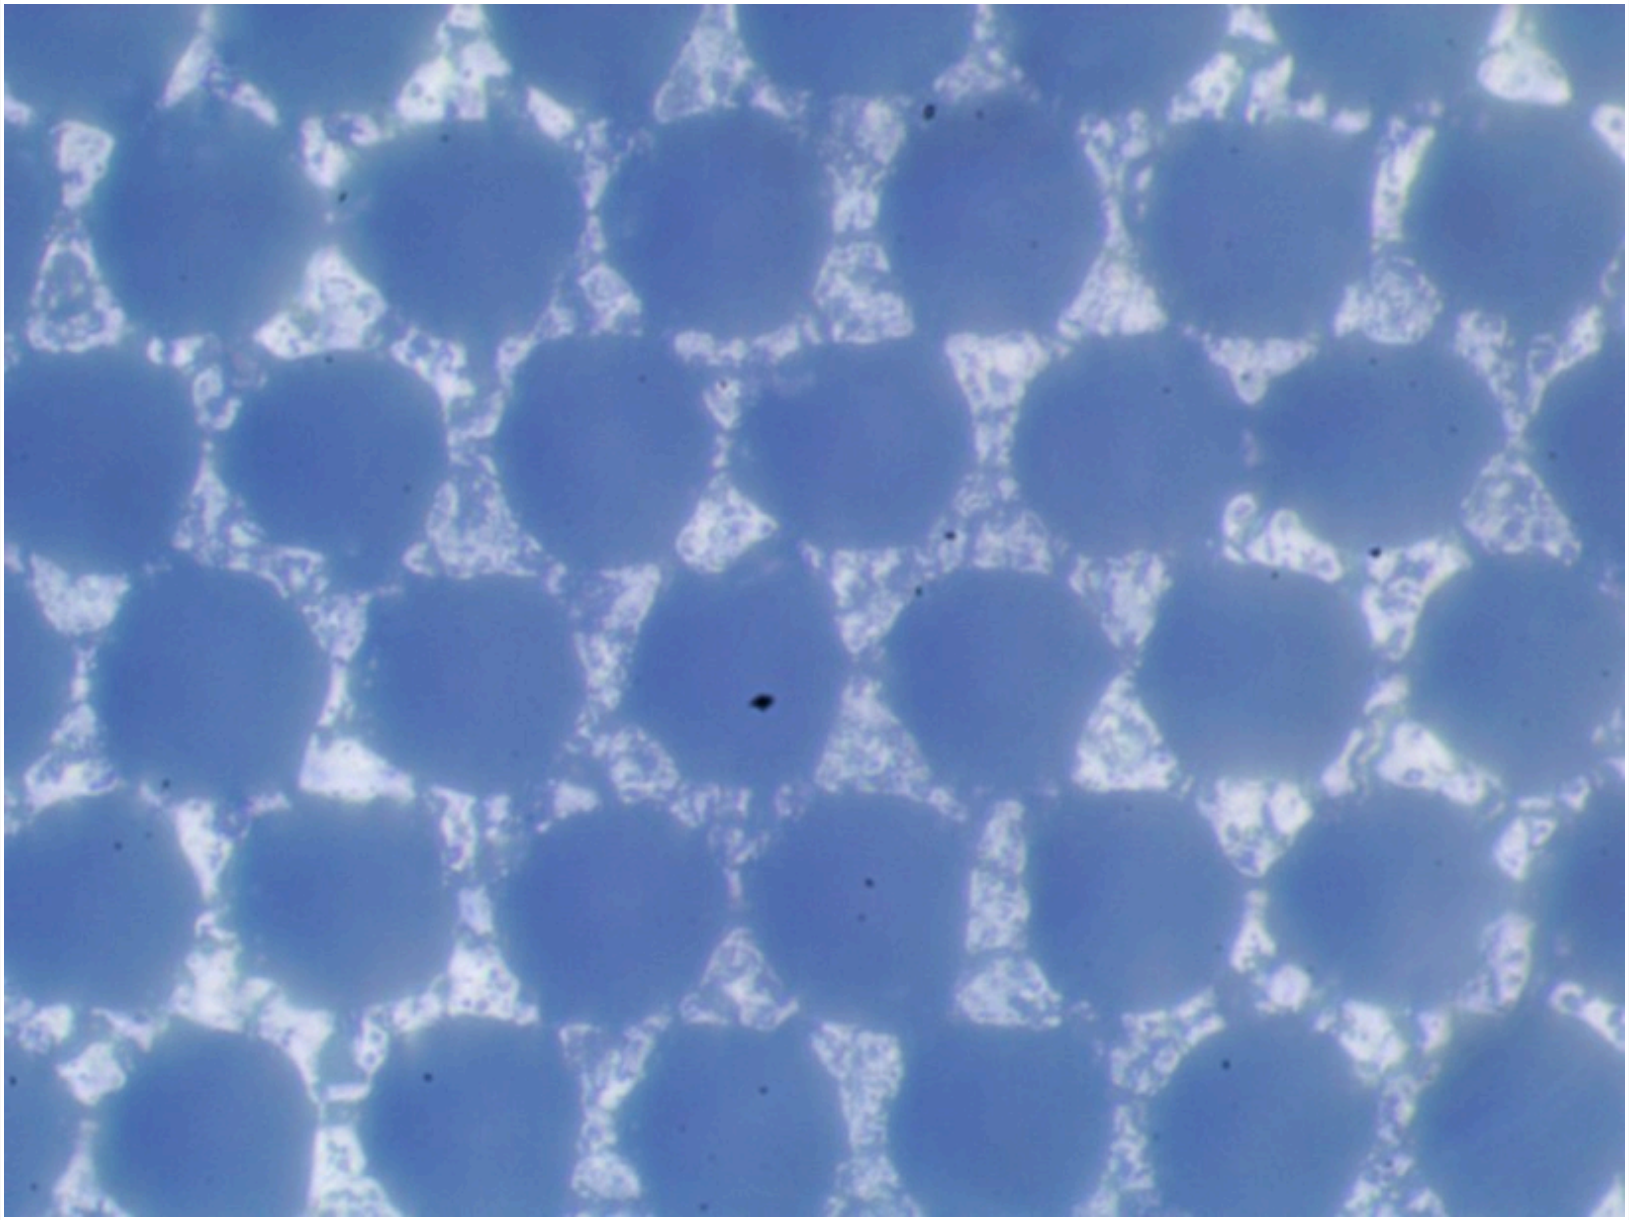
Page №164. Roll "a2724009". Length: 1300 mm. Photos with magnificaiton: x400. Cleaning passes: 1

Comment
chip 75 streak 385.
Roll slightly ground off.

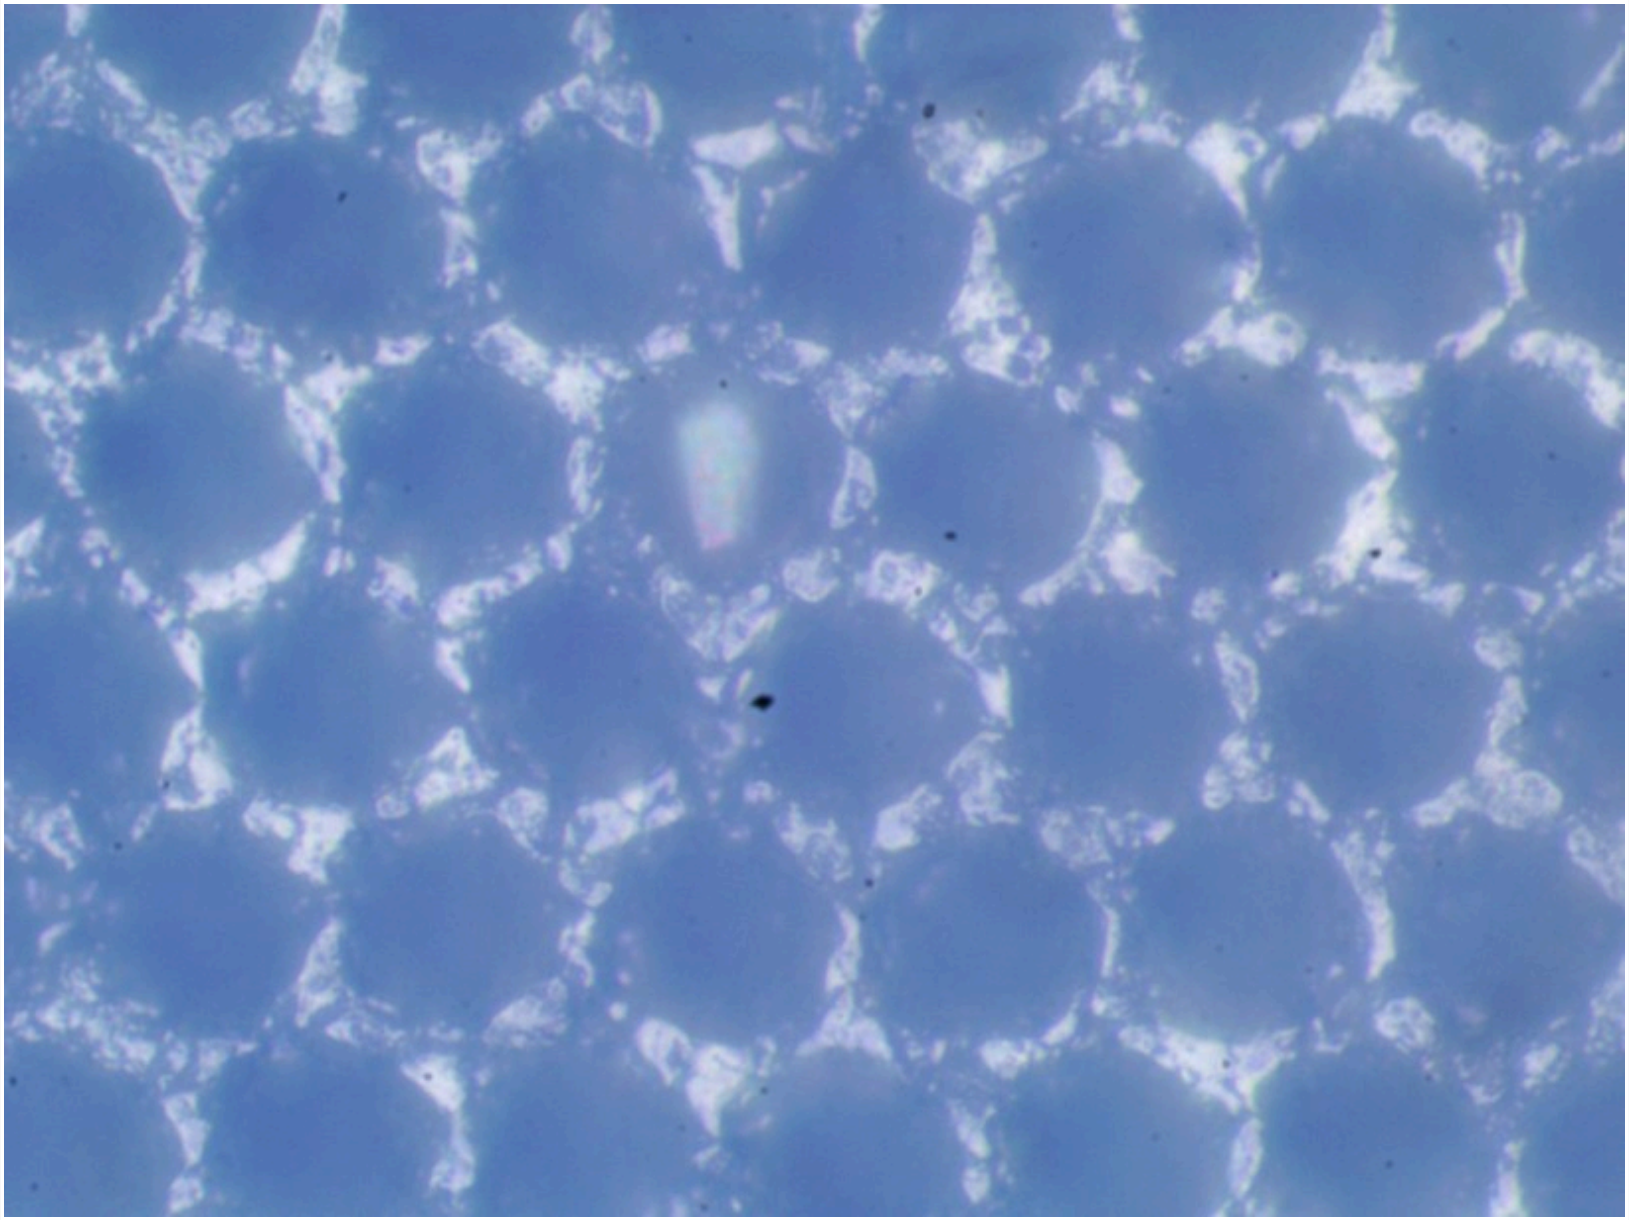
Page №165. Roll "sa008606". Length: 1300 mm. Photos with magnificaiton: x400. Cleaning passes: 1

Comment
dent 240 285.
Roll ground off.

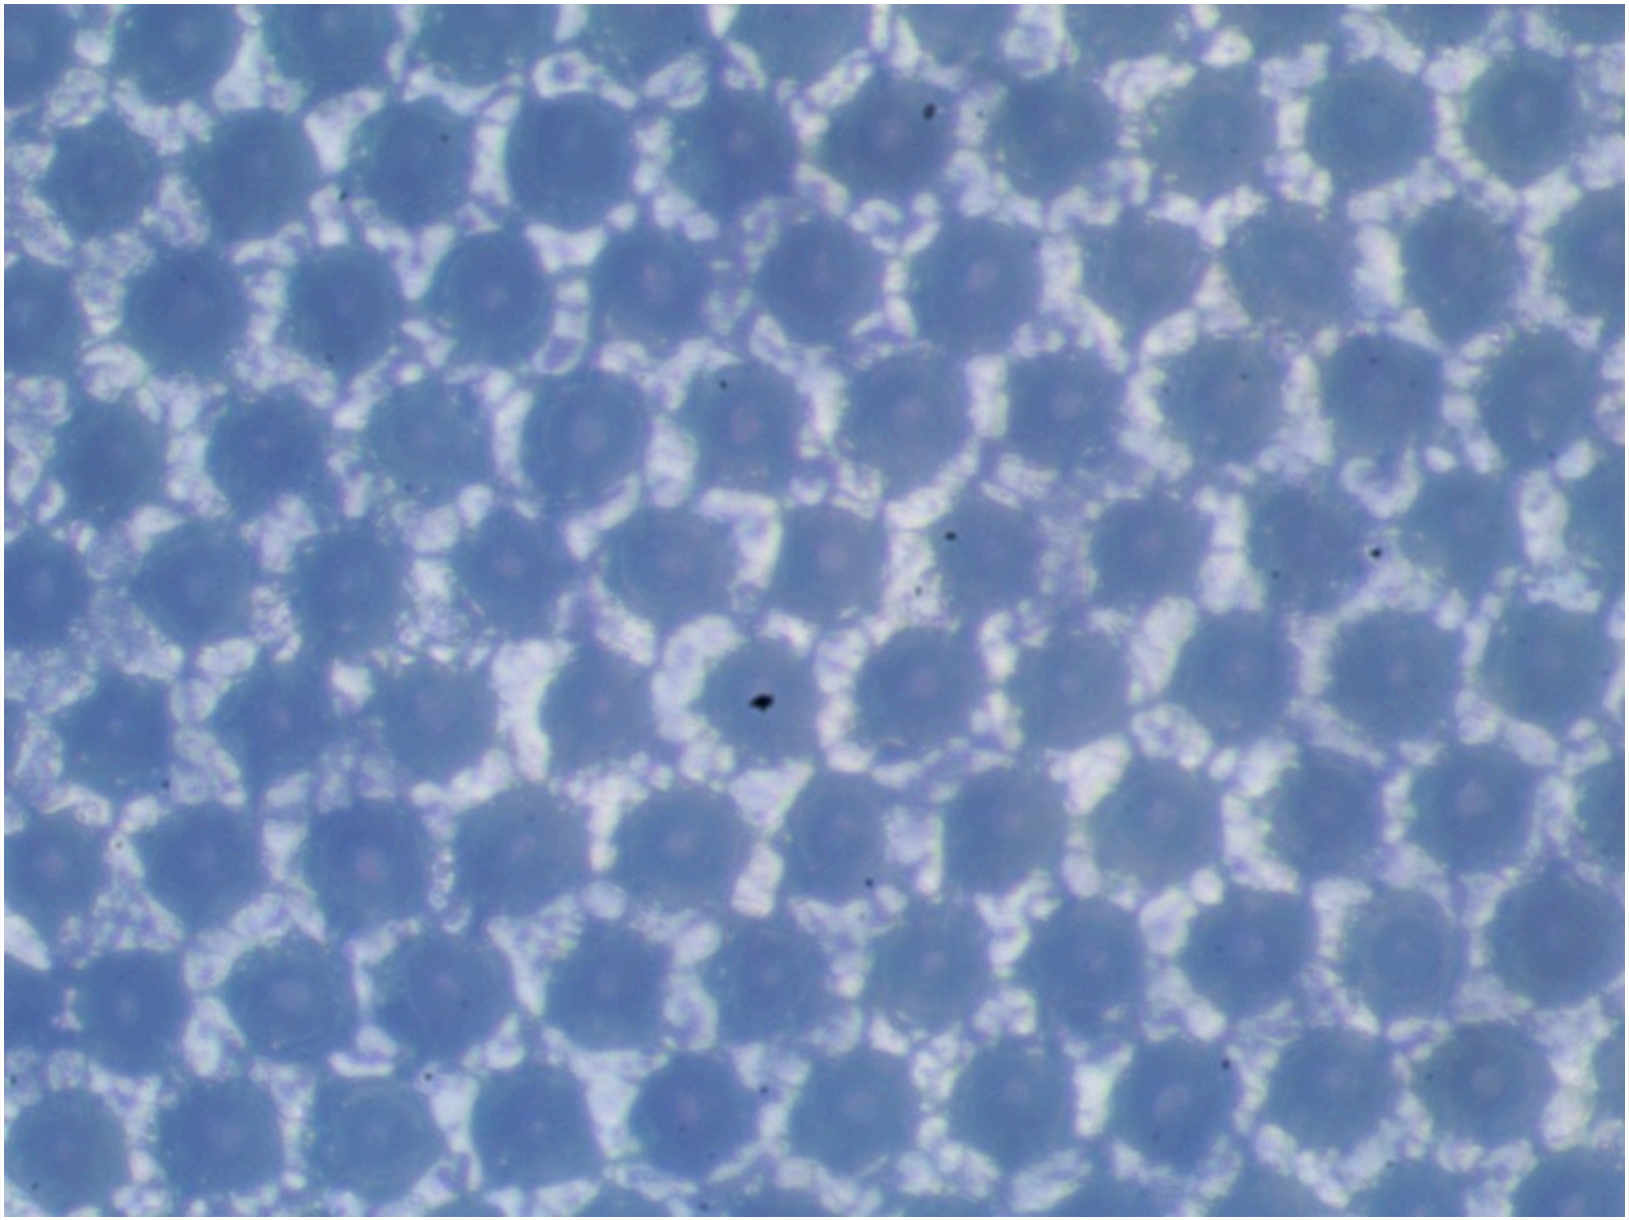
Page №166. Roll "sa008603". Length: 1300 mm. Photos with magnificaiton: x400. Cleaning passes: 1

Comment
Roll ground off.

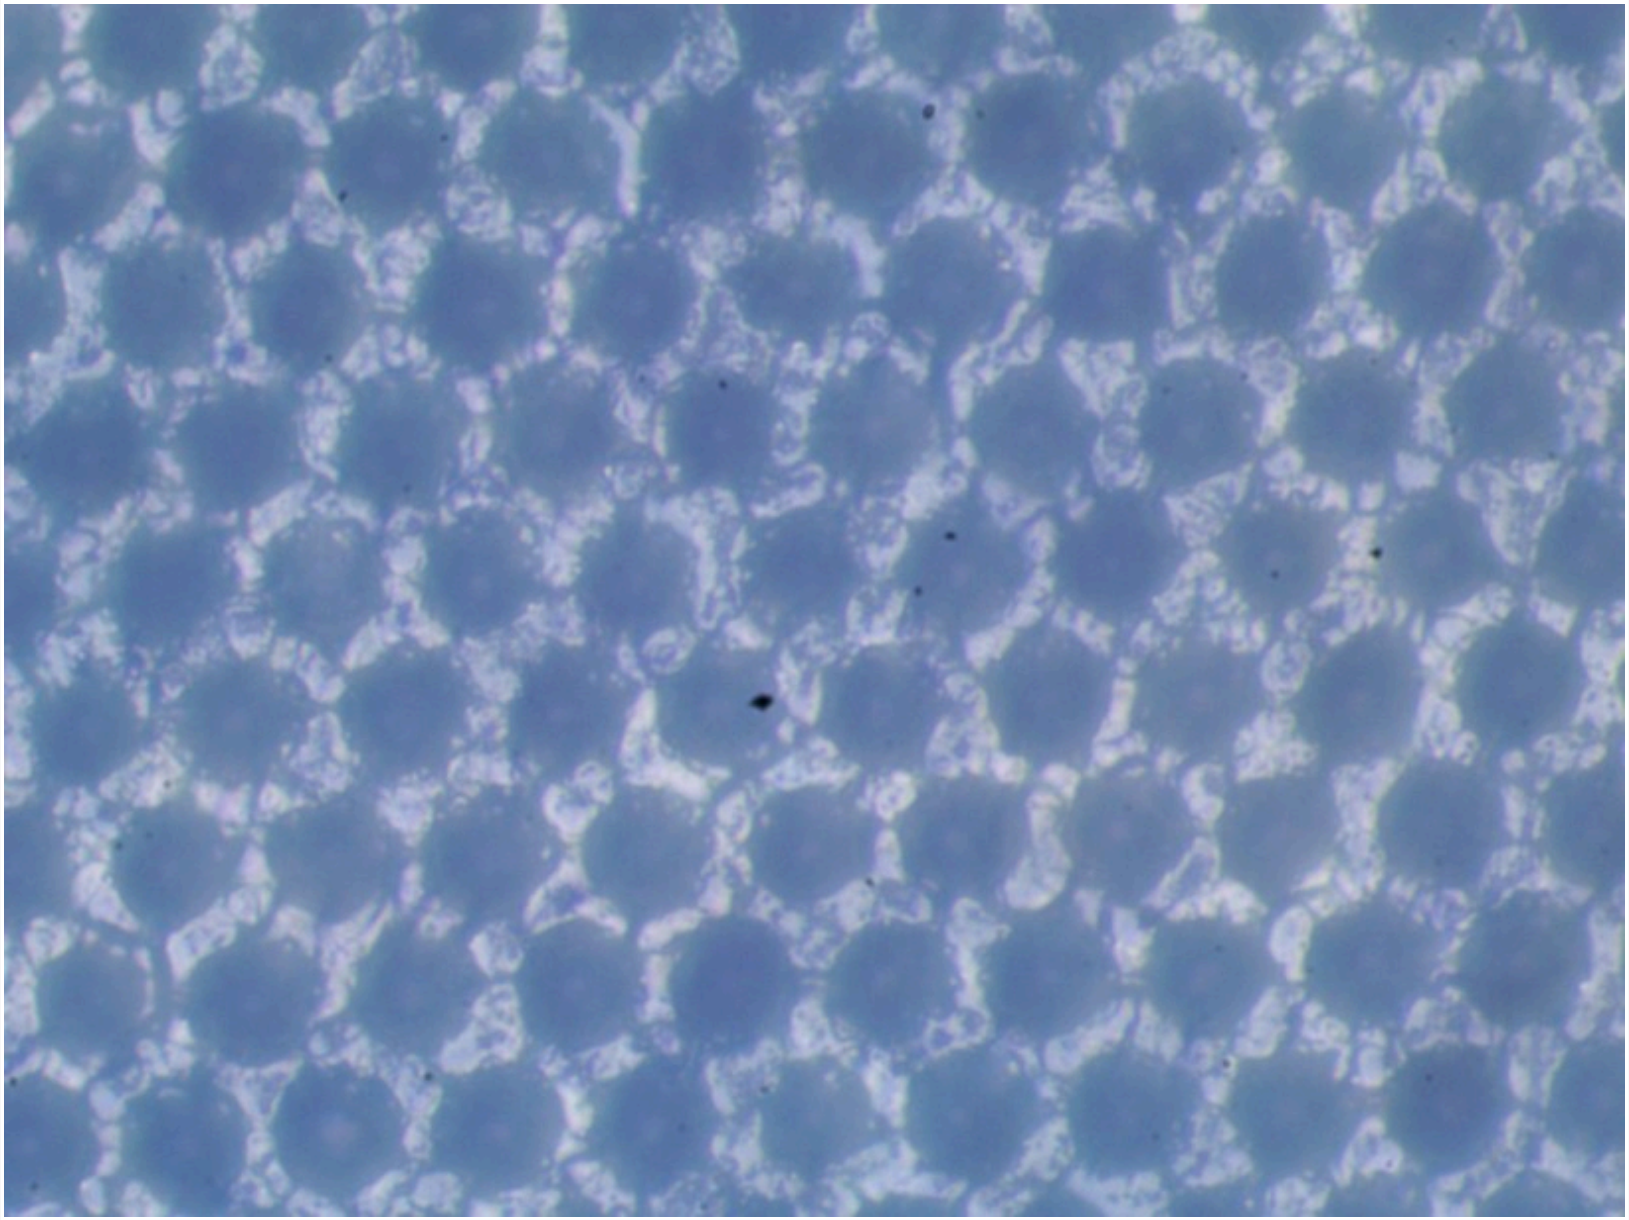
Page №167. Roll "sa008597". Length: 1300 mm. Photos with magnificaiton: x400. Cleaning passes: 1

Comment
dent 1200 1290 streak 1115.
Roll ground off.

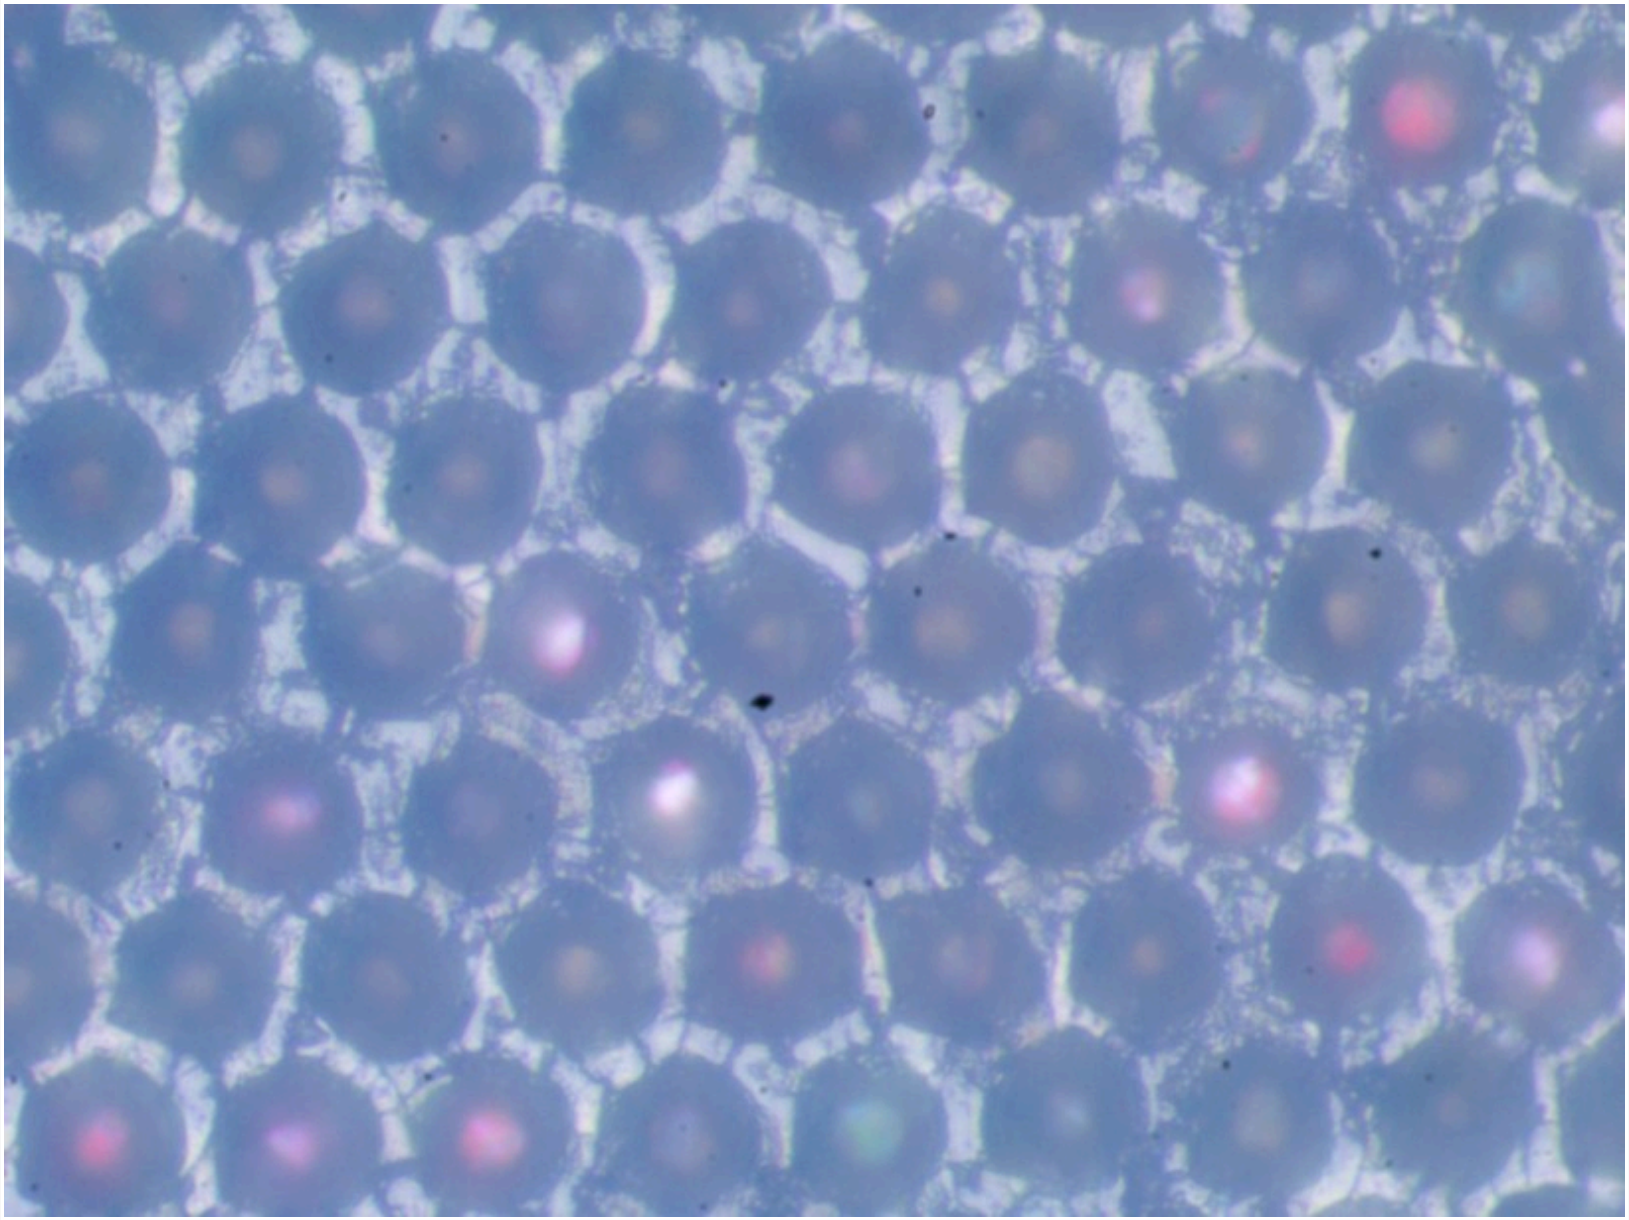
Page №168. Roll "sa008595". Length: 1300 mm. Photos with magnificaiton: x400. Cleaning passes: 1

Comment
streak dent 1235.
Roll ground off.

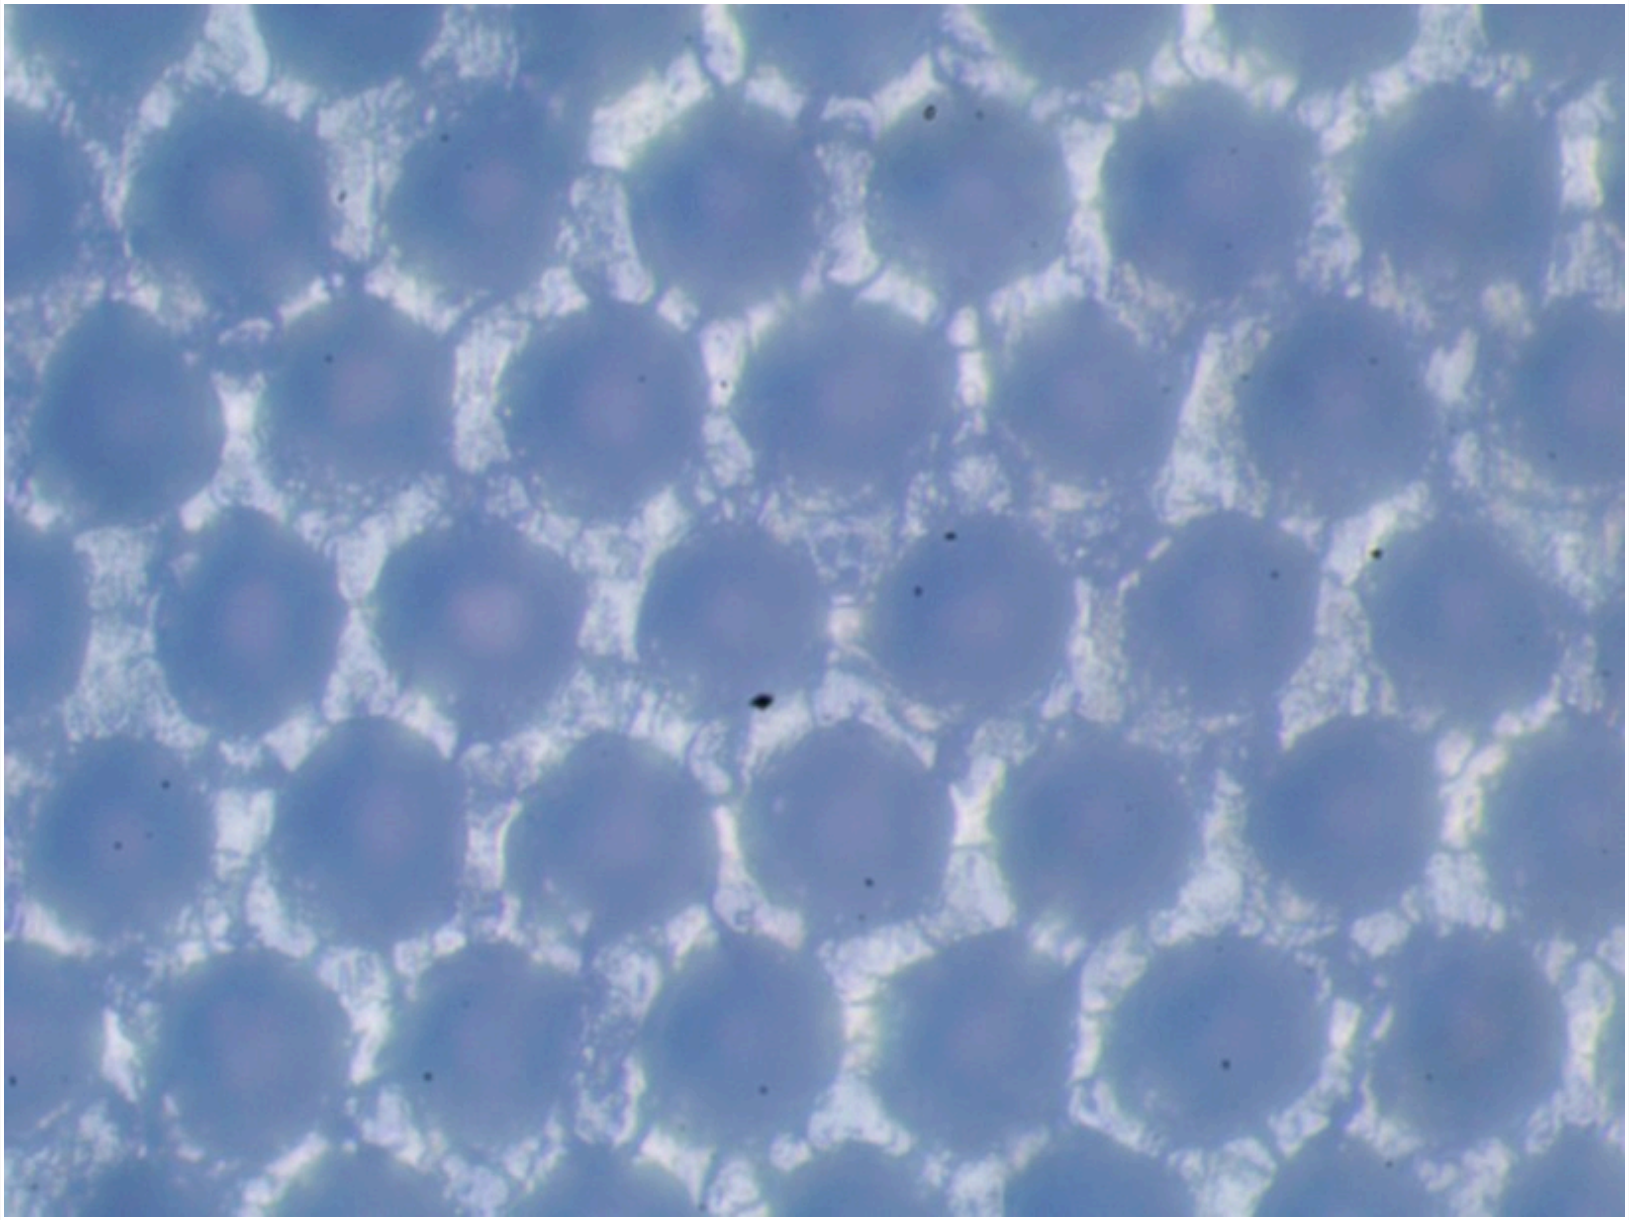
Page №169. Roll "h100748-4". Length: 870 mm. Photos with magnificaiton: x400. Cleaning passes: 1

Ink transfer volume decrease from the passport value: 52.8%

Bridge / Cell: 1 / 3
Depth before / after: 26.5 / 26.5 мкм
Depth decreased by: 0%

Comment
worn streaks.
Roll heavily ground off.

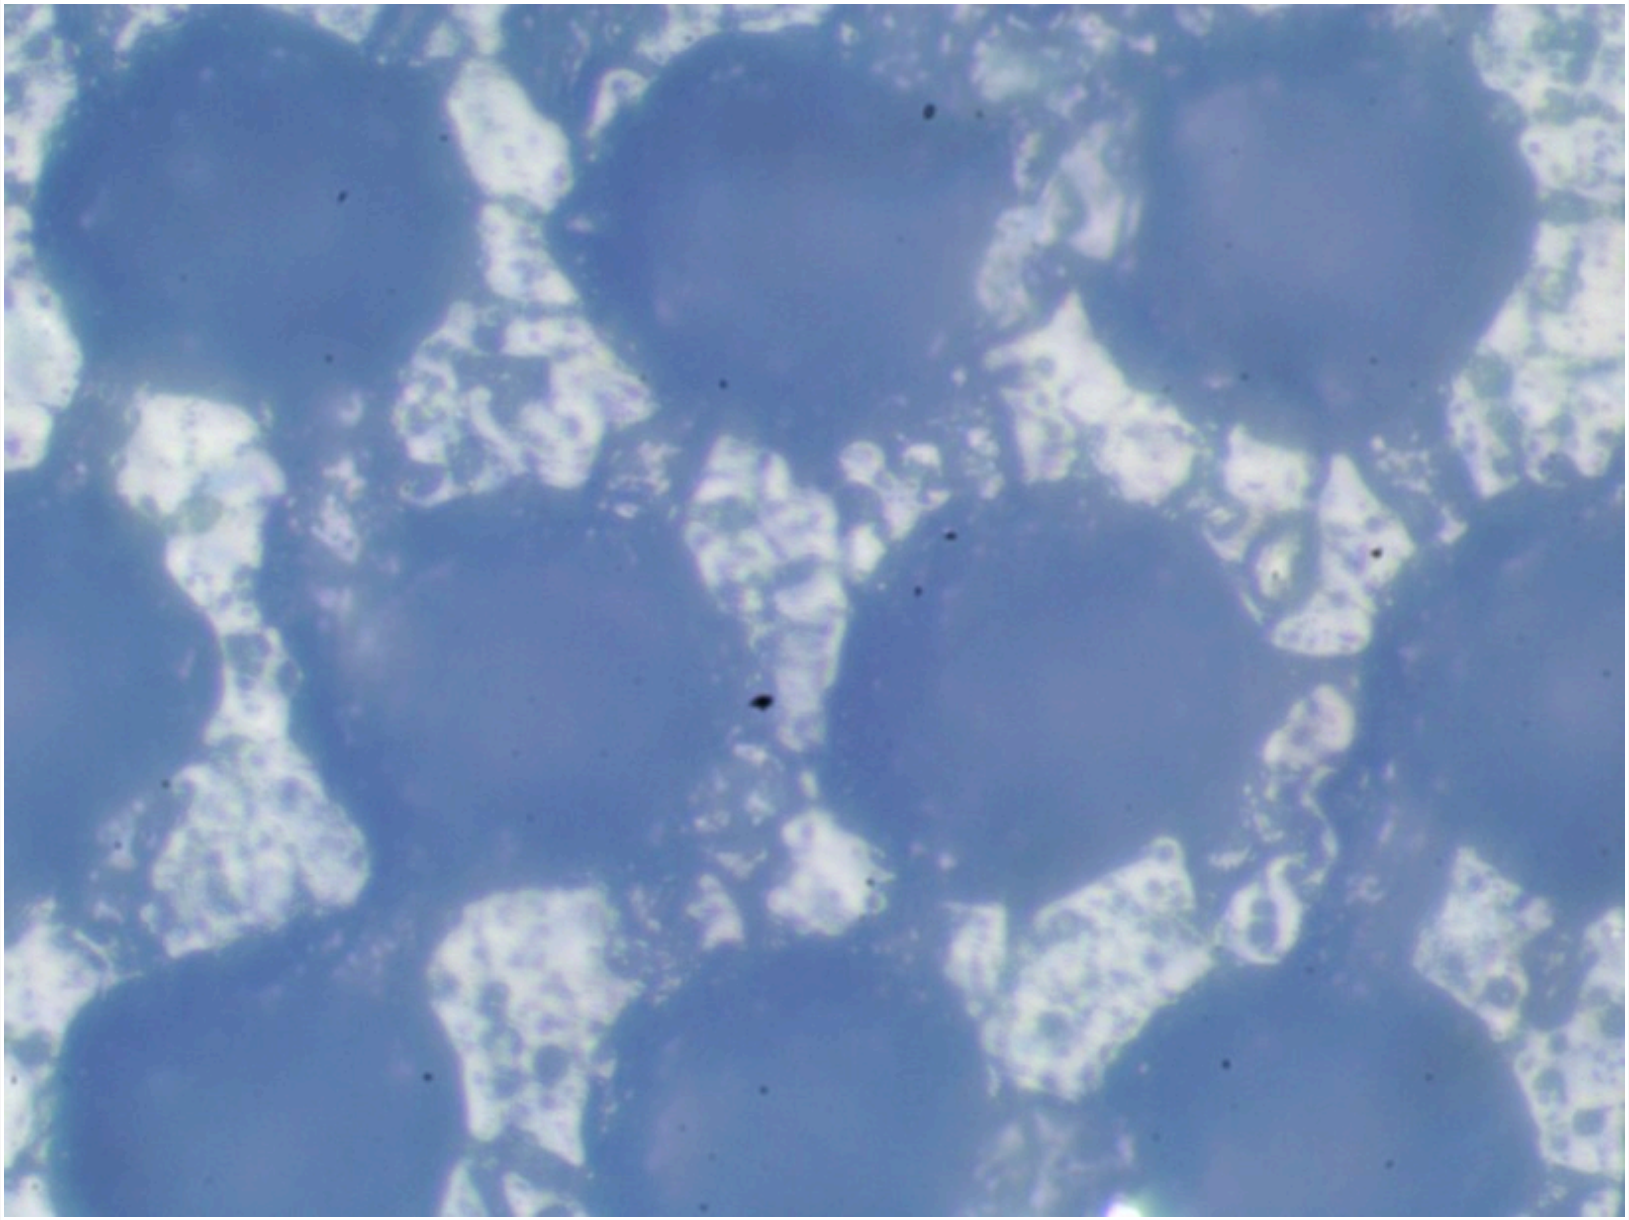
Page №170. Roll "z18006928". Length: 1300 mm. Photos with magnificaiton: x400. Cleaning passes: 1

Comment
scratch 1200 chip 1000.
Roll ground off.

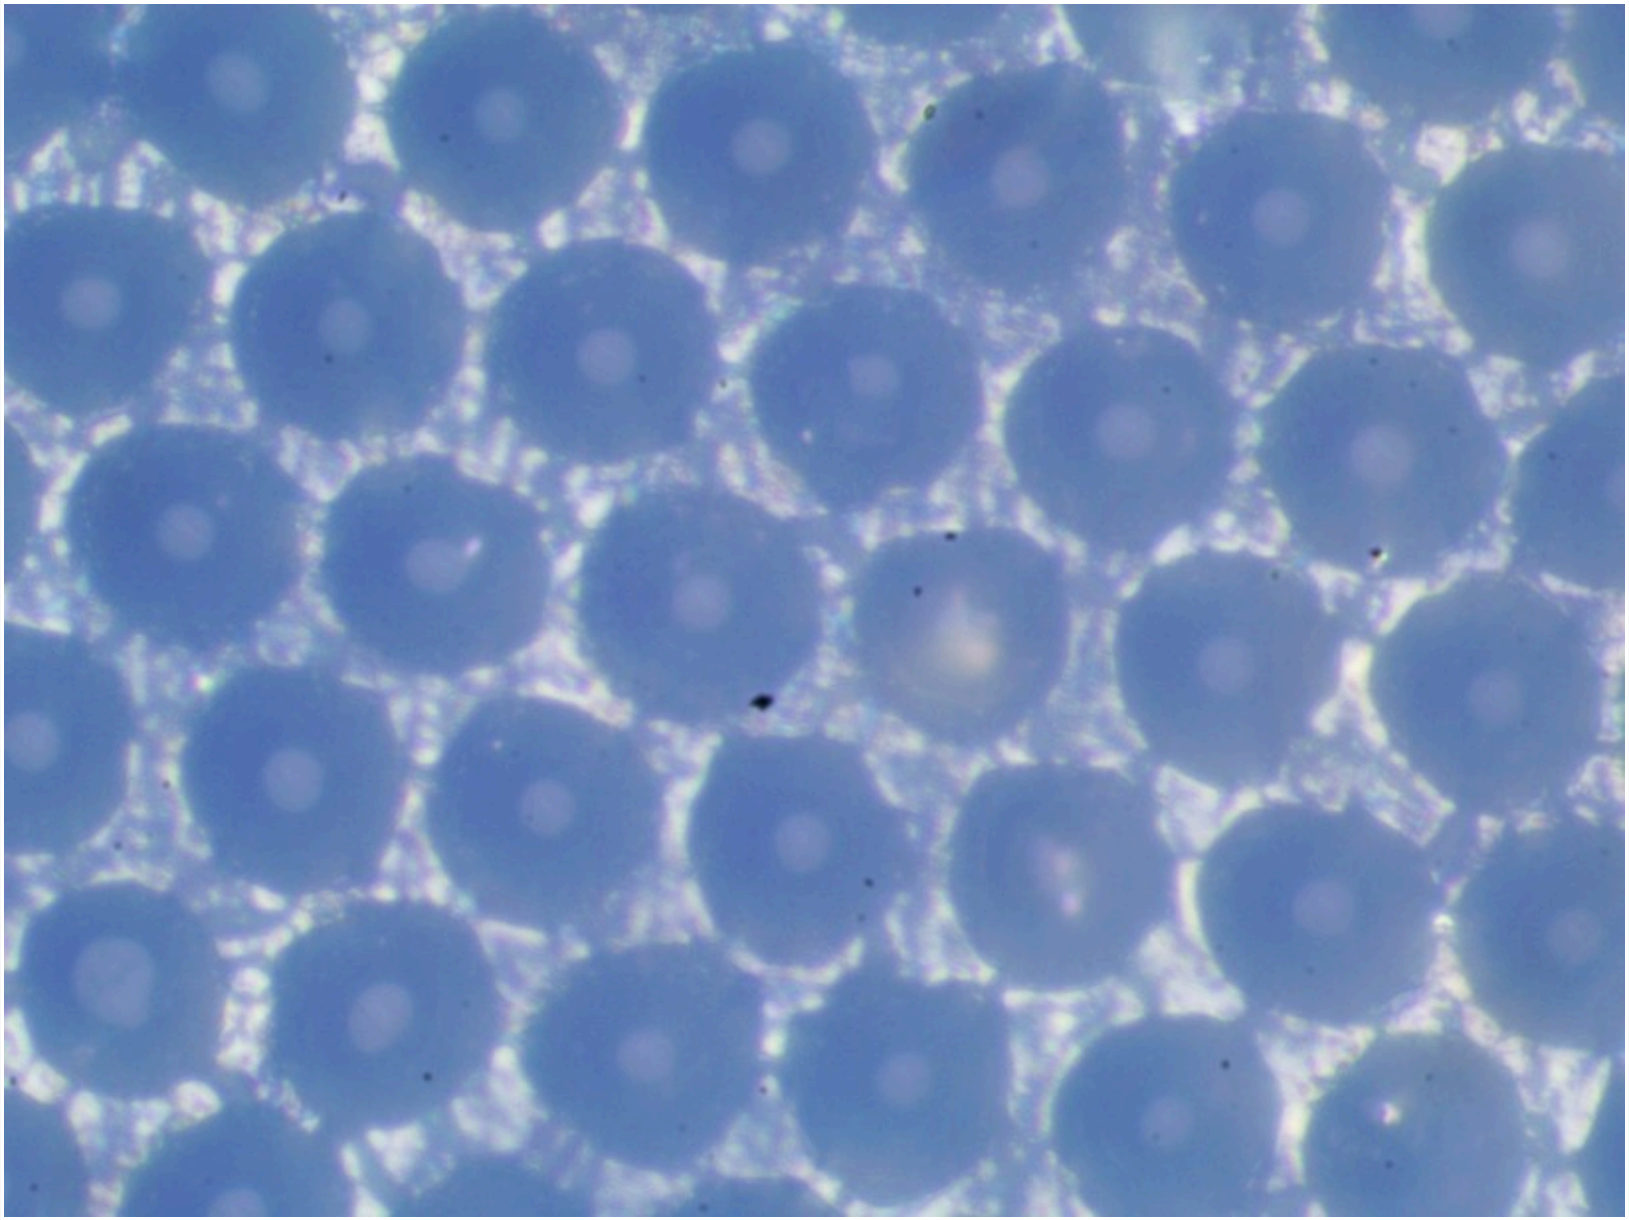
Page №171. Roll "h100751-3". Length: 1300 mm. Photos with magnificaiton: x400. Cleaning passes: 1

Ink transfer volume decrease from the passport value: 14.12%

Comment
chip 25 60 scratch 205 240 445 480 520 585.
Roll ground off.

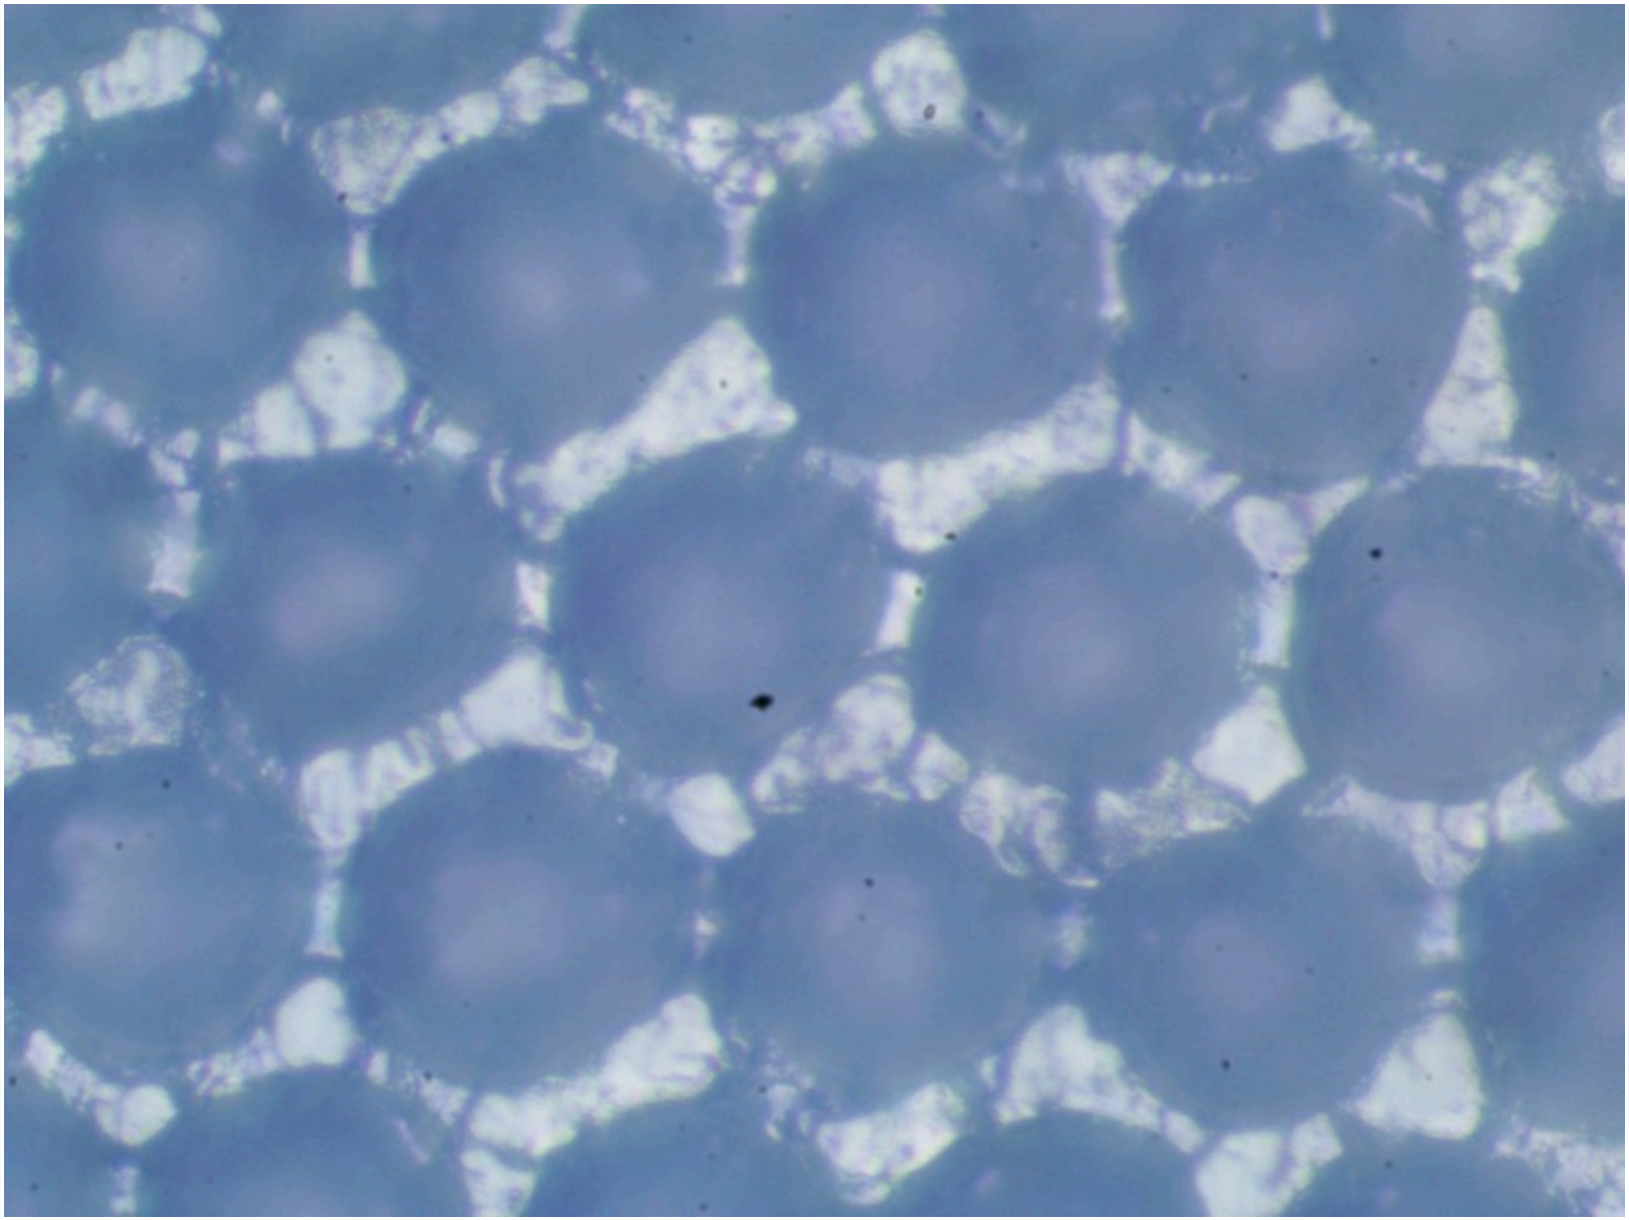
Page №172. Roll "z17011029". Length: 1300 mm. Photos with magnificaiton: x400. Cleaning passes: 1

Comment
streaks chemical stains chips across edges chip 235.

Roll ground off.
