RollerCheck360

Roll Inspection from 08.12.2025

Rolls: 178

We have analyzed for you 178 rolls.

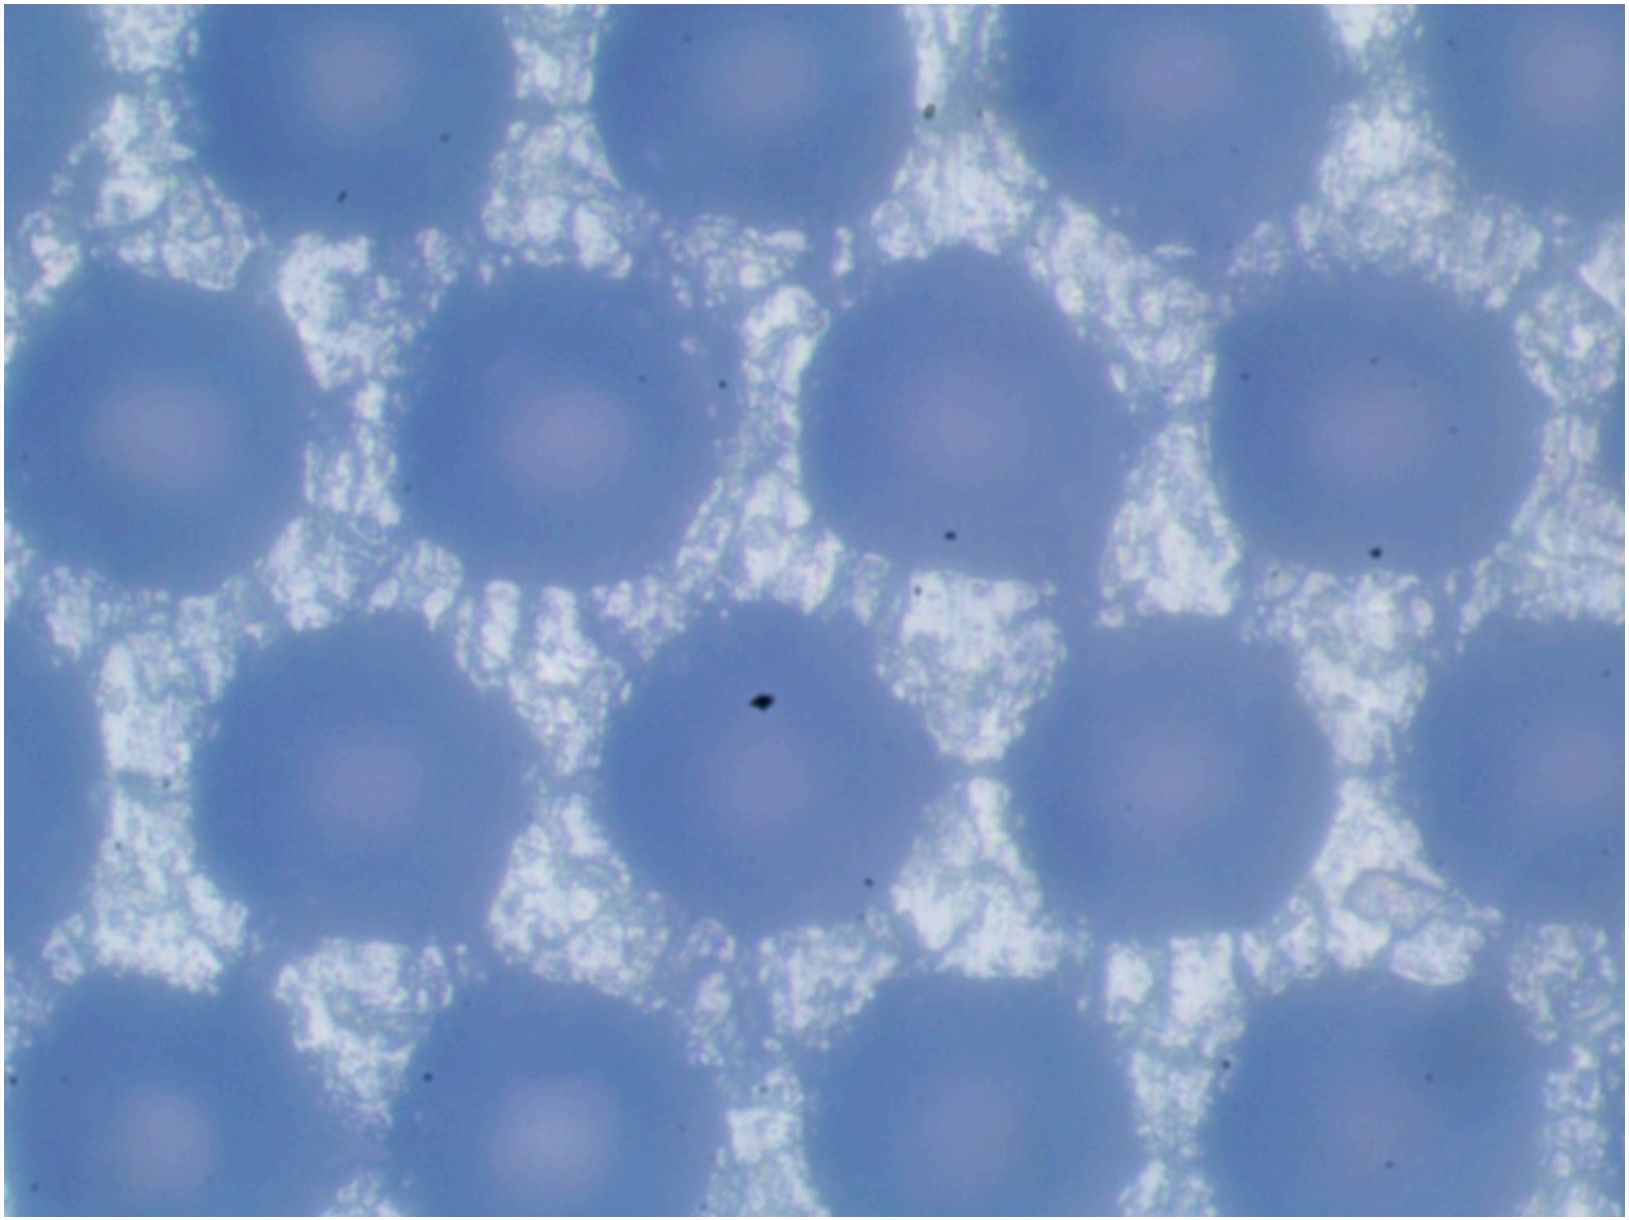
Page №173. Roll "z17011035". Length: 1300 mm. Photos with magnificaiton: x400. Cleaning passes: 1

Ink transfer volume decrease from the passport value: 45.95%

Bridge / Cell: 1 / 3
Depth before / after: 9 / 9 мкм
Depth decreased by: 0%

Comment
streaks scratch 470 chip 1180
1230.
Roll heavily ground off.

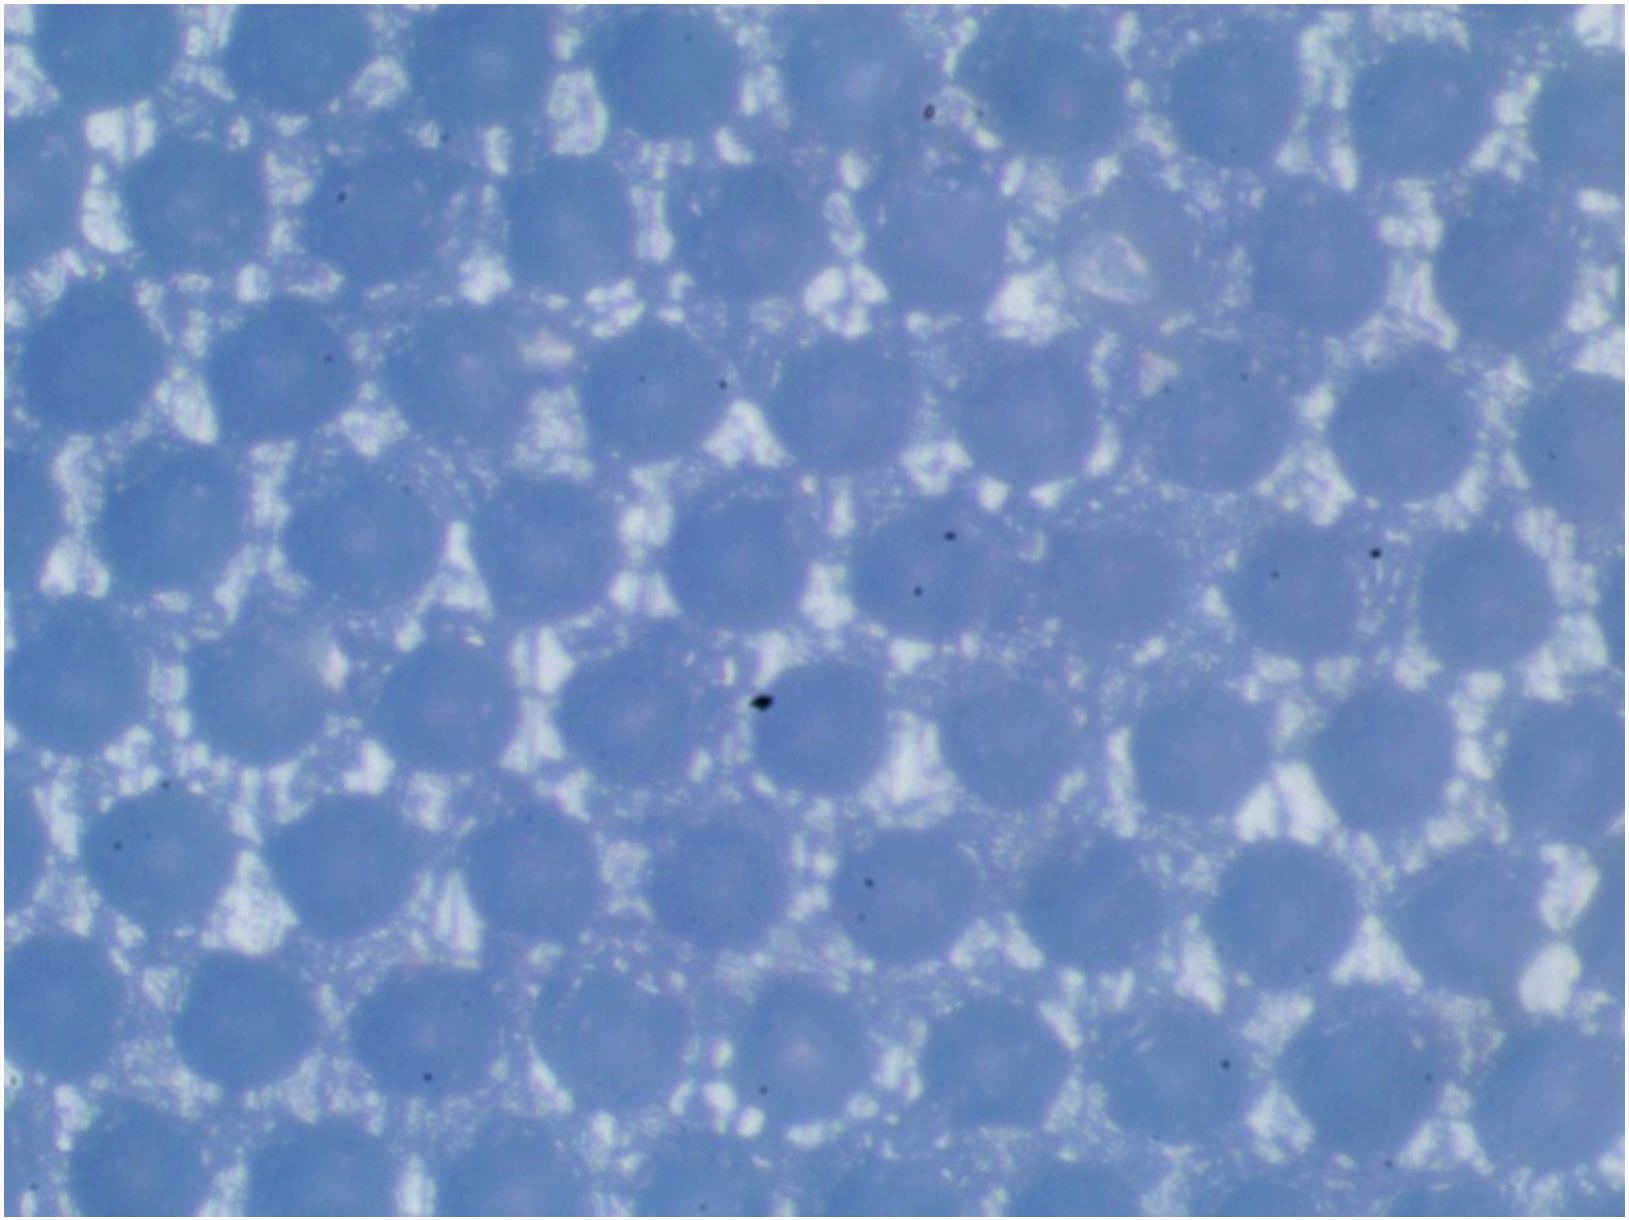
Page №174. Roll "z48074". Length: 1300 mm. Photos with magnificaiton: x400. Cleaning passes: 1

Comment
streaks chip 1170 1225 1230 spot 205.

Roll ground off.

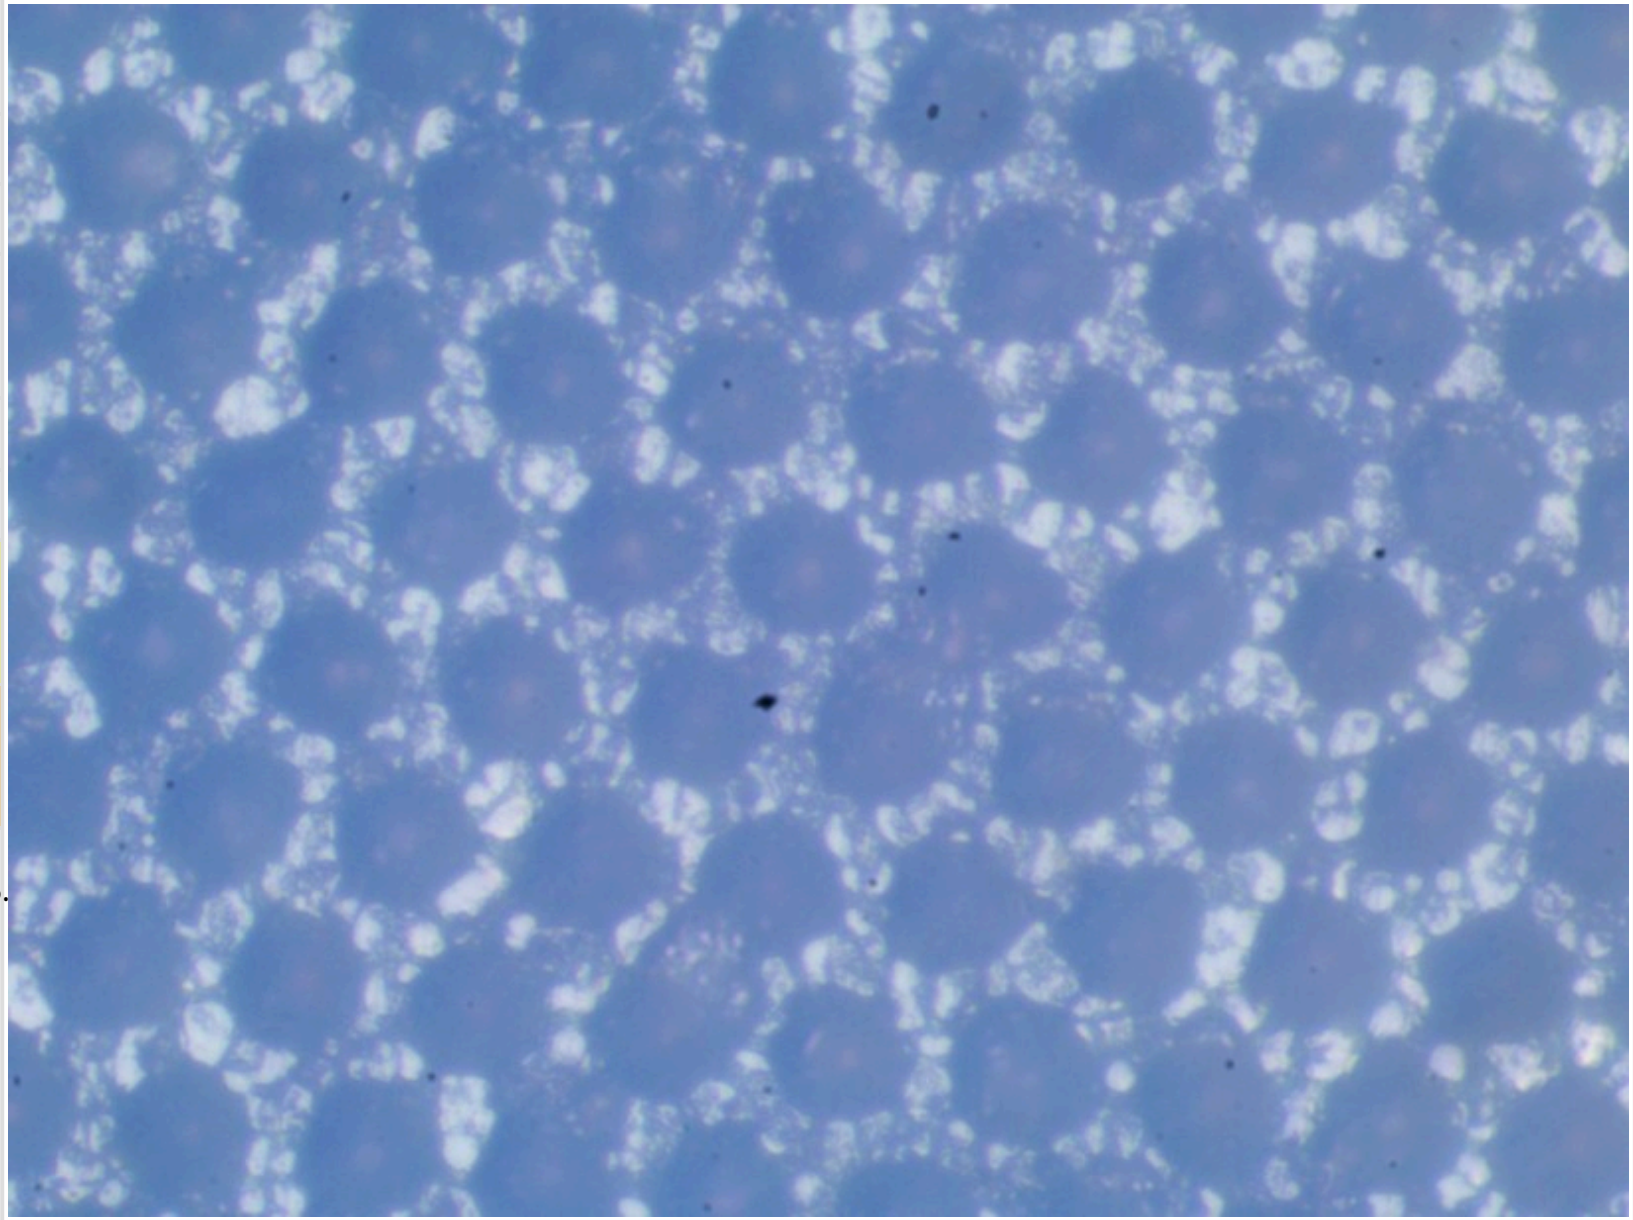
Page №175. Roll "z18006927". Length: 1300 mm. Photos with magnificaiton: x400. Cleaning passes: 1

Comment
chip 1120 1280 1035 1080 1190 1255.
Roll slightly ground off.

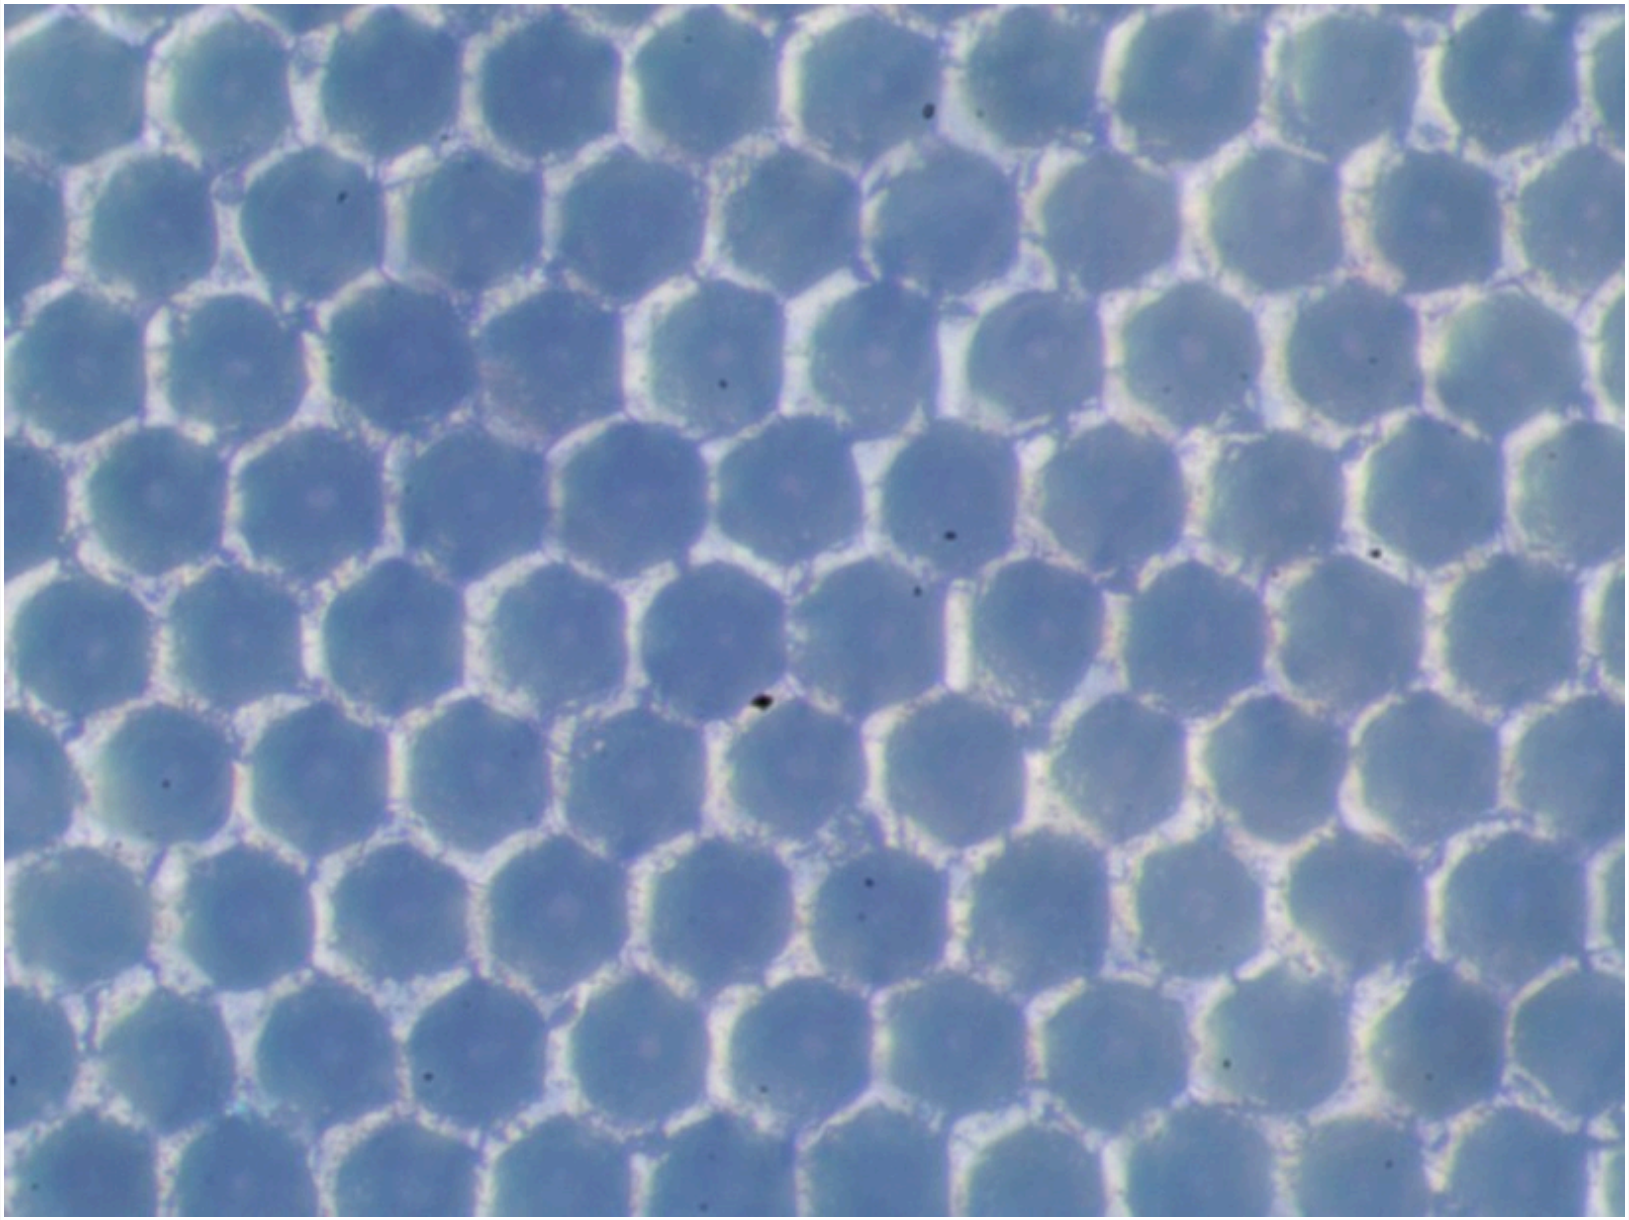
Page №178. Roll "z18009230". Length: 1300 mm. Photos with magnificaiton: x400. Cleaning passes: 1

Ink transfer volume decrease from the passport value: 27.14%

Comment
streak 124 335.
Roll ground off.
